DIGEST

No. 27, SEPT., 1961

DEPARTMENT OF CIVIL AVIATION

Prepared in the Division of Air Safety Investigation
Department of Civil Aviation.

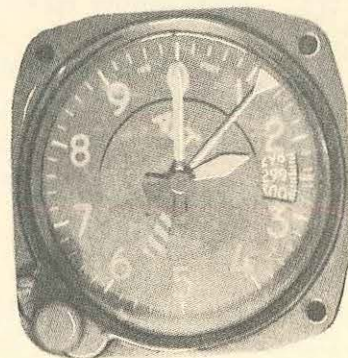
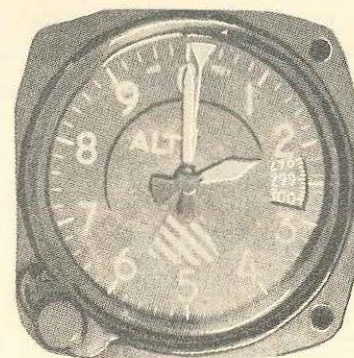
Error 1.

During a routine test flight of a four-engine commercial turboprop, the aircraft descended to 2,000 feet mean sea level without the pilots appreciating the fact. This altitude placed the aircraft just above a cloud layer. When the captain requested clearance to 3,000 feet MSL, he thought he initiated his descent from 12,000. The aircraft crashed while descending at an estimated 750 feet per minute. Nine people died in this one. The captain was a most highly regarded veteran of over 9,000 flying hours.

. . . what the pilot thought he saw

. . . what the altimeter actually read

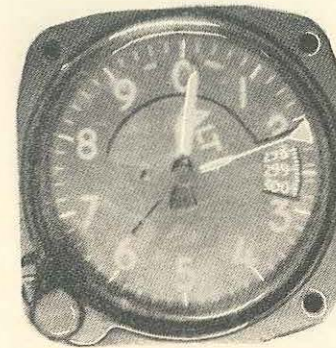
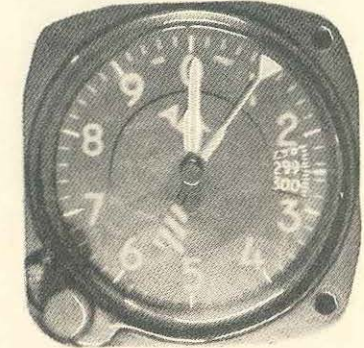
Error 2.

A multi-jet bomber crashed at an elevation of 4,500 feet MSL approximately two minutes after reporting leaving 20,000 feet. From the observations of another aircraft and mathematical computations it was conclusively proved the aircraft started its descent from 10,000 feet. The using command regards the probability as excellent that the crew misread their altimeters 10,000 feet. No crew members are alive to testify.

. . . what the pilot thought he saw

. . . what the altimeter actually read

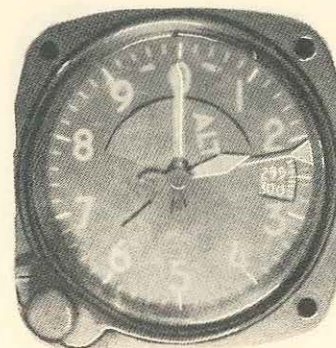
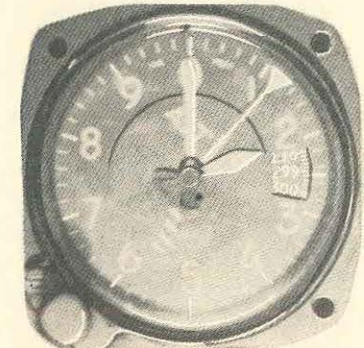
Error 3.

After making a missed approach, a multi-jet bomber climbed to —the crew thought — 22,000 feet. A seat change was made and a second penetration started. Going through what was thought to be 13,000 feet, the AC remarked that the ground looked awfully close. A recheck of the gauges revealed that it was — about 10,000 feet closer than the crew thought. Quite obviously the climb was made to 12,000 instead of 22,000

. . . what the pilot thought he saw

. . . what the altimeter actually read

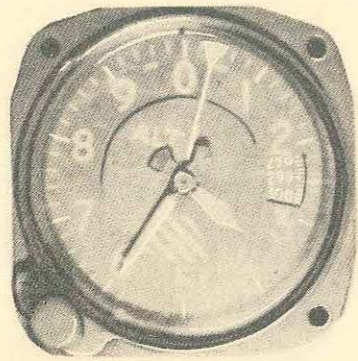
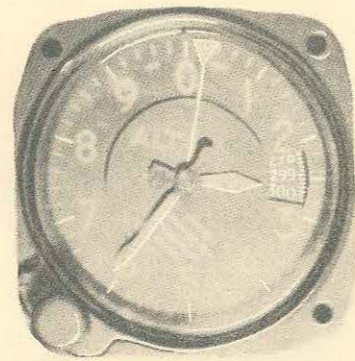
Error 4.

This multi-jet bomber was making a terminal VOR penetration at night. The aircraft touched down 10.5 nautical miles short of the runway. The crew made a recovery, climbed the damaged aircraft to 1,600 feet, intercepted the GCA glide slope, and landed without further incident. The runway was wet, permitting the rear gear, which was cocked 30 degrees left, to slide, and the crew was able to maintain directional control. The pilot misread his altimeter by 1,000 feet — reading 3,600 feet MSL, when the aircraft was actually at 2,600 feet MSL.

... what the pilot thought he saw

... what the altimeter actually read

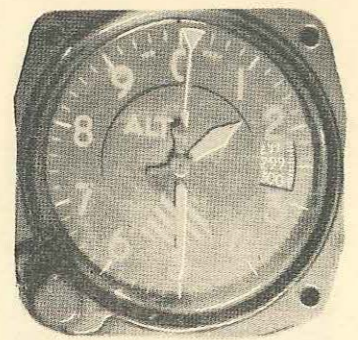
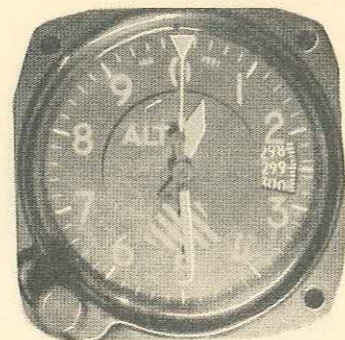
Error 5.

A four-engine MATS transport was making an instrument approach to a Middle East base. The aircraft commander, who had 7,200 flying hours, misread his altimeter 1,000 feet and the co-pilot failed to catch the error. Twelve people died in the ensuing crash.

... what the pilot thought he saw

... what the altimeter actually read

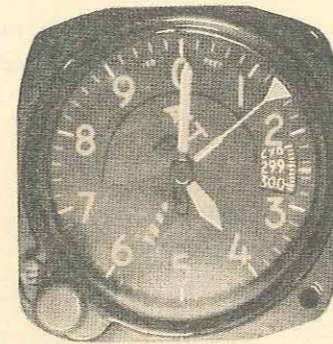
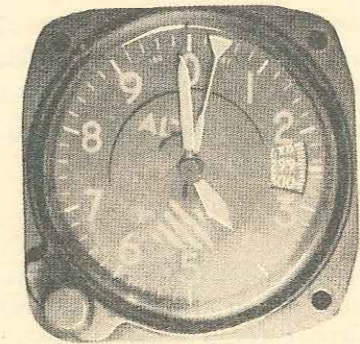
Error 6.

Another four-engine turboprop was approaching destination after a routine ferry flight at 24,000 feet. The aircraft was cleared for an approach, to report leaving 14,000 feet. A very short time after reporting out of 14,000 feet, the aircraft struck the ground in a wings level, descending attitude. The investigation conclusively proved the captain misread his altimeter by 10,000 feet and the co-pilot failed to catch the error. Incredibly enough, both pilots survived the crash.

... what the pilot thought he saw

... what the altimeter actually read

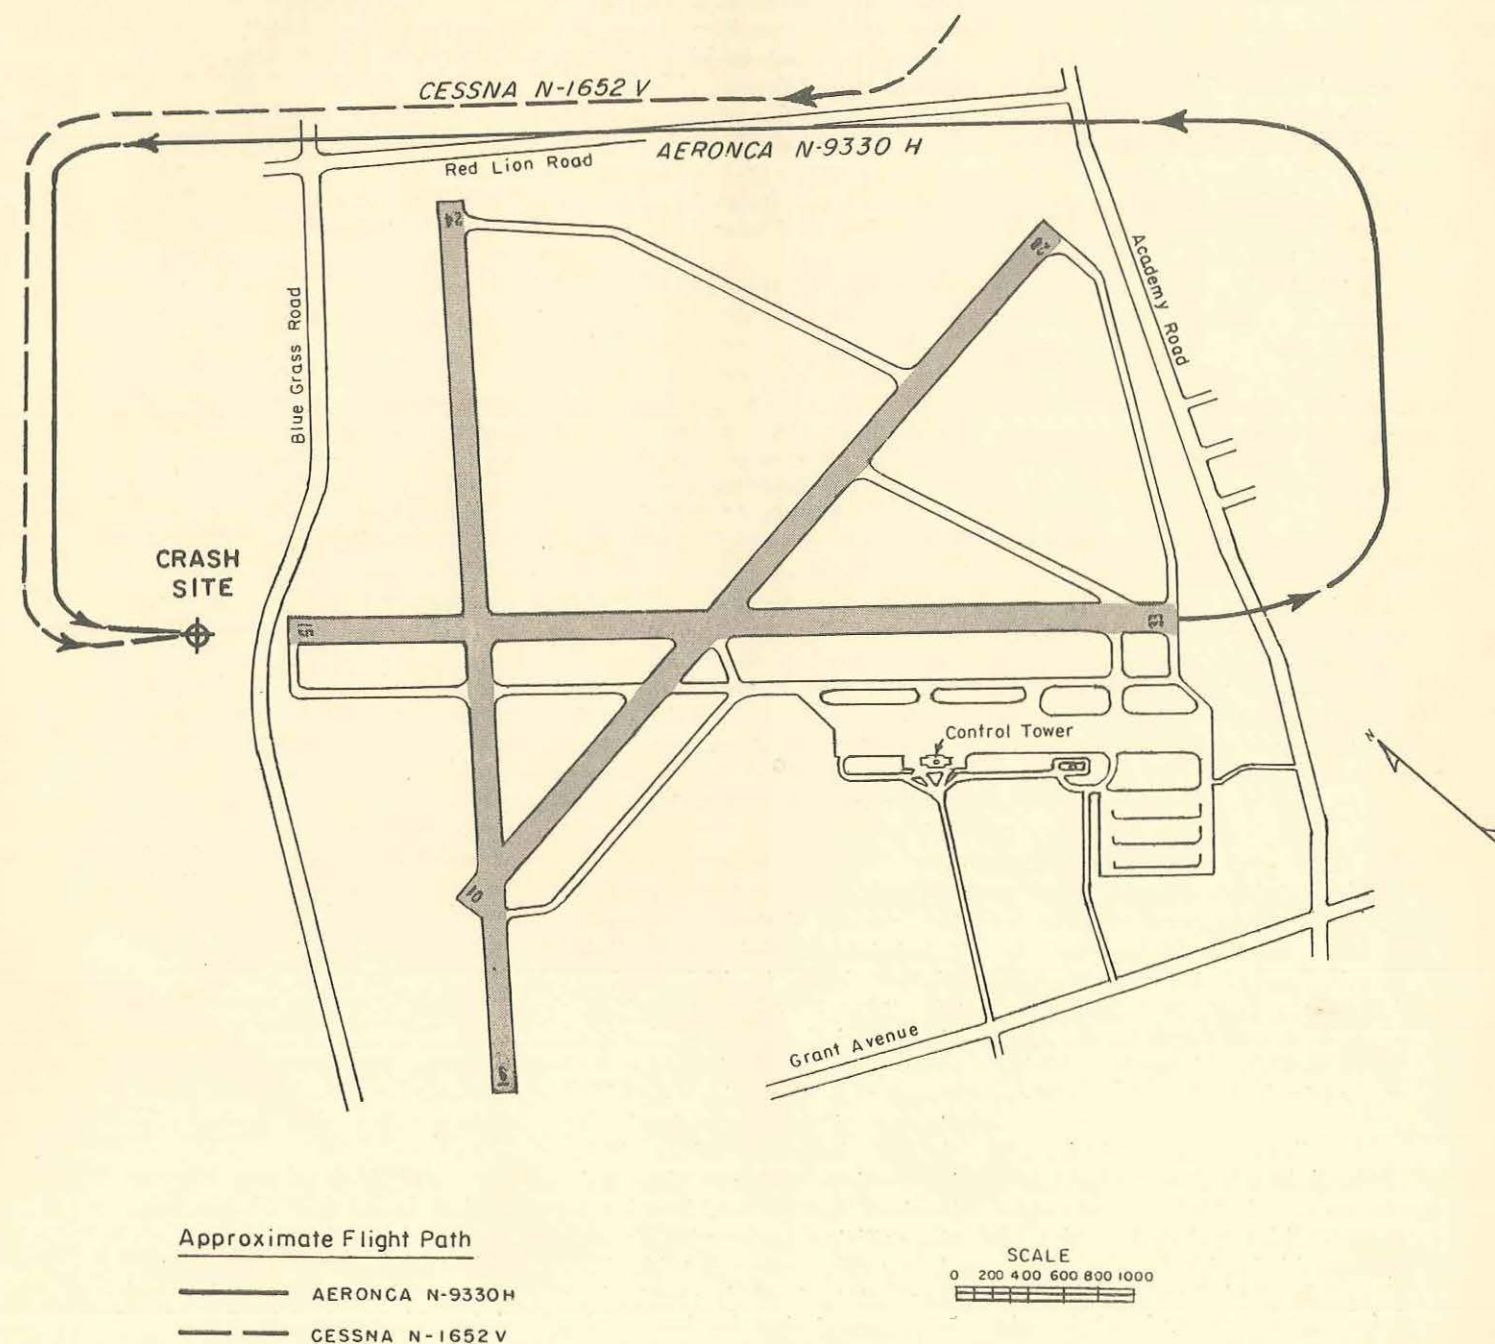
end and 375 feet to the left of the centreline of runway 15 (see sketch).

A witness in an automobile approximately 2,500 feet from the end of runway 15 observed the aircraft pass over his position just prior to the impact. He stated that at this point the Cessna was directly below and to the right of the Aeronca with a vertical separation of approximately 200 feet. All witnesses, including the North Philadelphia Airport tower personnel, agree on that relative position of the two aircraft just prior to impact.
