AVIATION SAFETY

DIGEST

No. 34, JUNE, 1963

DEPARTMENT OF CIVIL AVIATION

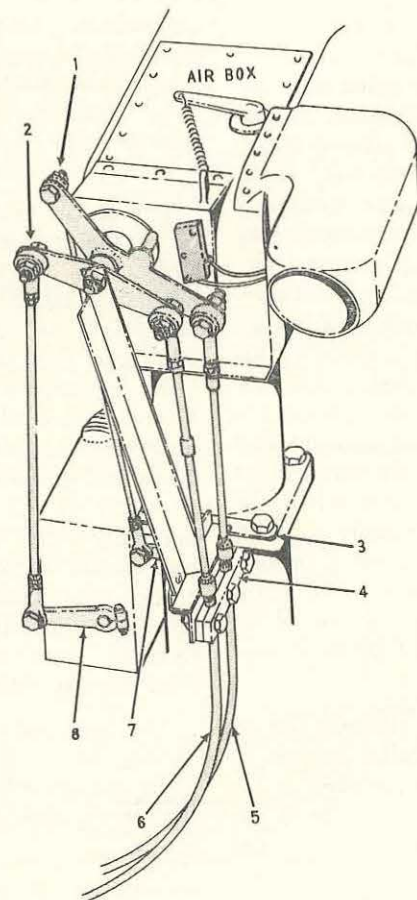
In the case under discussion the adjustable eye-end on the throttle rod had been installed on the starboard side of its lever, thus placing it between the two levers and bringing the heads of the bolts closer together. In this position both levers operated satisfactorily when tested independently on the ground. In flight, however, when the mixture control had been adjusted to approximately the half-open position, the bolt heads fouled as the throttle was advanced toward the fully open position.

| 1. Throttle Rod End. | 5. Throttle Cable. |

Although the situation was not critical in this case, correct assembly and rigging of all controls is essential for the safe operation of any aircraft. Licenced engineers are expected to be alert to the possibility of incorrect assembly and, by experience, be able to sense the correct installation position. Errors of this nature do not occur if engineers study the assembly before the linkages are disconnected and, where the correct assembly positions are not obvious, make a written note of the correct position.

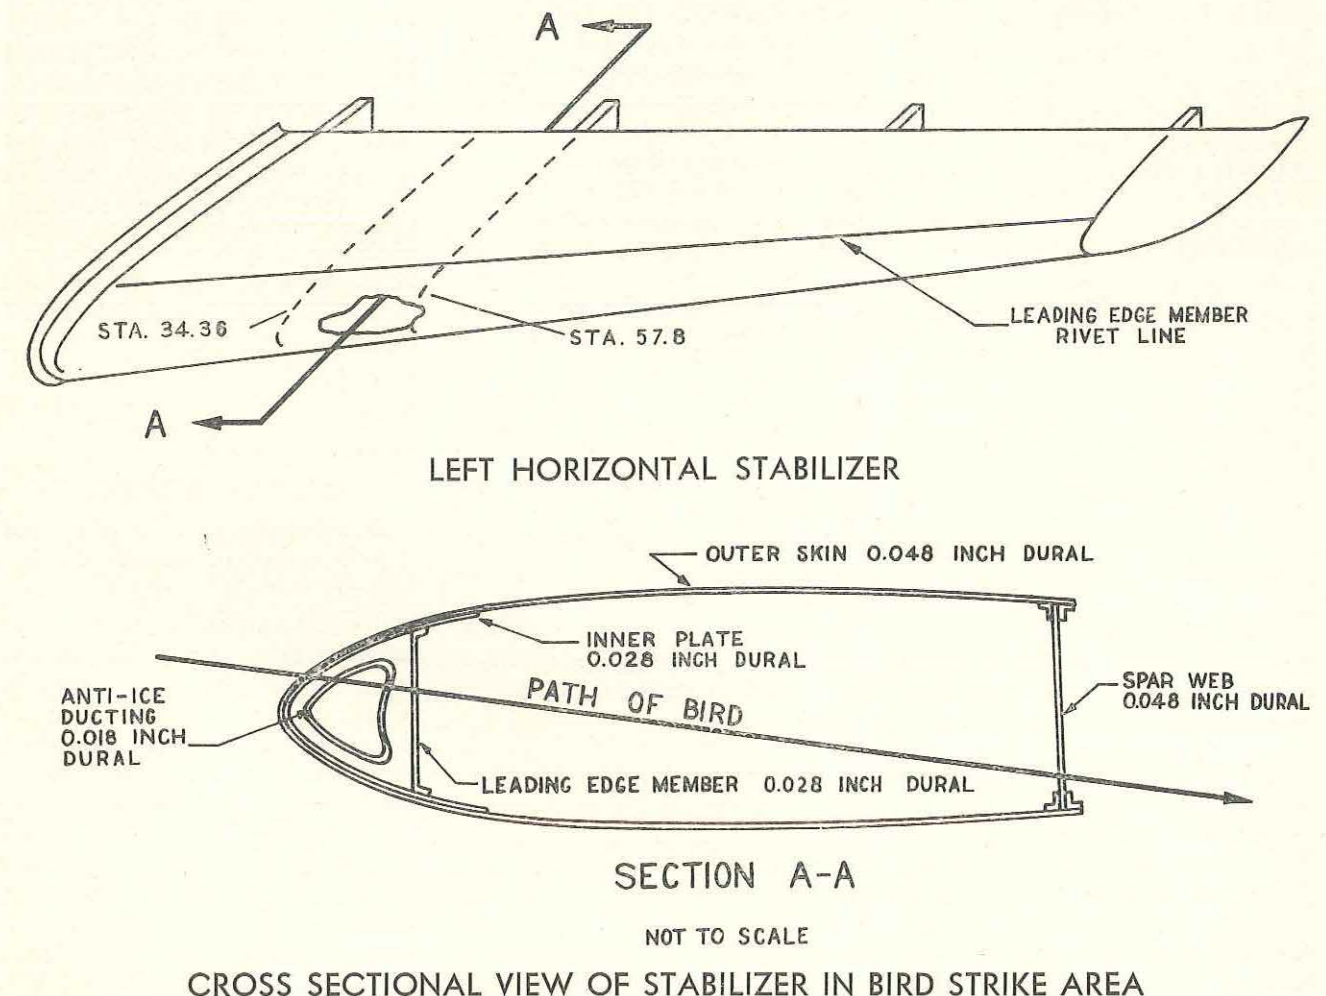
Subsequent to the accident, a partial bird carcass consisting of a large piece of skin covered with white feather, measuring 19 inches by 9 inches, was found 10 feet from the separated section of the left horizontal stabilizer. Specimens of white feathers, tissue and blood taken from the separated parts of the aircraft were identified by the U.S. Department of the Interior,

Fish and Wildlife Service, as belonging to an Olor Columbianus (whistling swan). The average weight of similar birds available at the Fish and Wildlife Service was 14 pounds for the male and 11.5 pounds for the female; however they are known to attain weights in excess of 18 pounds.
