# AVIATION SAFETY

# DIGEST

No. 35, SEP., 1963

Prepared in the Division of Air Safety Investigation,  
Department of Civil Aviation.

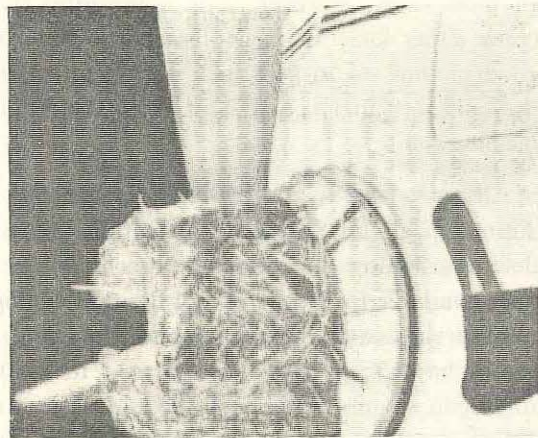
The bird's nest in the picture was discovered during pre-flight inspection of a Beechcraft Bonanza. The aircraft had not been flown for six days. Had the bird used shorter raw material so that none protruded from the blade cutouts in the propeller spinner, the nest might have gone unnoticed.

It takes a chicken 21 days to hatch an egg, and a turkey 28 days. Thus it would seem the harder the mother hen sits (or sets) on the egg the longer it takes to hatch. From this we wonder how long it would take to hatch the bird egg at the loads encountered in the spinner at the cruising r.p.m.

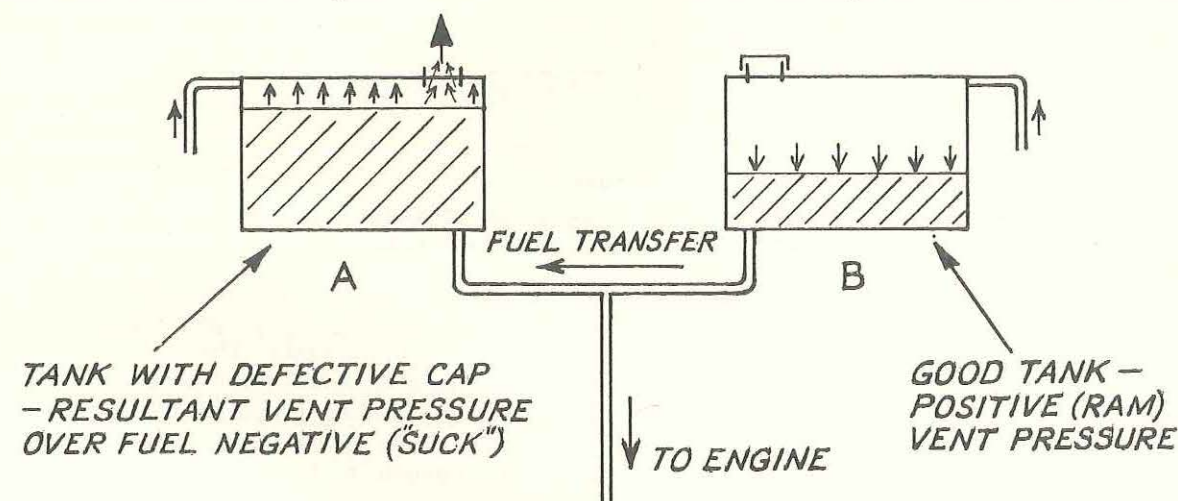
caps are almost inevitably located at the highest point in the system, i.e. on top of the wing, where the static air pressure in flight is always less than the free-stream air pressure (remember that "suck" above the wing is the main force supporting an aeroplane in flight). An improperly sealed tank cap in effect creates an additional vent open to a low pressure region, thereby causing a substantial reduction in air pressure in the tank and a corresponding reduction in the effective "head" of fuel available at the pump inlet or, in a pure gravity feed system, at the carburettor. With interconnected fuel tanks, however, the outcome can be much worse. In such cases the resulting unbalance in the respective tank vent pressure may not only lead to uneven feeding between two tanks, but to actual transfer of fuel from one tank to another. In a number of reported cases an effect of this nature has resulted in substantial quantities of fuel being ejected overboard through the defective filler cap before the situation became obvious to the pilot. Somewhat paradoxically, it is the "good" tank which empties first under these circumstances, as illustrated in Figure 1.

FIGURE 1  
ILLUSTRATING EXTREME CASE OF UNBALANCED VENT PRESSURES  
TANK "A" REMAINS VIRTUALLY FULL AND LOSES FUEL OVERBOARD WHILE THE LEVEL  
IN TANK "B" FALLS. WHEN TANK "B" EMPTIES AIR WILL BE DRAWN INTO THE  
ENGINE SUPPLY LINE.

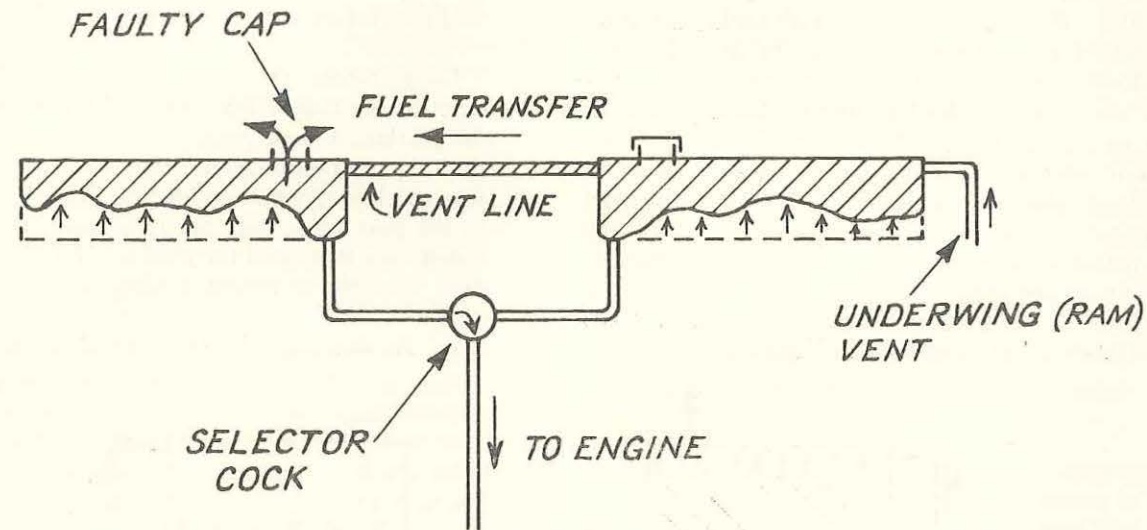
The only reasonable explanation is as follows. Firstly, the starboard tank cap must have been sealing so badly that substantial suction was applied to both fuel tanks (there is an interconnecting vent line) despite inflow of air through the pressure vent line fitted to the port tank. This would result in both tank cells collapsing from the bottom upwards, since they are buttoned to the supporting wing structure on the upper surface. At this stage another diagram may help — see Figure 2.

FIGURE 2  
ILLUSTRATING SQUEEZE EFFECT ON BAG TANKS DUE TO FAULTY FILLER CAP — FUEL FROM BOTH TANKS LOST OVERBOARD.

It will be seen that the starboard tank would have been gaining fuel from the port tank through the vent interconnection at the same time that it was losing fuel, at an even greater rate, through its own filler cap, not to mention the amount being drawn off to the engine. The inevitable depletion of this tank no doubt corresponded with the first reported power cut. It is obvious that the port tank must also have lost most of its fuel by this stage as the second engine failure followed quite shortly after selection of that tank.

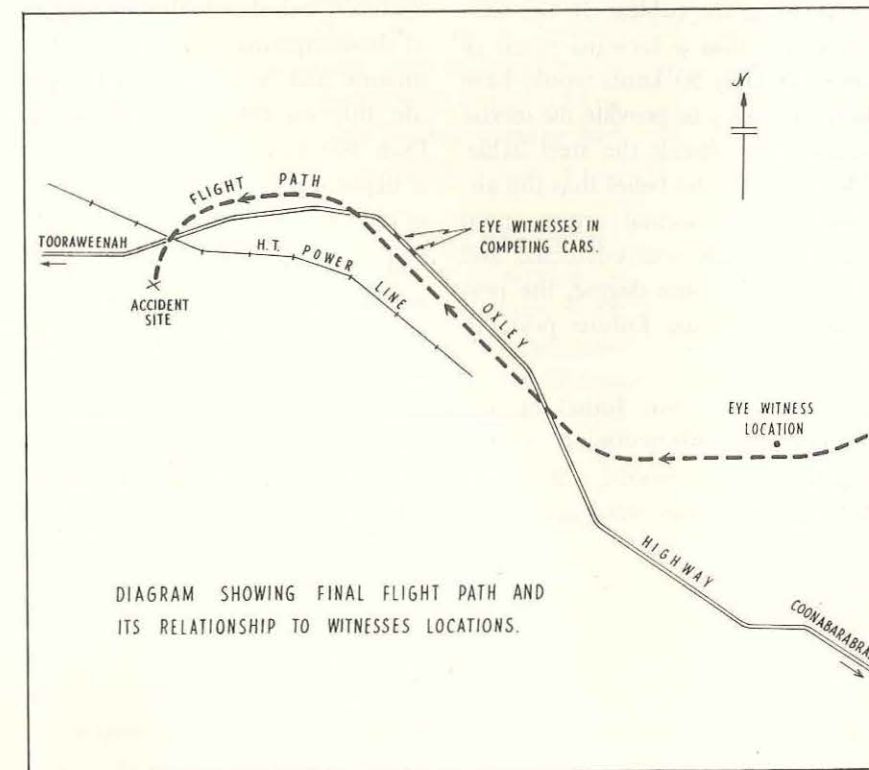
During the morning, a number of witnesses observed the aircraft flying at various heights along sections of the Oxley Highway between Tooraweenah and Coonabarabran. Immediately prior to the accident, the aircraft was observed by one witness flying towards Tooraweenah near the tops of trees bordering the Highway (see the locality diagram).

It was in full view of the observer until it turned to the right at a point approximately 600 yards from the observer's position. The aircraft was then occasionally obscured by trees until a short time later when it climbed slightly to just above tree top height and commenced a turn to the left. After turning through some 90 degrees, the aircraft was then obscured by a slight rise in the terrain and, almost immediately, smoke and flames were observed in this direction.
