AVIATION SAFETY

DIGEST

No. 38, JUNE 1964

DEPARTMENT OF CIVIL AVIATION

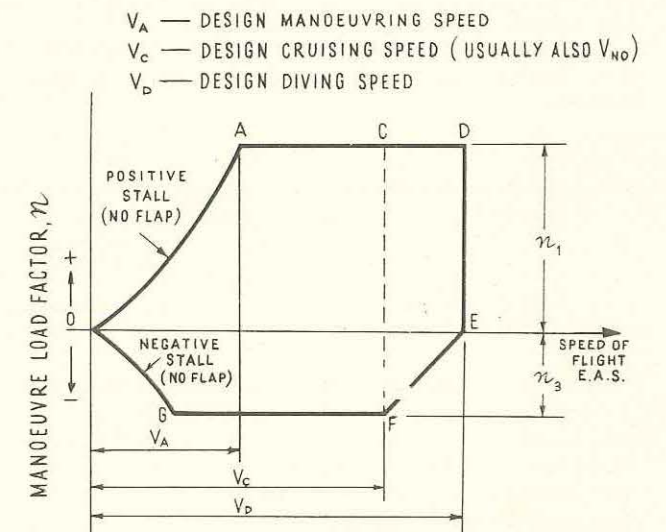
FIG.1 TYPICAL MANOEUVRE ENVELOPE

Loads imposed on the aircraft structure during symmetrical manoeuvres may be presented graphically in the form of a V-n diagram, often called a Manoeuvre Envelope. A typical Manoeuvre Envelope is shown in Fig. 1. The vertical axis of the graph is the load factor “n”, which is simply the ratio of the total lift produced by the aircraft structure, to the actual weight of the aircraft. (To make this relationship clear, we can take the example of an aeroplane in a balanced steep turn maintaining a constant airspeed with a 60° angle of bank. As many of us will recall from our student days, this manoeuvre will subject the aircraft to a force of “2G”, i.e., twice the force of gravity. Because the aircraft is in a state of equilibrium, the lift it is producing in the turn must equal twice the force of gravity. In other words the ratio of the lift to the weight of the aircraft is 2:1). The horizontal axis of the graph is the aircraft speed, “V”, and as long as the aircraft is never operated at a combination of “V” and “n” outside the Manoeuvre Envelope, it remains structurally safe.

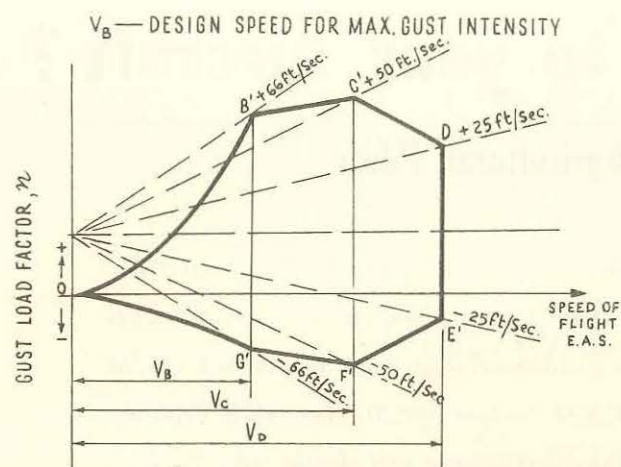
FIG. 2 TYPICAL GUST ENVELOPE

that it is the gust itself which introduces the loads to the structure by effectively changing the angle of attack of the aeroplane. The effects of gust loading can also be presented in the form of a V-n diagram, which in this case, is called a Gust Envelope. A typical Gust Envelope is shown in Fig. 2.

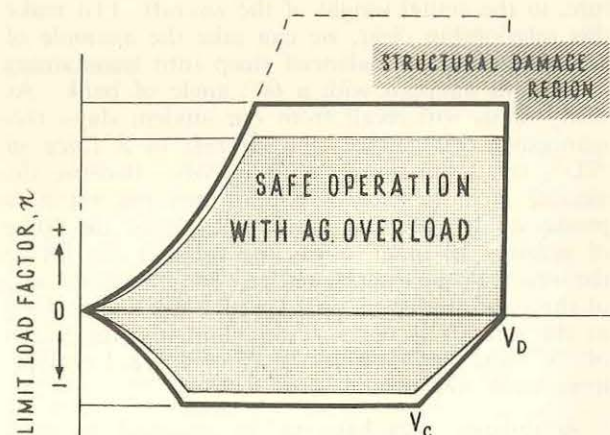
FIG. 3 FLIGHT STRENGTH ENVELOPE

Although the difference in load factor may not appear to be large, it represents for a typical aircraft of 3,000 lb. design weight, a reduction in limit load of approximately 15 per cent. This means that the limit load is becoming more easily attainable, particularly when it is remembered that the flight controls were designed to function under the more generous limitations of the original load factor. It will also be noted that not only are the load factors lower, but the stall boundaries have moved, giving higher stalling speeds.

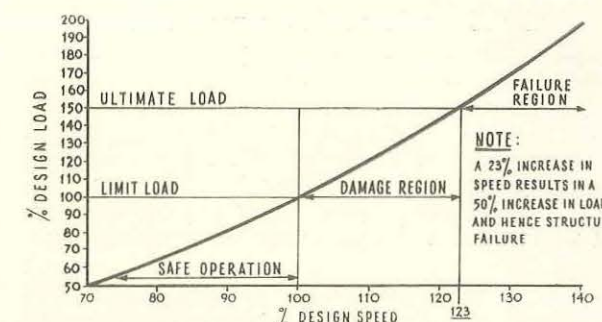
FIG. 4 VARIATION IN APPLIED LOADING WITH SPEED

Flight tests in connection with the Department's fatigue studies have shown that some pilots operate their aircraft up to measured limit load factors of 3.0g. While this is safe at normal design weights, it is most hazardous at any higher weight and adversely affects fatigue life.

The effects of "bunting" to close hopper doors is another practice which can affect fatigue life, as

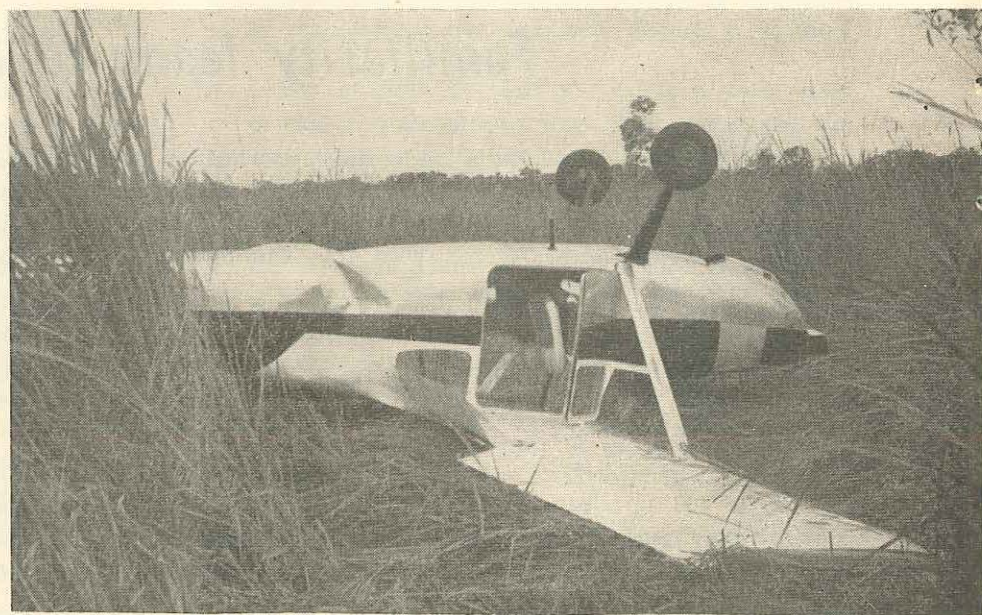
The total loss of engine power had been brought about by what appears to have been simultaneous mechanical failure in both magnetos; subsequent examination showing that the tungsten contact points had become detached from the fixed arm of the contact breaker assemblies.

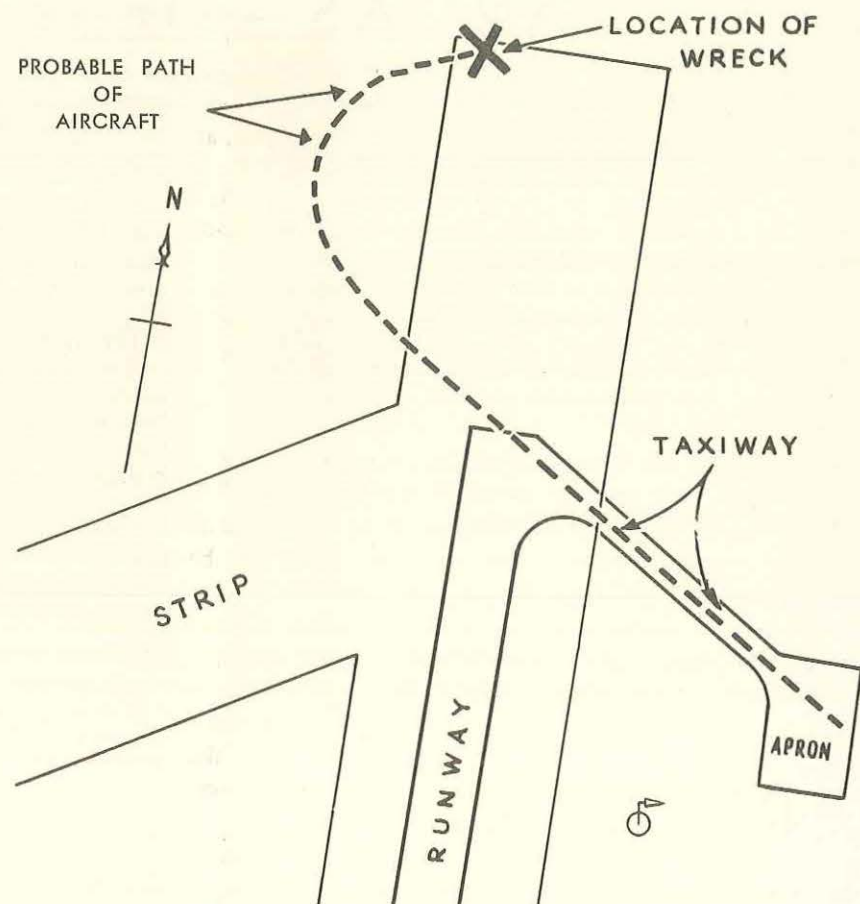
ground in a level attitude 350 feet from the point of first contact. The force of this last impact was severe enough to dislodge the engine from its mountings and to fracture the fuselage just aft of the rear cockpit. No fire broke out and both occupants were able to extricate themselves from the wreckage. The pilot suffered a broken nose and

A thorough examination of the wreckage was carried out, including a strip inspection of the engine. This investigation could not produce evidence of any defect or malfunction which could have been a contributory cause of the accident. Indeed, the inspection of the engine and propeller showed that the engine was delivering power at the moment of impact, and it was concluded that as a result of the fuel having been turned on, the engine had commenced to fire again an instant before the aircraft crashed.
