AVIATION SAFETY

DIGEST

No. 39, SEPTEMBER, 1964

DEPARTMENT OF CIVIL AVIATION

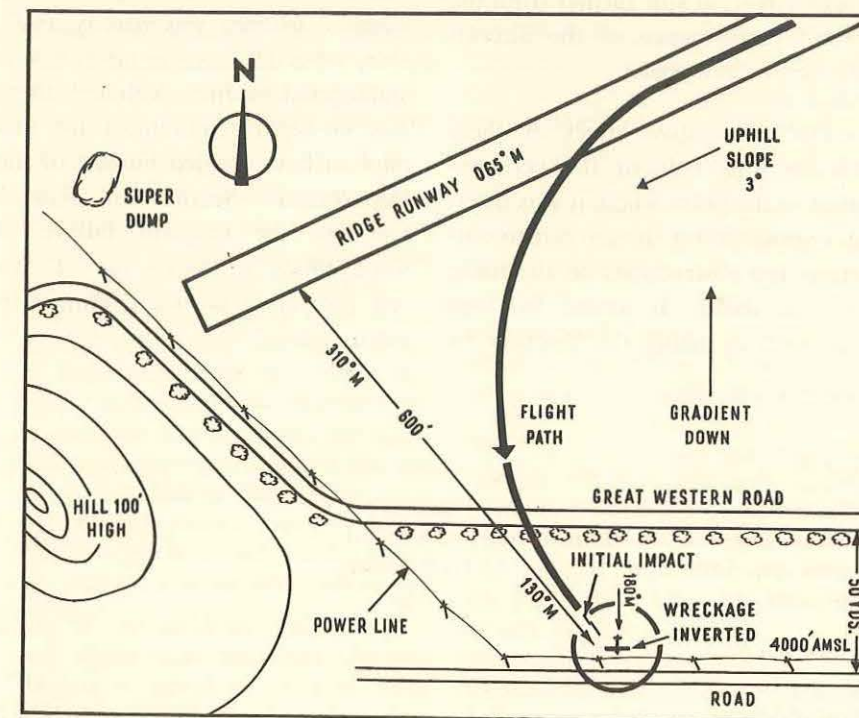
The fact that the aircraft overshot during the approach to land on the strip is not at all surprising when the circumstances are considered. In the first place, the pilot's total experience was limited, and was spread over a period of some twelve years. During the year preceding the accident he had flown only 22 hours. Secondly, his experience on the aircraft type amounted to only 17 hours. It has been found that inexperienced pilots often misjudge an approach when they enter a circuit area at an unfamiliar height, and so the third factor against the chances of a successful precautionary landing was the necessity for making the circuit at a low altitude. Finally there was the airstrip itself. Such characteristics as its slope and the proximity of obstructions might well have been con-

fusing to the pilot, particularly in the state of mental stress to which he would have undoubtedly been subjected at the time.

As a result of the overshoot, the aircraft was still nearly ten feet above the ground when it was approximately half way up the airstrip. Even so, it is very probable that the aircraft could have been brought to a standstill in the remaining length if the pilot had persisted with the landing. Even if this could not have been achieved, the consequences of over-running the end of the strip would have been far less serious than those of attempting another circuit. An experienced pilot would probably have appreciated this fact, and made the best of the landing in the space that remained.

It is apparent that the accident stemmed from the pilot's attempt to carry out a missed approach procedure which was beyond the performance of his aircraft. The weather conditions existing at the time, together with the lack of experience displayed by the pilot firstly in persisting with the flight into adverse weather, and then in misjudging his approach to land, were contributing factors.

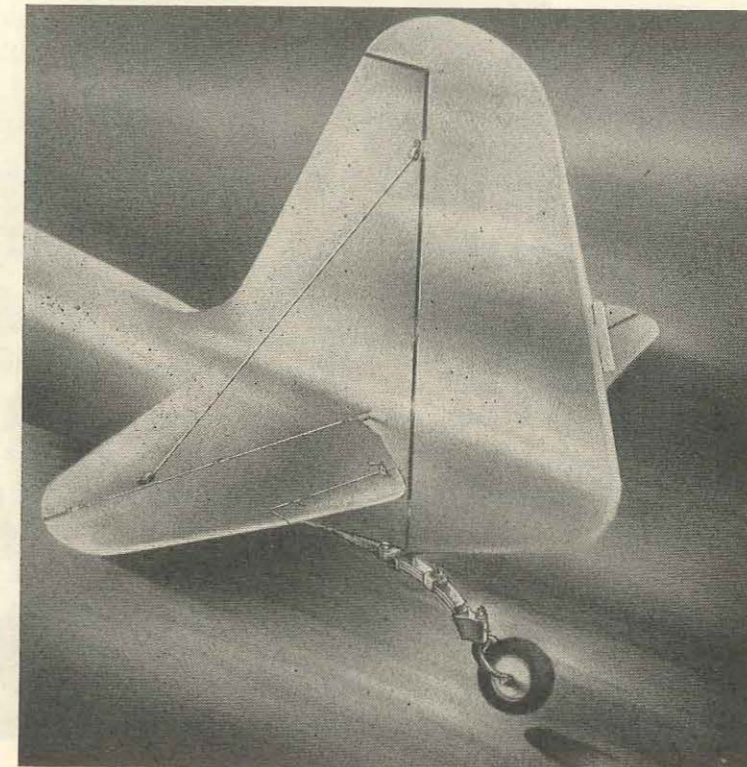
"Where can I locate my wheel?" So wrote the pilot of a light aeroplane in reply to an enquiry from this Department asking if a wheel found on a South Australian country aerodrome had fallen from his aircraft. Incredible as this story may sound, it is true!

When the Senior Groundsman of the aerodrome was making his regular inspection of the movement area, he discovered what appeared to be a tail wheel and fork from an Auster aircraft. It was learned that only one light aeroplane had landed at the aerodrome during the preceding two days and so the Department immediately wrote to the owner/pilot to see if he could shed any light on the mystery. The pilot replied, confessing his embarrassment at the situation but at the same time admitting his relief that the tail wheel had been found! His letter went on to explain how the predicament had occurred.

split pin. To make his aircraft more comfortable on the ground, this pilot had previously replaced the solid-tyred wheel with a pneumatic one, but it was his practice to carry the original tyre and fork assembly as a spare. On this occasion, the pneumatic tail wheel had been punctured after landing so it was removed by raising the tail of the aircraft, undoing the castle nut and pulling out the pivot bolt. The spare assembly was then substituted and the nut replaced and tightened but, **because the split pin had been lost in the grass, the nut was left unlocked.**

The pilot's first inkling that anything was amiss was when he landed back at his home after a flight from the aerodrome concerned. The nut apparently worked loose while the aircraft was taxiing on departure and the assembly probably fell off during the take-off run. No damage was done to the aircraft when it landed as the leaf spring to which the tail wheel assembly had been attached, acted as a tail skid.

As the pilot pointed out in his letter, he has learned that nuts will not stay on without being locked. He hopes someone else might benefit from his experience!

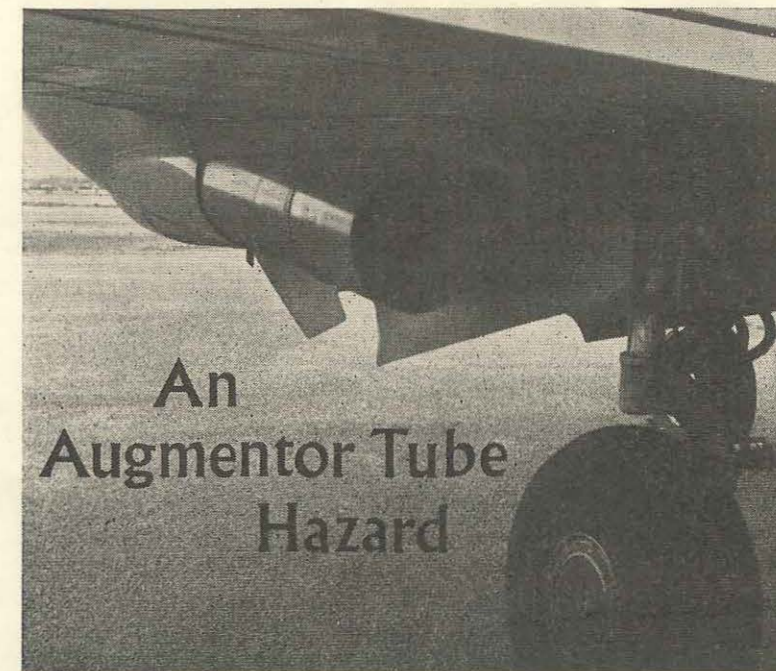
At Canberra recently, an engine of a Cessna 310 caught fire while it was being started for a flight to Cootamundra. A loud explosion inside the engine nacelle caused the cowlings to be blown open and the fire followed, but it was quickly extinguished by the fire crew and the damage was confined to the cowlings themselves.

At the time the engine was hot and the pilot had at first tried to start it without priming. When the engine would not catch, he primed it for two or three seconds and the explosion occurred on the next start attempt.

The problem is not confined to Cessna and Beech aircraft but applies equally to the starting of all aircraft that are fitted with augmentor tubes. Pilots can do much to eliminate the problem by at least observing the two golden rules of avoiding engine flooding, especially with a hot engine, and ensuring proper ventilation of the nacelle area by avoiding, as far as possible, downwind or excessive cross-wind start-ups.
