AVIATION SAFETY DIGEST

DEPARTMENT OF CIVIL AVIATION

Prepared in the Air Safety Investigation Branch,
Department of Civil Aviation, Commonwealth of Australia.

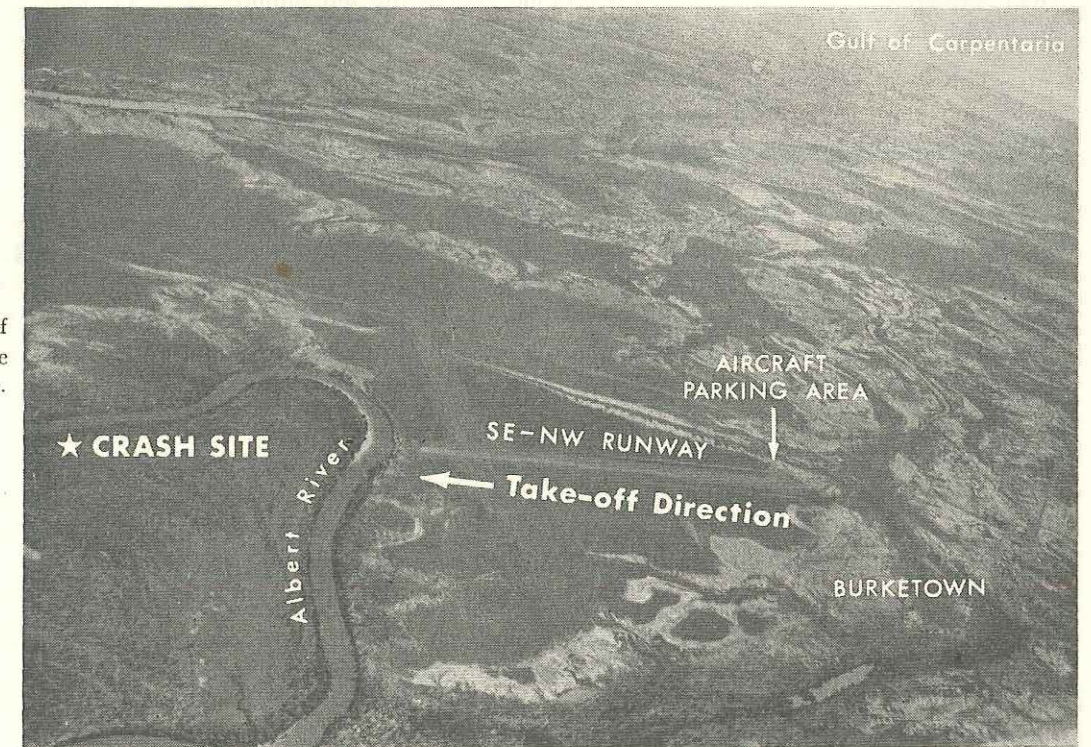
The aircraft had taken off from the parking area into the south-west and the wreckage was found three-quarters of a mile beyond the river, almost in line with the direction of NE-SW runway. Examination of the wreckage and the spindly trees among which the crash occurred, clearly showed that the aircraft had dived almost vertically into the ground at high speed. The propeller hub was buried 15 inches in the ground, and the entire cabin area and the mainplanes had been crushed and telescoped. Only the tail assembly and the section of the fuselage aft of the luggage compartment remained substantially intact, though badly buckled in places. The damage to the engine and flying controls was so severe that it was impossible to determine their settings before the crash, but no evidence was found of any failure that was not the result of impact forces. The

Aerial view of Burketown Aerodrome and Crash Site.

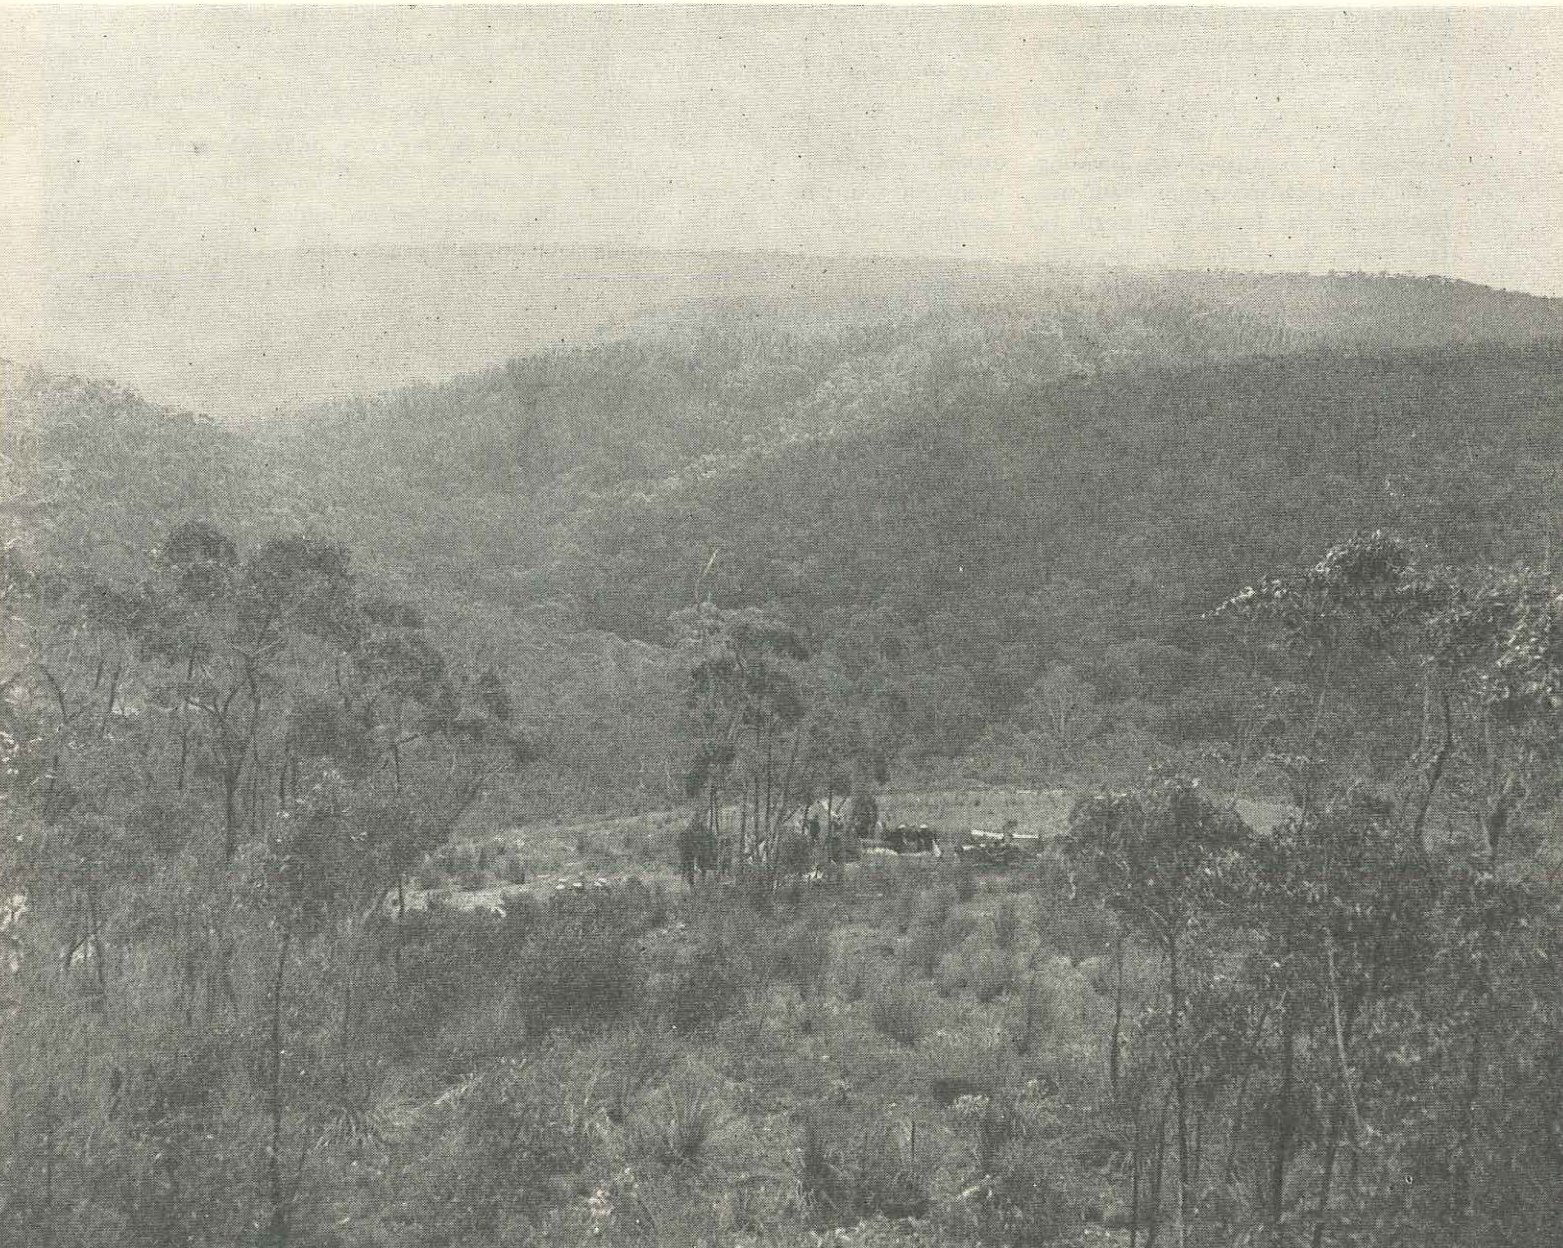
View looking back along final flight path from hillside immediately above accident site.

the highest point in the range. The ridge is 1400 feet above sea level and the aircraft struck the ground 150 feet below its summit.

The impact with the ground was severe, disintegrating the aircraft structure almost completely and forcing the engine and propeller more than two feet into the hillside. Despite the very extensive damage, it was determined that the engine was developing substantial power at impact and an exhaustive examination of the wreckage failed to disclose any defect which might

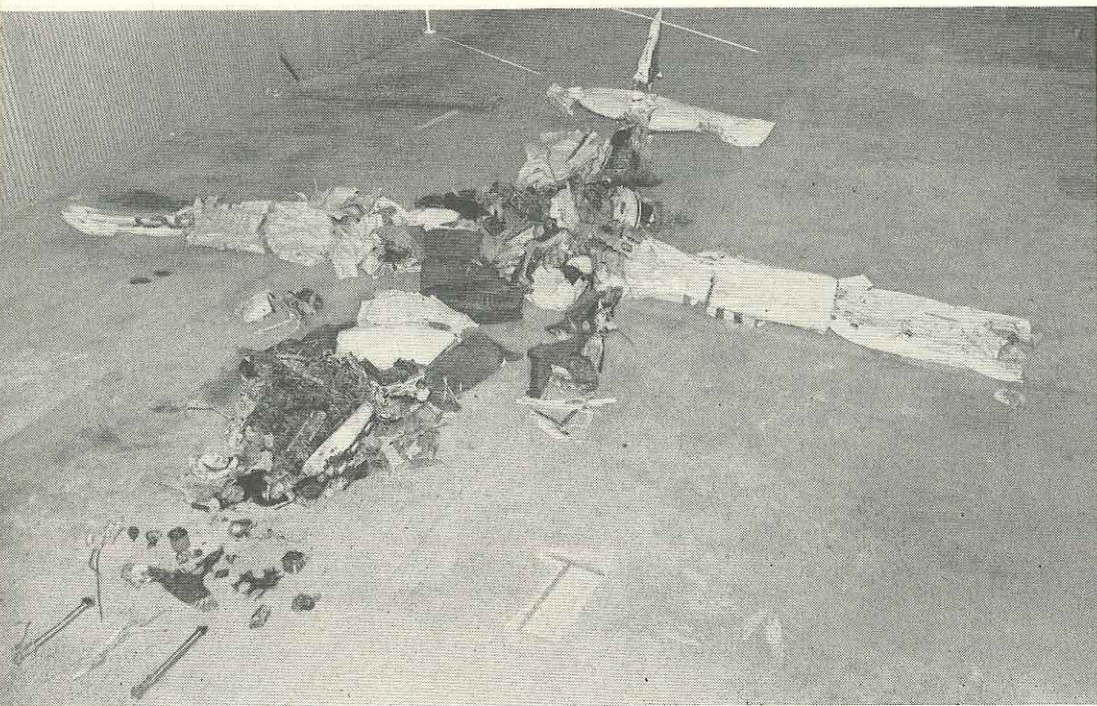
The wreckage re-assembled during the investigation. Note the extreme chord-wise compression of the wings.

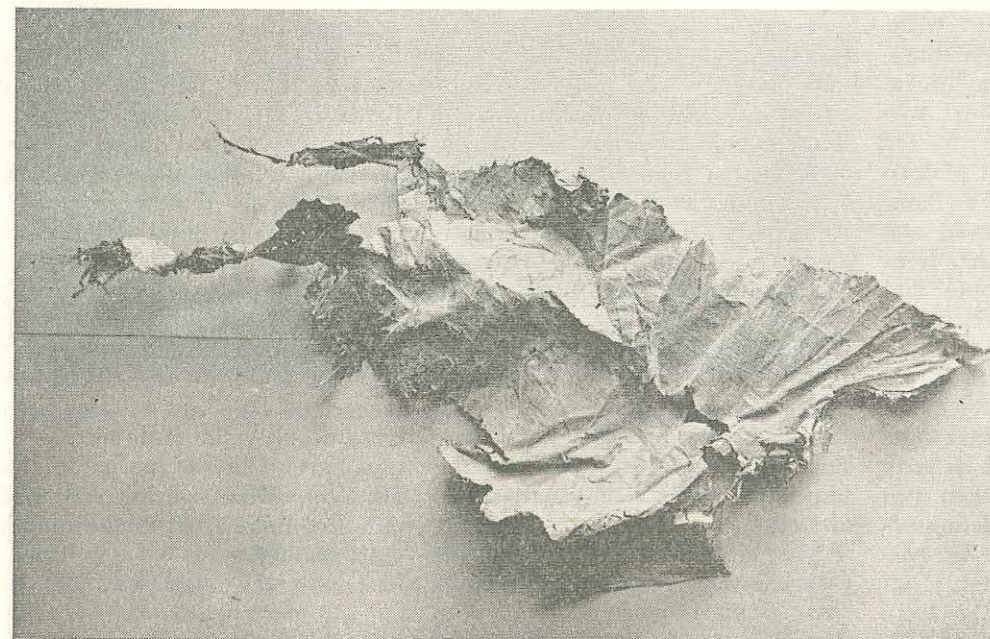
A large piece of reinforced packing paper was found in the wreckage associated with the base of the hopper and the louvers. This had probably prevented the dumping of the load. It was also probable that it had prevented the hopper from discharging fully on the previous flight, with the result that the aircraft could have been overloaded for the second flight. Numerous other pieces of packing paper were found in the bulk super-phosphate heap at the airstrip. The fertilizer had been transported in rail trucks lined with the paper and pieces had apparently been torn out when the trucks were being unloaded.

THE SUSPECT —

This is not considered to be a situation warranting mandatory procedures, but it would certainly seem that all agricultural operators and pilots should be conscious of the hazard and should implement preventative measures which ensure that the safety of their operations is not prejudiced.

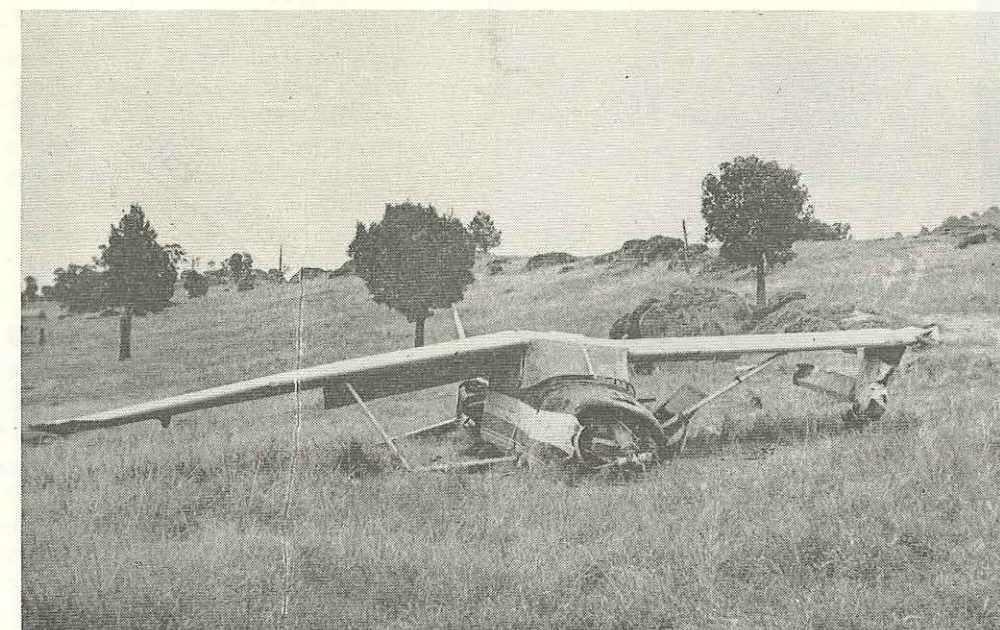
— AND THE VICTIM

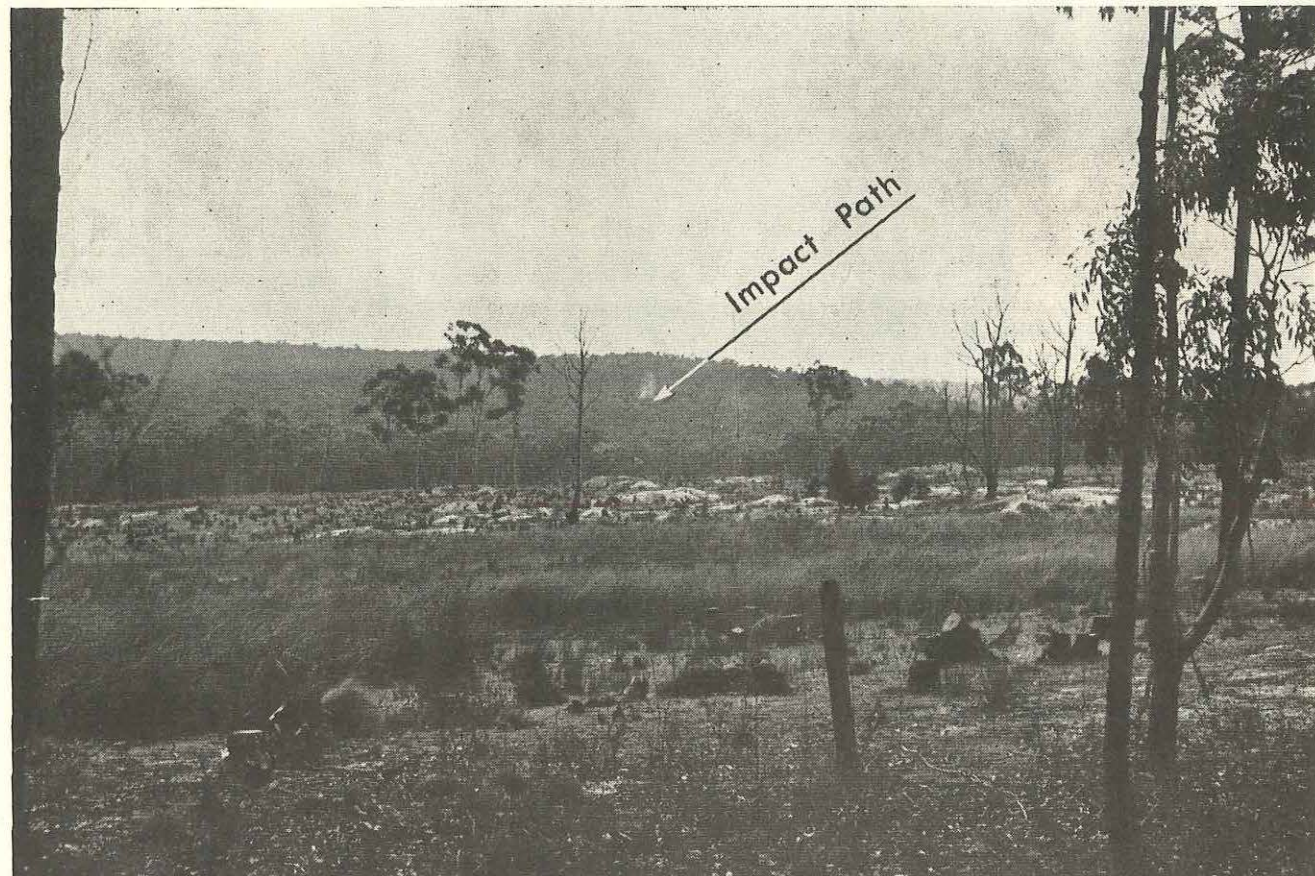
View looking east towards accident site in general direction of flight. The smoke marker shows the location of the wreckage.

The accident occurred at an elevation of 1300 feet on the south-western slopes of a heavily timbered hill 1500 feet high. The site is 14 miles south-west of Ballarat and twelve miles south-west of the intended track.

Examination of the scene showed that the aircraft had first struck a tree 30 feet above the ground, and had then been demolished as it descended through other trees. The engine was buried four feet in the ground and wreckage was scattered over an area almost 200 feet square. From the tree damage and wreckage, it was evident that the aircraft had dived steeply into the ground at high speed. The engine had been delivering considerable power at impact and the wreckage yielded no evidence of any defect that could have contributed to the accident. Both the flaps and the undercarriage were in the retracted position.

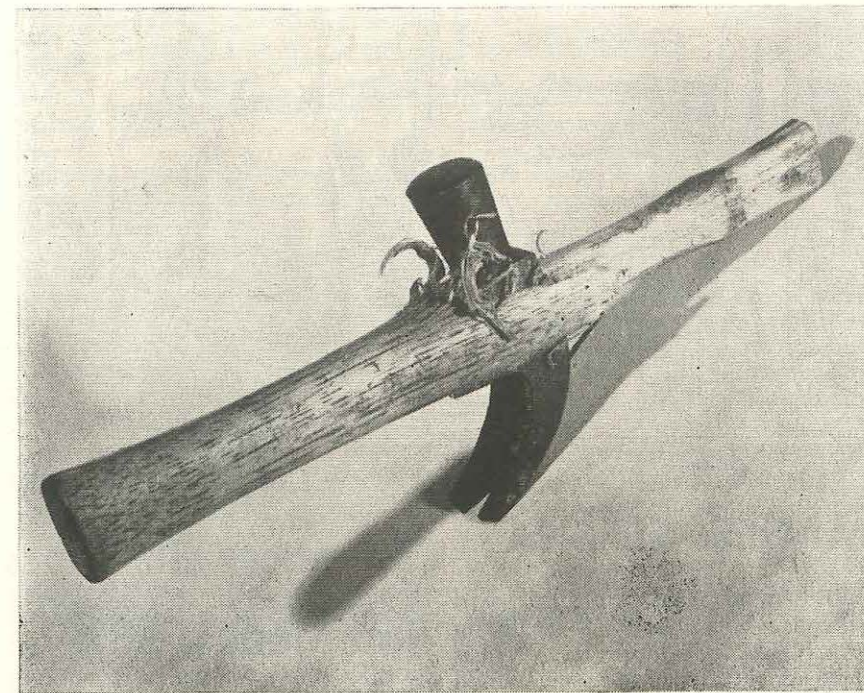
This hammer was carried in the aircraft's tool kit. The position into which the head has been forced graphically portrays the violence of the impact.

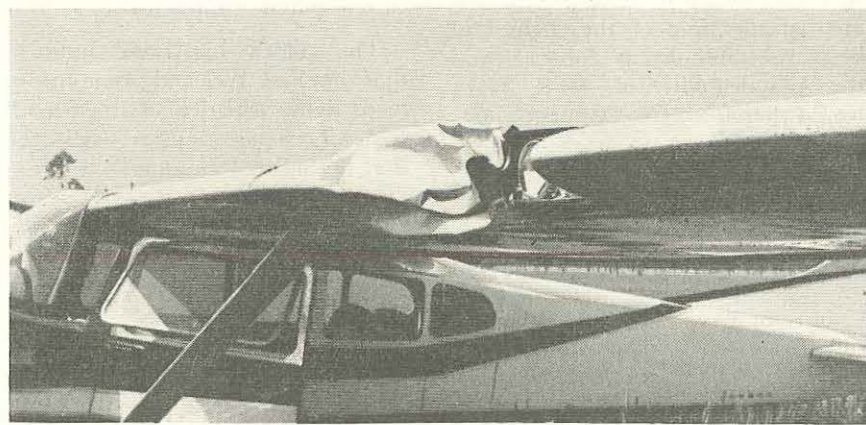
After descending to 700 feet and reducing the airspeed to 90 knots, the pilot began a medium turn to starboard, concentrating on keeping the station buildings in the view of the photographer. The aircraft had almost completed a full turn when a heavy bump was felt on the port side. Looking quickly around, the pilot saw the remains of a large wedge-tail eagle fluttering towards the ground and that the leading edge of the port wing had been badly damaged.

When the internal wing structure was inspected, it was found that three leading edge ribs had been severely damaged and the main spar slightly bowed.

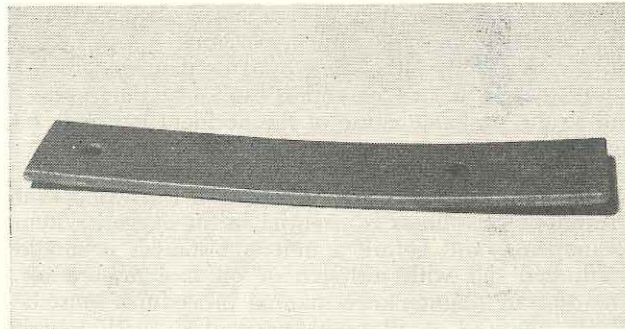
FIGURE 1

seriousness of these incidents. It is remarkable that although in both cases the objects fell into closely settled residential suburbs, no injuries or damage were caused. Figure 1 shows one of these pieces of aerial jetsam, which is obviously a riveting dolly. It is not difficult to imagine the consequences of it falling into a crowded street.

Over the years, Australian aircraft maintenance engineers have built up an enviable standard of workmanship. It would be a great pity if this reputation were marred because we omit to make a thorough check for all our tools and equipment after completing a service on an aircraft.

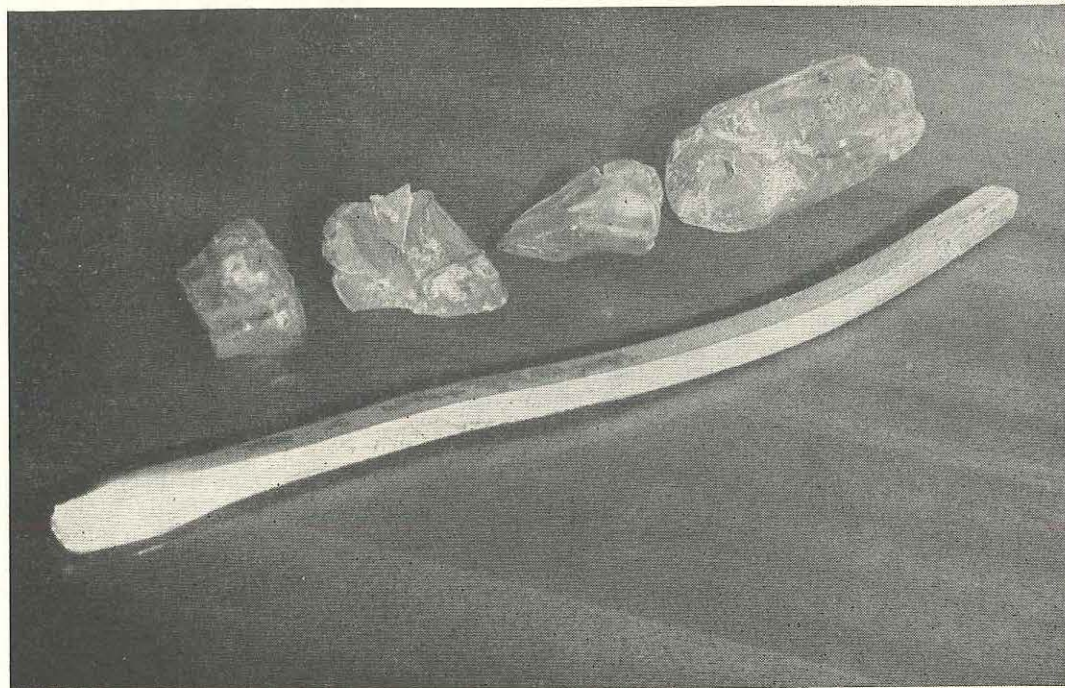
FIGURE 2

Quite apart from the potential danger to life posed by loose articles left in engine bays or wheel-wells or aircraft, costly damage can be inflicted on the aircraft itself. On one occasion when an engineer was making an in-transit check of the engines of a Boeing 707, a plastic handled screw-driver fell from his pocket after he had climbed into the air intake of one engine. It evidently lodged somewhere adjacent to the guide vanes where it was hidden from the view of other engineers who made a final brief check before the engines of the aircraft were started for departure. While the particular engine was being started, there was a sudden metallic clang at about 60% r.p.m. and the mangled screw-driver handle and shaft were ejected from the fan outlet. The engine was shut down, and it was found that two first stage blades and one second stage blade had been damaged. Figure 2 shows the remains of the screw-driver.

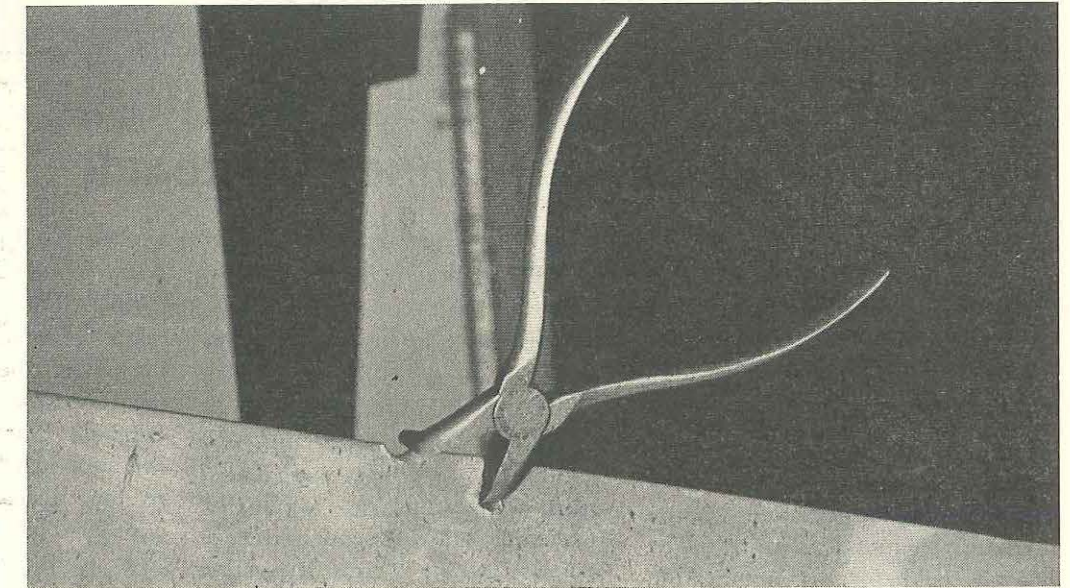
FIGURE 3

been damaged by picking up objects dropped on the runway from other aircraft. Figures 3 and 4 show damage caused to a Viscount during a landing run when a main-wheel tyre picked up a pair of pliers lying on the runway and flung them into the arc of the No. 2 propeller, damaging two blades. The rotating propeller blades then threw the pliers up into the belly of the aircraft, piercing the metal skin in two places. The runway had been inspected early that morning and was believed to be clear. It seems

Damaged propeller blade with pair of pliers repositioned in gashes.

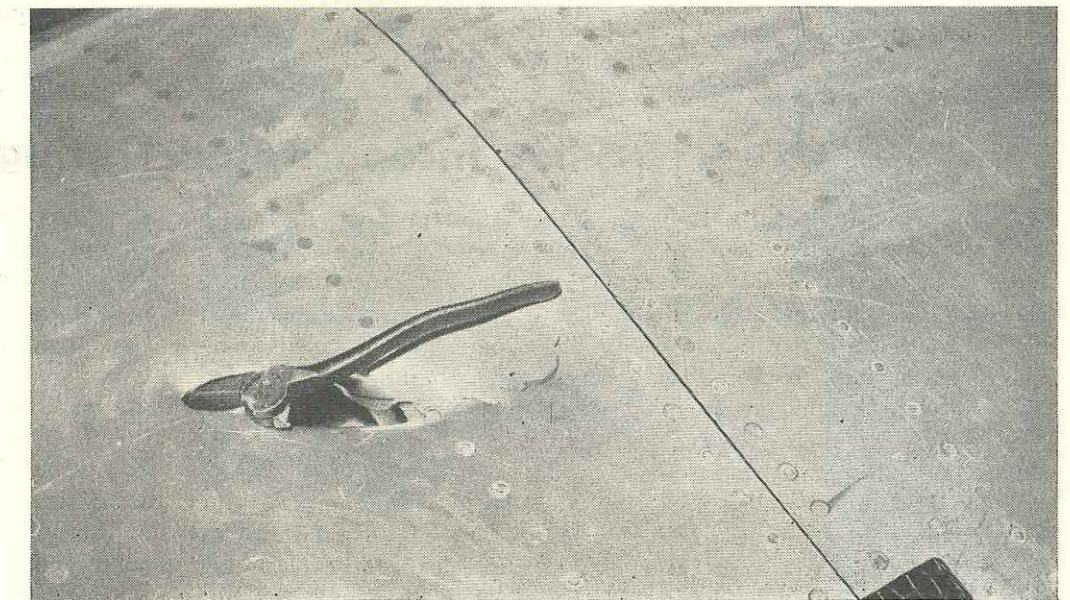
FIGURE 4

Skin damage to underside of aircraft.
