AVIATION SAFETY DIGEST

DEPARTMENT OF CIVIL AVIATION

No. 43

SEPTEMBER, 1965

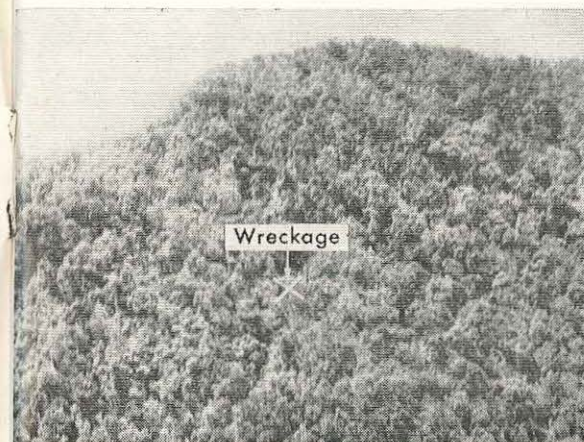
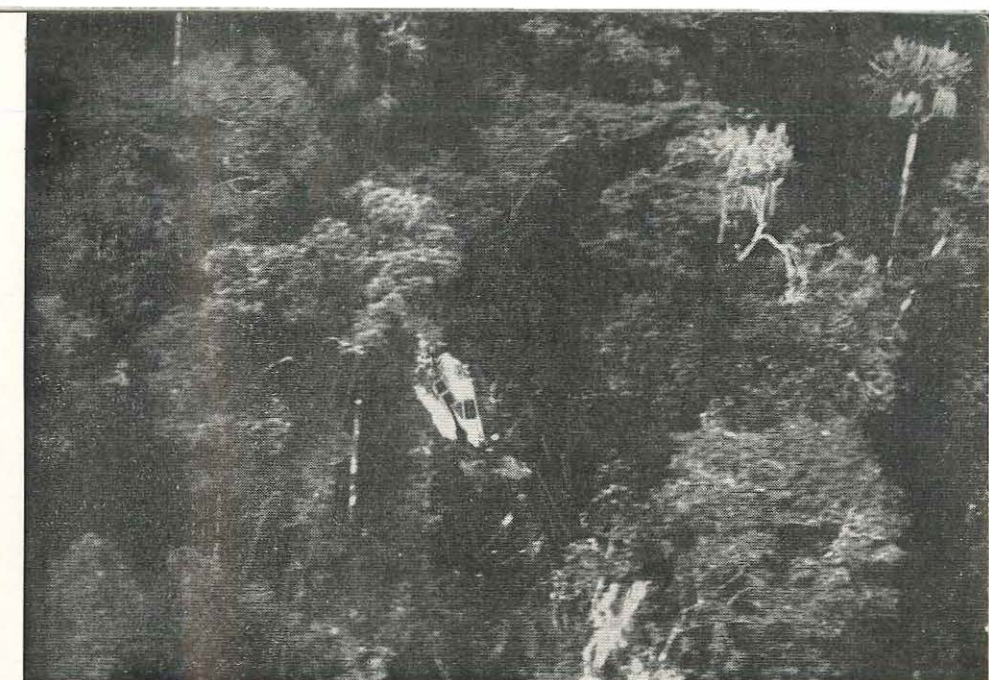
The aircraft had crashed on the northern side of a ridge of the main range at an altitude of 8,350 feet, 400 feet below the crest of the ridge. Both occupants had been killed on impact. The site was heavily timbered with slope of at least 65 degrees and the aircraft was lying nearly longitudinally and laterally level with the engine almost completely buried in the mountainside. One propeller blade had been torn from its hub and was lying badly damaged, 20 feet

These photographs convey some impression of the extremely rugged nature of the slopes on which the aircraft crashed.

Above: The wreckage as sighted by the search aircraft.

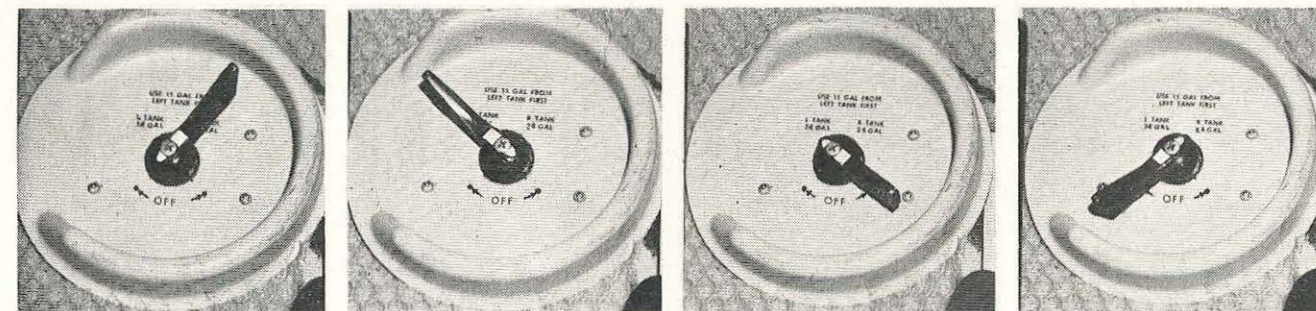
In this case the pilot, for an unknown reason, believed that the port side "Off" position (see Figure 2 (a)) was a "Both" tanks position. Altogether, it was obvious that his knowledge of the aircraft's fuel system was totally inadequate, and there seems little doubt that this aspect of the pilot's conversion training was inadequately covered by his flying instructors.

Fig. 2: Beech Musketeer Fuel Selector Positions: (a) and (b) Fuel Off. (c) Port Tank Selected. (d) Starboard Tank Selected

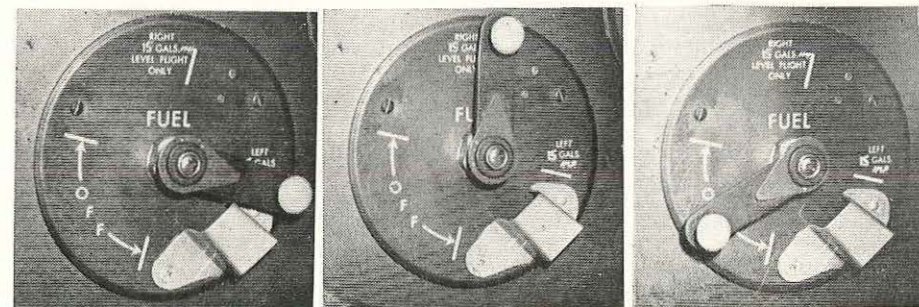
Fig. 3: Piper Colt Fuel Selector Positions: (a) Port (Main) Tank Selected. (b) Starboard (Auxiliary) Tank Selected. (c) Fuel Off.

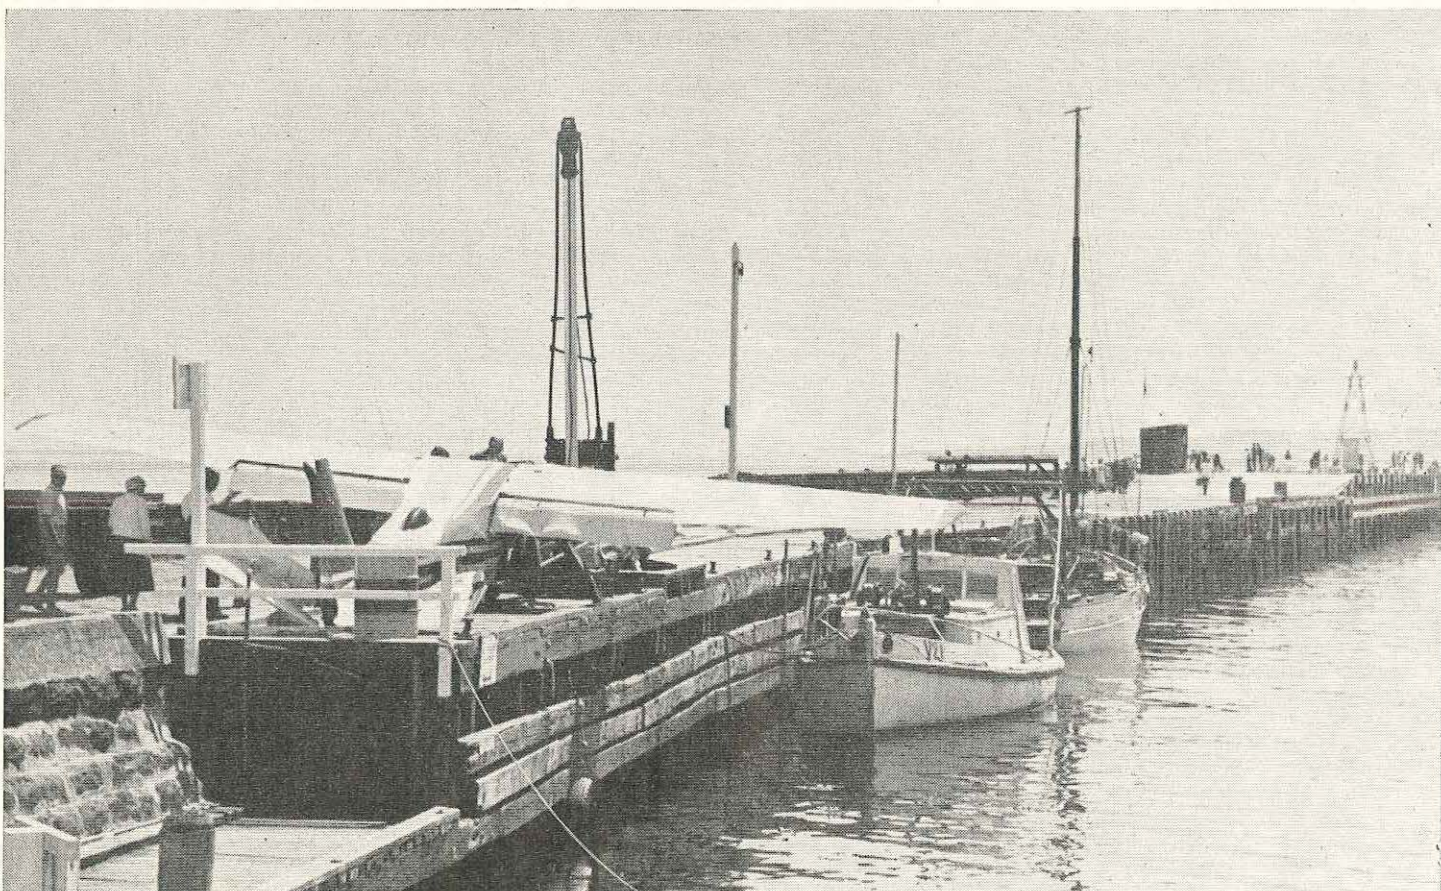
The damage to the aircraft showed that it had struck the water at a moderate to high speed while in a slightly nose down attitude with the wings almost horizontal and with some degree of skid to starboard. The virtually undamaged propeller was consistent with the pilot's evidence that he had closed the throttle before impact. A thorough examination of

The wreckage on the wharf at Mornington after being recovered from the water.

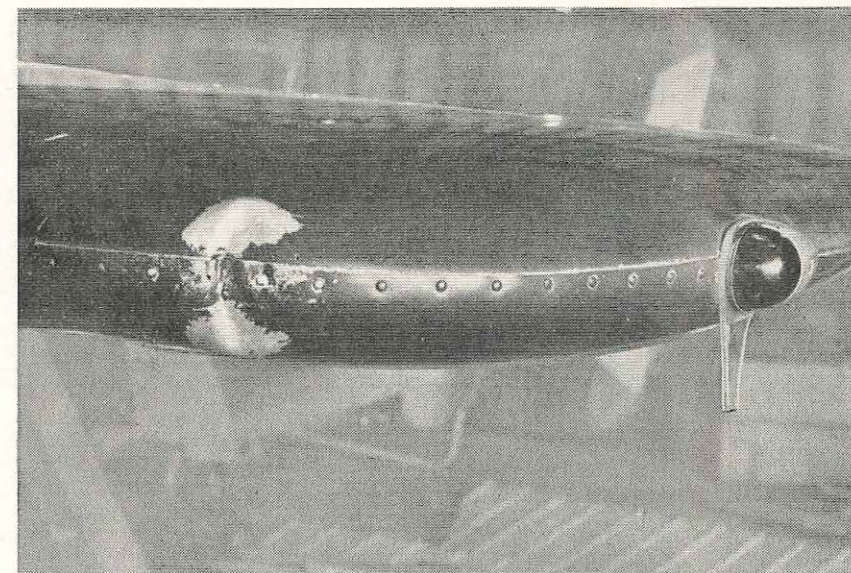
Damage to port wing tip caused by collision with hangar post.

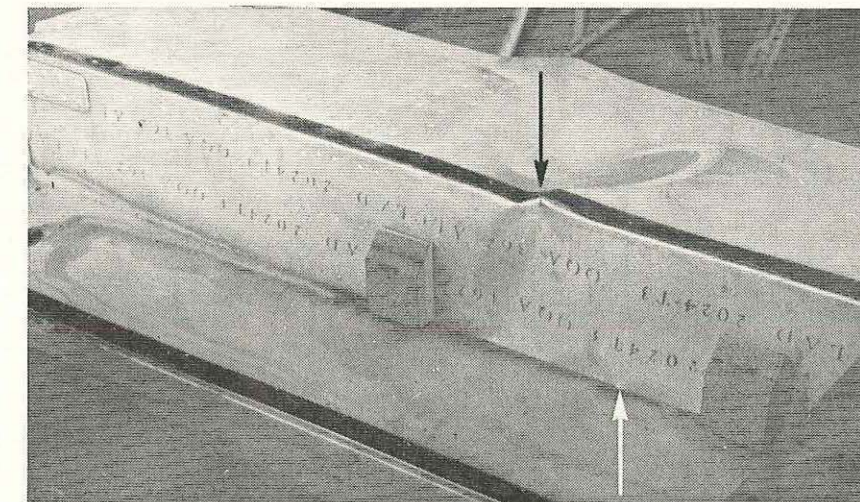
While making a daily inspection at Esperance, W.A., the pilot of a Cessna 172 noticed some distortion on the port wing trailing edge close to the fuselage. The pilot, a member of the aero club which was operating the aircraft, had flown 5 hours 40 minutes since picking up the aircraft from Bunbury the previous day.

Damage to rear spar and skin viewed from tank bay. The spar to fuselage attachment bracket is shown in the upper left corner of the photograph.

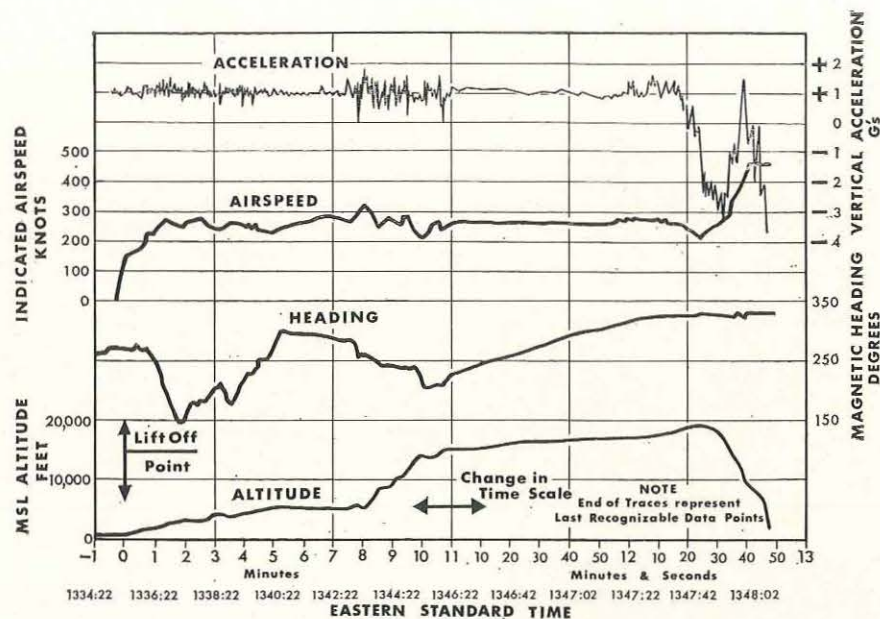
Read-out obtained from Flight Recorder Traces.

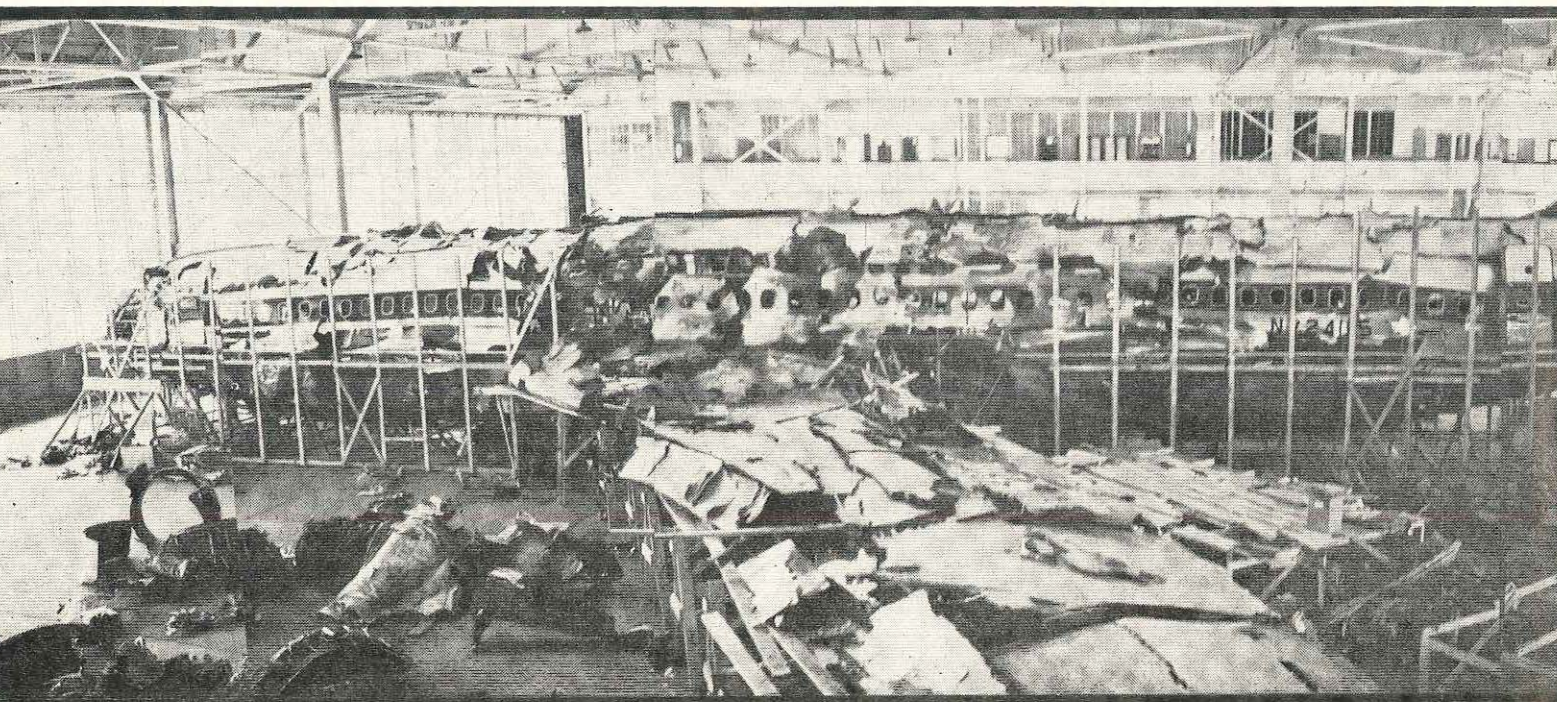
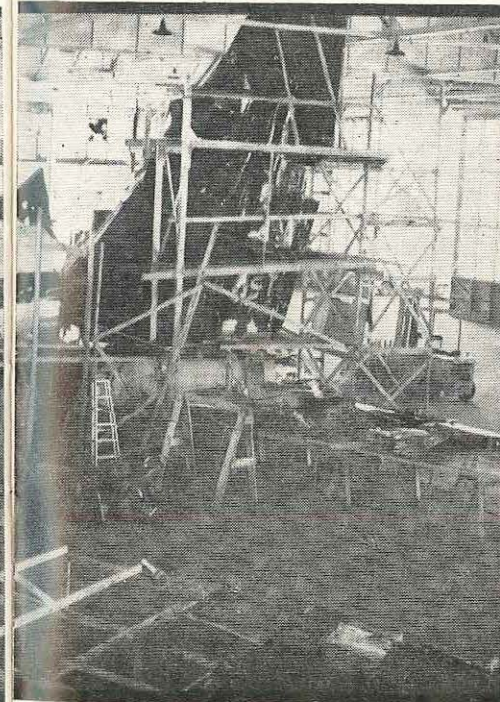
The wreckage being "reconstructed" at Opa Locka Airport, Miami. A helicopter was used to lift the wreckage piece by piece from the accident site.
