# AVIATION SAFETY DIGEST

DEPARTMENT OF CIVIL AVIATION

MARCH, 1966

# FIRE

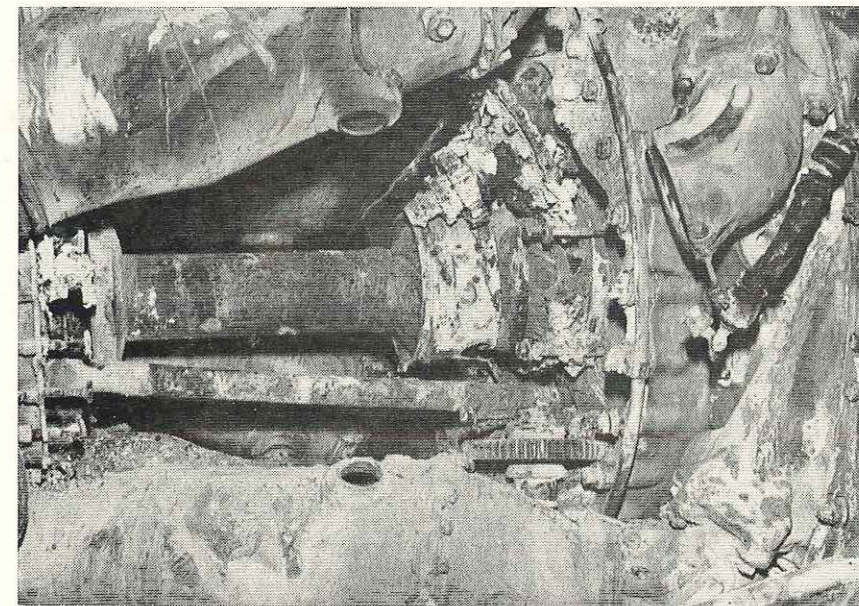
It was found that the engine fire had been sustained principally by combustion of the magnesium alloy intermediate casing, which was almost completely destroyed. (Fig. 1). Residual fuel in the low

Fig 1. The intermediate casing completely burnt away, exposing the damaged compressor shaft and auxiliary drive gear trains.

A detailed examination of the damaged engine after it had been removed from the aircraft, disclosed a failure of the rear compressor bearing. Metal from the failed bearing had contaminated the engine oil scavenge filters and the main pressure filter. Cracks in the flame tube air cases, the flame tube support lugs and the failure of an oil cooler mounting lug indicated that the engine had been subjected to high vibration. Mechanical damage to the blades of the second stage compressor, the bearing air seal and the teeth of the gears in the auxiliary drive gear train, suggested that the failure of the rear compressor bearing had been the primary failure, permitting the second stage compressor shaft to move forward until the turbine to compressor spline drive became disconnected.

There was no evidence to suggest that the engine fire had been started by torching emitted from the combustion chambers, and there was little doubt that the fire had originated from over-heating of the failed compressor bearing. The bearing had obviously been extremely hot and had probably ignited its lubricating oil. Once started, the fire would have been fed with air from the failing adjacent bearing oil seal, and would have spread from the inside to the outside of the magnesium alloy intermediate case, where it became visible to the crew from the

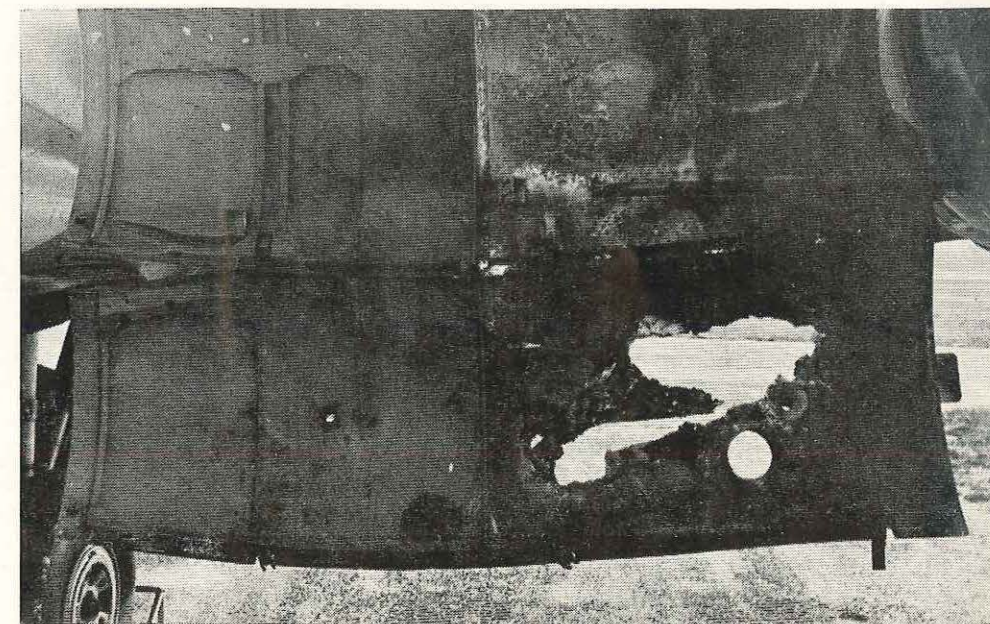
pressure fuel line, and engine oil probably also contributed to the intensity of the fire. Incandescent magnesium falling from the burning casing had burned a large hole in the underside of the engine cowling (Fig. 2), but the rest of the cowling was intact though buckled by heat. The fire behind the bulkhead had been burning in two places. Electrical insulation had ignited from radiant heat, and waste oil lying in the base of the engine cowling had been set on fire by hot gas and magnesium particles coming from the engine breather pipe. The engine fire had been extinguished before it could damage the airframe structurally.

Fig. 2. Heat damage to the engine cowlings. Incandescent magnesium falling from the intermediate casing burnt the large hole in the lower cowl.

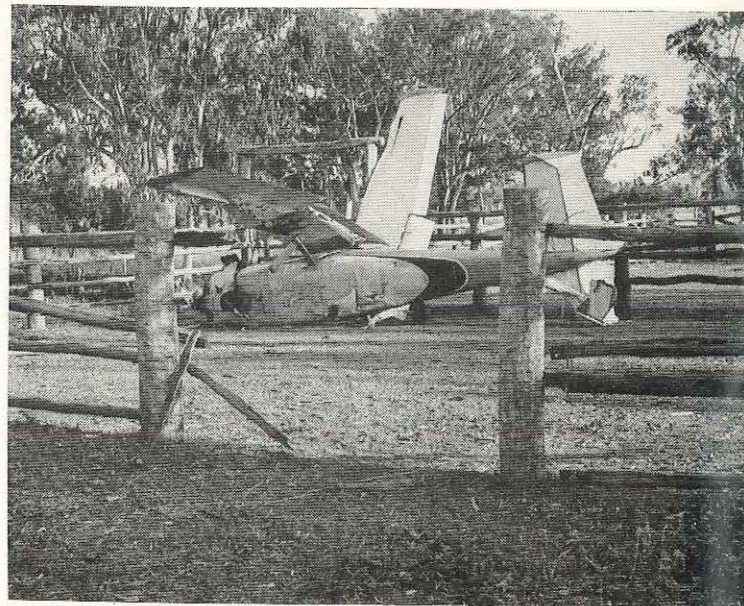
*All that remained of a Cessna 182 that ran away, after being hand started, and coralled itself in a cattle stock yard.*

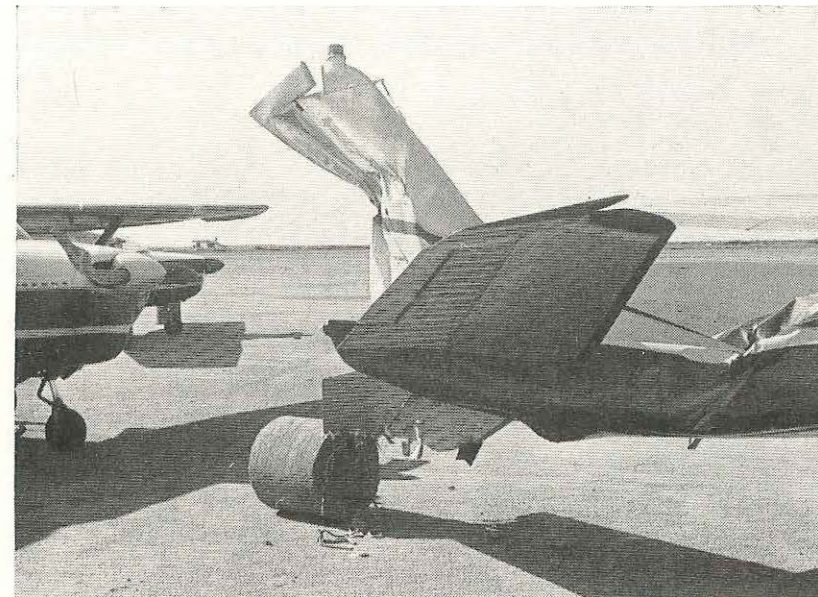
*The aircraft with the bent propeller (left) also ran away after being hand started. Its starboard wing collided with the fin and rudder of the aircraft in the foreground, telescoping the tail and fuselage as shown, while the whirling propeller blades hacked into the port tailplane.*

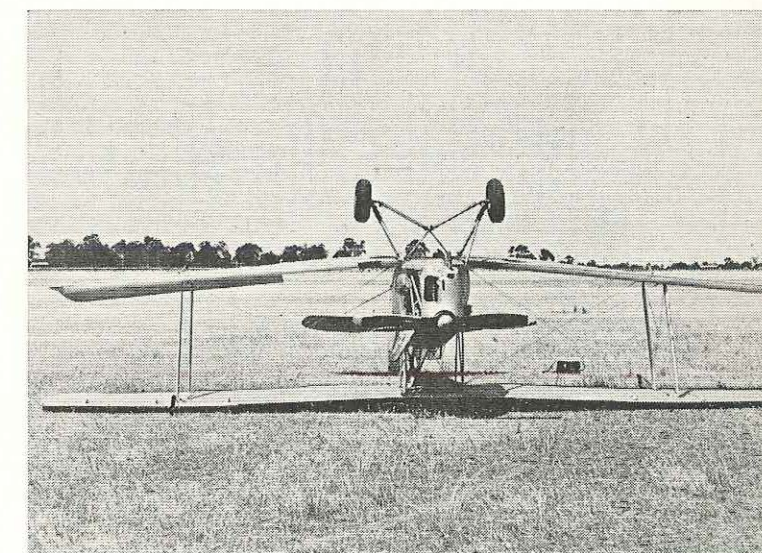
*This DH 82 moved off unoccupied after being started without chocks, swung downwind, and was blown over on to its back.*

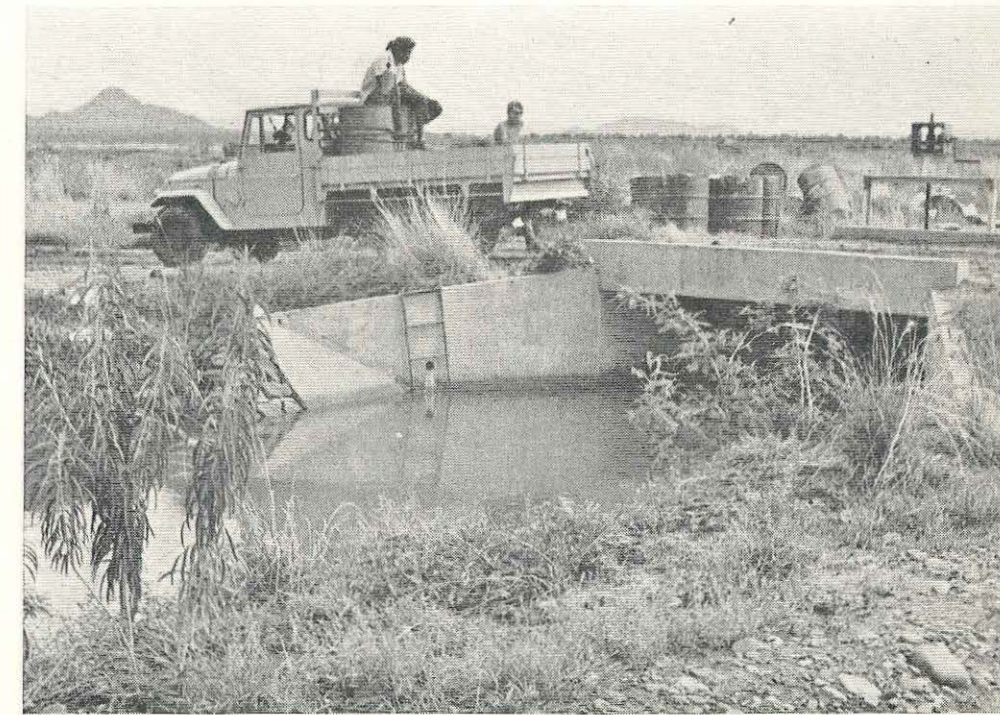
Investigation of the accident established that the engine failure had been caused by contamination of the fuel system by water. The contents of the main fuel filter, the fuel line from the filter to the carburettor and the carburettor itself, aggregating together about

a pint, were drained into a jar and were found to consist entirely of water. With the aircraft's fuel selector turned on, the fuel filter line was drained again and a further half pint of water was discharged before fuel began to flow. The amount of residual water in the fuel tanks could not be positively determined because one tank had been split open in the crash and the other was lying in a position from which the contents could not be readily drained. It was nevertheless clear that there had been sufficient water in the tanks to occupy all the unusable fuel space and to cover the base of the fuel line stand pipes.

*This picture was taken from where the helicopter landed for the first refuelling. The tender was parked as shown, and the refuelling hose was afterwards dragged back through the canal before being replaced on the vehicle.*

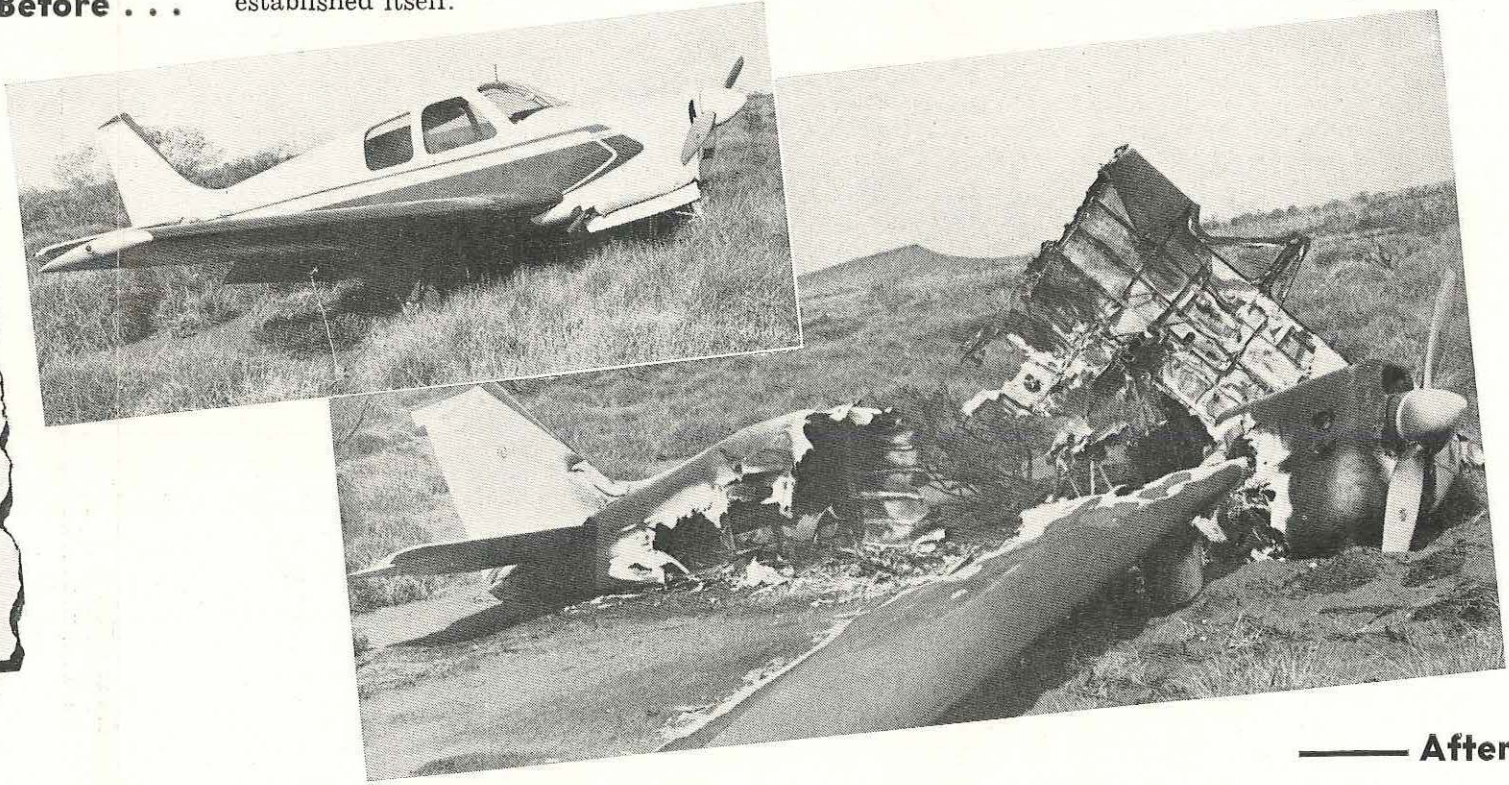
After!

There is no doubt that the fire was started by a static discharge. The static electricity hazard involved in using a plastic funnel that cannot effectively be earthed is serious enough at any time, but it would have been compounded on this occasion by the extreme heat of the day. The shade temperature at the site was +40°C. and as the aircraft had been standing in the sun, the surface of the wing would have been very hot indeed. The spilt fuel would have quickly formed dangerous vapour that only required the slightest spark to ignite it. The likelihood of a static discharge in these circumstances could have been eliminated by ensuring that the aircraft, the drum and the funnel were all at the same electrical potential. This is normally achieved by electrically bonding the three elements, but such bonding can never be effective while one link in the chain, the funnel, is non-conductive plastic.

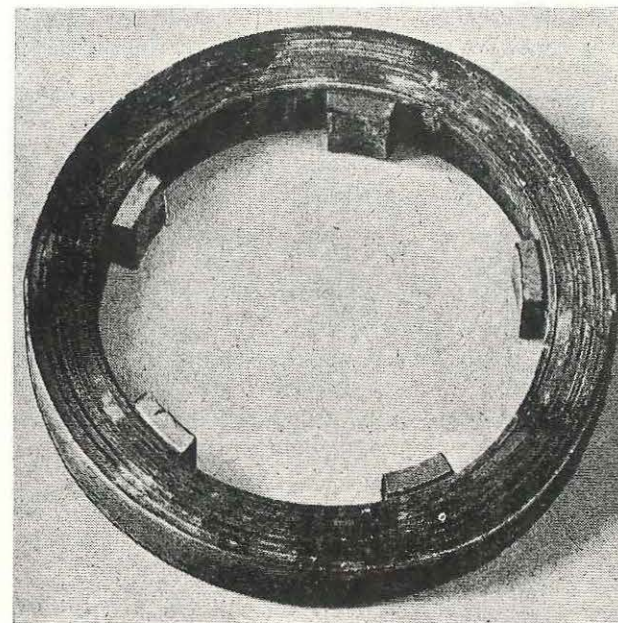
Left: Brake disc recovered from No. 4 wheel assembly showing deep grooves apparently made by heavy braking while taxi-ing on runway before take-off.

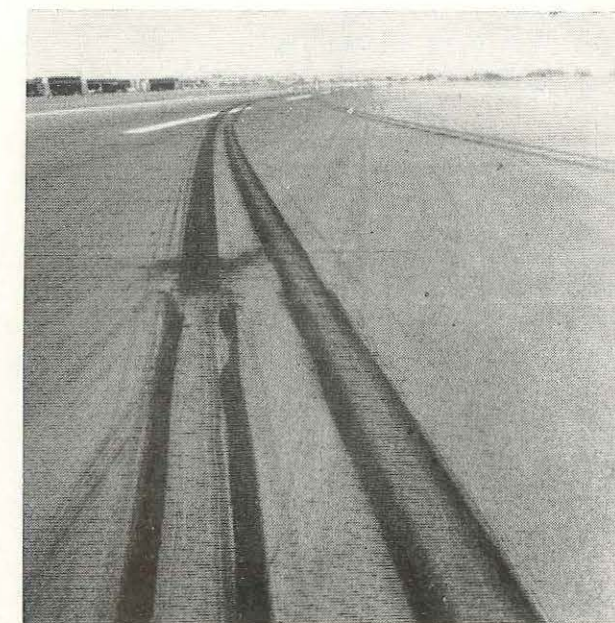
Right: A typical blow-out stain similar to the one found at the beginning of the runway from which the Caravelle took off.

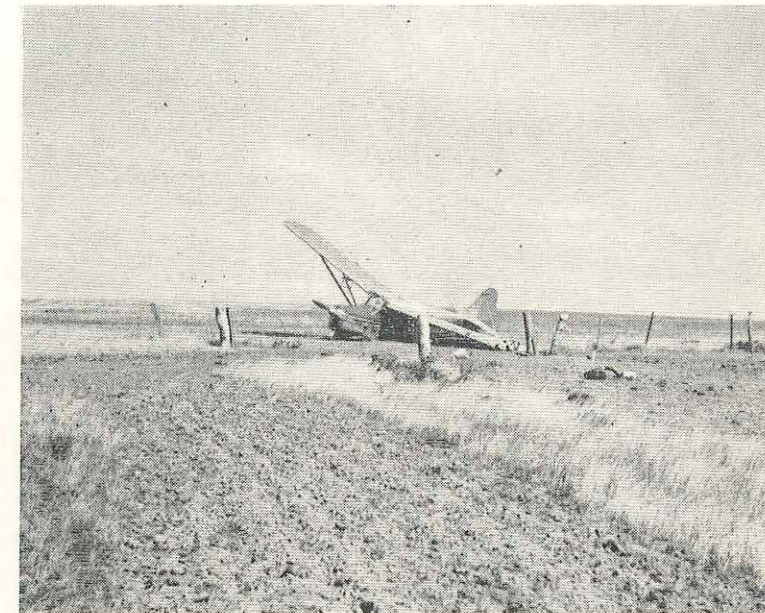
The Auster Autocar shown in the picture on the next page was the victim of this inexpertise. Loss of engine power from carburettor icing forced it down only a few minutes after taking off on a cross country flight in South Australia, because the pilot didn't recognize the trouble in time to correct it.

*Carburettor icing forced this Auster down only a few minutes after taking off. The aircraft struck a fence during the landing.*

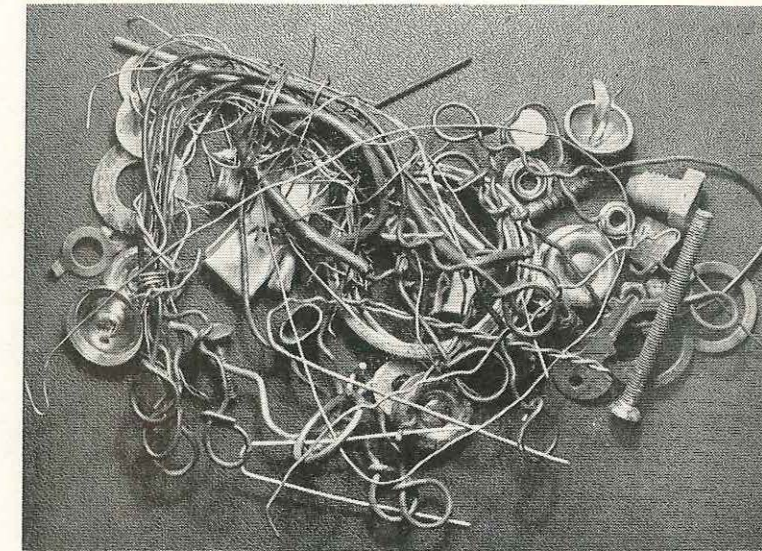
Debris picked up on the apron of a major airport.

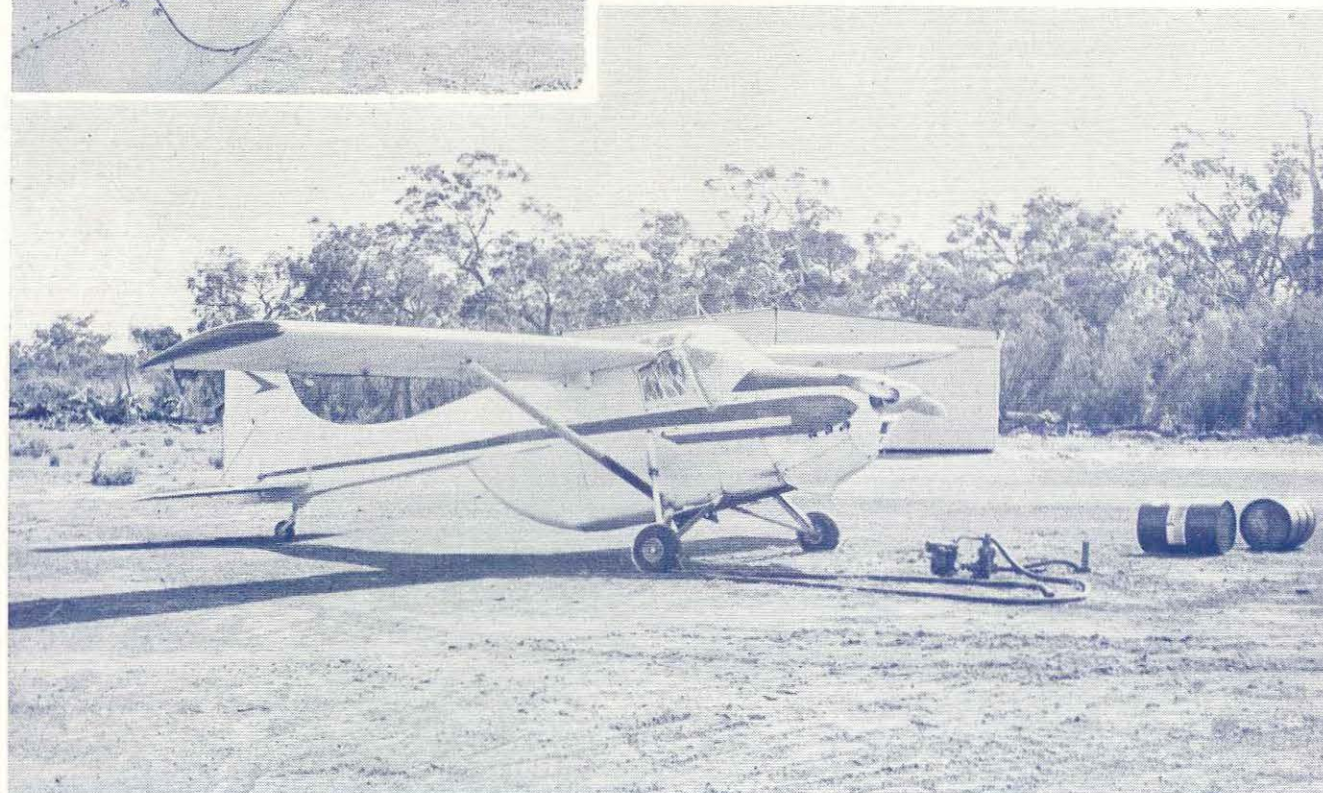
*Below: After taxi-ing forward a few yards, this EP9 collided with a fuel drum, damaging its propeller. Even if the propeller had missed the drum, the aircraft would still have run into the refuelling equipment. Inset: The bent propeller. Both blades were damaged beyond repair.*
