AVIATION SAFETY DIGEST

DEPARTMENT OF CIVIL AVIATION

No. 52

SEPTEMBER, 1967

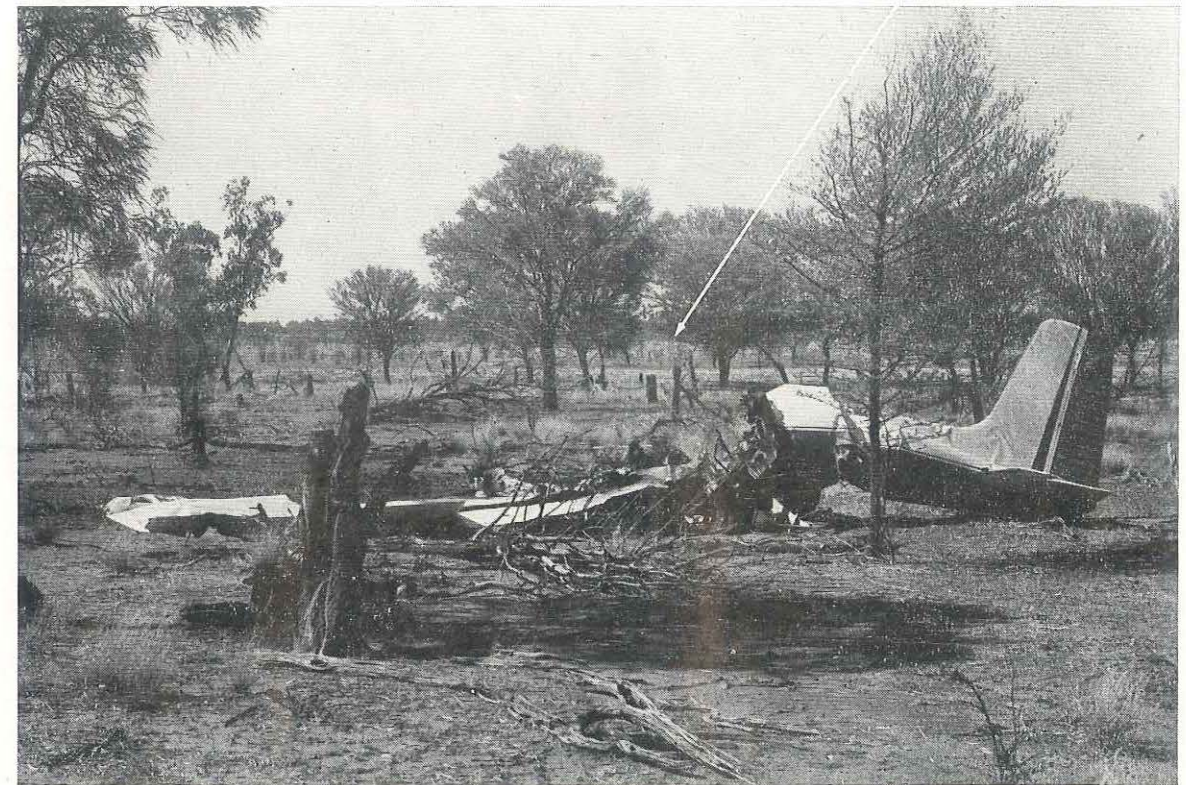
The burnt-out wreckage. The angle at which the aircraft struck the ground is graphically displayed by the slashed foliage of the small tree at right.

The cause of the accident was that the pilot, who was not qualified for instrument flight and whose capacity to act as a pilot was impaired by the consumption of alcohol, did not maintain control of the aircraft following a take-off at night.

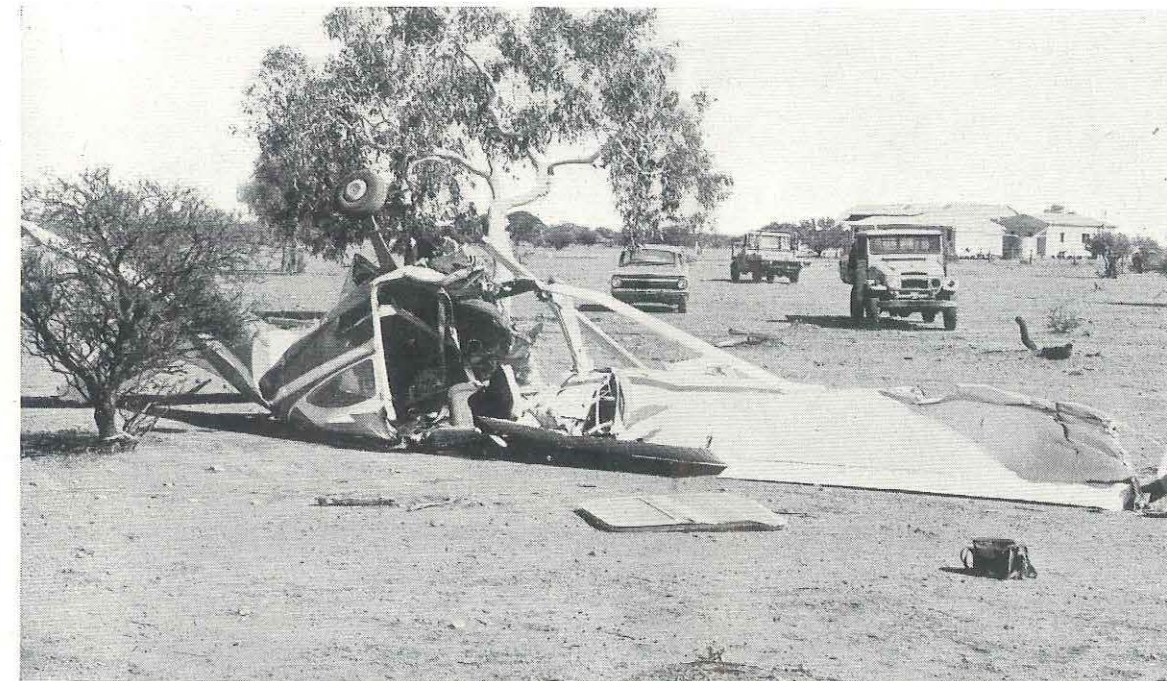
Examination of the wreckage showed that the aircraft had struck the ground nose-first while sharply banked to starboard. The aircraft had then cartwheeled for 100 feet and come to rest inverted. It was determined that no mechanical condition in the aircraft had contributed to the accident and there was no evidence of fuel contamination in the aircraft's fuel system.

The wreckage of the aircraft as it came to rest, looking in the direction of impact. The shearers' quarters, near which some of the eye witnesses were standing, can be seen in the background.

The probable cause of the accident was that the pilot, whose judgment and ability were impaired by the consumption of alcohol, did not maintain control of the aircraft when he was suddenly deprived of visual reference during a flight at night.

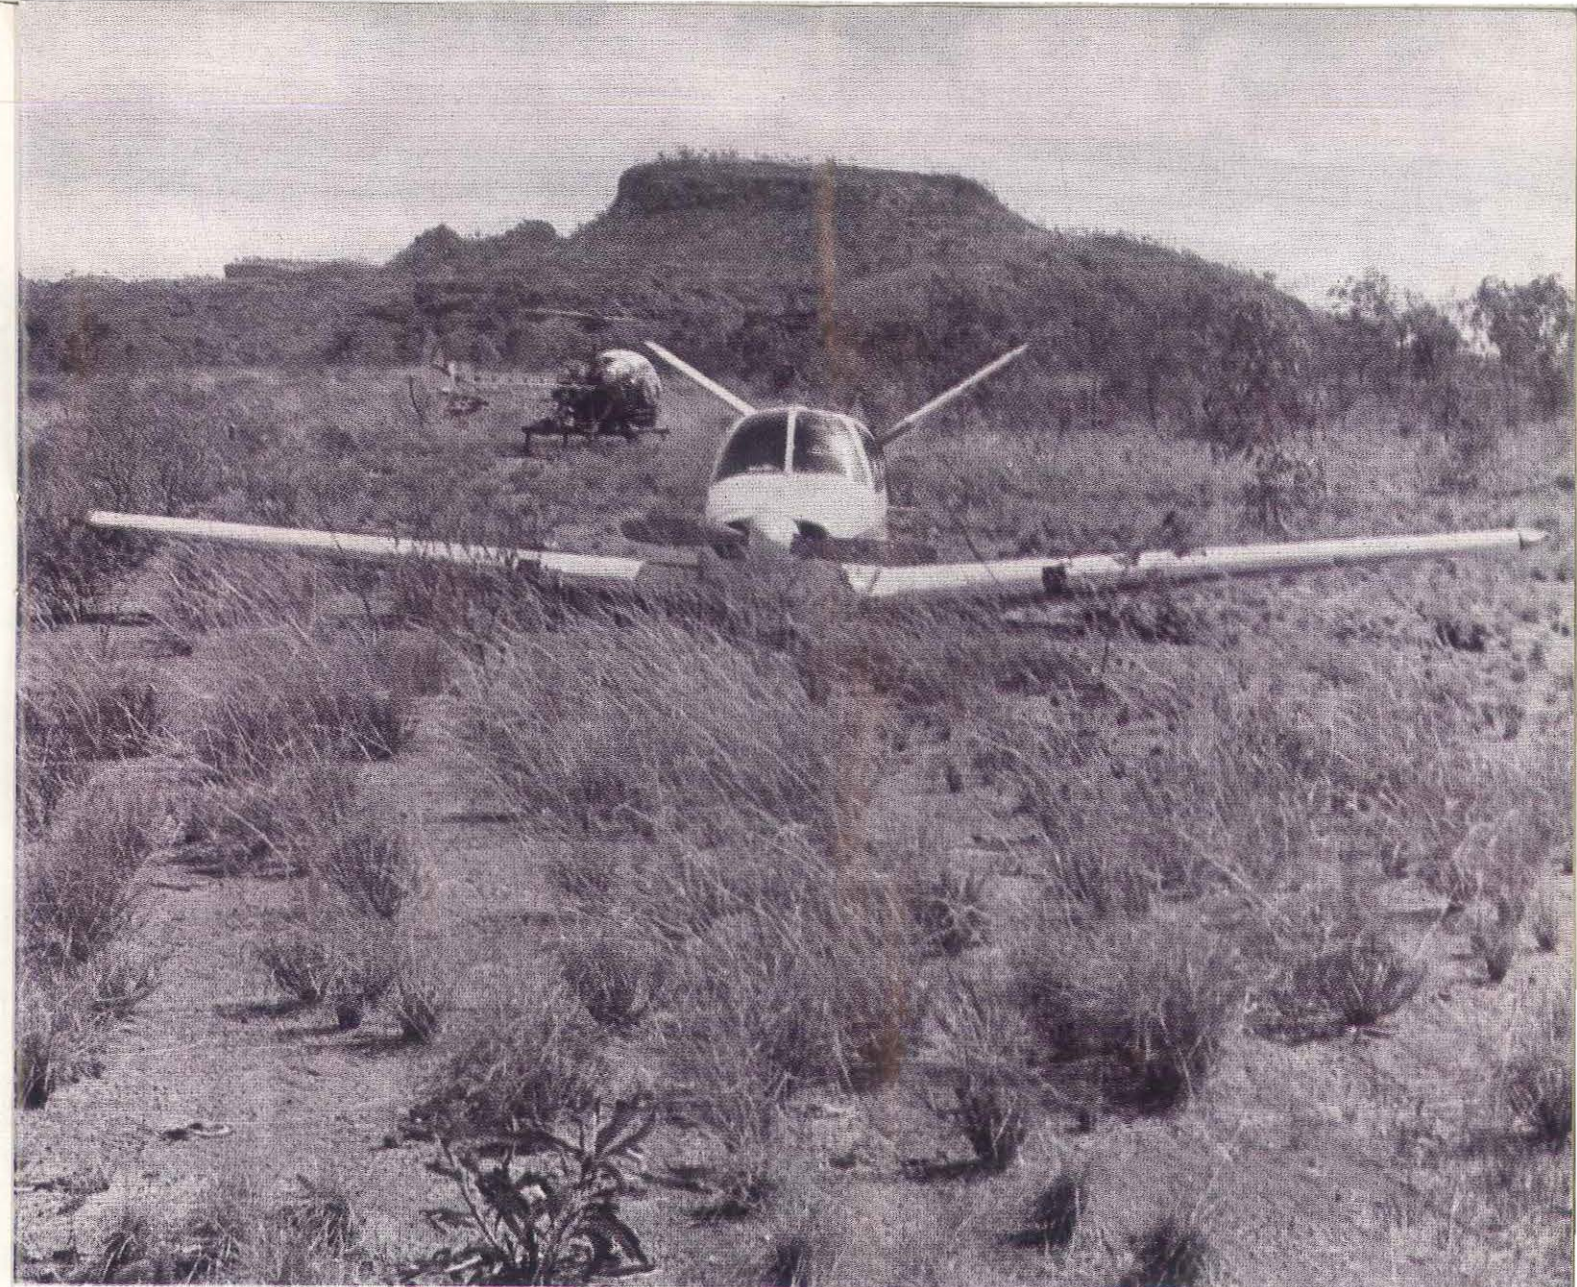
grass on the strip so he quickly selected the undercarriage "up" and carried out a wheels-up landing. The aircraft struck a sapling and an anthill as it touched down, but damage was confined mainly to the undercarriage doors, the underside of the fuselage and the propeller.

The aircraft wheels-up on the disused airstrip. Note the rugged terrain in the background.

The Bonanza's engine was dismantled and inspected later and it was found that the No. 2 piston had broken up. Metal from the broken up piston had circulated in the engine oil causing the oil filter screen to collapse. The break-up of the piston was attributed to the failure of the top

compression ring on the No. 2 cylinder, which had allowed combustion gases to torch past the side of the piston. The reason for the failure of the compression ring could not be determined.

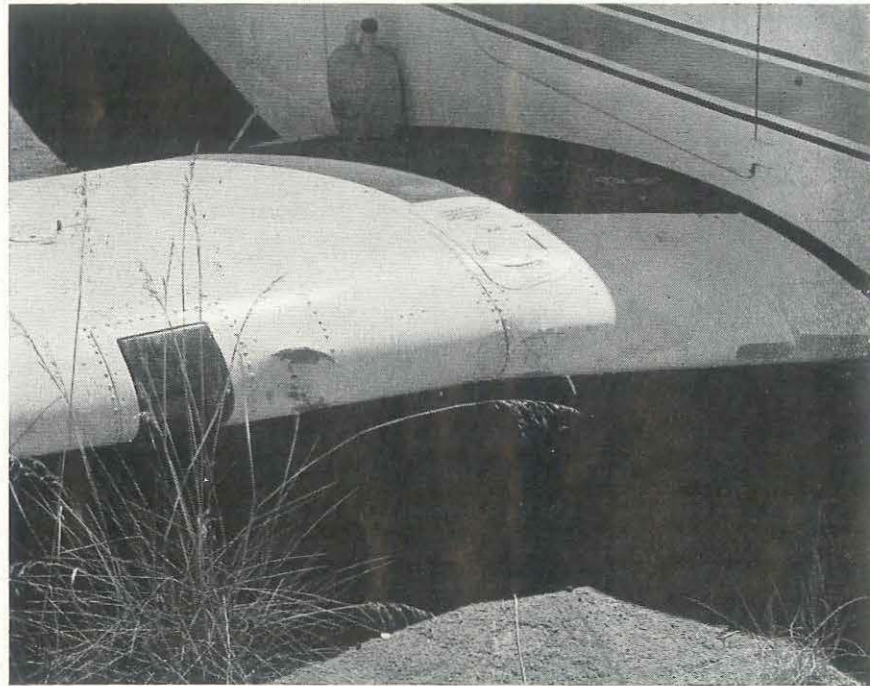
Damage to the leading edge of the wing, sustained by striking anthills on the disused airstrip after touch-down.

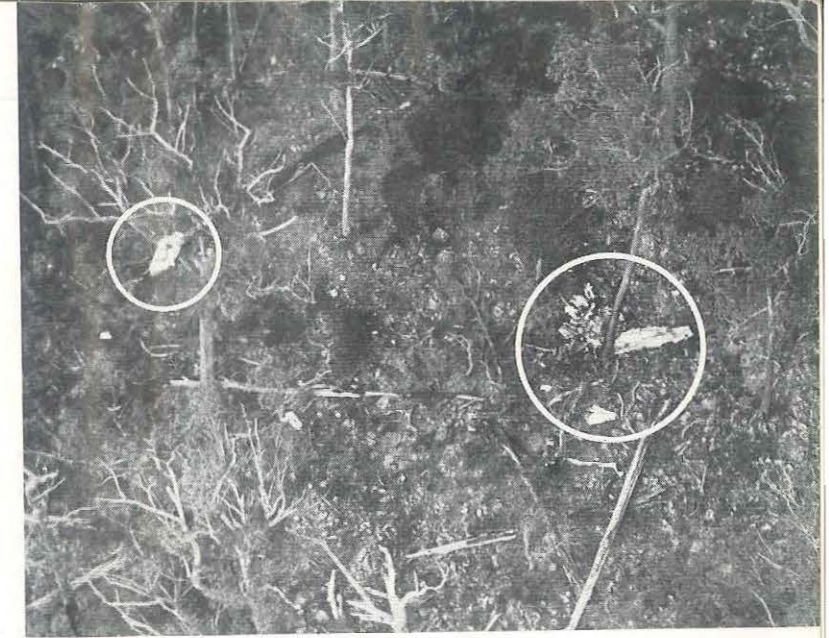
The wreckage as sighted by the search aircraft. Note the wing caught in the upper branches of the tree.

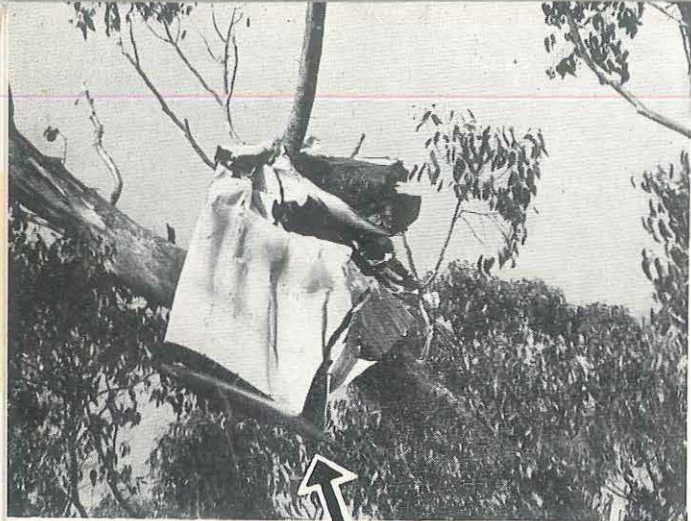
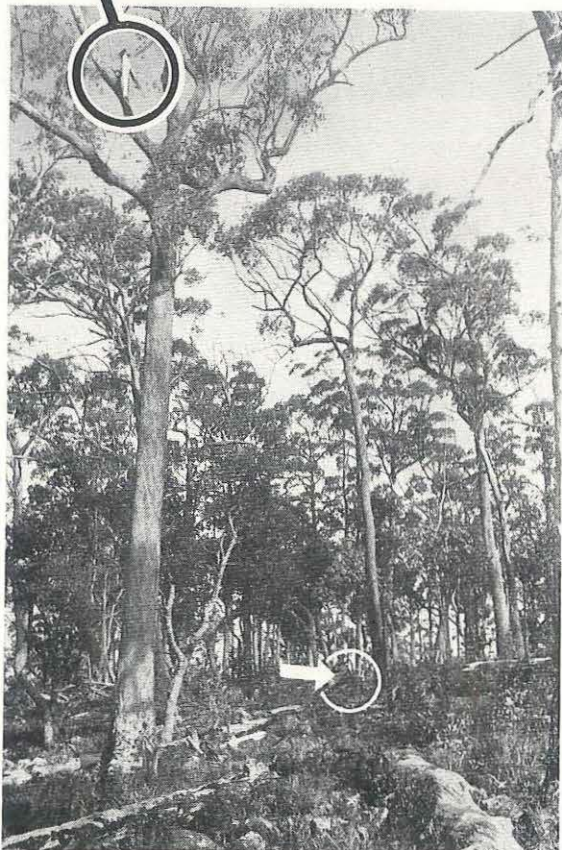
Ground view of accident site. The enlarged photograph of the starboard wing caught in the tree, clearly shows that it struck the branch, trailing edge first.

Although the wreckage examination showed beyond any doubt that the aircraft was out of control when it struck the first tree, the investigation failed to uncover any positive evidence which could point to a reason for the loss of control. To try and establish the reason for this loss of control, a number of possible factors were therefore considered:
