AVIATION SAFETY DIGEST

DEPARTMENT OF CIVIL AVIATION

No. 53

NOVEMBER, 1967

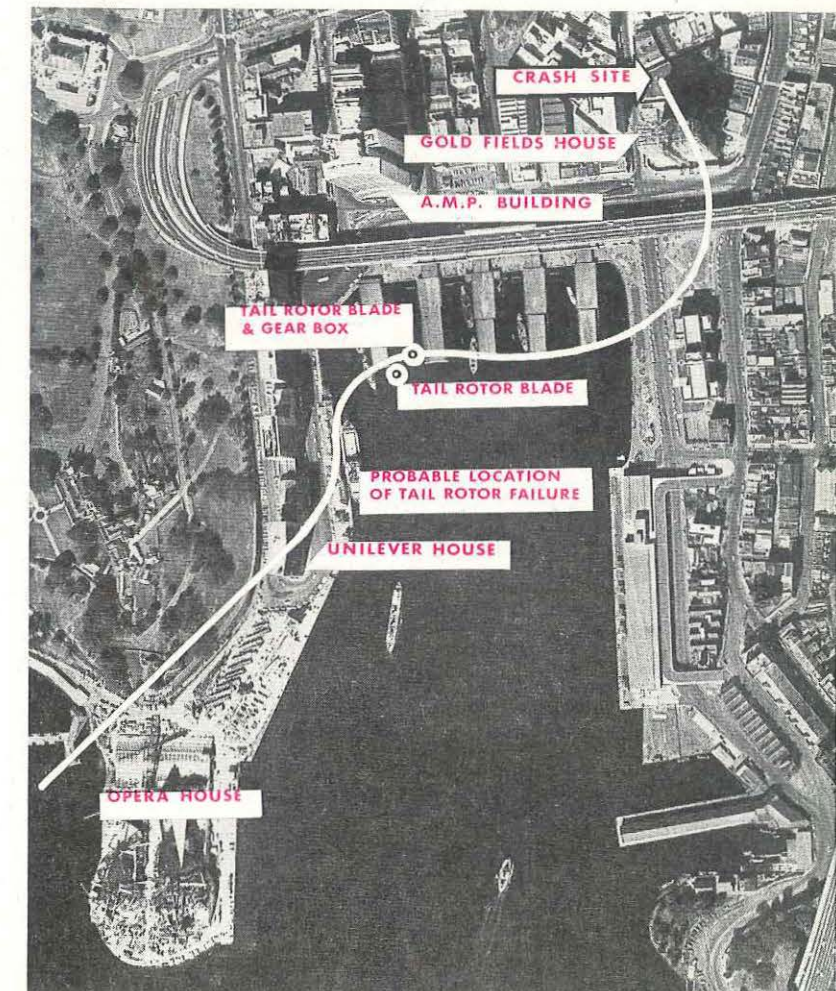
Aerial view of Circular Quay area showing final flight path.

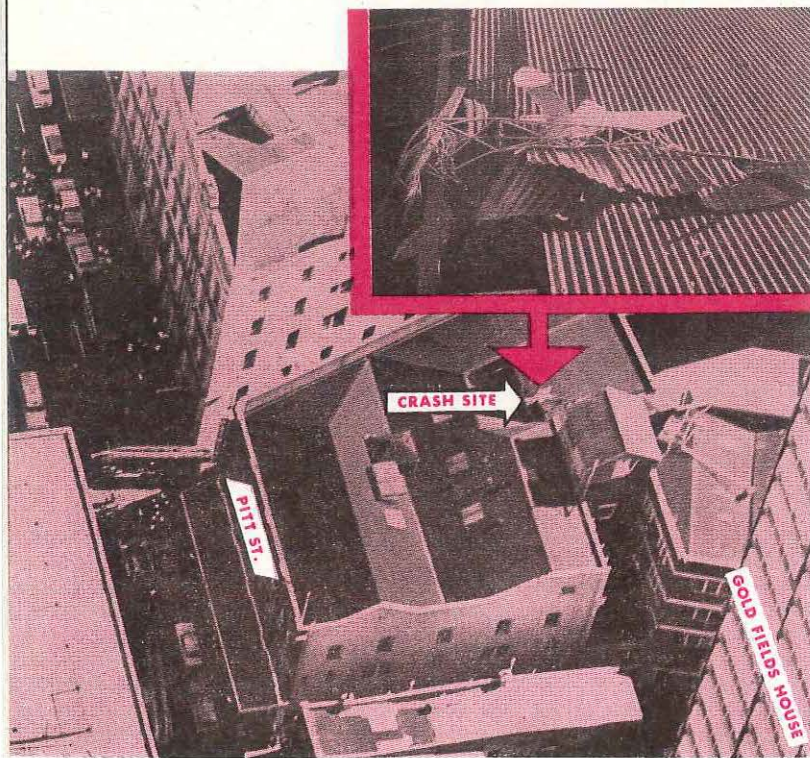
The final impact site in Pitt Street. The inset shows where the main wreckage crashed through the roof, leaving the tail structure on the roof itself.

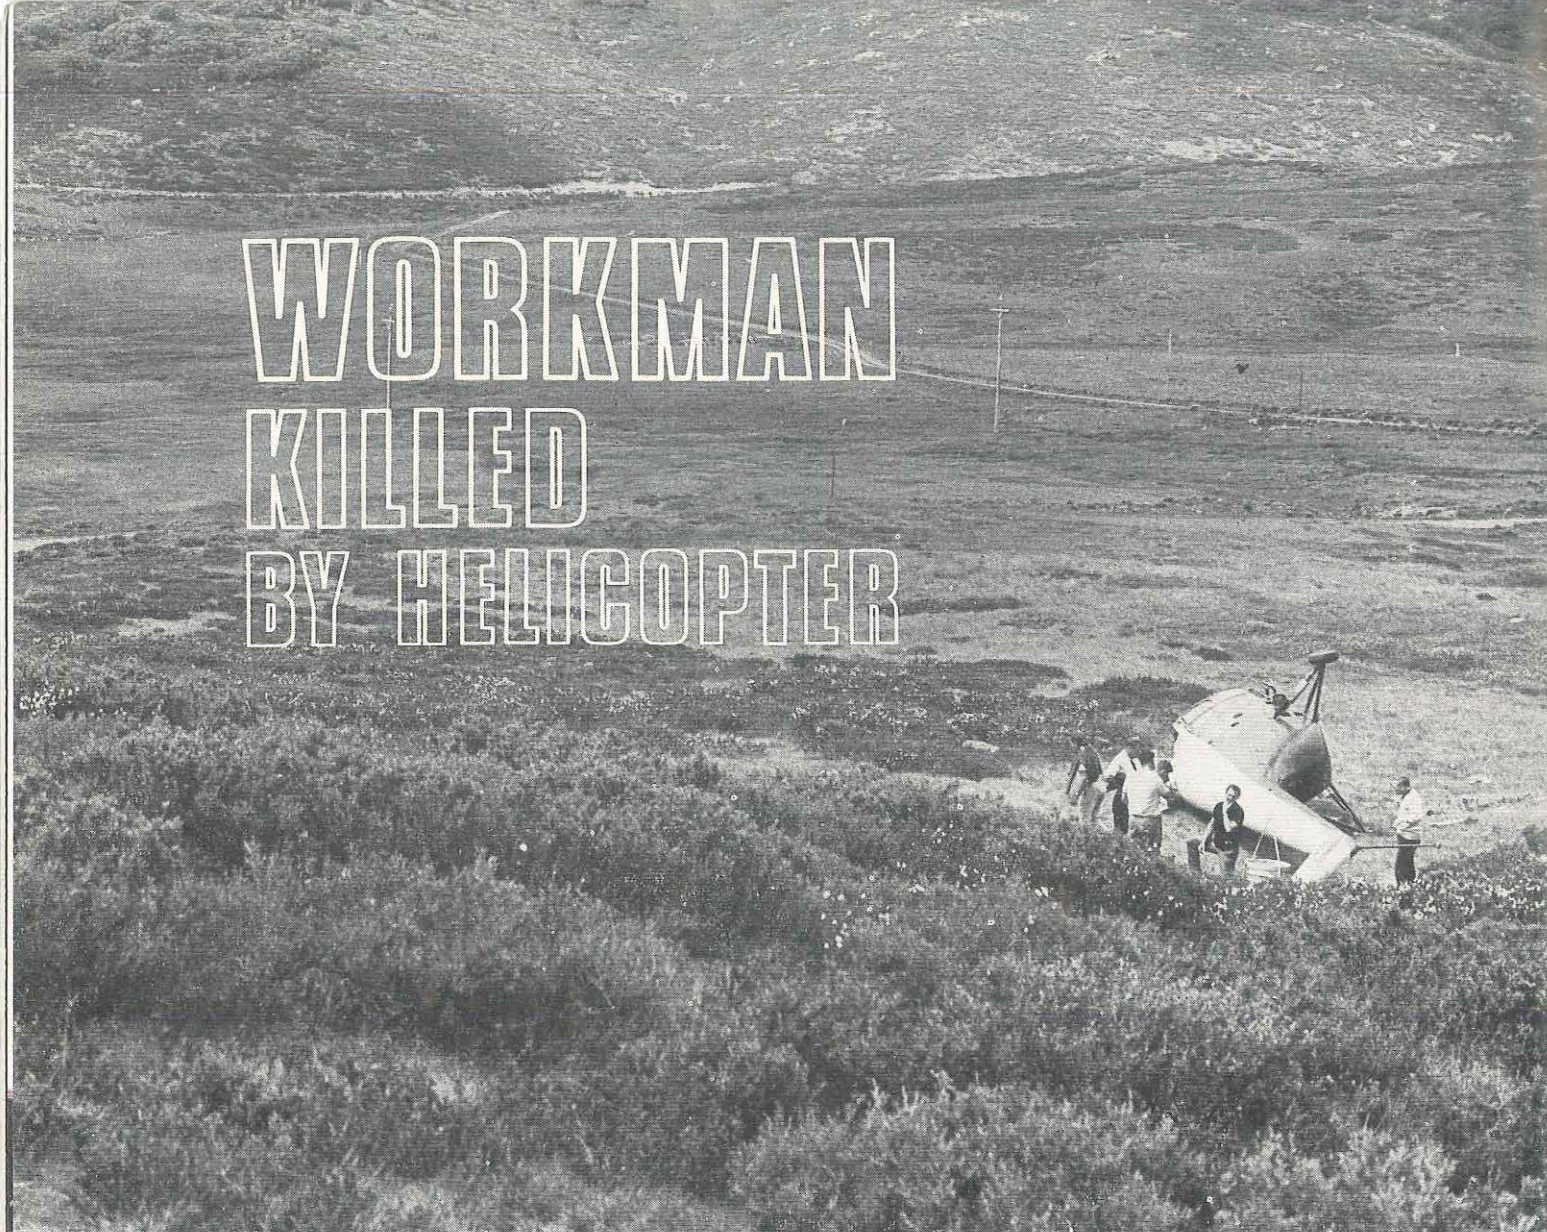
Accident site as seen from the point where the tail rotor first struck the ground.

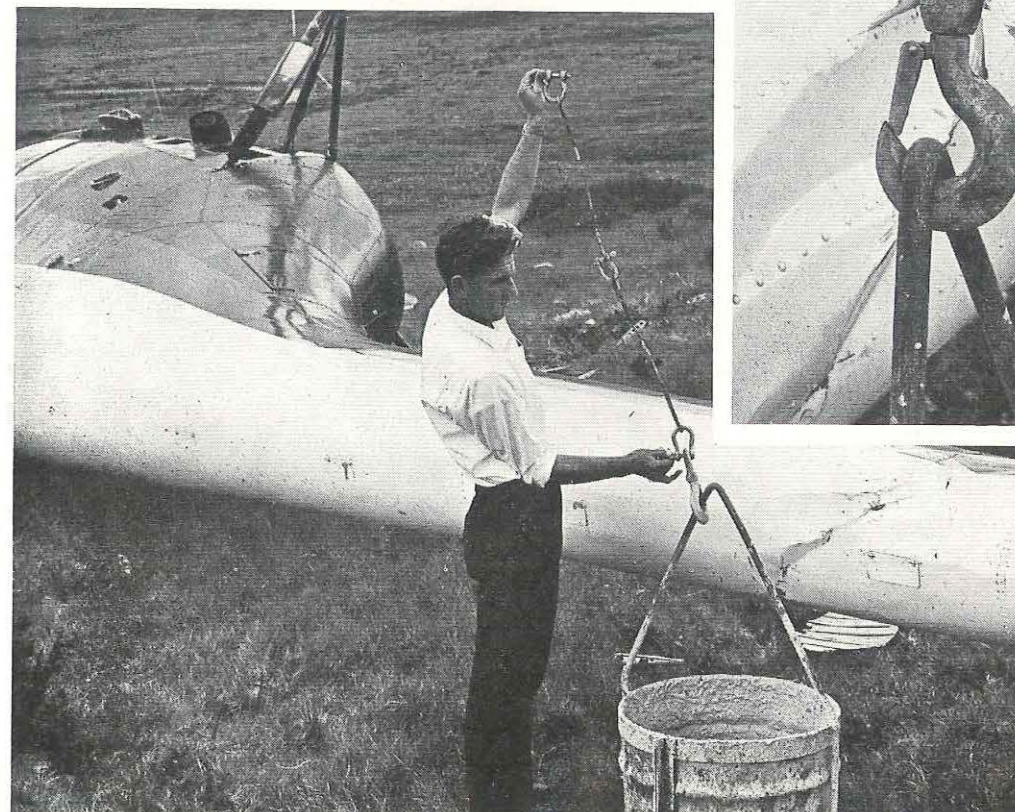
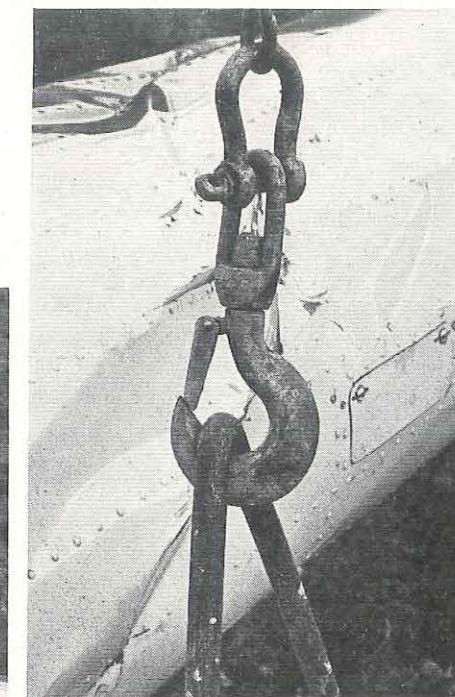
The bucket and sling assembly used to carry the concrete. The inset shows the snap-hook attachment to the bucket handle.

It cannot be established why the bucket and sling fell from the aircraft in the first instance, as the sling attachment was checked and found serviceable. The most probable explanation is that the dispatcher did not ensure the latch was fully locked when the last bucket was attached and that once the concrete had been released from the bucket at the foundation site, the oscillations of the sling during the return flight, caused the locking jaws of the snap-hook to open.

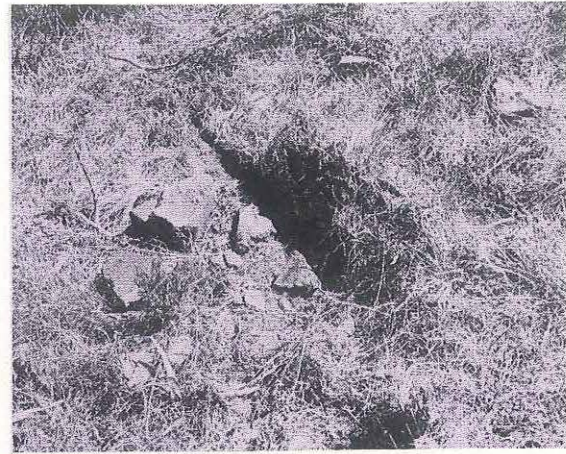
Deep ground slash made by the main rotor blade after control was lost. Note the partly imbedded rotor blade balance weight.

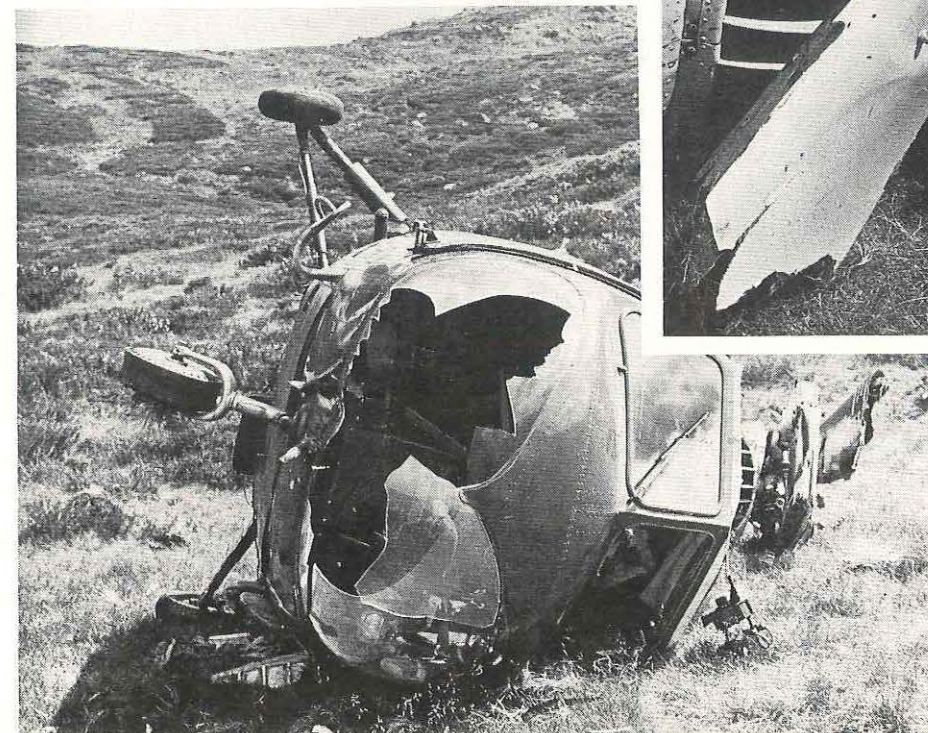
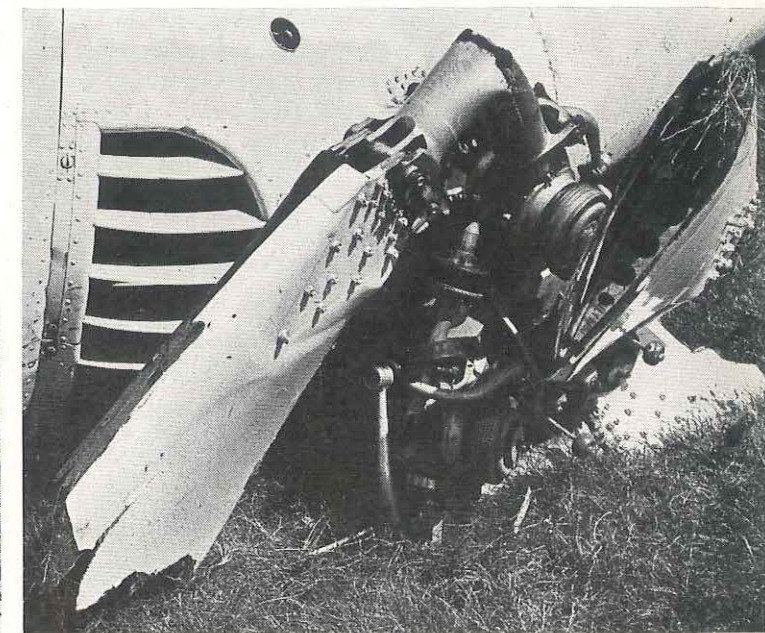
The cause of the accident was that, having misjudged the slope of the terrain, the pilot hovered the helicopter at a height which was too low to provide safe clearance between the tail rotor and the ground.

View of the wreckage looking back along the flight path. The ridge struck by the tail rotor is just out of the picture in the immediate background.

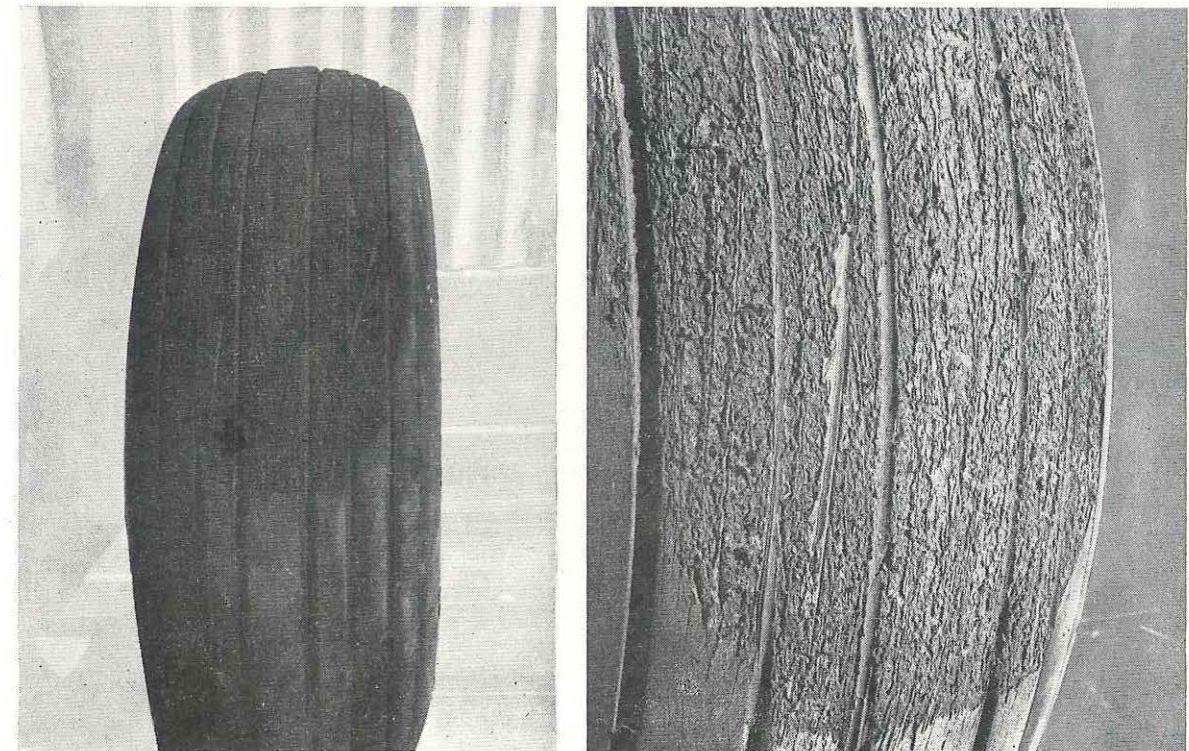
An aircraft tyre exhibiting tell-tale effects of aquaplaning. The abraded sections of the tread are not skid marks but patches of heat affected "reverted" rubber. This effect has been produced by super-heated steam, generated in the film or water beneath the tyre, when it ceased rotating while aquaplaning at speed.

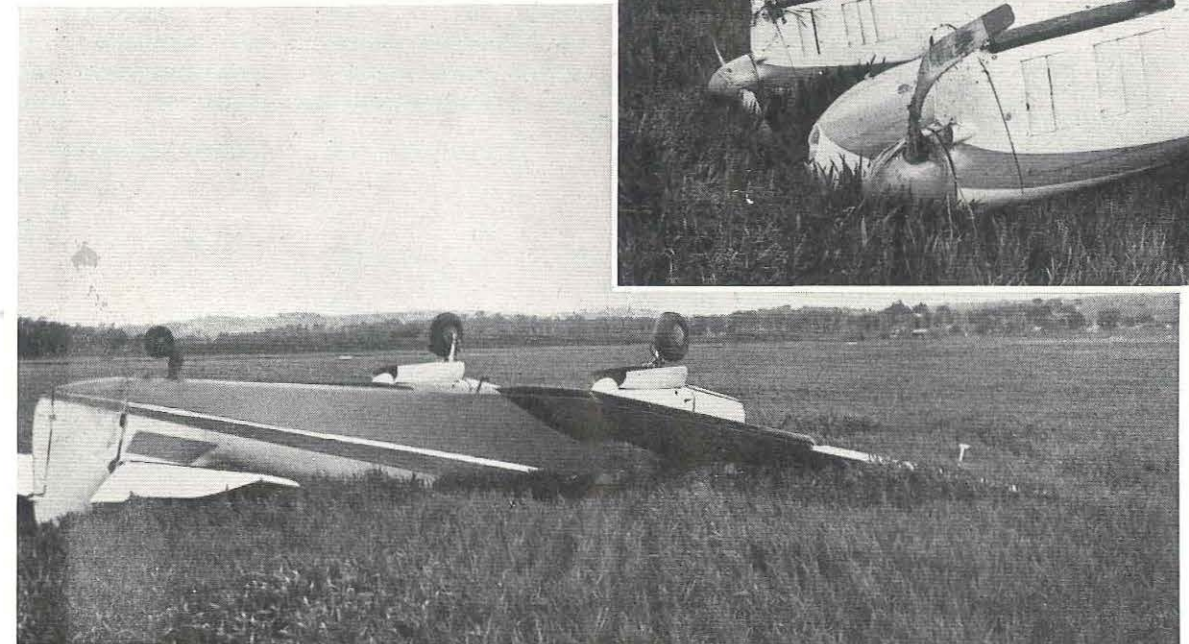
The aircraft upside down in the wheat crop.

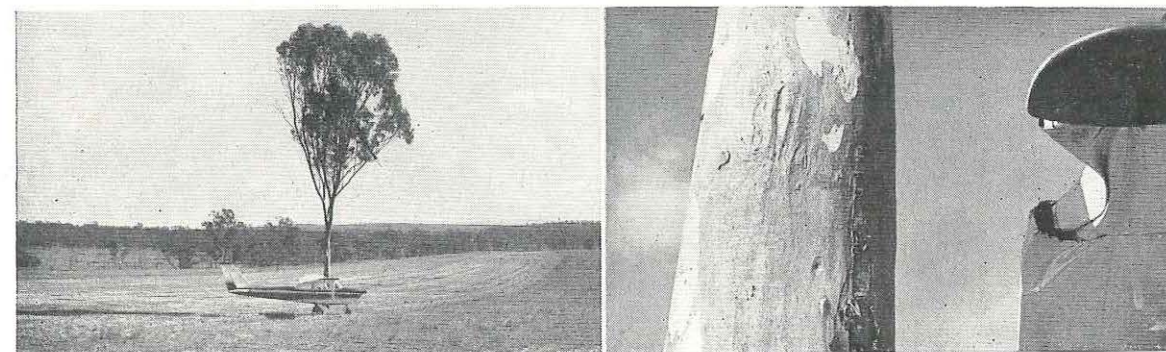
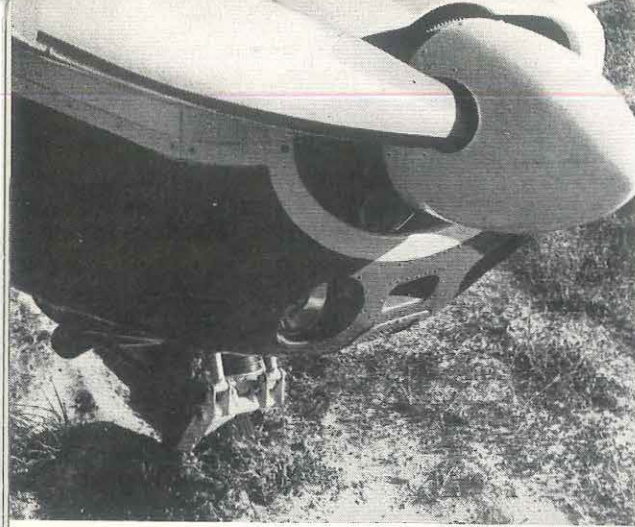
The result of inattentive taxi-ing on a bush airstrip.

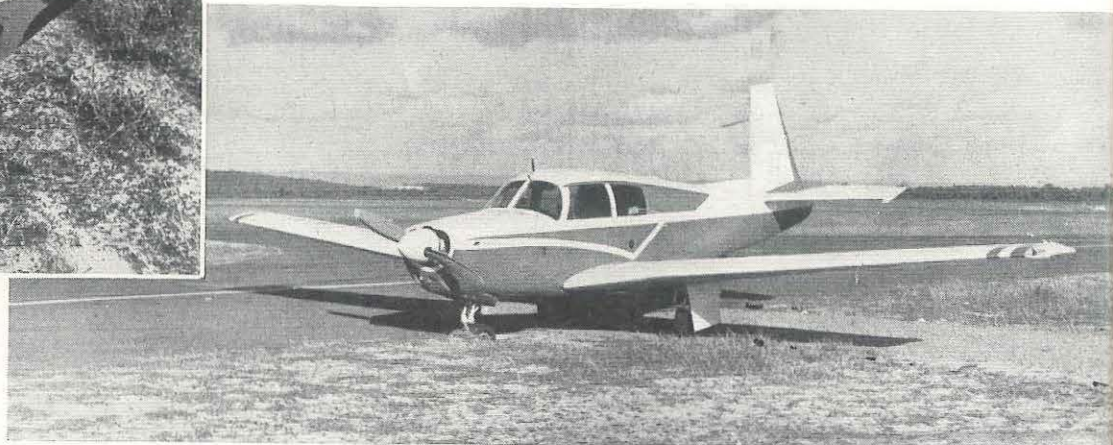
The result of manoeuvring outside the boundaries of prepared movement areas. Note the damage to the propeller.

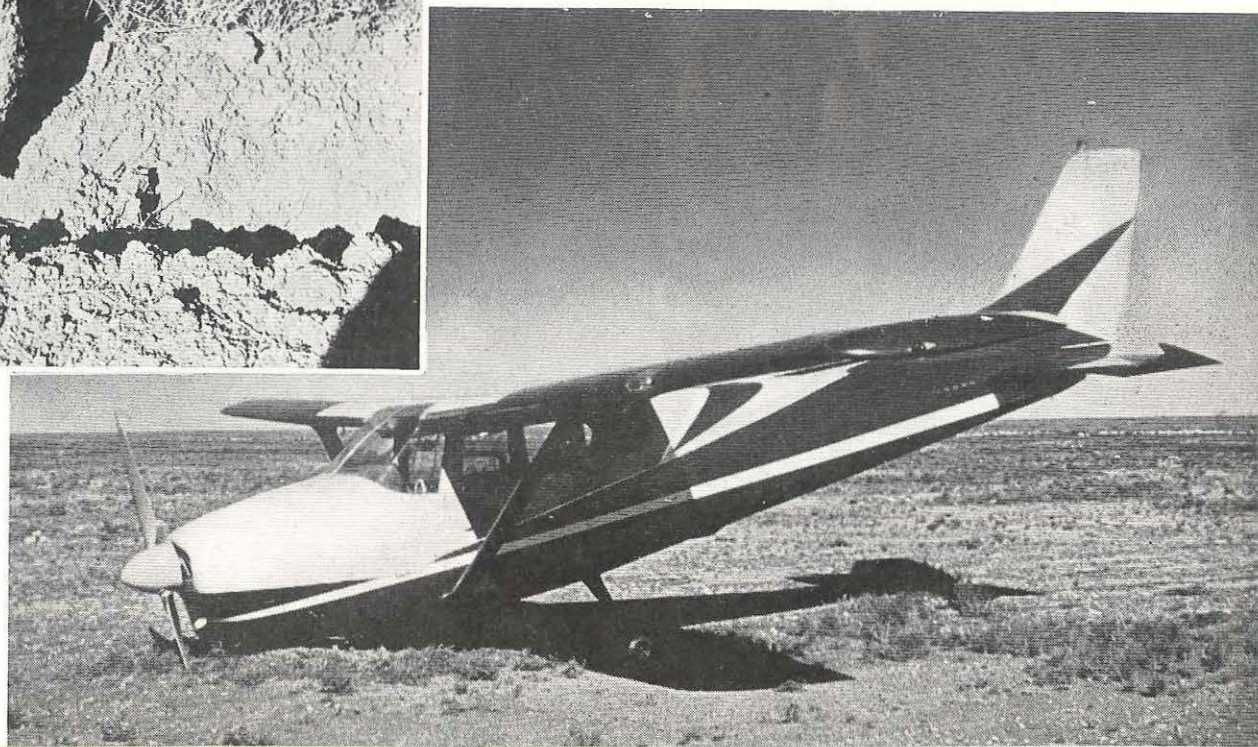
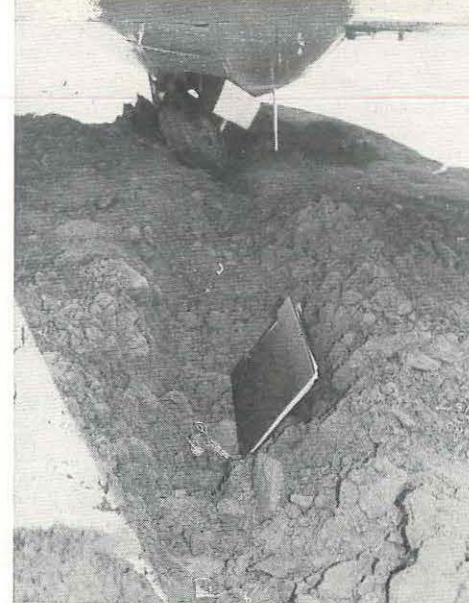
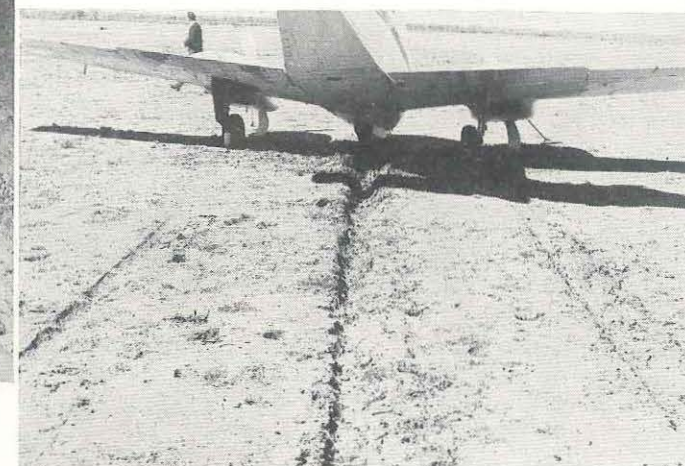
Winter rains turned this small area of an outback strip into a bog, though it was not apparent on the surface. Before the aircraft landed, the strip had been inspected and passed as serviceable.

After making a normal landing on an apparently serviceable outback aerodrome, the nose-wheel of this light twin broke through the surface crust and sank 11 inches into the mud beneath. The resulting drag collapsed the nose-wheel strut. Heavy rain had fallen during the three weeks preceding the accident.
