AVIATION
SAFETY
DIGEST

No. 57

JULY 1968

Tragedy at Barracouta	1
Sideslip Leads to Forced Landing	8
707 Breaks Up in Air	10
Misunderstandings — On Both Sides	14
Clean it First	16
Fuel Exhaustion	17
History Repeats Itself	18
Flight Over Mountains	22
This Concerns You	26
Don't Become Complacent About Cloud	27

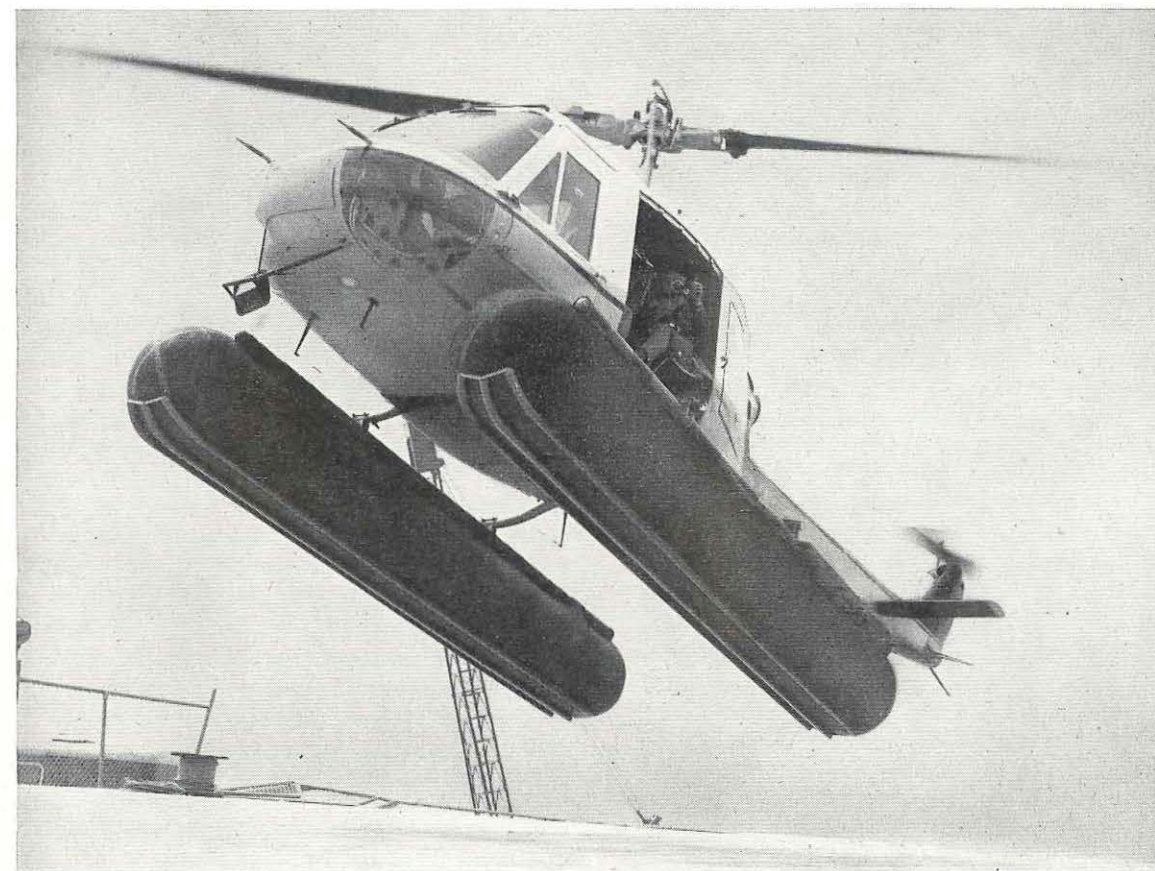
Left: This photograph was taken when the helicopter had reached a hovering position approximately 10 feet above the helipad. The final stage in the failure of the tail fin is just beginning.

The second photograph on Page 5, was taken when the undersurfaces of the pontoons were approximately four feet above the helipad deck and it shows that the ultimate structural failure of the tail fin has just occurred. The upper forward section, including the tail rotor gearbox and the tail rotor itself, has rotated upwards about a hingeline running approximately fore and aft along the starboard side of the tail fin, so that the tail rotor is, in fact, rotating in a near horizontal plane. Having regard to the positions from which these two photographs were taken, it is apparent that the helicopter has yawed some 25 degrees to the right in the time interval between the two exposures but there is still no sign of the helicopter rolling from its normal hover attitude.

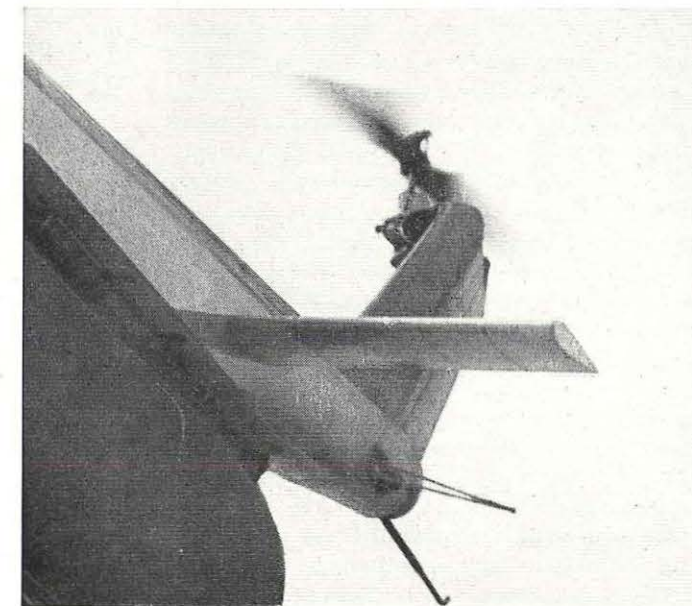
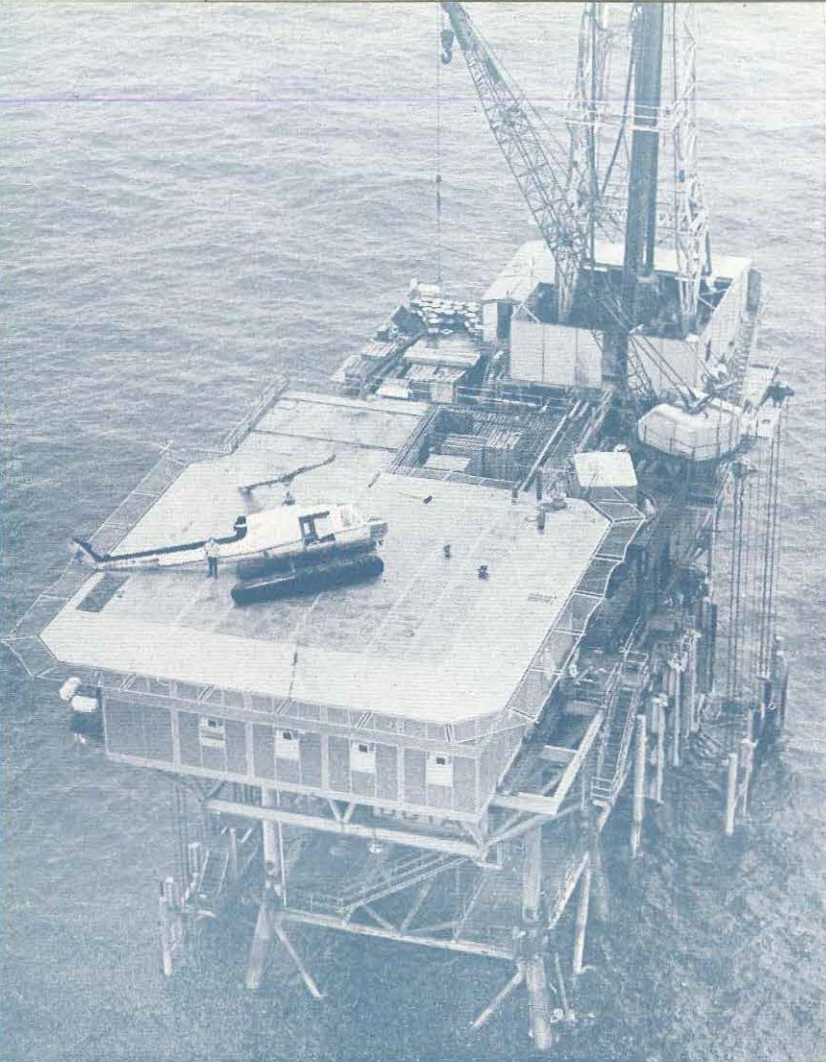
Above: This remarkable picture was the last to be taken of the helicopter before the accident. At this point the helicopter's pontoons were only four feet above the deck of the helipad. The enlargement at right shows clearly that the final failure of the tail fin had just occurred and the tail rotor shaft has pivoted into a vertical position, depriving the pilot of directional control.

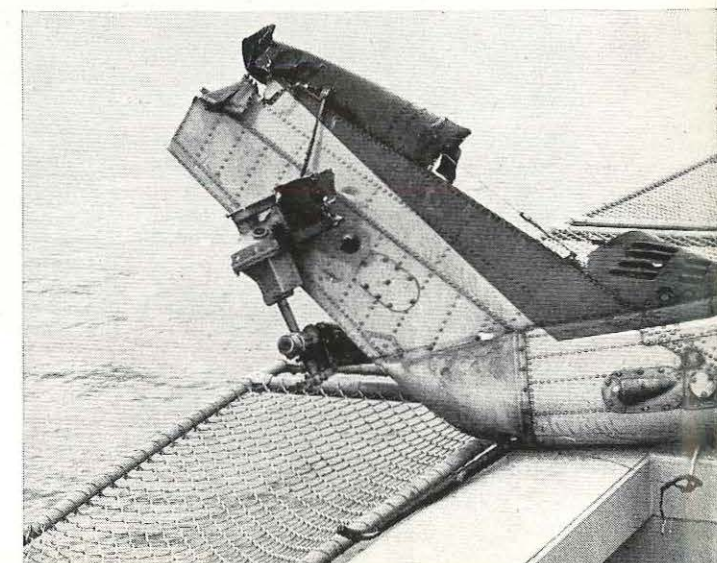
A most potent source of fatigue-cracking loads in the tail fin area would be a condition of unbalance in the tail rotor assembly. The damage arising from the separation of one tail rotor blade prevented a balance check being made of the tail rotor assembly as a whole and so a careful dismantling had to be undertaken. At the outset it was noted that a substantial relative movement between the tail rotor yoke and the rotor shaft could be obtained and this was measured at .065 inches. At the conclusion of the dismantling process the two most significant facts discovered were that, although the manufacturer's instructions relating to centring of the trunnion would require that the trunnion shims (see Diagram of Tail Rotor Assembly, Item 7) be evenly distributed about the trunnion, this particular assembly contained a shim pack difference of .022 inches. It was also found that the nylon thrust washer was missing from the trunnion end at which the thinner shim pack was located. The missing component is illustrated as Item 5 in the diagram. In size, at 7/16ths of an inch diameter, it is no bigger than a shirt button and, in its installed position, it provides a spacing of approximately .060 inches between the end of the tail rotor trunnion and the trunnion bearing cap.

Stress calculations have shown that the forces to be expected from the degree of unbalance found in this incorrectly assembled tail rotor, would be sufficiently high to induce fatigue cracking of the tail fin and that this could progress to the point of ultimate failure within the flight time which this helicopter had experienced since the last tail rotor change. As already pointed out however, the metallurgical examination confined the cracking period to a much shorter span of flight time and pointed to the probability that all or most of it had occurred during the earlier flying on the day of the accident.

Above: Aerial photograph of the damaged helicopter on the Barracouta helipad, taken soon after the accident. The access stairway can be seen near the helicopter's tail.

Below: The failed tail fin, showing the tail rotor hub and gear box torn away and retained only by the control cables.

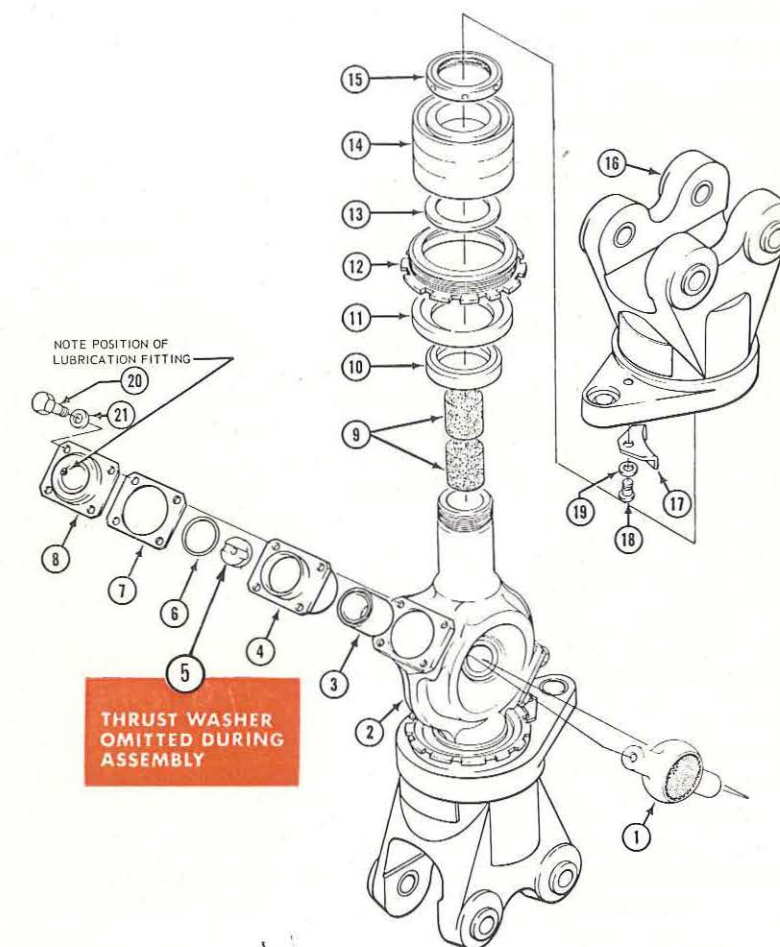
Diagram of Tail Rotor Assembly, with rotor blades removed, showing component parts.

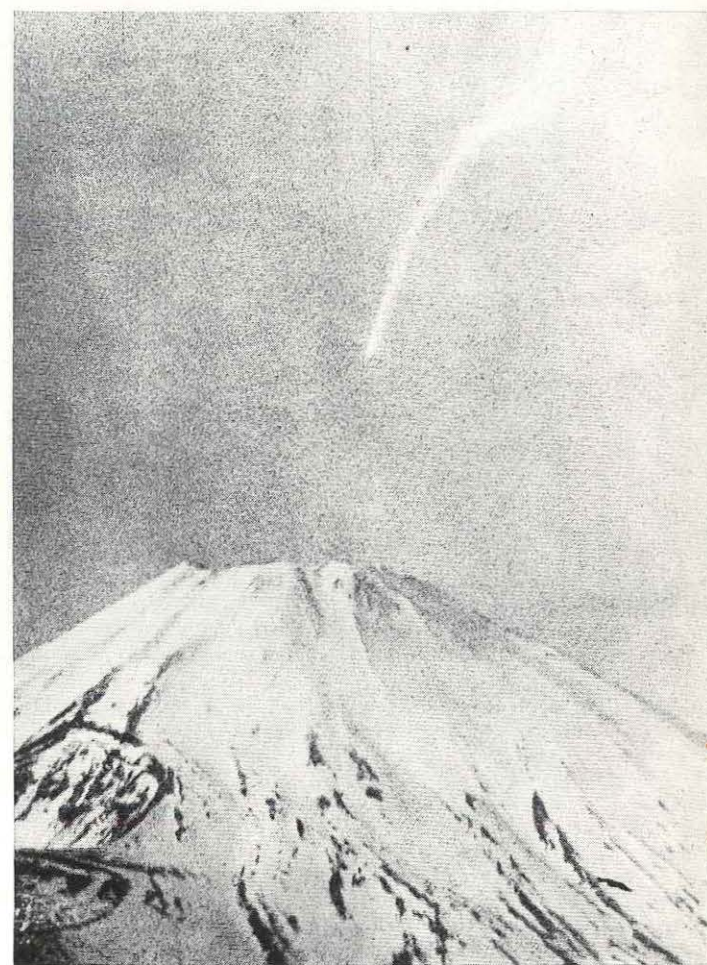
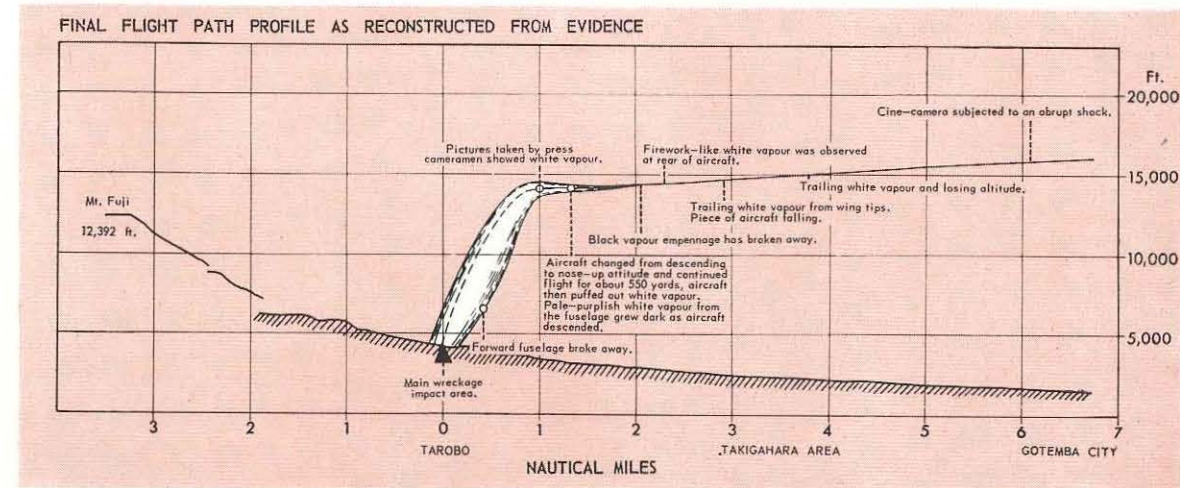
Right: The aircraft, trailing white vapour, begins its downward plunge near Mt. Fuji.

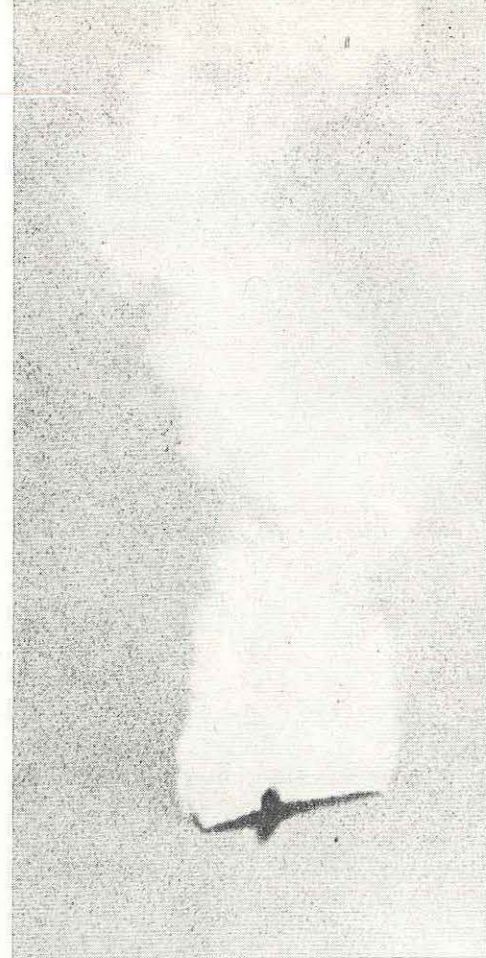
The fuselage and main portion of the wing, descending in a flat spin. The tail section is missing and portion of the starboard wing is just breaking away.

The probable cause of the accident is that the aircraft suddenly encountered abnormally severe turbulence over Gotemba City which imposed a gust load considerably in excess of the design limit.

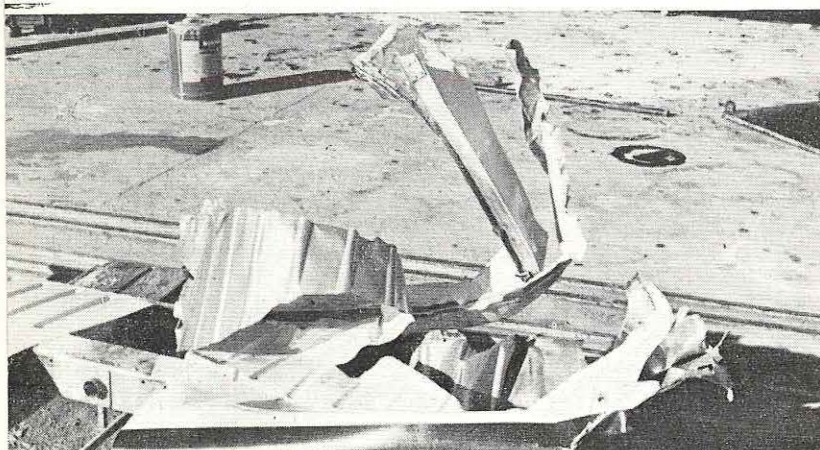
While he was manoeuvring his aircraft in this way, without any forward vision, it collided with the tail of another Cherokee parked near the apron. The pilot's aircraft sustained no damage, apart from minor scouring of its propeller blades, but the port tail plane of the other aircraft was literally slashed to pieces by the rotating propeller.

The tailplane of the damaged aircraft after being removed for repair. The propeller of the other aircraft has literally hacked it to pieces.

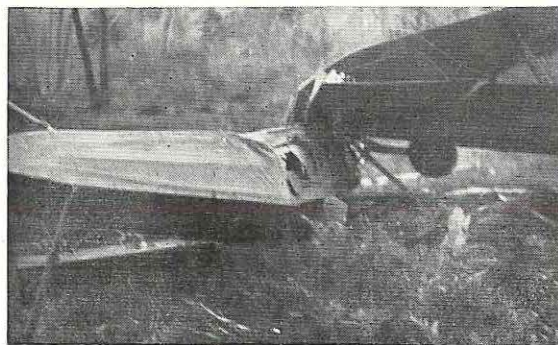
The shattered wreckage of the Tiger Moth after its collision with the tree.

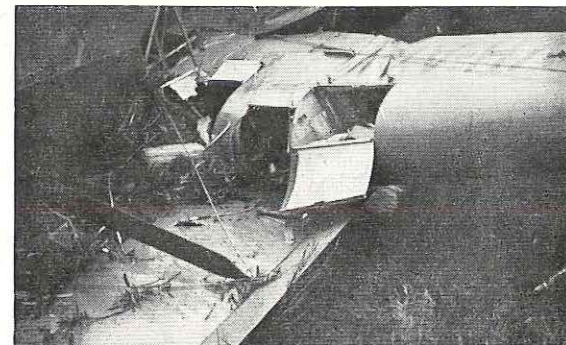
The site of the crash, just to the north-east of Bundanoon, was only nine miles from the site of the Tiger Moth accident 14 years earlier.

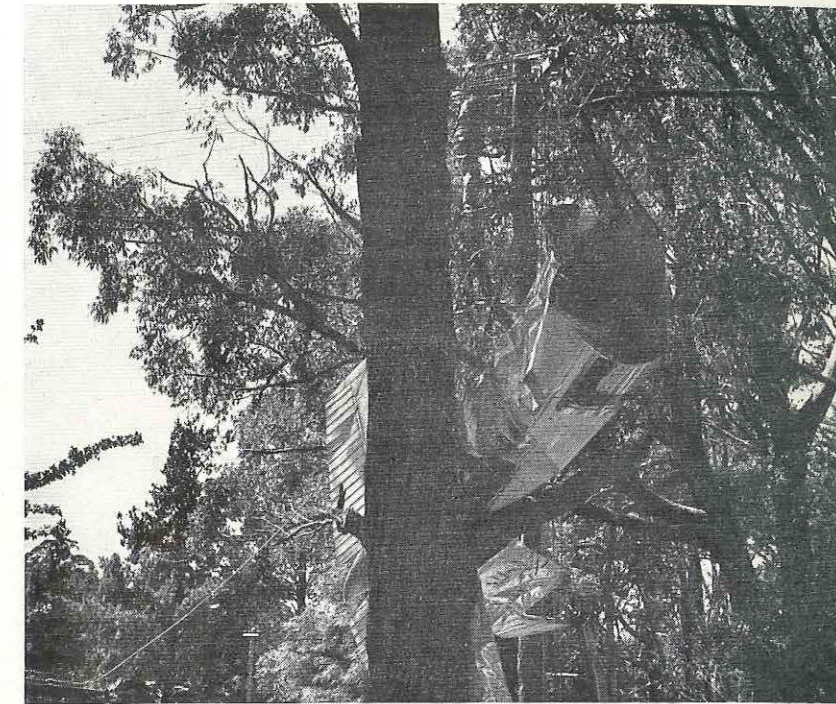
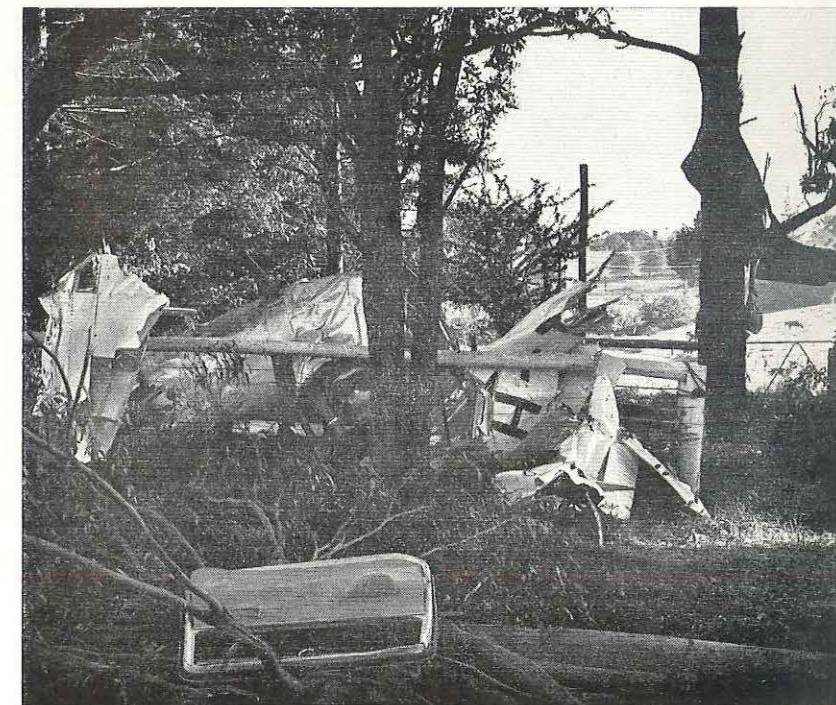
Above and Below: The disintegrated remains of the Cessna 182 after it had crashed through the trees, struck a power line, and fallen to the ground. Note the rear fuselage caught in a fork of the large tree in the picture above.

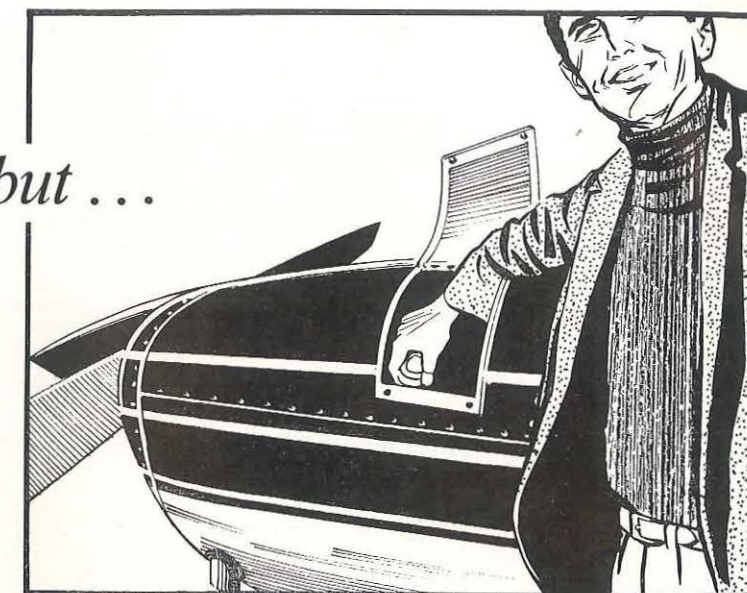
- Inattention during pre-flight inspection.
- Oil Cap not correctly secured.
- Oil "blow back" soon after take-off — leading to immediate loss in forward vision and total loss of oil contents in minutes.

... don't allow yourself to be distracted while carrying out your pre-flight checks.
