No. 65 NOVEMBER 1969

AVIATION SAFETY DIGEST

DEPARTMENT OF CIVIL AVIATION AUSTRALIA

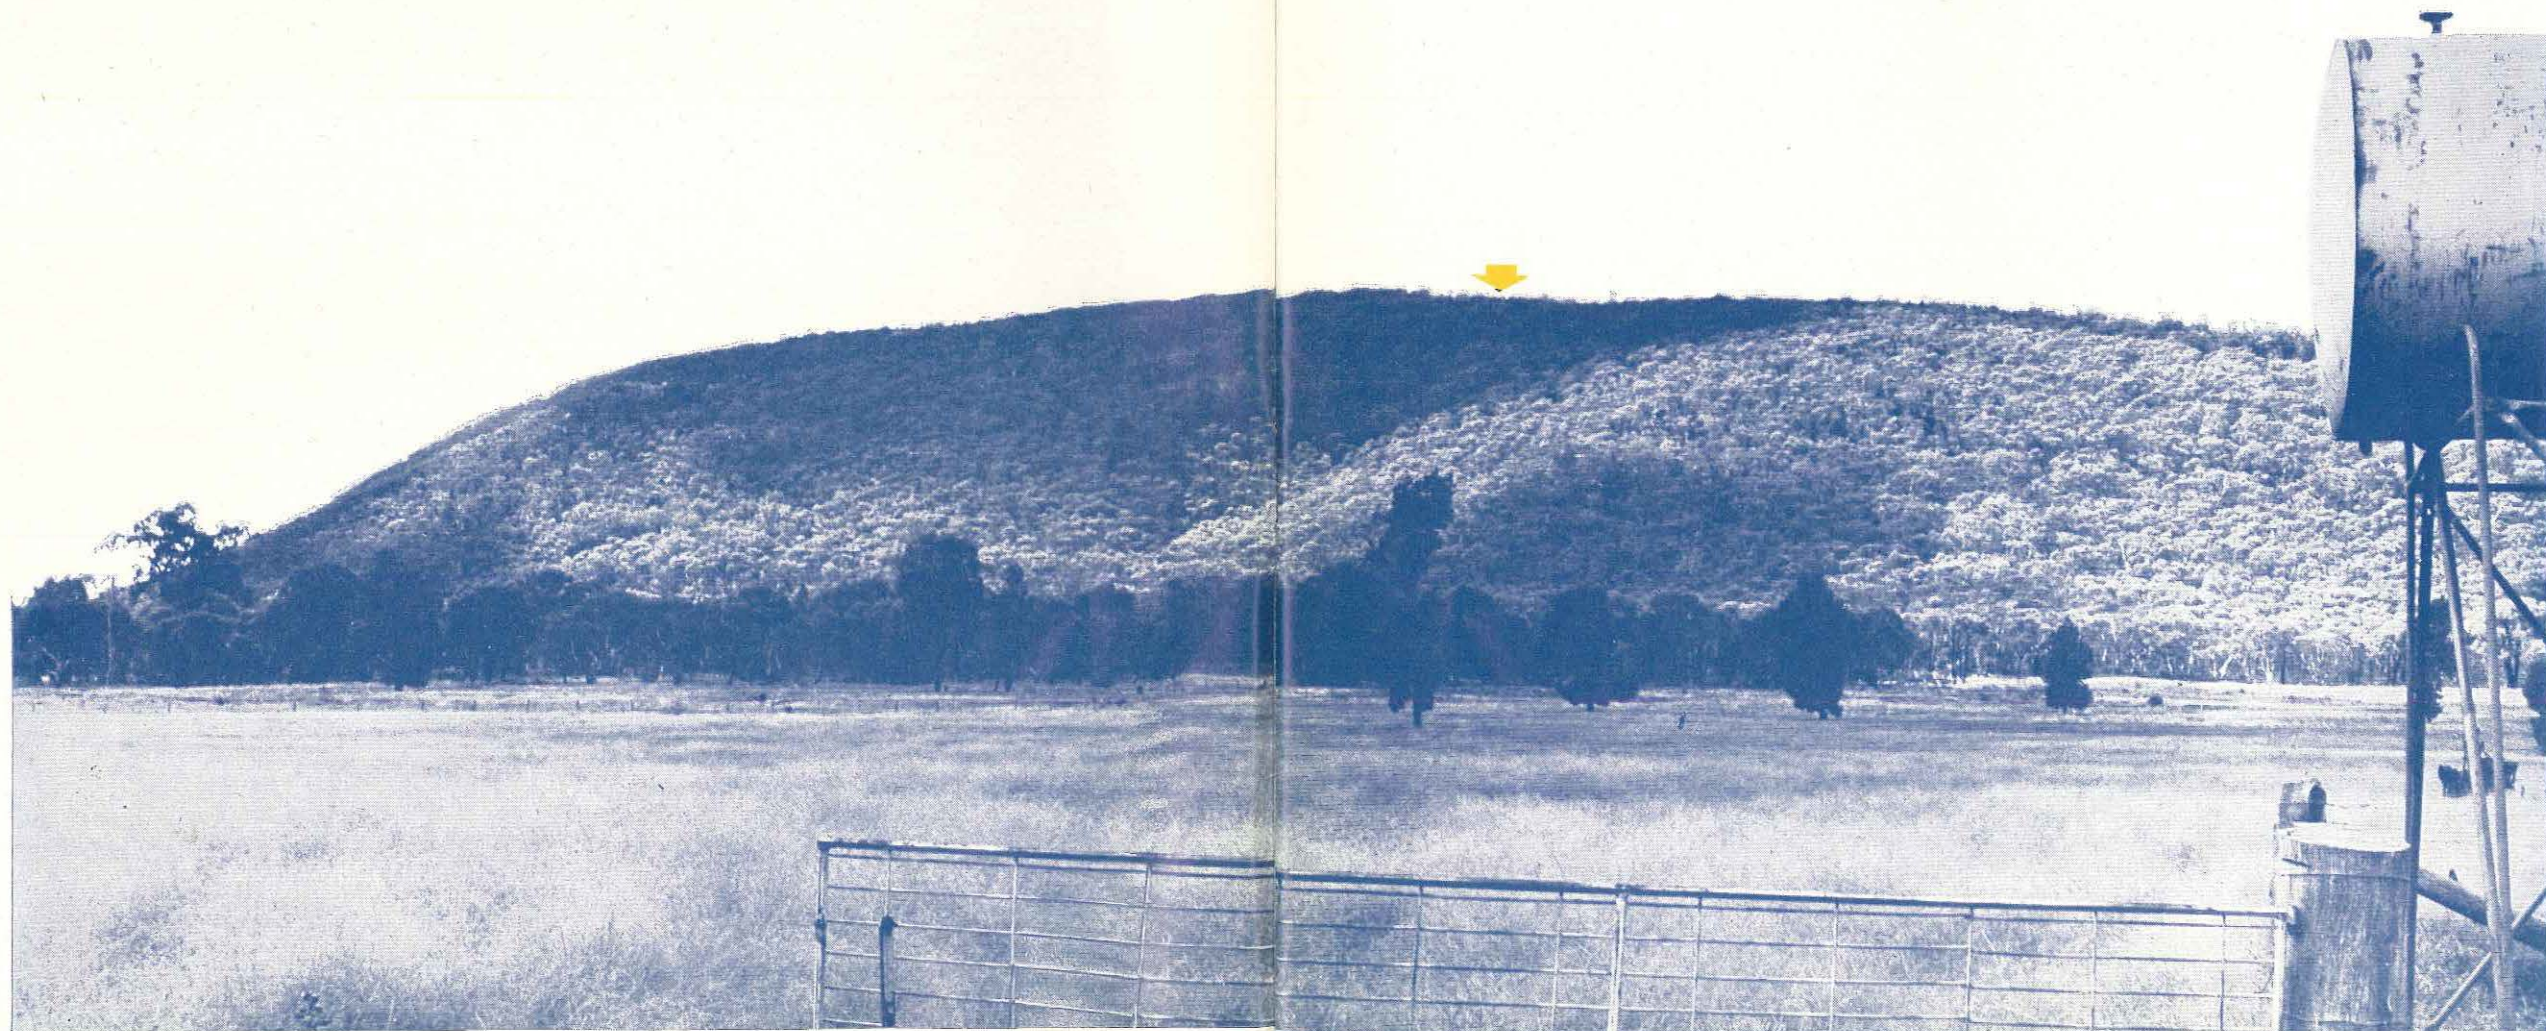
Below: The Weddin Range as seen from its western side. Note how steeply it rises from the surrounding terrain. The arrow indicates the crash site.

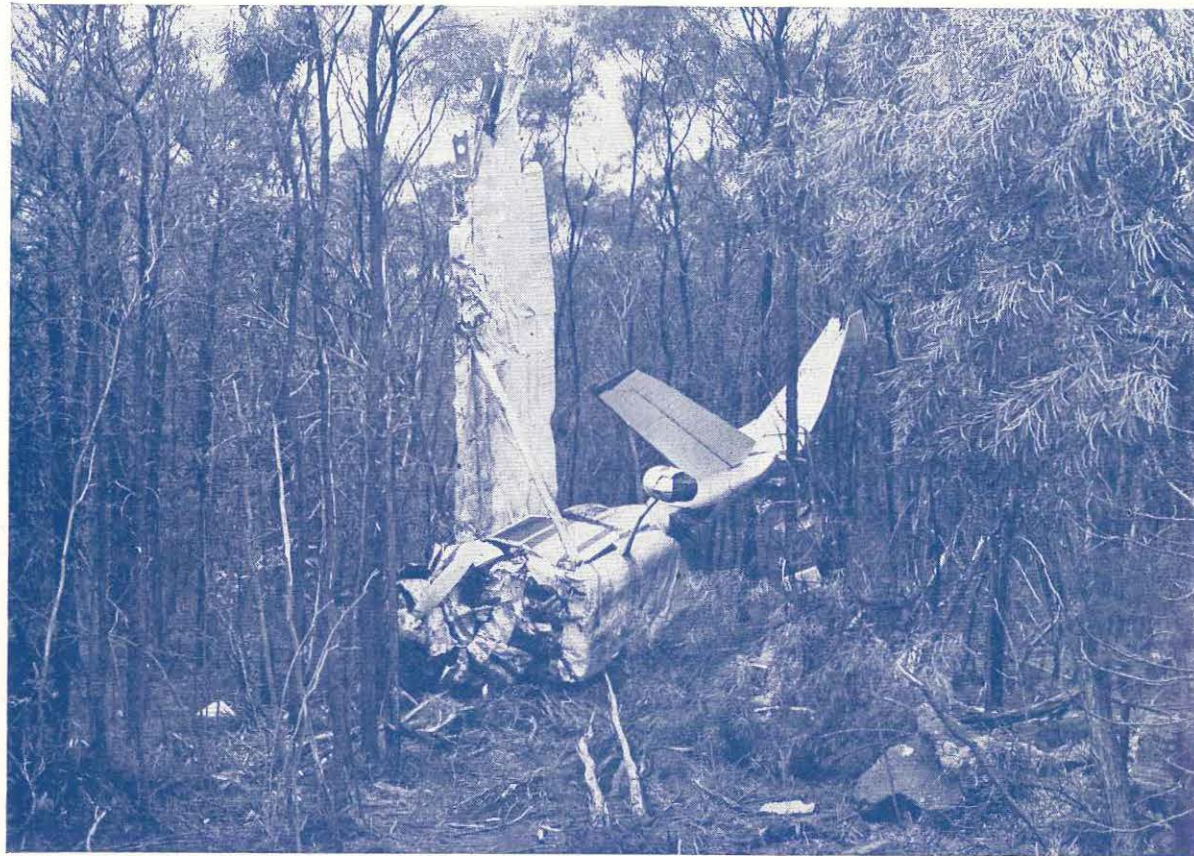
The main wreckage as it came to rest on top of the thickly timbered ridge, looking in the direction of impact.

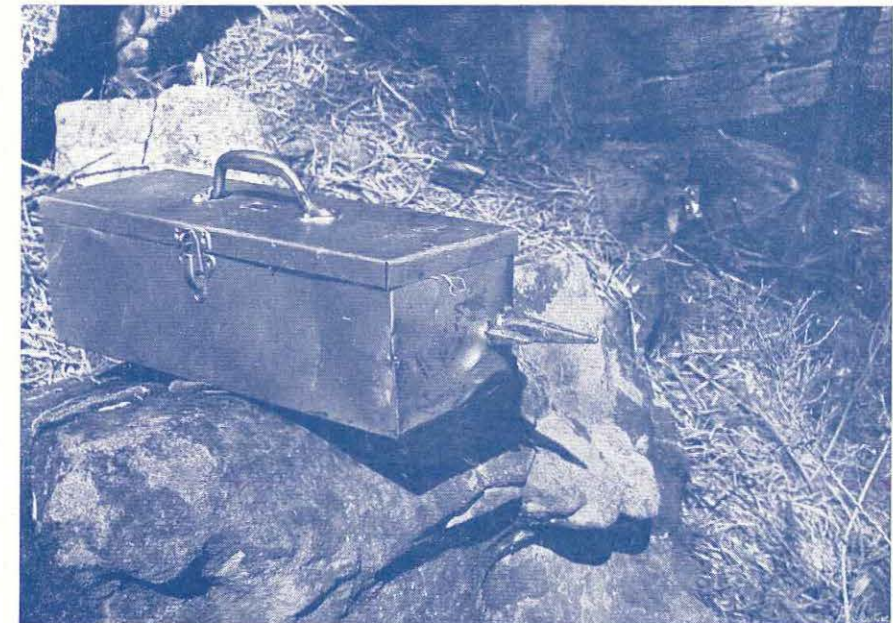
Some idea of the deceleration forces during the impact is conveyed by the damage sustained by this tool box. Two tie-down pegs contained in the box have penetrated its steel sides to a depth of three inches.

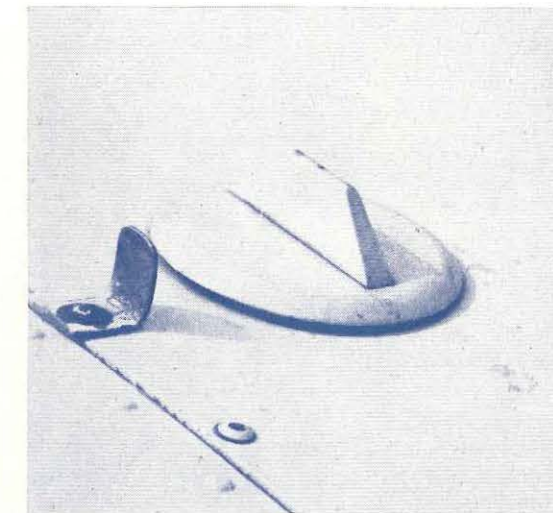
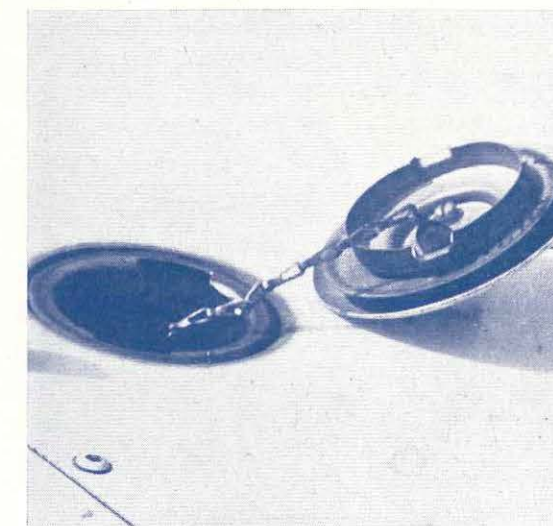
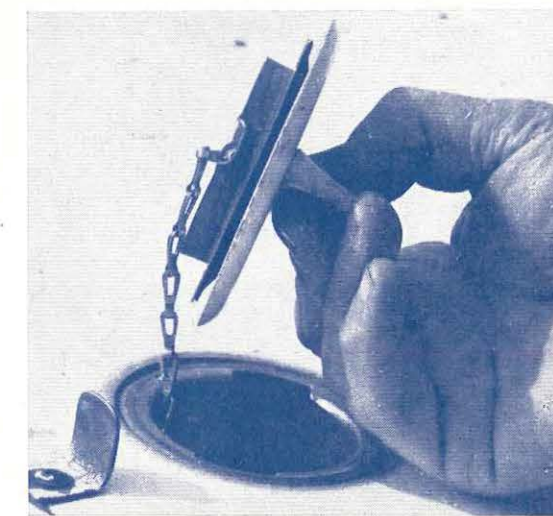
An example of the damage that dust can cause was demonstrated in a recent incident in which a PA.32 Cherokee Six, departing from Alice Springs on a flight to Mount Isa, was forced to return because of fluctuating fuel pressure. When the defect was investigated it was found that the fuel injector was faulty and that the malfunction had been caused by the gradual wearing effect of dust in the fuel. The aircraft had been operating for some time in the Mt. Isa area in dusty conditions but even so, how could enough dust to cause the damage have found its way into the fuel system? Very simply:

Those of us who fly Cherokee 140s, 180s or Cherokee Sixes will know that the fuel cap fits directly on to the neck of the fuel tank and that, because there is no lip on the tank, the opening is on the same level as the surface of the wing. In dusty conditions when the aircraft is on the ground, dust can collect on the wing under the edge or "overhang" of the fuel cap. Consequently, when the cap is taken off, it is almost impossible to prevent the dust falling directly into the fuel tank. In the aircraft involved in this case, enough dust had apparently fallen into the tank in this manner over a period of time to cause the damage to the fuel injector.

In practice, there is a very simple way to overcome this problem—by blowing around the fuel cap before removing it. As there is a small clearance between the cap and the edge of the filler neck, it is quite easy to blow the dust away from around the cap. So, when operating in dusty conditions, remember: **Blow First — Then Remove the fuel cap!**

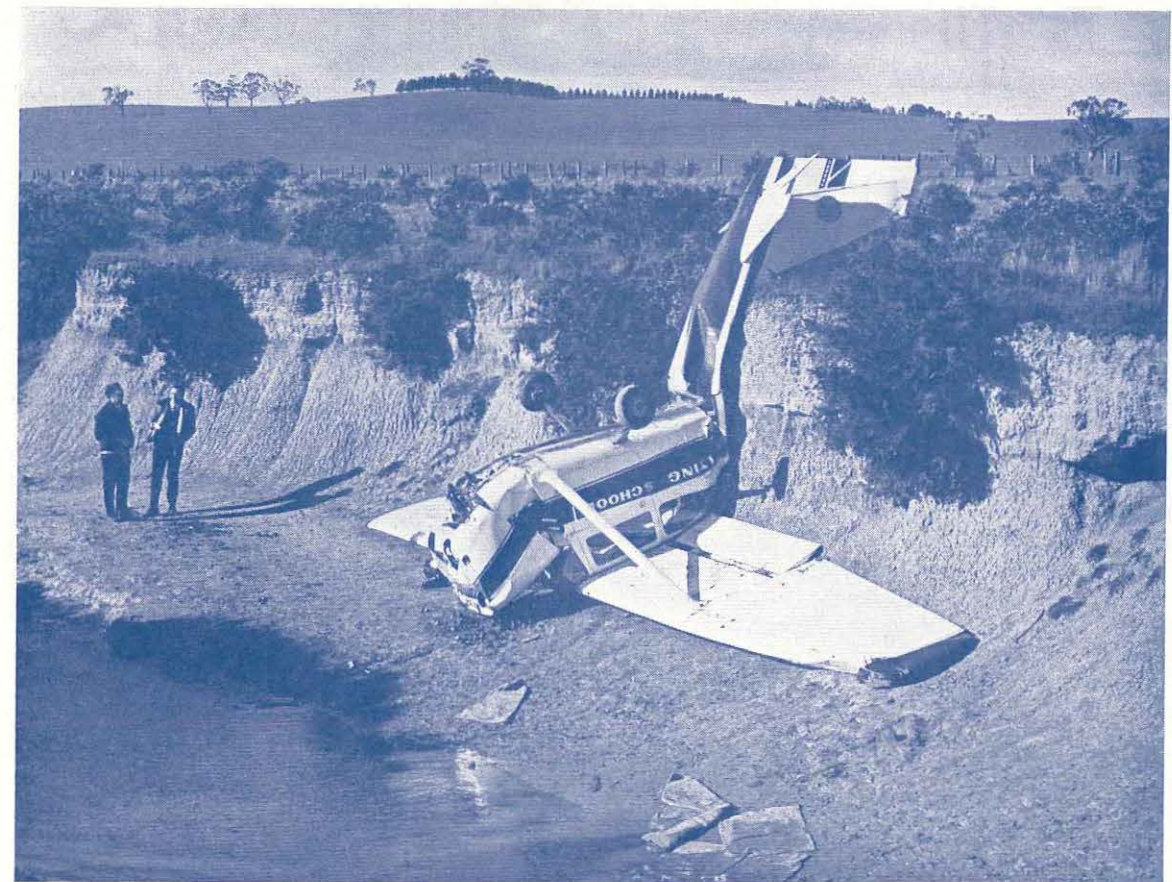
The impact dislodged the nosewheel and the aircraft dropped on to its nose and slid for a further 100 feet before it plunged into a steep-sided creek bed, where it somersaulted and came to rest inverted against the far bank. The student pilot received serious injuries and the aircraft, as is clearly evident from the photographs, was damaged beyond repair.

The wreckage after somersaulting in the creek bed, lying against the far bank.

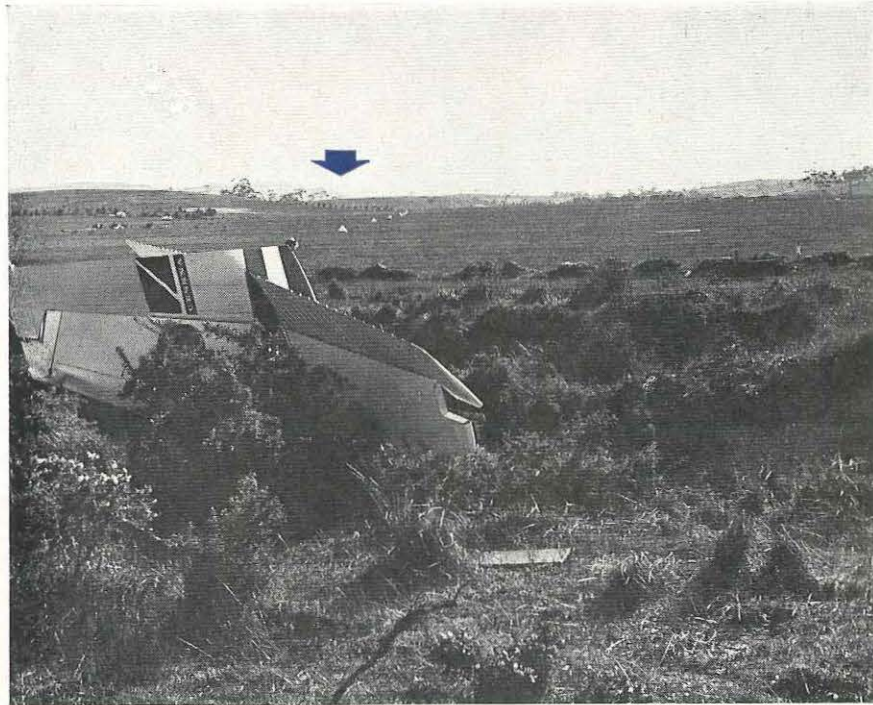
View looking back along the strip from just beyond the creek. The "go around" was commenced, only just before reaching the cone marker arrowed. The marker is 180 feet from the end of the strip.

The cause of the accident was that the instructor, as pilot-in-command, did not take timely action to initiate a go around.

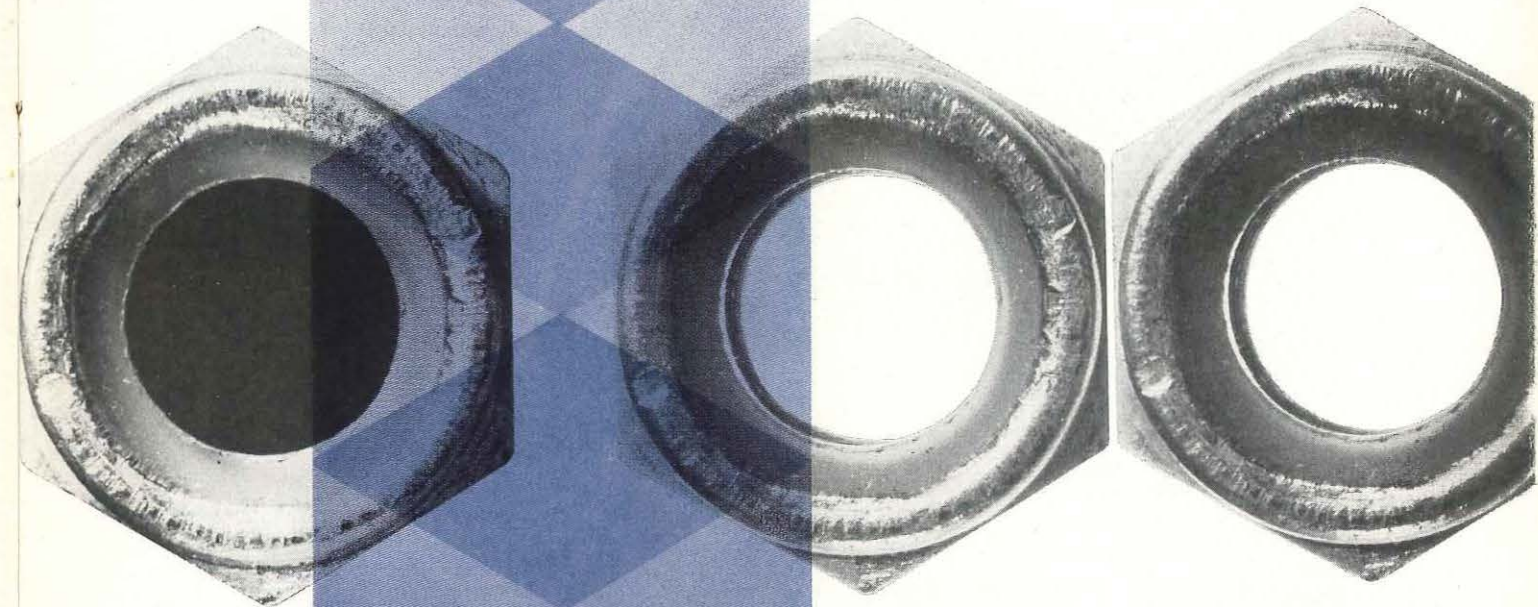
Recently in Western Australia, the tail wheel assembly of a Piper Super Cub fell off in flight and was lost. It was quite evident that the tail wheel yoke retaining nut had worked off in flight, allowing the assembly to fall out of its mounting bracket. The nut's loss of torque was attributed to the fact that it had been used several times over.

On this occasion the aircraft landed safely and no great harm was done. But as we see it, a similar fate could just as easily have befallen one of the stop nuts on the primary flying control system or perhaps the engine controls. In this event, the outcome could have been a very different story. As we said in our earlier article—new stop nuts are cheaper than new aeroplanes!

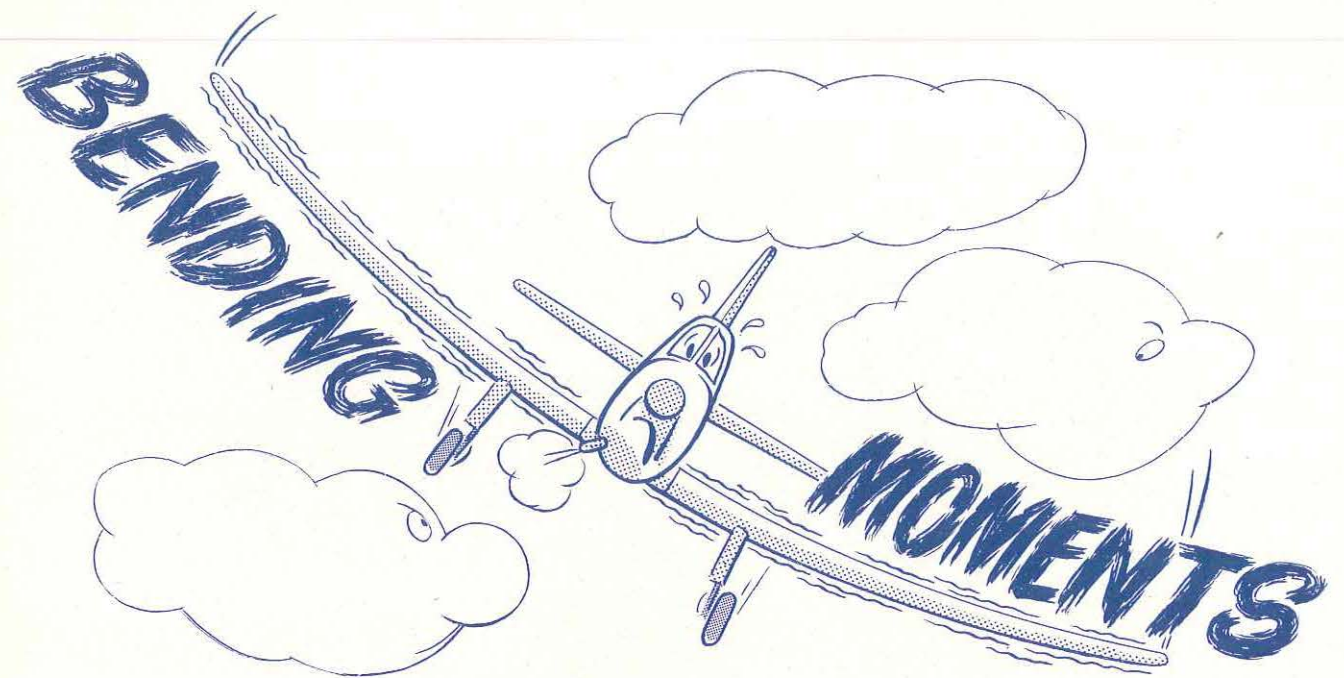
RECENTLY, while a daily inspection was being carried out on a flying school's Chipmunk, both wings were found to be distorted just outboard of the undercarriage leg on each side, apparently as a result of excessive in-flight loads. Although the official report on the matter was endorsed "cause not established", little imagination is required to appreciate that the aircraft must have been subject to some particularly ham-fisted aerobatic flying.

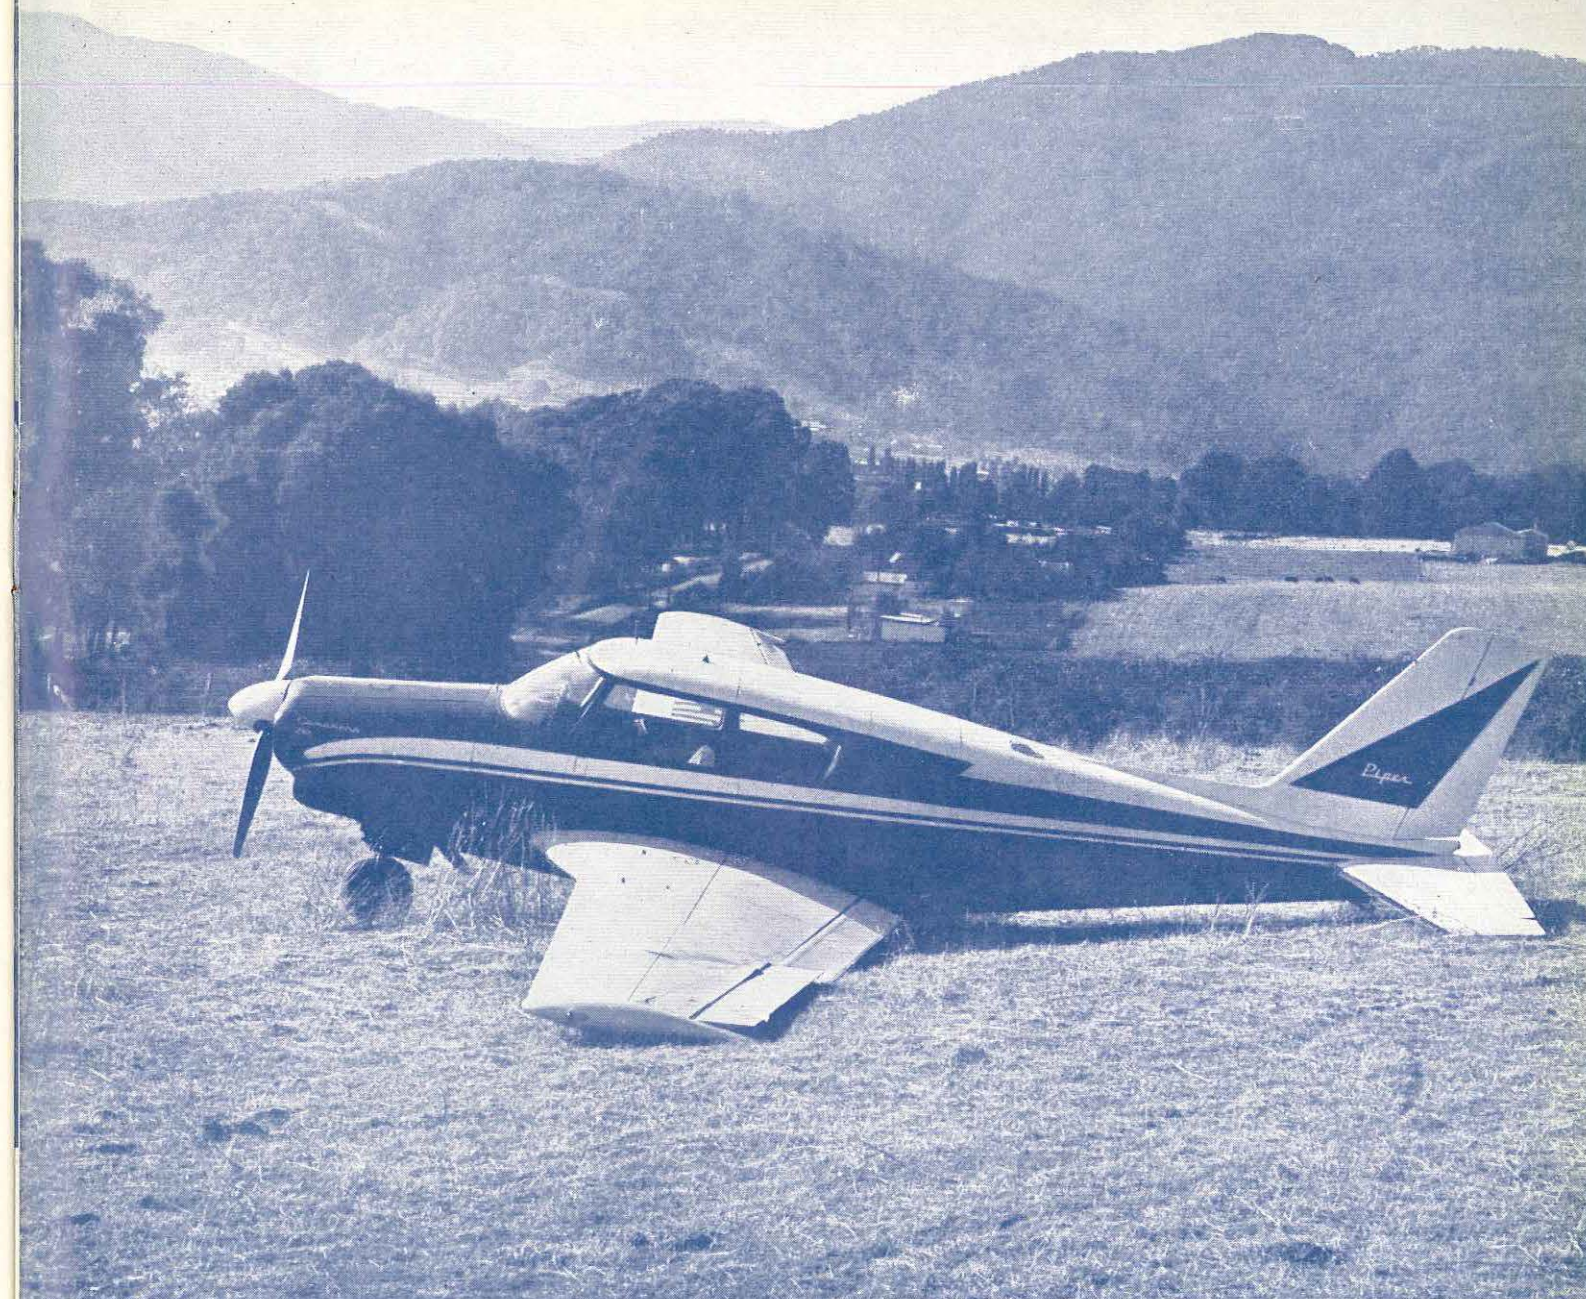
The aircraft, with port undercarriage collapsed at the end of the "strip". The picture is taken in the direction of the landing run. Note the steepening gradient beyond the aircraft.

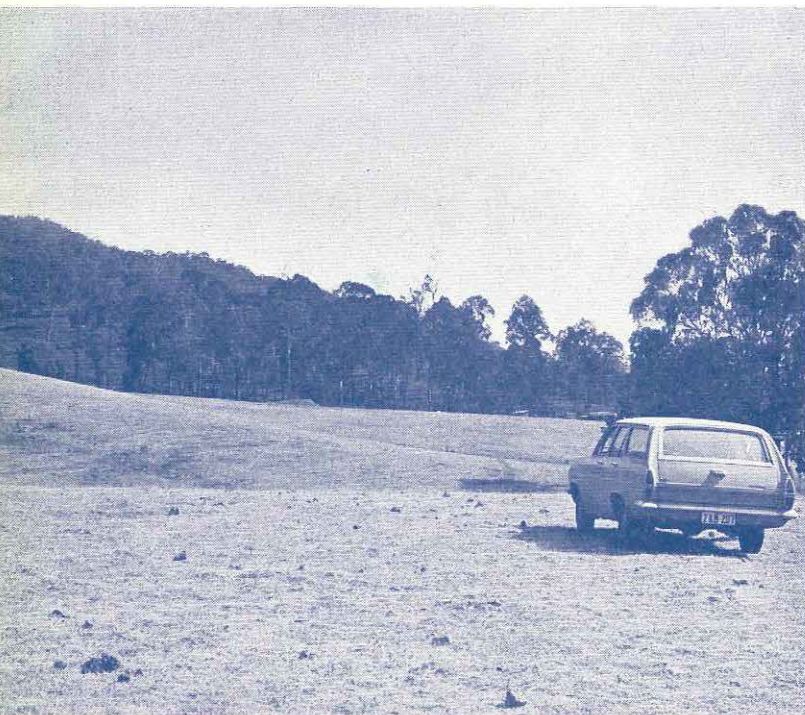
Above: The approach path to the strip taken from the commencement of the usable landing area.

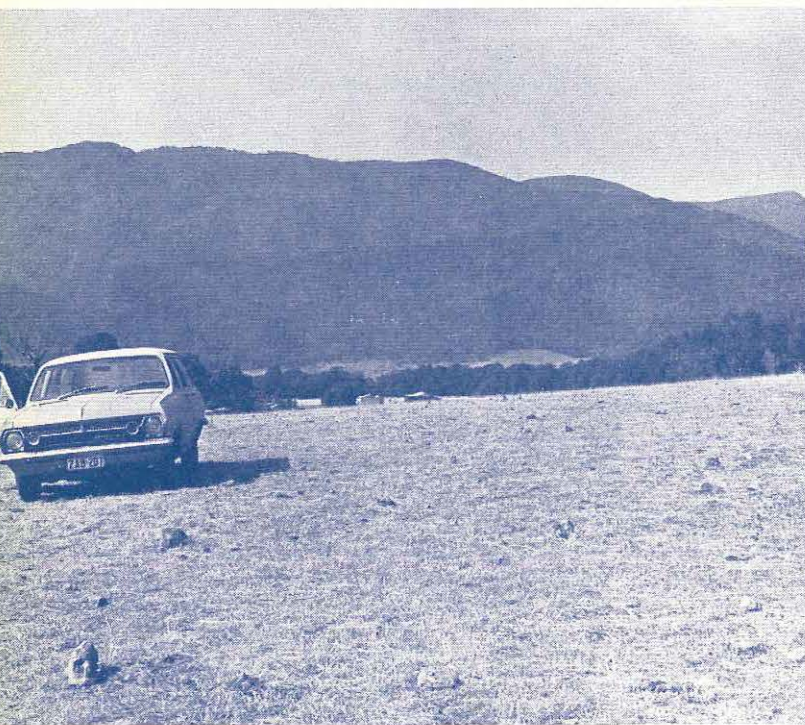
Below: View taken from the same point looking down the field in the direction of landing. The overall downward gradient is clearly evident.

Investigation of the circumstances of the accident showed that the aircraft had been operating normally and that its loaded weight of 2,520 lbs. was well below the maximum take-off weight. The pilot said that no wind was blowing at the time of the landing and references to the landing weight chart for this model Comanche show that in zero wind conditions and at the weight to which it was loaded, a distance of 2,480 feet is required for a landing. Examination of the field in which the accident occurred, however, showed that because of a gully at its northern end, the maximum length of run available for landing or take-off was only 1,840 feet. Furthermore, in the direction used, the surface of the field was level for the first 140 feet but then sloped downward with a progressively steepening gradient. The slope over the final 800 feet was nearly $2\frac{1}{2}$ degrees and the overall downward slope of the usable landing area was approximately two degrees, or one in 30. By contrast, the maximum allowable longitudinal grade for an authorised landing area is one in 50.

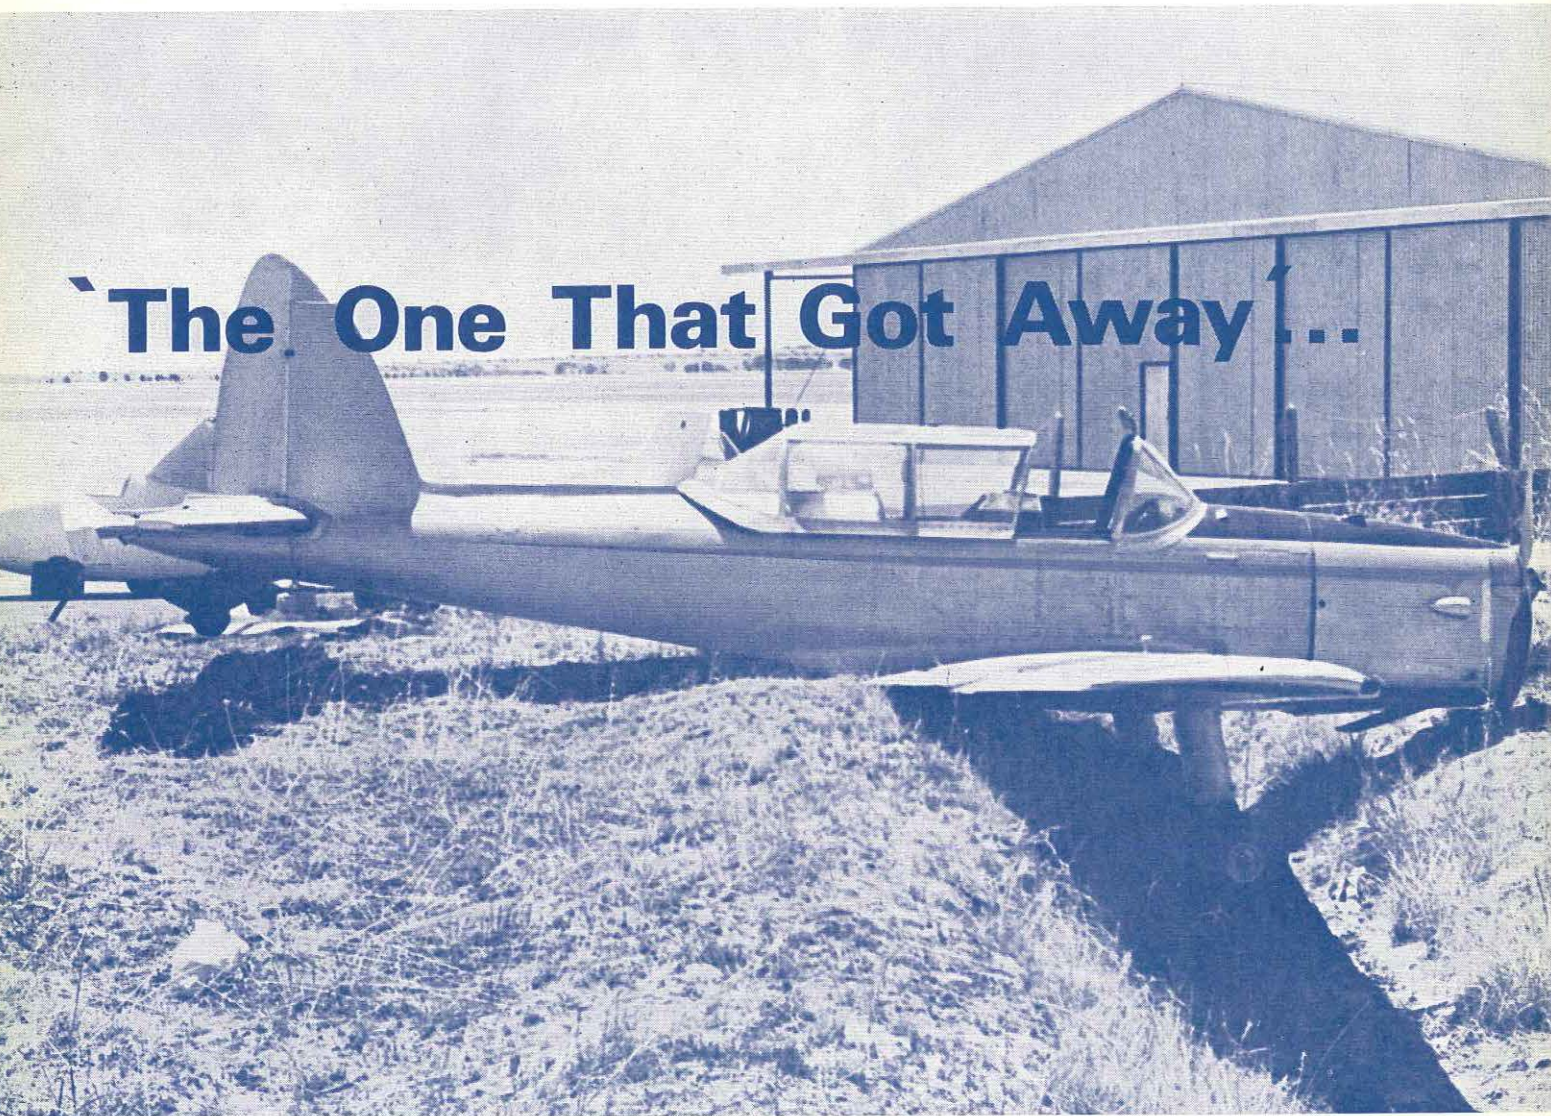
NO, this isn't a fish story. The escapee in this case is the dejected looking Chipmunk in the picture above. It ran away after being hand-started, demolished the wing of a nearby glider, and finished up in the ditch.

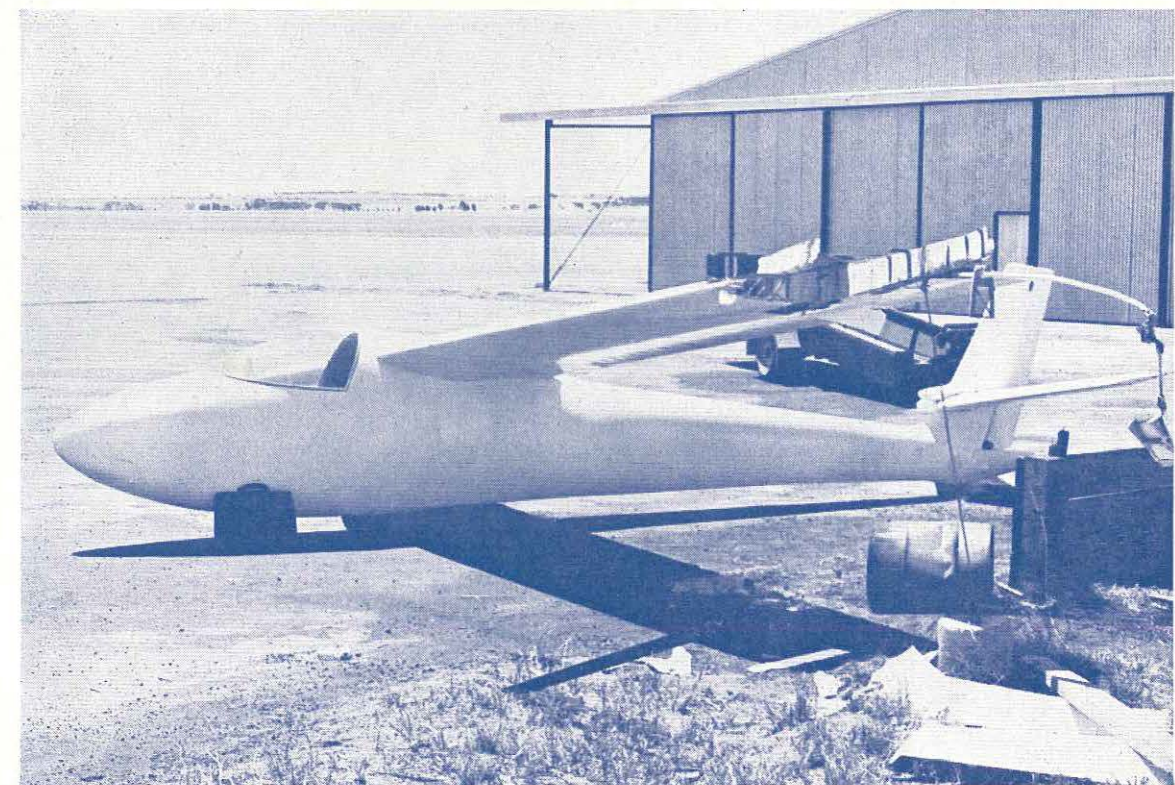
The Boomerang glider with its port wing "sawn off" by the Chipmunk's propeller.
