# AVIATION SAFETY DIGEST

DEPARTMENT OF CIVIL AVIATION AUSTRALIA

No. 67 MARCH, 1970  
DEPARTMENT OF CIVIL AVIATION, AUSTRALIA

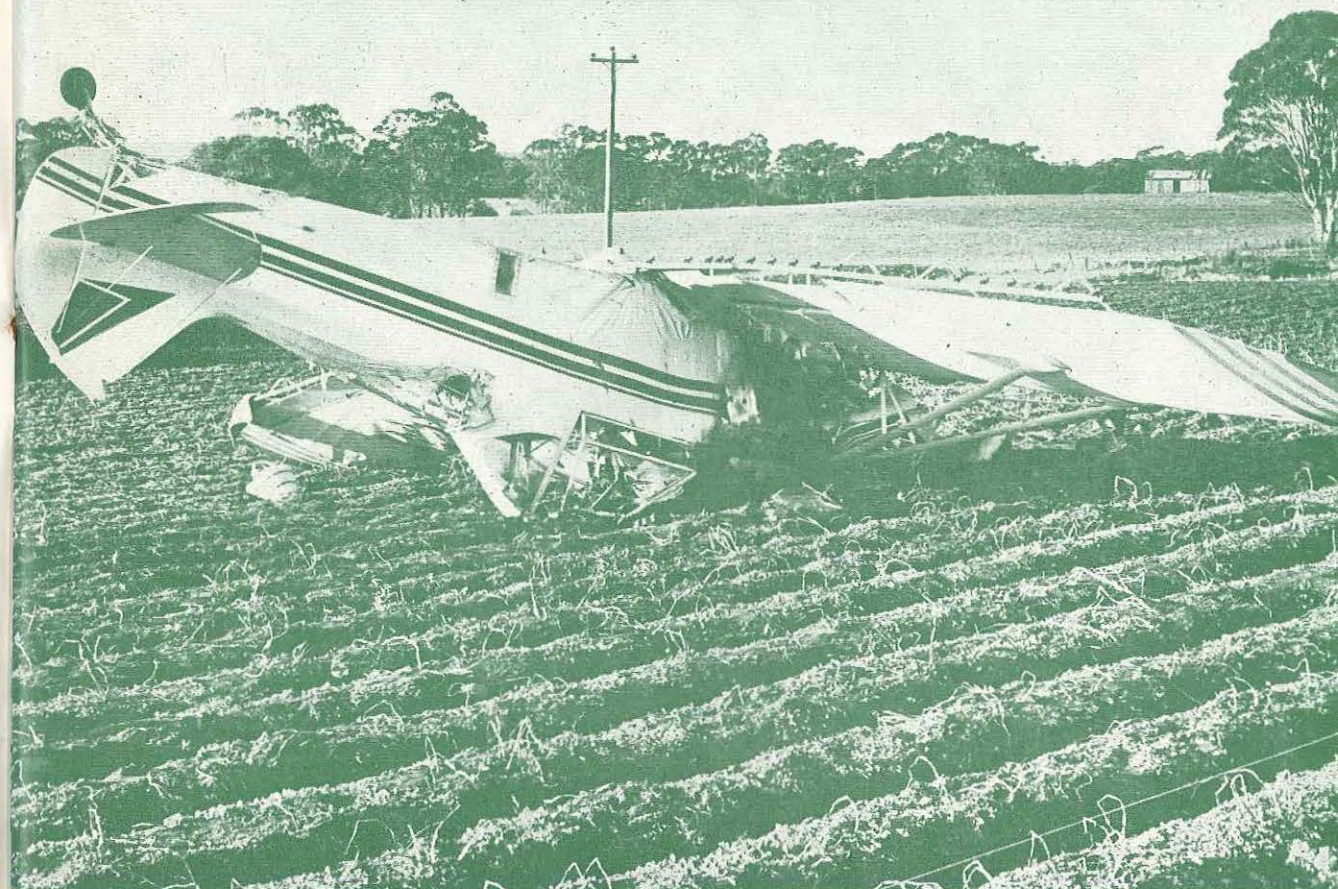
THE wrecked Pawnee in the picture above was being used to spray a crop of potatoes in Western Victoria, when it flew into a power line.

run, but this time on the northern side of the power line. Towards the middle of the run, as he was looking back to check the drift of the spray swathe, the aircraft collided with a three wire spur power line which runs north at right angles from the main line. The aircraft pitched down steeply, struck the ground on its nose, bounced and somersaulted in the air, and came to rest on its back. Fire broke out in the engine bay almost immediately. Fortunately for the pilot, who was not able to extricate himself, two farm workers who had been digging potatoes nearby, ran to the site to help him from the burning wreckage, then assisted in extinguishing the fire. The pilot was admitted to hospital with serious injuries.

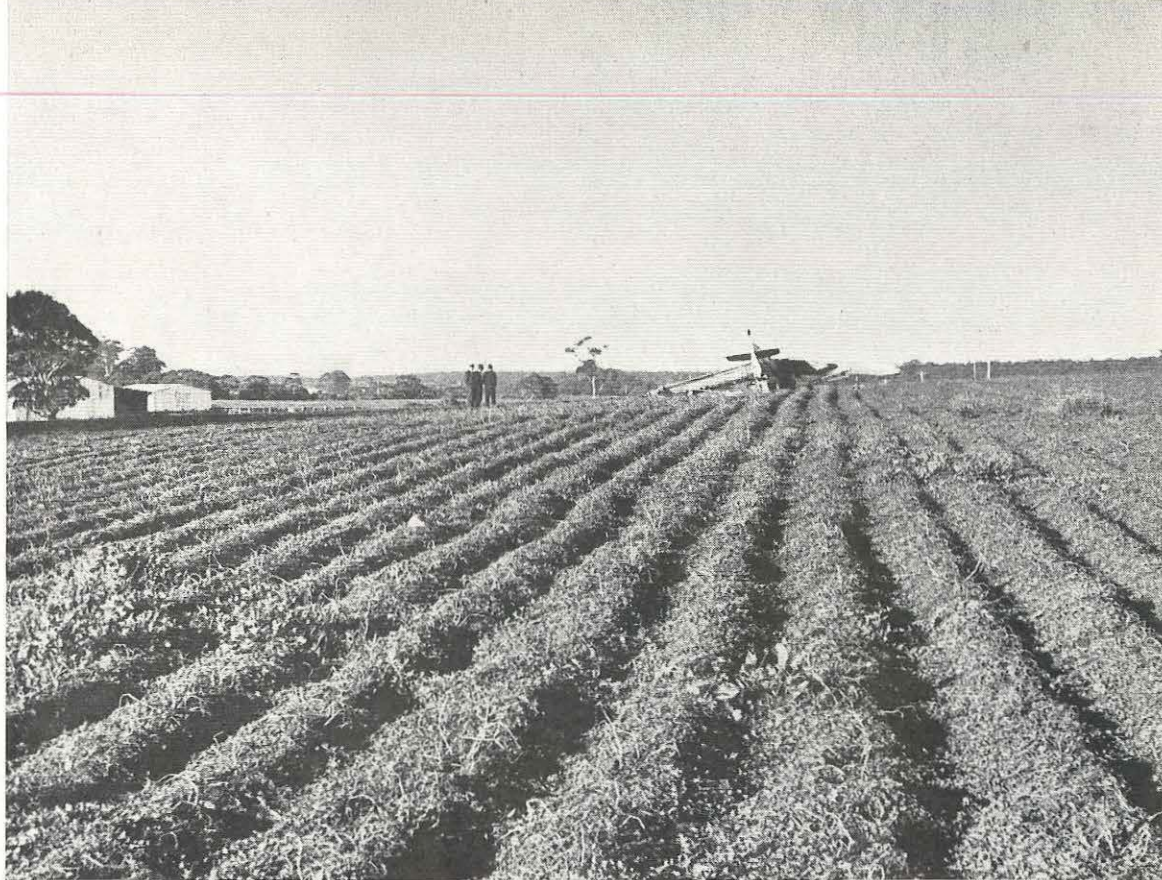
View of accident site looking back towards aircraft's direction of approach. The line of poles marking the position of the main power line is on the right of the aircraft. The first pole of the spur line is just out of the picture near the tree at the extreme left.

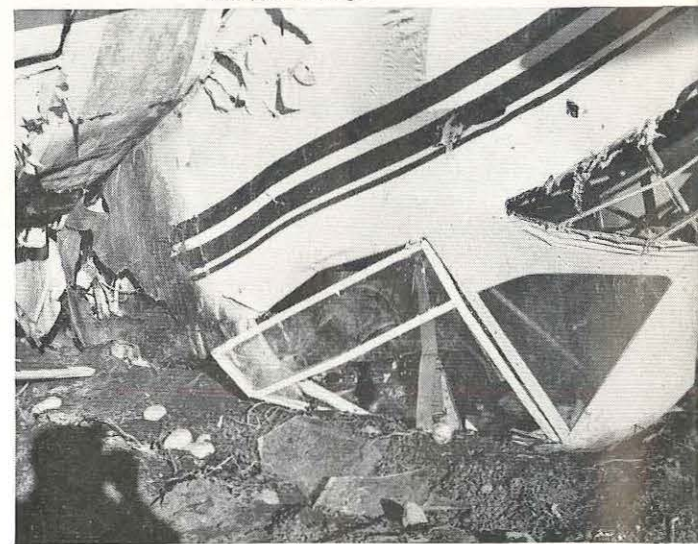
A close up of the cockpit showing the degree of impact and fire damage.

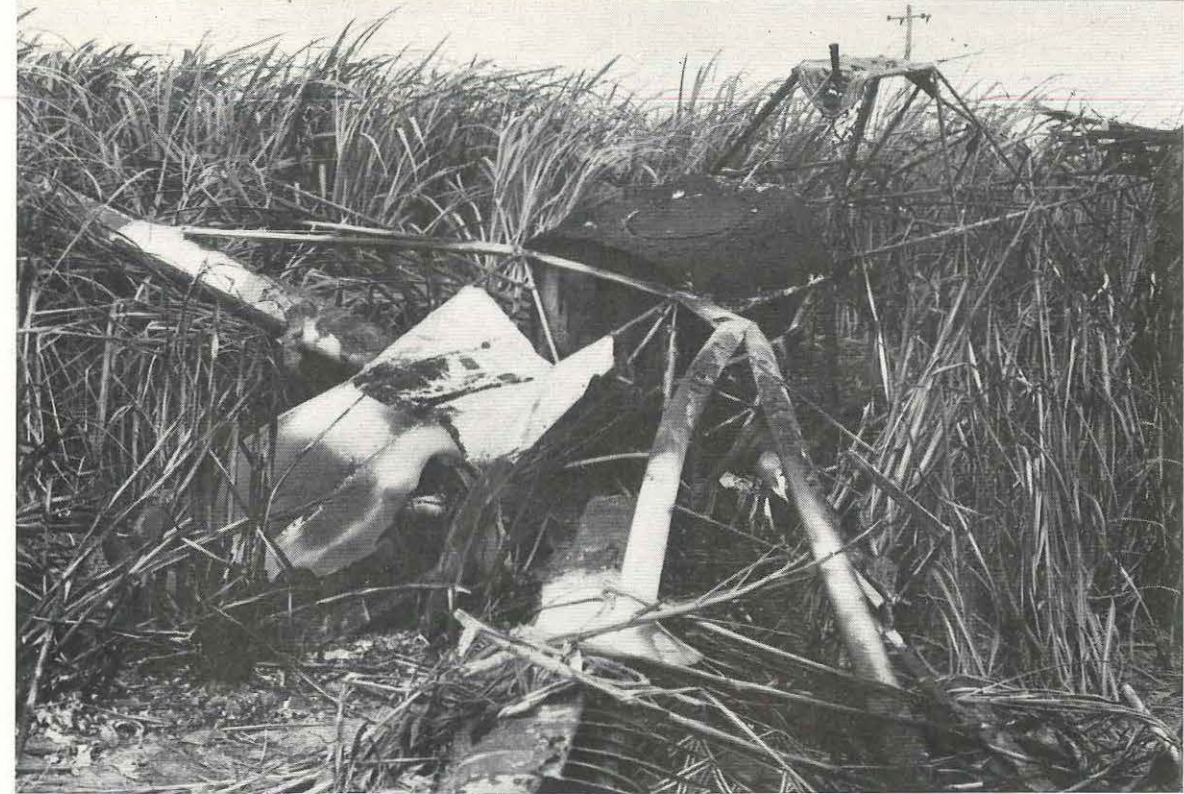
THE burnt out remains in this picture are those of another Pawnee which struck a power line while crop spraying—this time near Proserpine in Queensland, where the crop was sugar cane.

The pilot opened the throttle and raised the nose steeply in an attempt to clear the power line, but the tail wheel caught on the wires. One wire broke but the other stretched and the aircraft decelerated rapidly. The nose dropped, and the aircraft

struck the ground in a nose down, laterally level attitude and burst into flames. The tightly stretched power cable, still attached to the tail wheel, then rebounded, pulling the aircraft backwards some 20 feet. During this fortuitous movement, which momentarily drew the flames away from the cockpit, the pilot hurriedly evacuated the aircraft. He suffered no injuries but the aircraft was completely destroyed by fire.

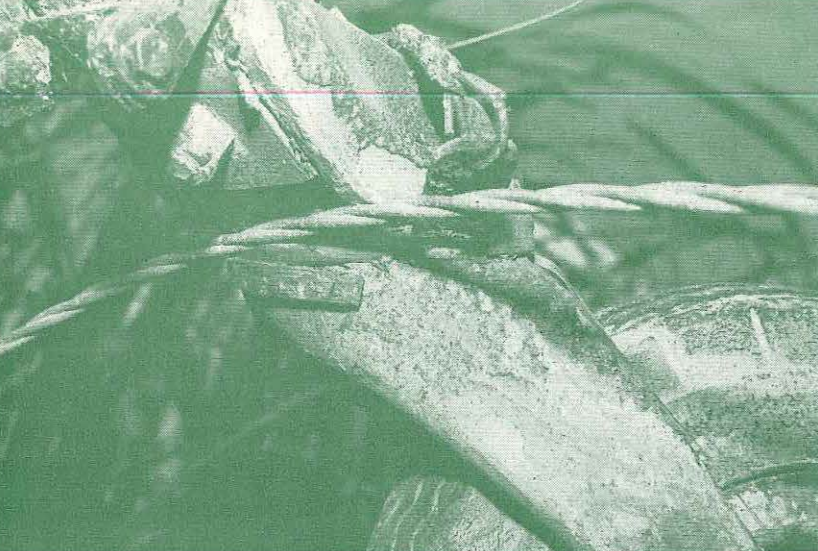
The cable that arrested the aircraft lying in the groove it wore in the tail wheel assembly.

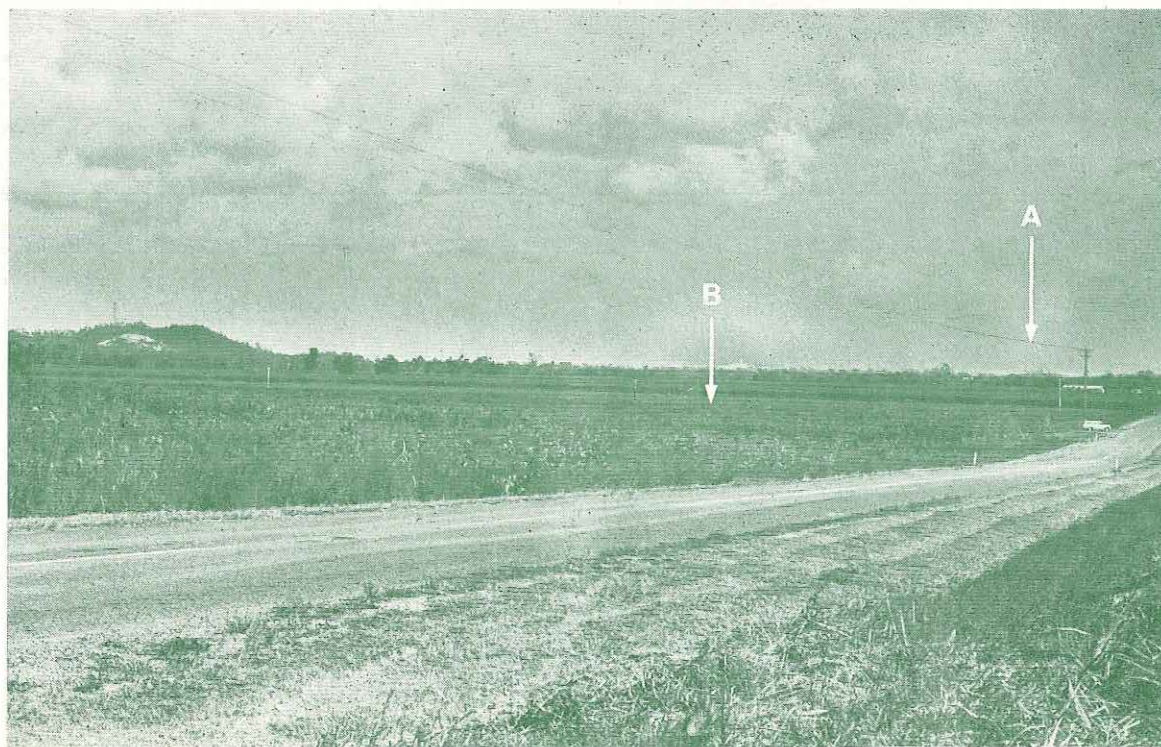
View of the 10-acre paddock of sugar cane showing "A" point of impact with power line. "B" point of impact with ground. The two-strand power line parallel to the flight path can be seen on the far boundary of the paddock.

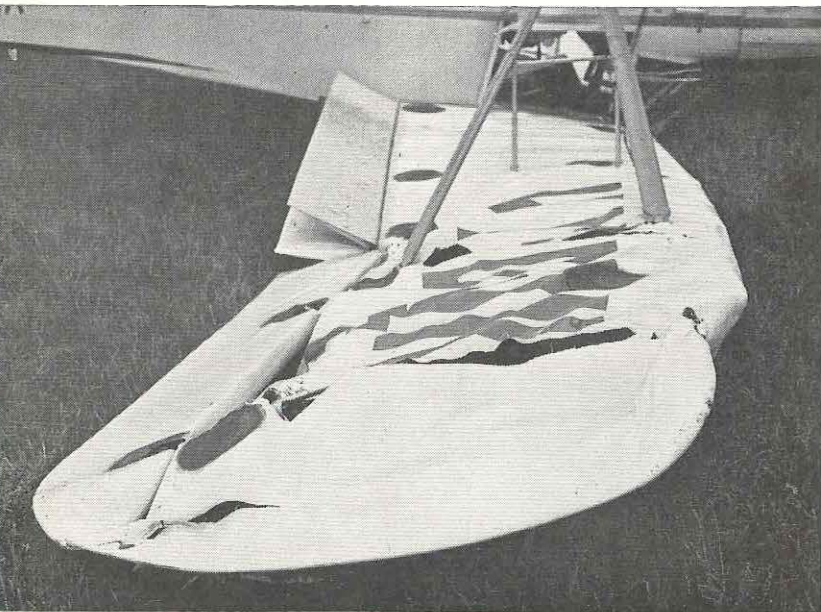
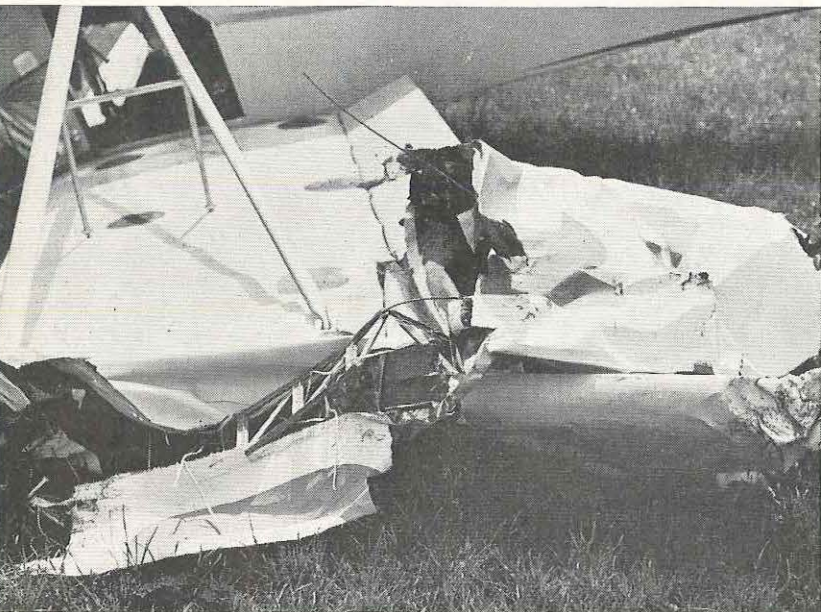
*The damage sustained by port and starboard wing tips when the aircraft cartwheeled.*

Examination of the aircraft after the accident established that the engine had failed simply for want of fuel. But despite the fact that the aircraft fuel tank was empty, the fuel contents gauge was still indicating four gallons.

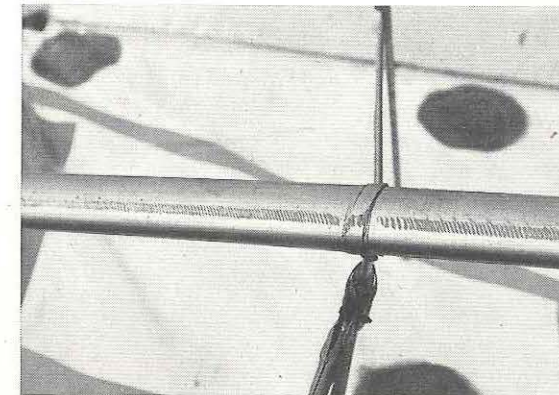
*The impact marks of the cable imprinted on the port wing strut.*

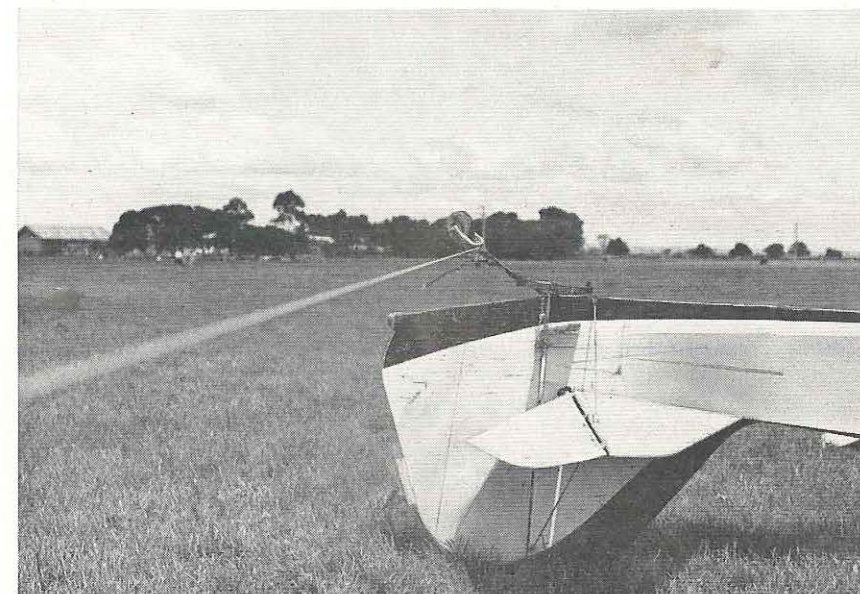
*The second cable of the power line still hooked on the tail wheel of the inverted aircraft.*

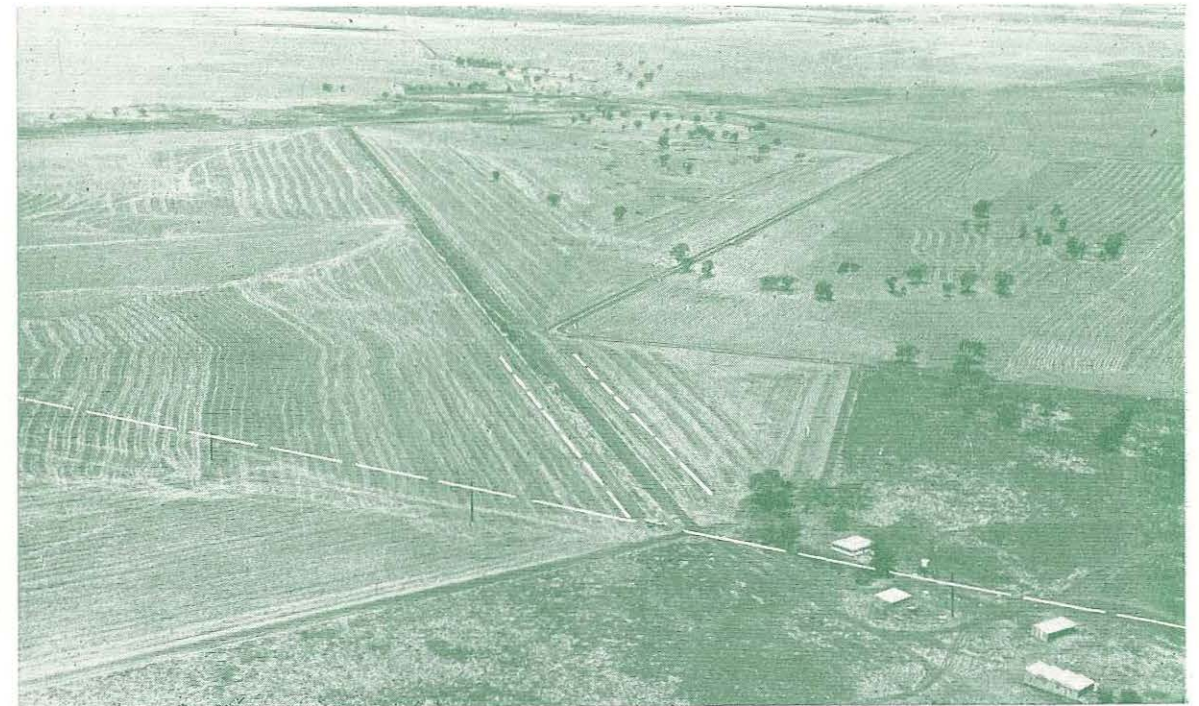
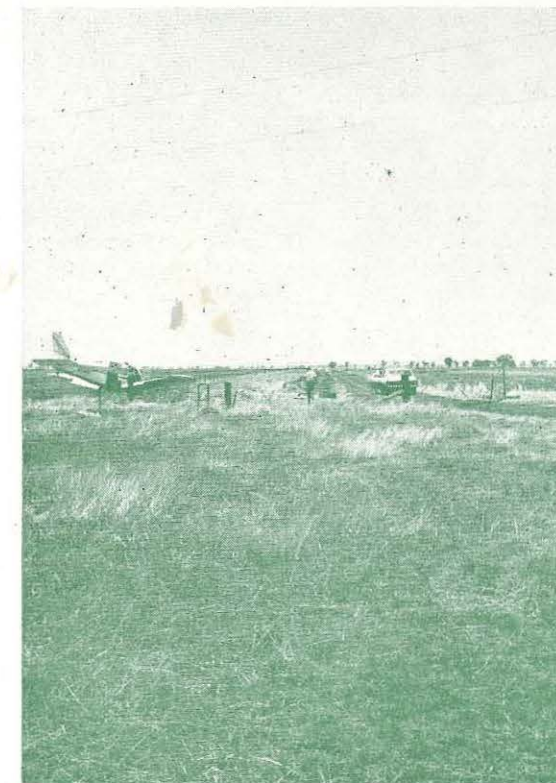
Examination of the area being used for the landing showed that, when allowance was made for the position and height of the power line in accordance with the published requirements for authorised landing areas, the position of the threshold should have been 400 feet beyond the boundary fence over which the aircraft was approaching. This "displaced threshold" would still have left a sufficient length of run in the paddock for the operation of a PA.28-235 in the existing conditions. As the pilot intended to park the aircraft near the approach end of the strip however, he was attempting to

Above: General view of the area showing relative positions of power line and landing strip.  
Below: The accident site looking in direction aircraft was landing. The repaired power line can be seen in the upper foreground of the picture.

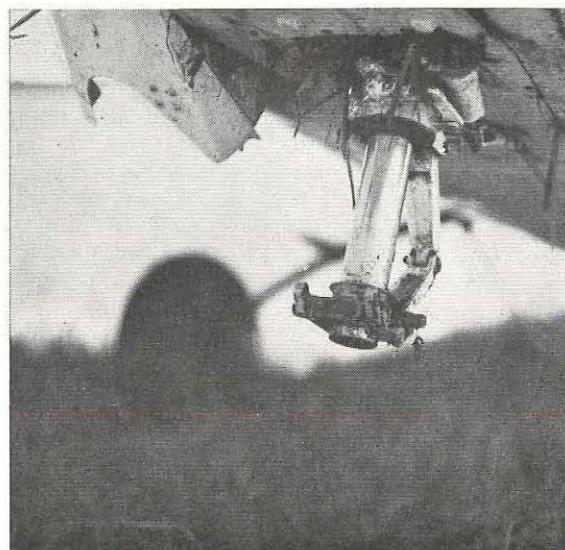
*The nosewheel fork was sheared off when the holding bolts fractured as the aircraft ran into the swamp.*

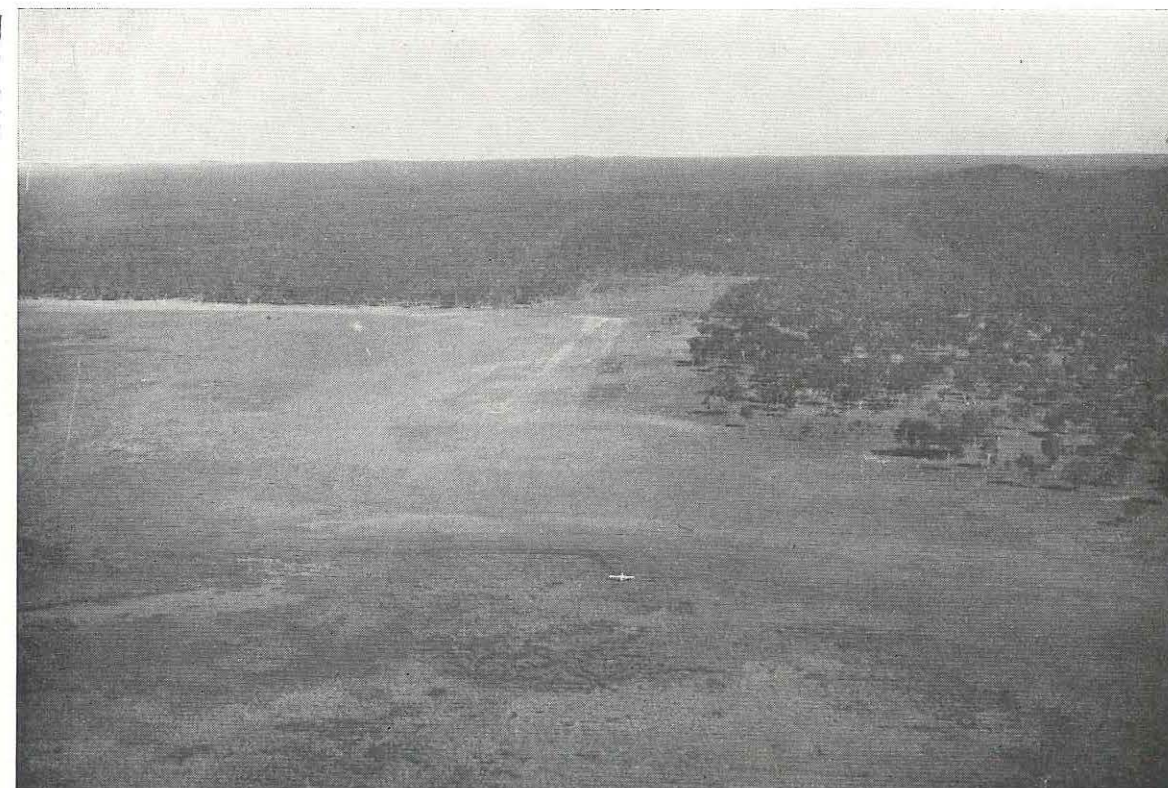
*The aircraft where it came to rest after running into the swamp. The aircraft's tracks through the mud can be seen leading from the firm ground in the centre of the picture. The strip is in the middle distance.*

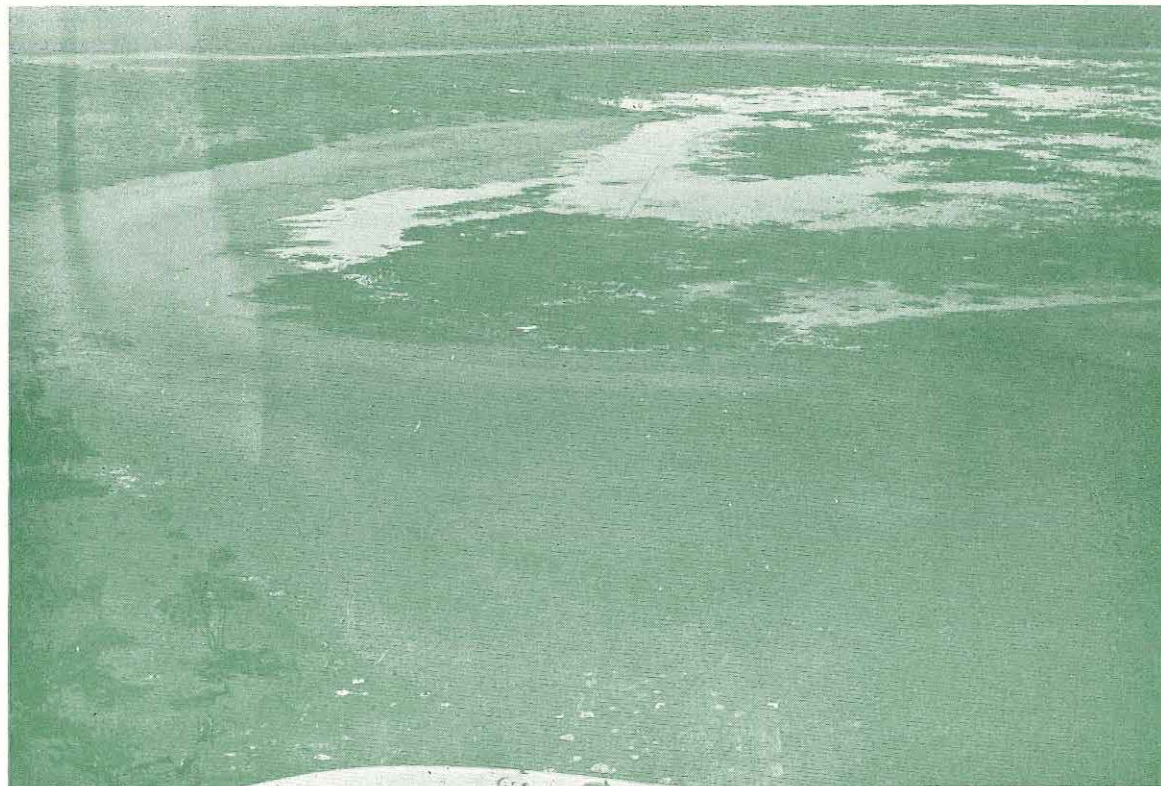
*This photograph, taken looking in the direction of take-off, shows the obstruction-free area over which the aircraft would have been able to climb if it had cleared the fence. The end of the strip and the fence can be discerned at the bottom of the picture. The aircraft is at the edge of the swamp near the centre of the picture.*

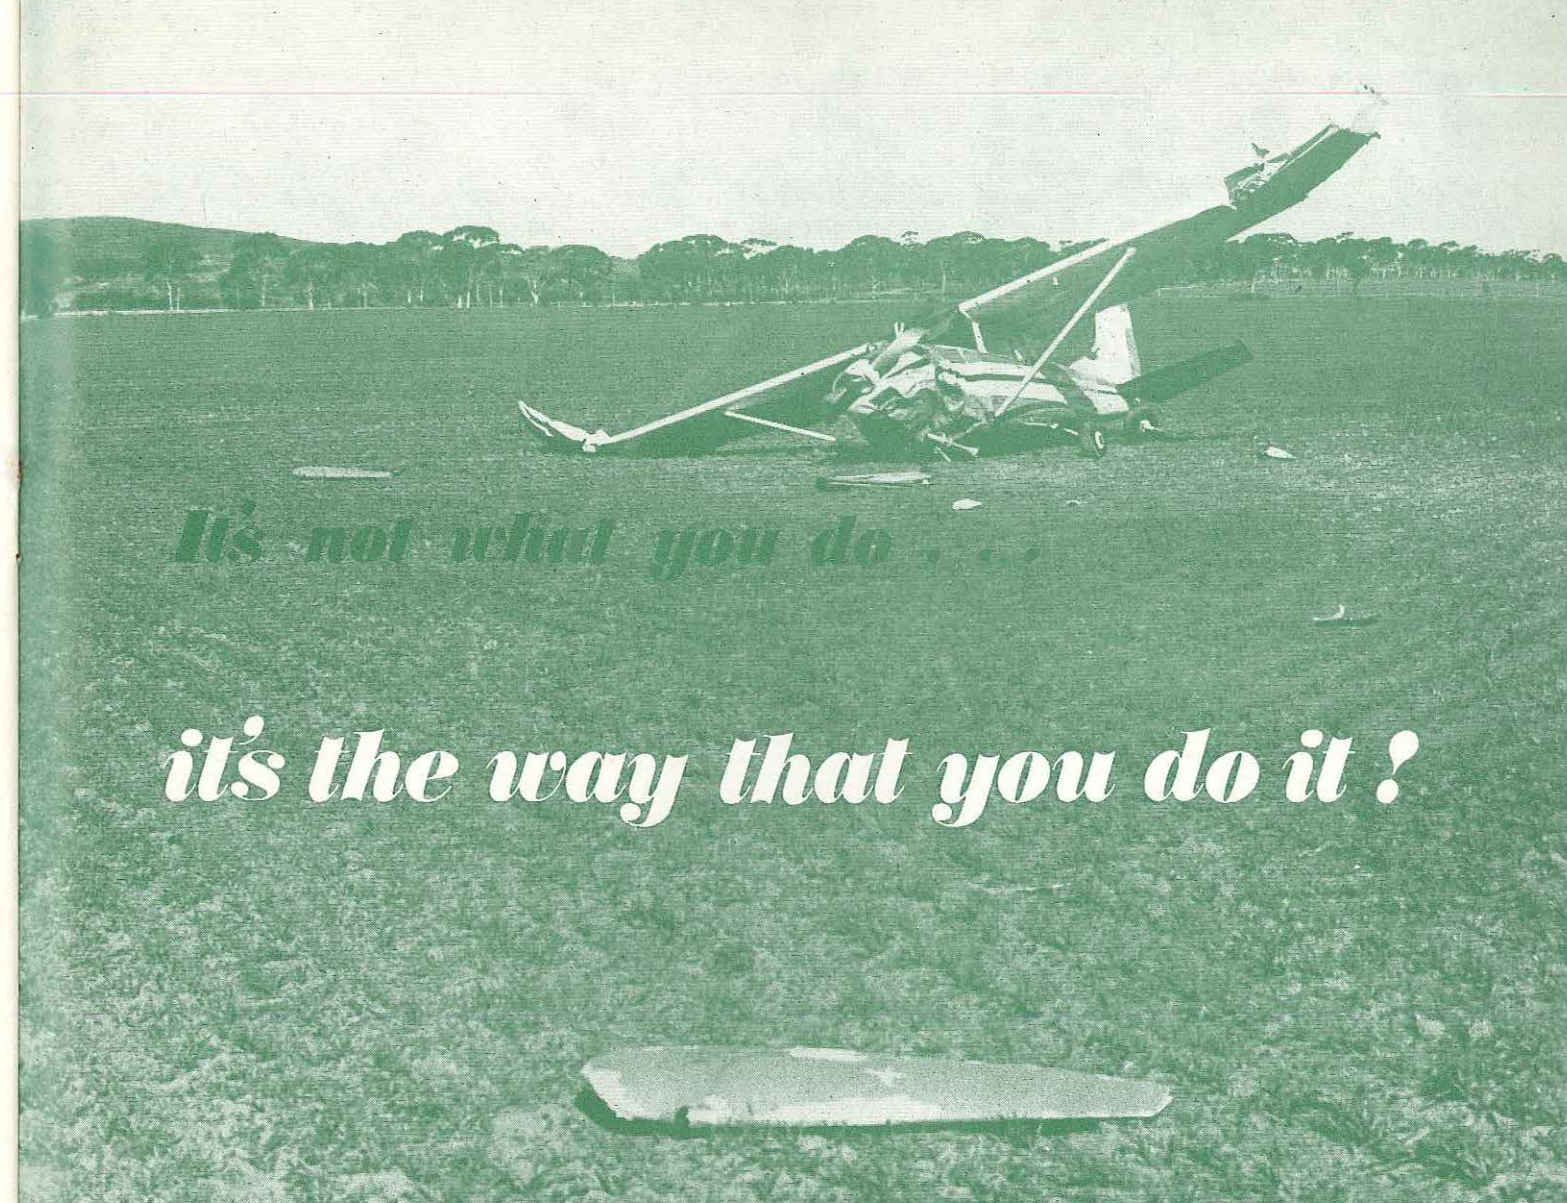
**T**HE battered Cessna 182 shown in the photograph came to rest in the manner indicated at the conclusion of a business flight with three passengers, from Jandakot, Western Australia to Merredin, some 130 miles to the east. Before leaving Jandakot, the pilot had ascertained that the Merredin Shire landing area, which comprised two gravel strips of more than adequate length for operation of his aircraft, was situated approximately four and a half miles south-east of the town. The flight from Jandakot was uneventful and when the aircraft arrived over its destination, the pilot duly located the landing area. After circling the general area several times, the pilot decided that as no prior arrangements had been made to transport the party from the aerodrome to the town, he would look for a paddock nearer

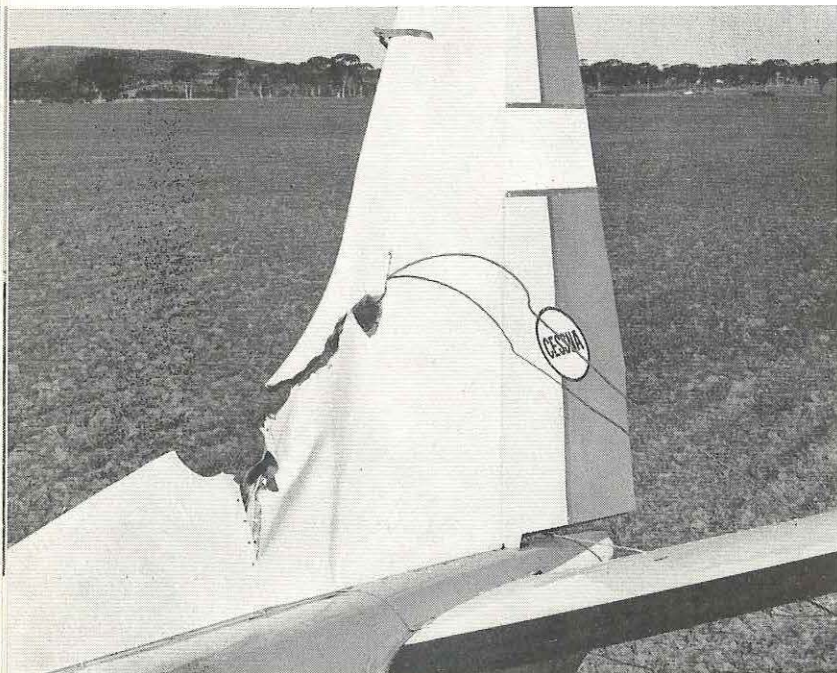
The power cable embedded in the fin of the wrecked aircraft.

Almost immediately the pilot had recovered from the turn, only 20 feet above ground, the aircraft flew into high tension power lines which neither the pilot nor his passengers had seen. There was a brilliant flash from the port wing and the windscreen shattered as three wires were torn from the two nearest poles, 900 feet apart. The aircraft continued in flight, but yawed to the left and began to descend towards the corner of an adjacent paddock. As it did so, one wire slid up over the mainplanes and became embedded in the fin, causing the nose to pitch up sharply.

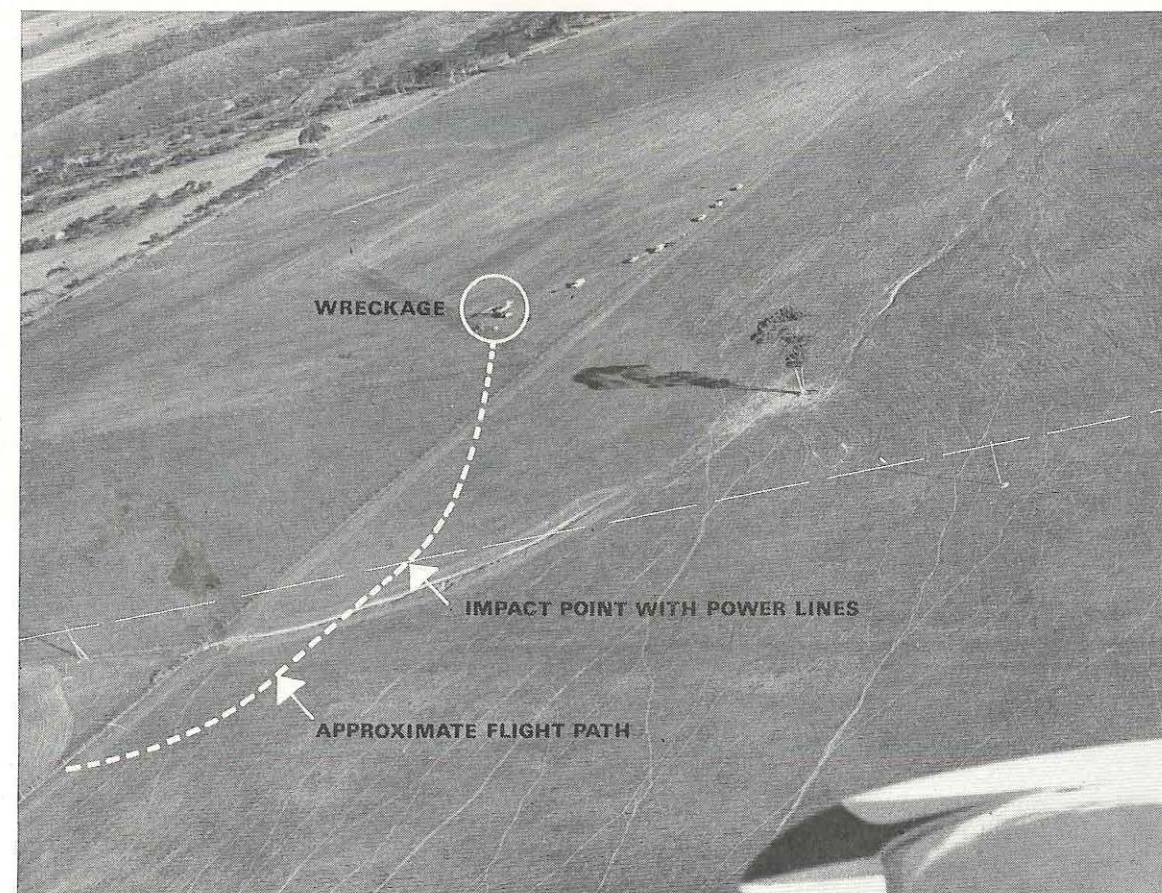
Aerial view of accident site showing flight path and position of power line. The pilot intended to make a low pass over the area immediately to the right of the fence running diagonally through the centre of the picture.

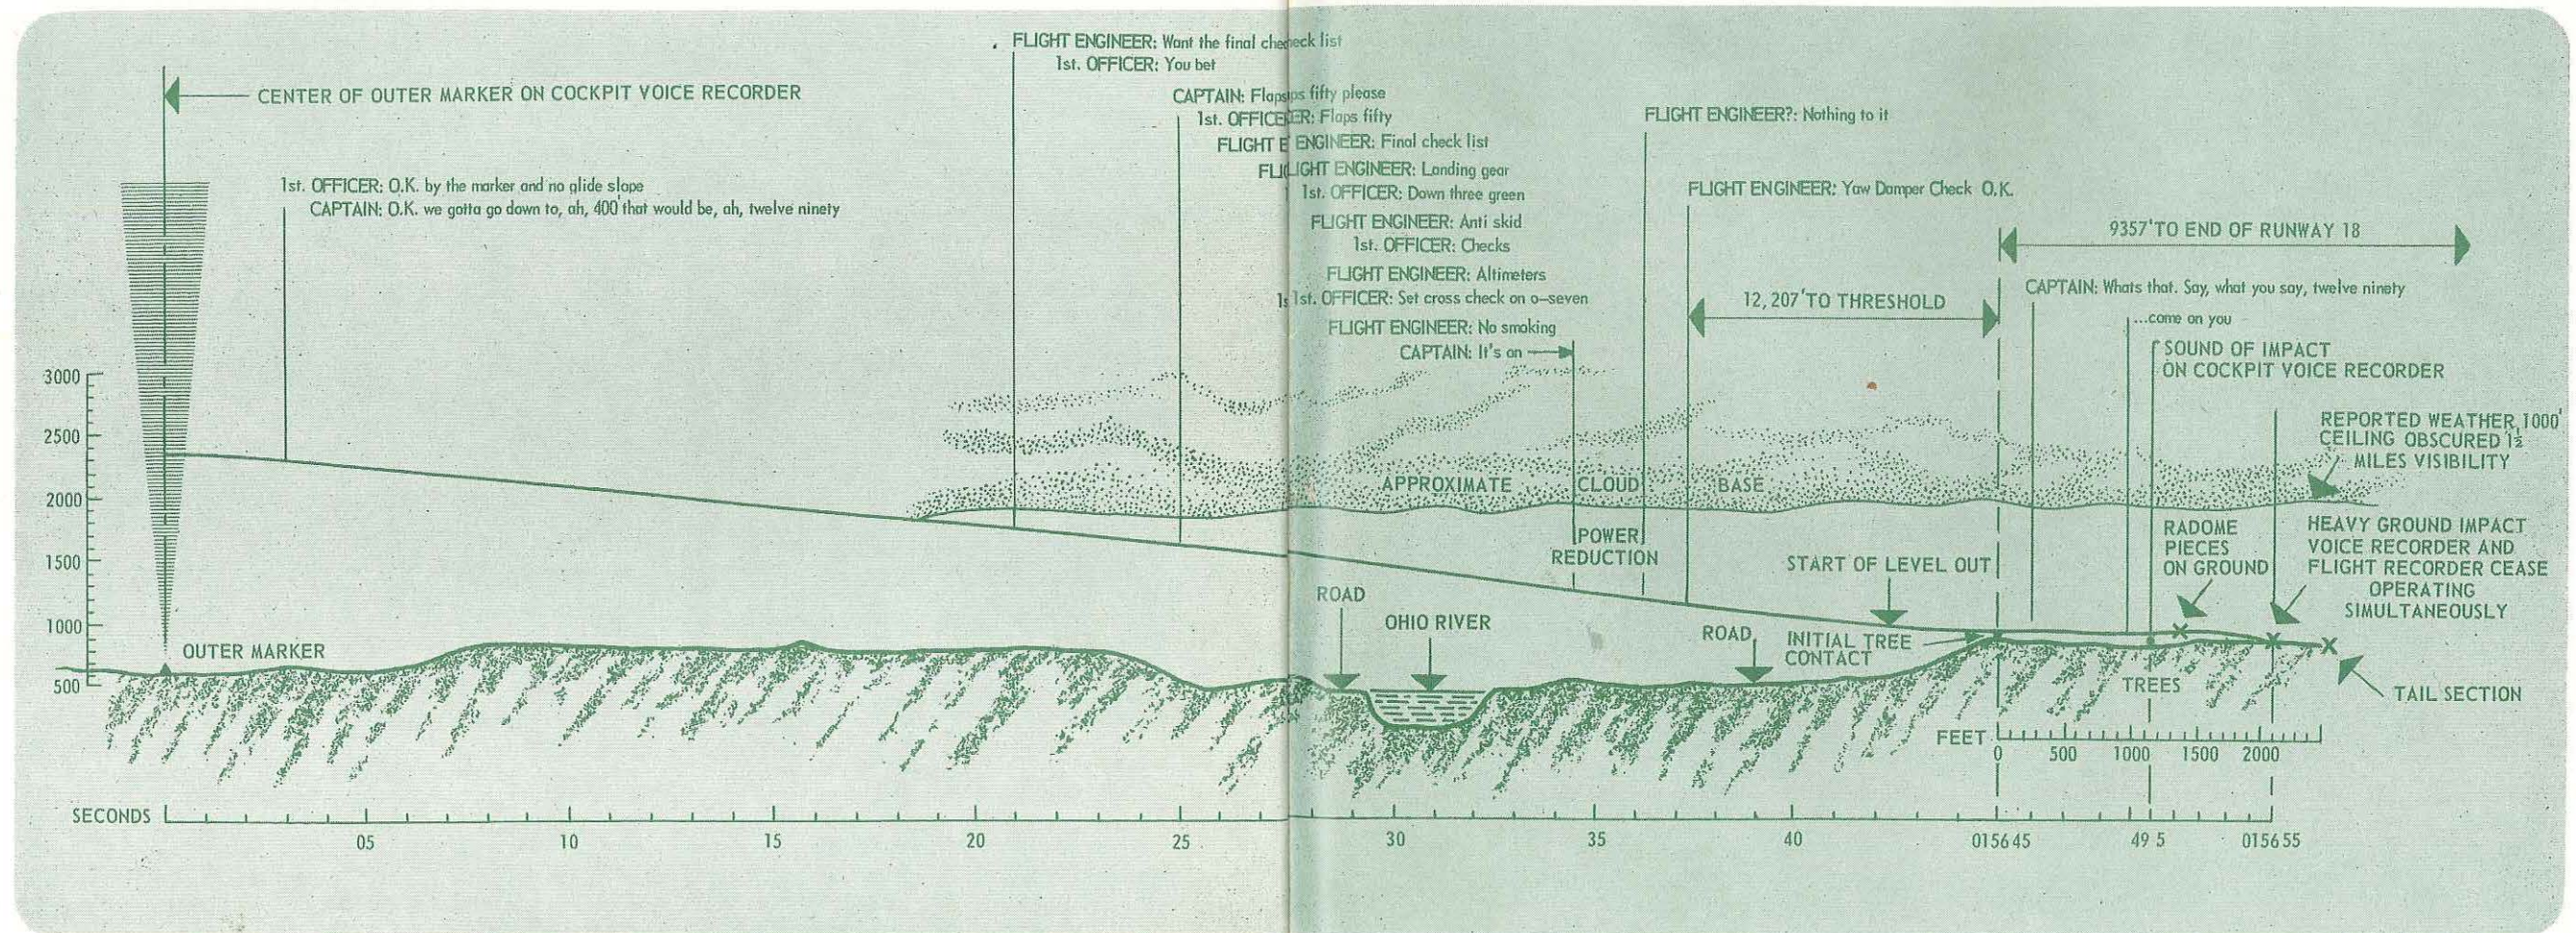
Diagram showing sequence of events during final approach as reconstructed from Cockpit Voice Recorder.

The Board determined that the probable cause of this accident was an attempt by the crew to conduct a night, visual, no-glide-slope approach during deteriorating weather conditions without adequate altimeter cross-reference. The approach was conducted using visual reference to partially lighted irregular terrain which may have been conducive to producing an illusionary sense of adequate terrain clearance.
