AVIATION SAFETY DIGEST

Number 72 Jan. 1971

DEPARTMENT OF CIVIL AVIATION
AUSTRALIA

TRAGEDY IN THE DARK

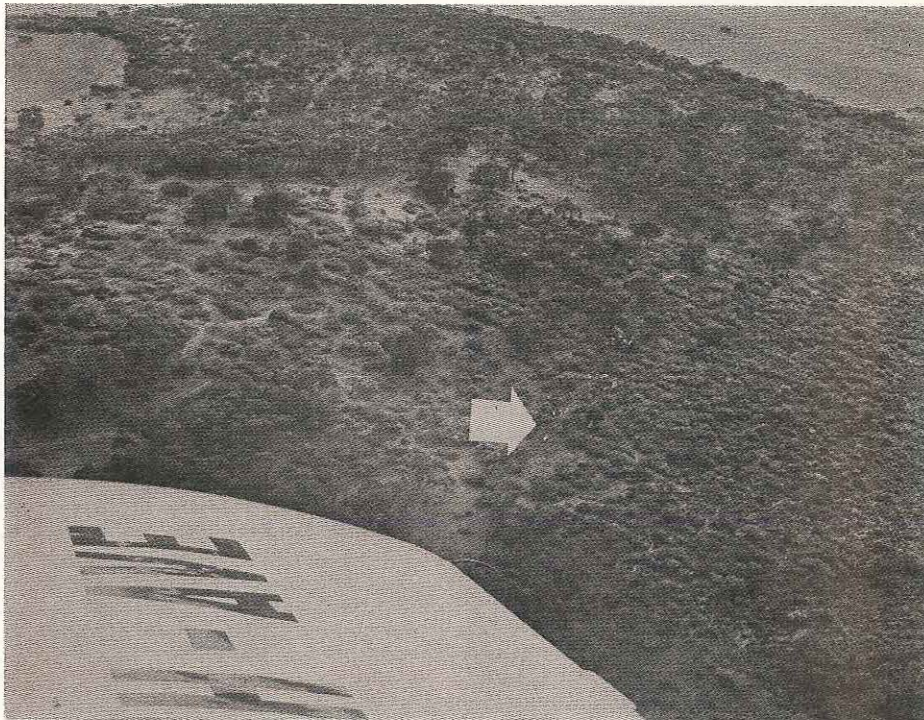
Opposite page, top: The accident site seen from the air. The wreckage trail, extending 400 feet across the slope of the ridge away from the camera, is visible in the centre of the picture.

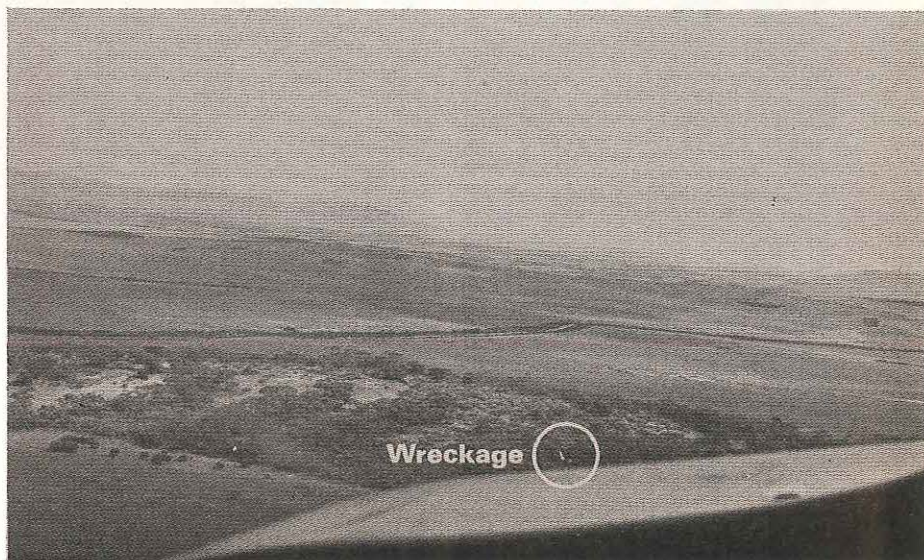
Bottom: General view of the accident site looking in a north-westerly direction towards the ranges of Darke Peak and Caralue Bluff. Some thirty minutes before the accident, the aircraft passed close to these ranges at a very low height in conditions of almost total darkness.

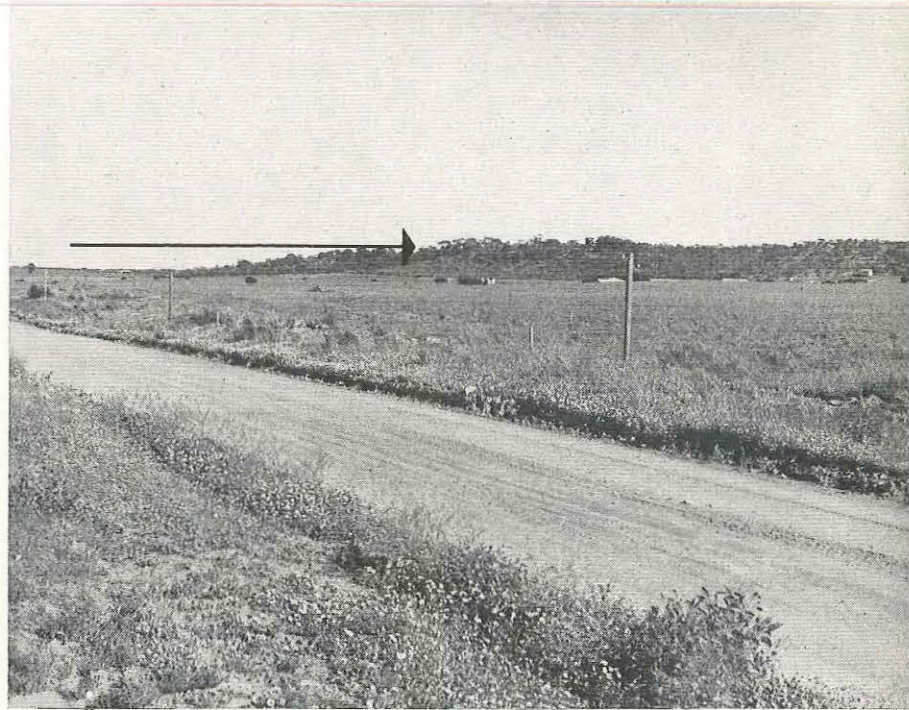
View of the scrub-covered hill on which the accident occurred showing approximate final flight path. The low elevation of the hill above the surrounding terrain is clearly evident in this picture.

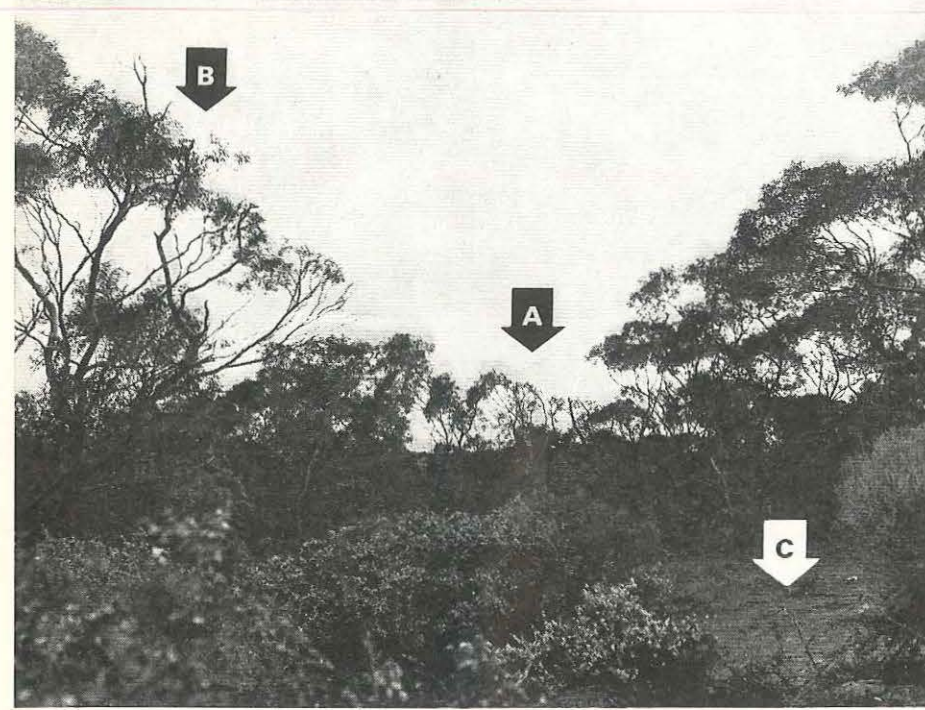
View looking back along the approach path, showing (A) first tree-strike by port wing, (B) other trees struck by starboard wing and (C) point at which port wing tip struck the ground.

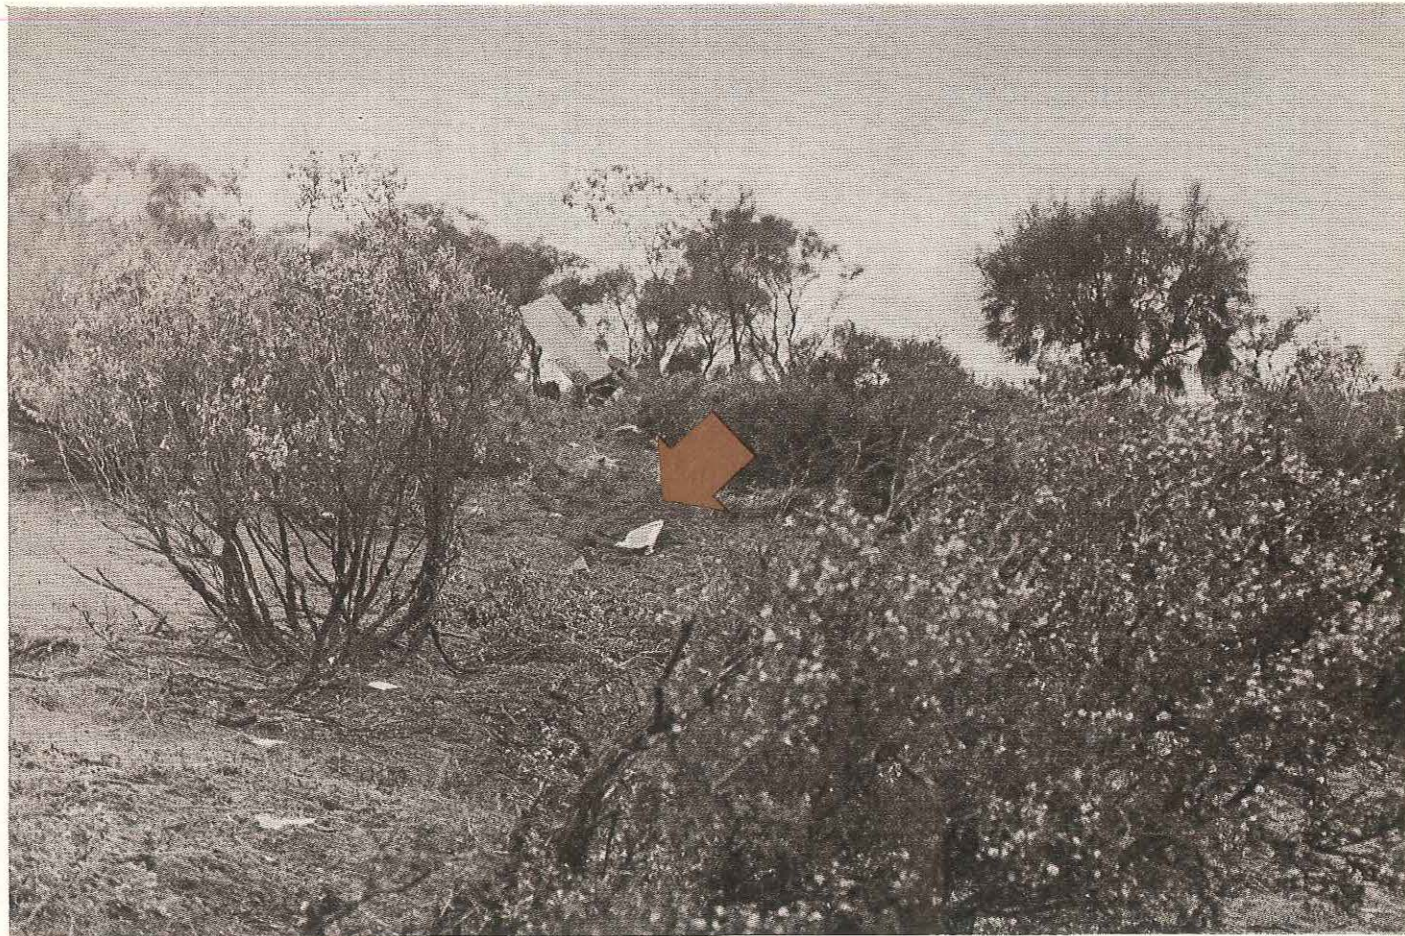
Inspection of the accident site showed that the aircraft, flying a north-easterly heading, had flown into a scrub covered hill 950 feet AMSL and about 150 feet above the surrounding cleared farming country. The initial point of impact was with the tops of gum trees about 20 feet above the ground, on the south-western slope of the ridge and 50 feet below its crest. From this point, a trail of wreckage extended across the scrub-covered slope of the ridge for 400 feet to the position where the main wreckage came to rest.

View looking along the narrow wreckage trail in the direction of impact. The arrow indicates the point at which the engine and fuselage first struck the ground.

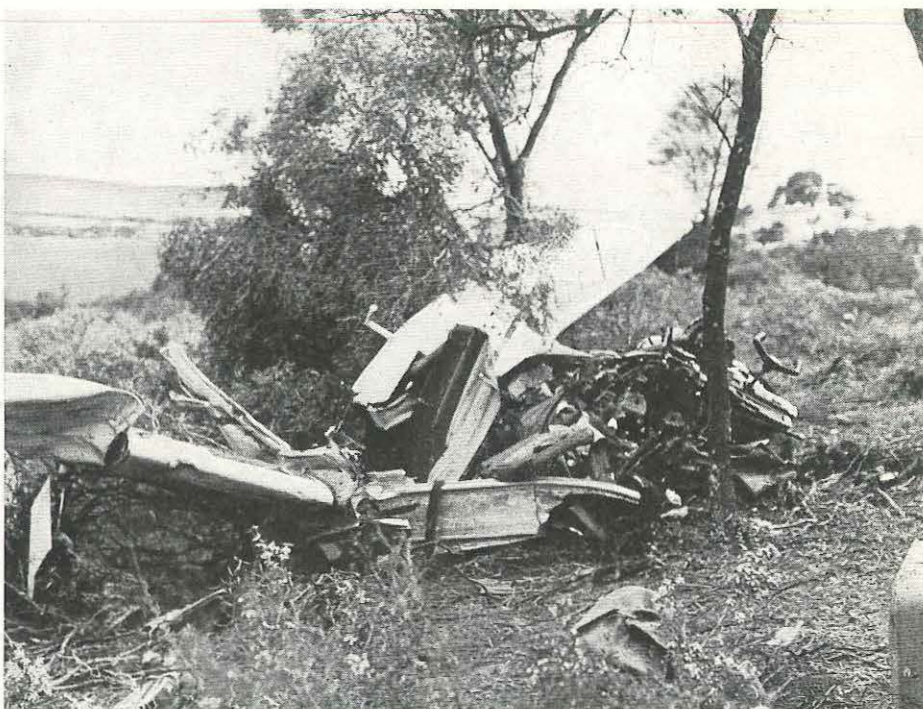
The main wreckage lying in the group of trees which finally brought it to rest. In this picture, the starboard wing has been pulled clear to gain access to the cabin area.

The probable cause of the accident was that the pilot, who was inexperienced in night VMC operations, exceeded the limits of his capability by continuing a flight at night in adverse conditions. ➡

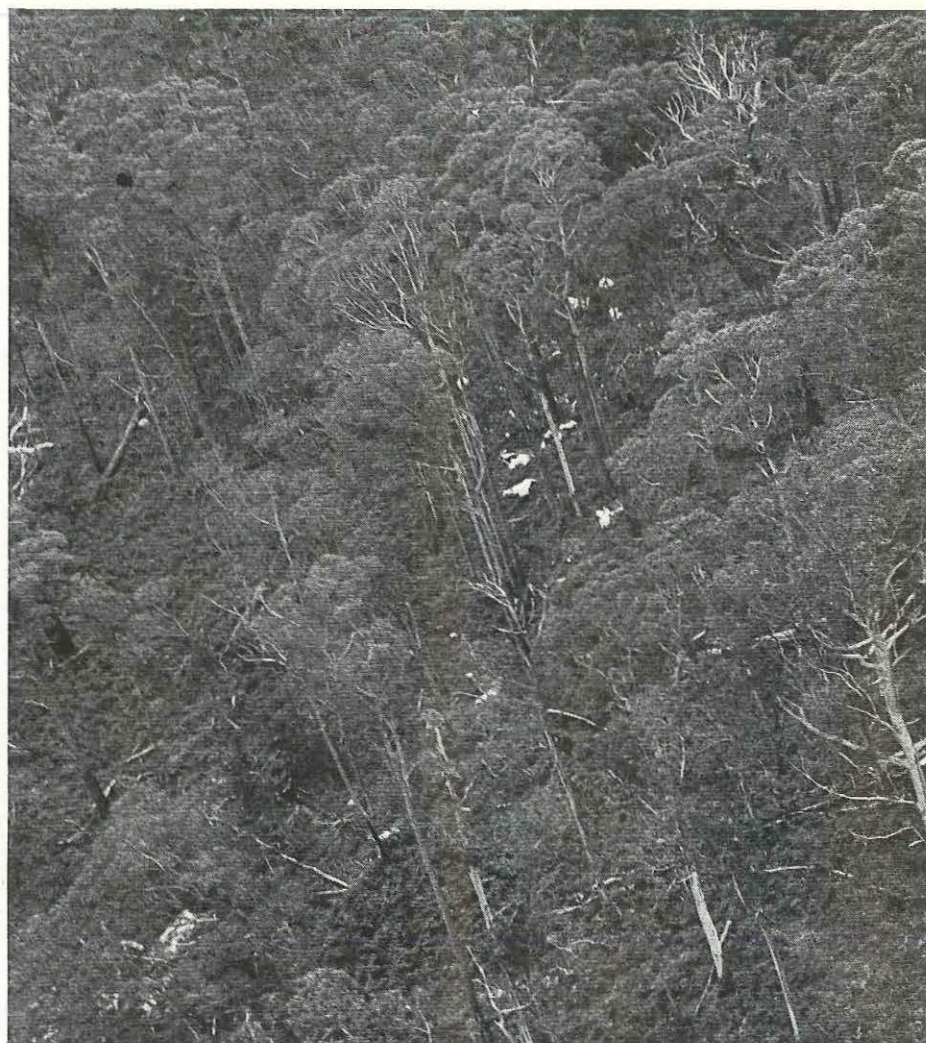
This page: View looking back in the direction from which the aircraft approached. A section of the wreckage lies in the foreground. The heavily timbered nature of the terrain and the dense undergrowth at the accident site are particularly evident in this picture.

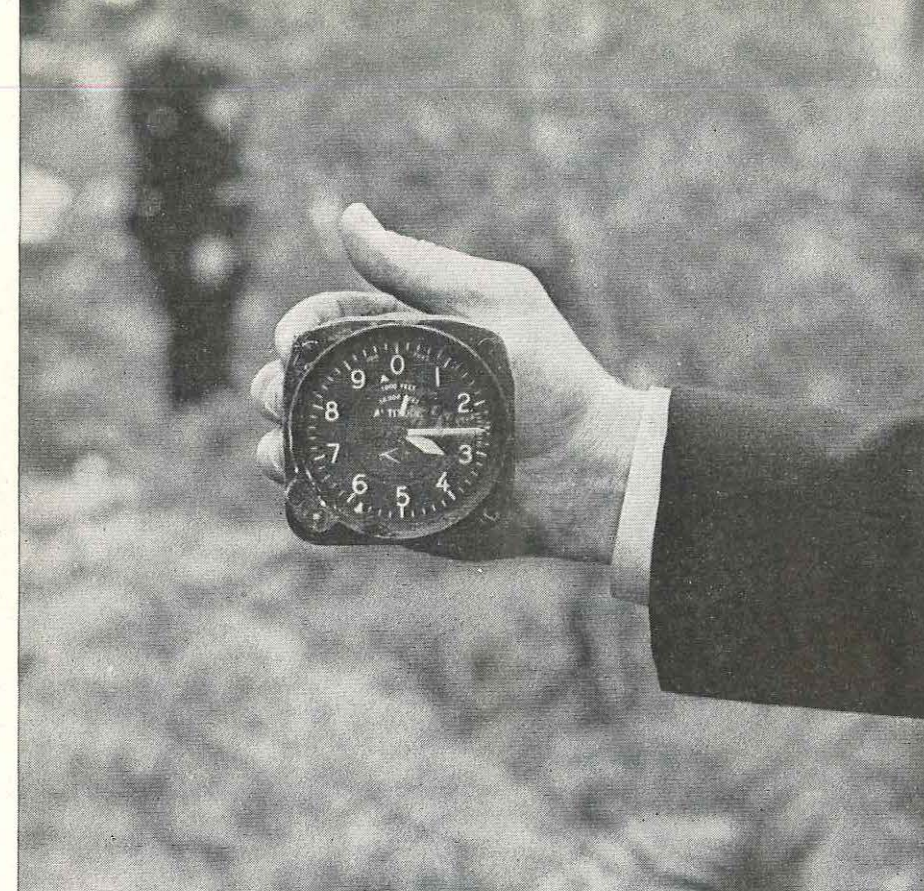
The aircraft's altimeter as recovered from the wreckage showing the reading at time of impact. The area QNH altimeter setting current at the night of the accident was correctly set on the instrument's pressure sub-scale.

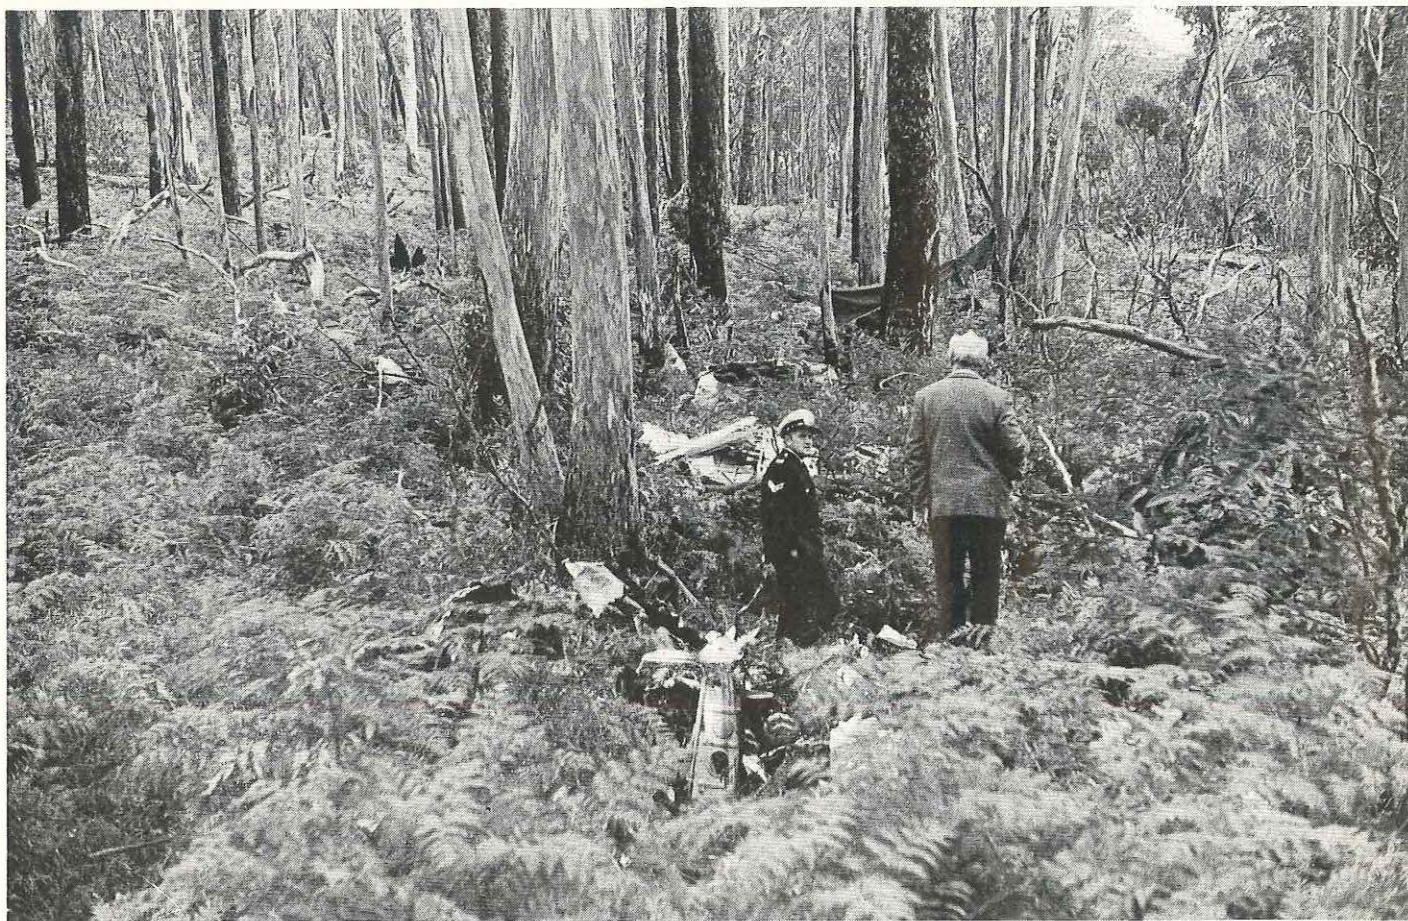
View of the wreckage trail as it was found, looking back in the direction of impact. The badly damaged engine and instrument panel are in the centre foreground of the picture partly hidden by the thick undergrowth.

The cause of the accident was that the pilot, who was inexperienced in night VMC operations operated the aircraft at an unsafe altitude at night.

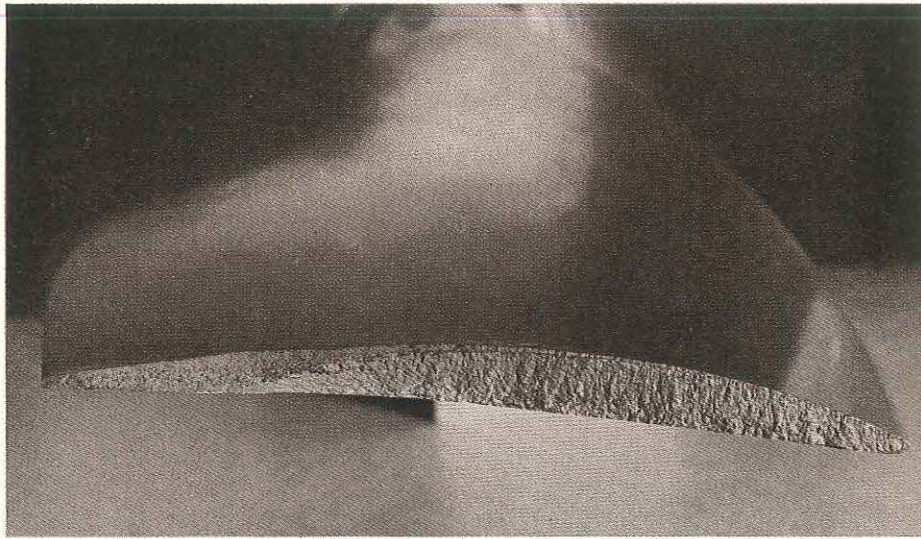
The second point is supported by the results of investigations into blade failures. Laboratory inspection of blade fractures indicates that the period of time between the occurrence of a stone bruise and the initiation of a crack in the blade, is short. When first formed, a crack is usually so small that it is hardly perceptible to the naked eye. But once a crack starts, its rate of progression increases quite rapidly so that by the time it is visible to the naked eye, the

Figure 1: Marks characteristic of fatigue cracking are clearly visible in this series of photographs showing the fracture surface of the failed propeller blade after its removal from the Mooney. The stone bruise from which the crack originated is seen more clearly in the centre picture, as a very dark area at the leading edge of the blade.
