Number 75 July 1971

DEPARTMENT OF CIVIL AVIATION AUSTRALIA

AVIATION SAFETY DIGEST

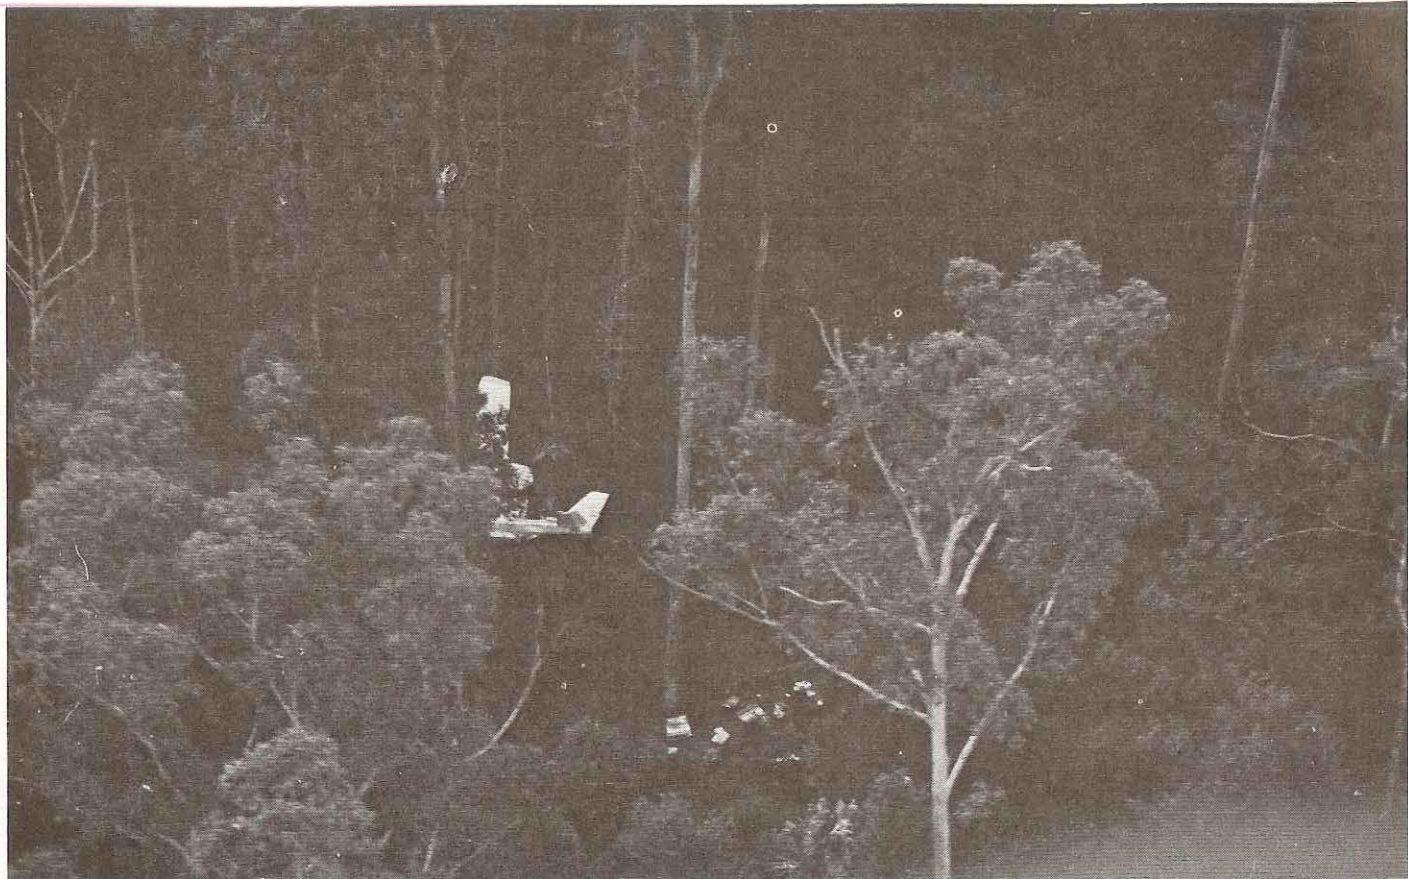
The wreckage of the Cessna, lying on its starboard side, as first sighted from the air. The surrounding trees at the accident site are up to 70 feet high.

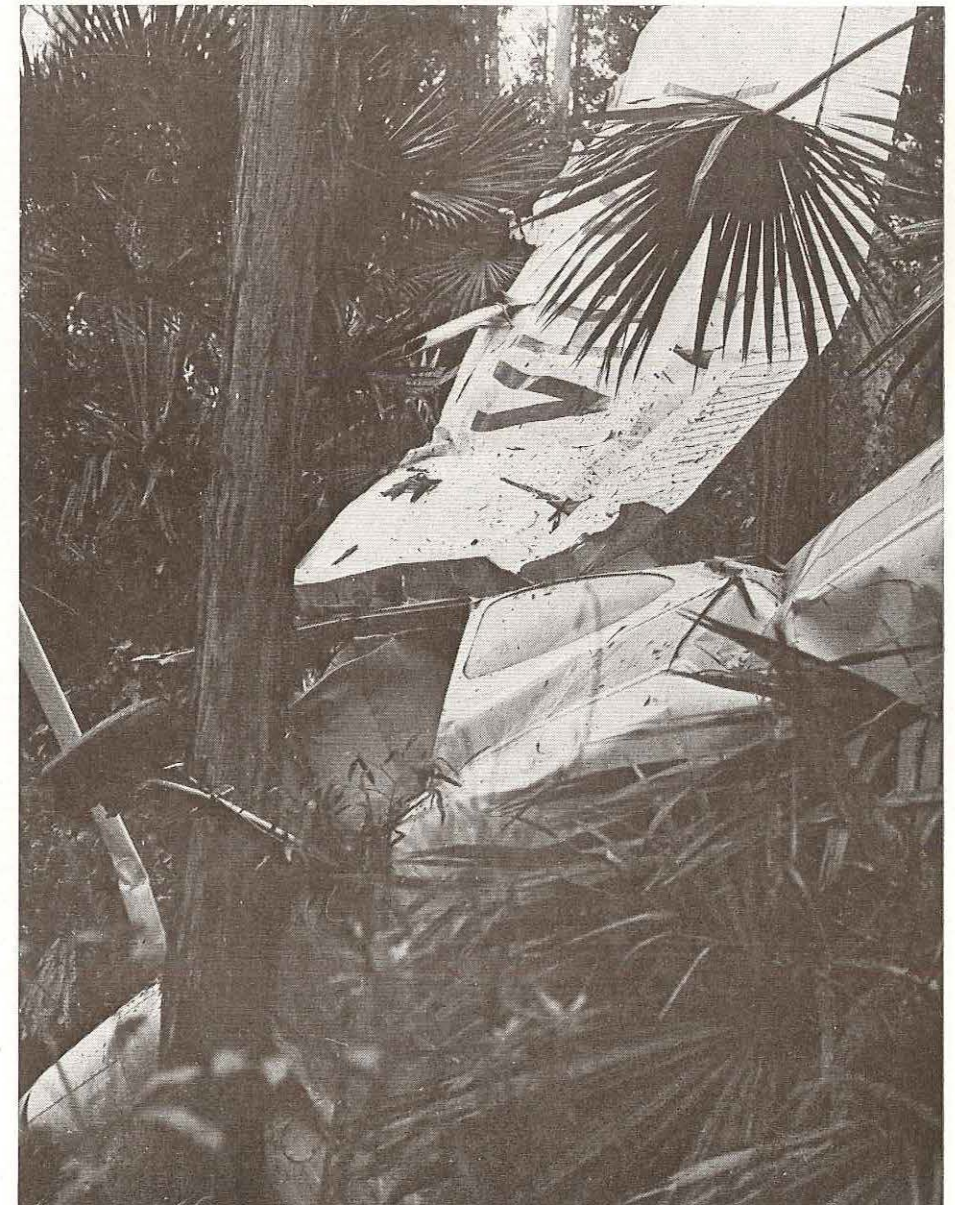
Close-up of aircraft, showing cabin area and dislodged port wing lying across the top of the fuselage. Fuel from the port tank drenched the occupants before they could extricate themselves from the wreckage.

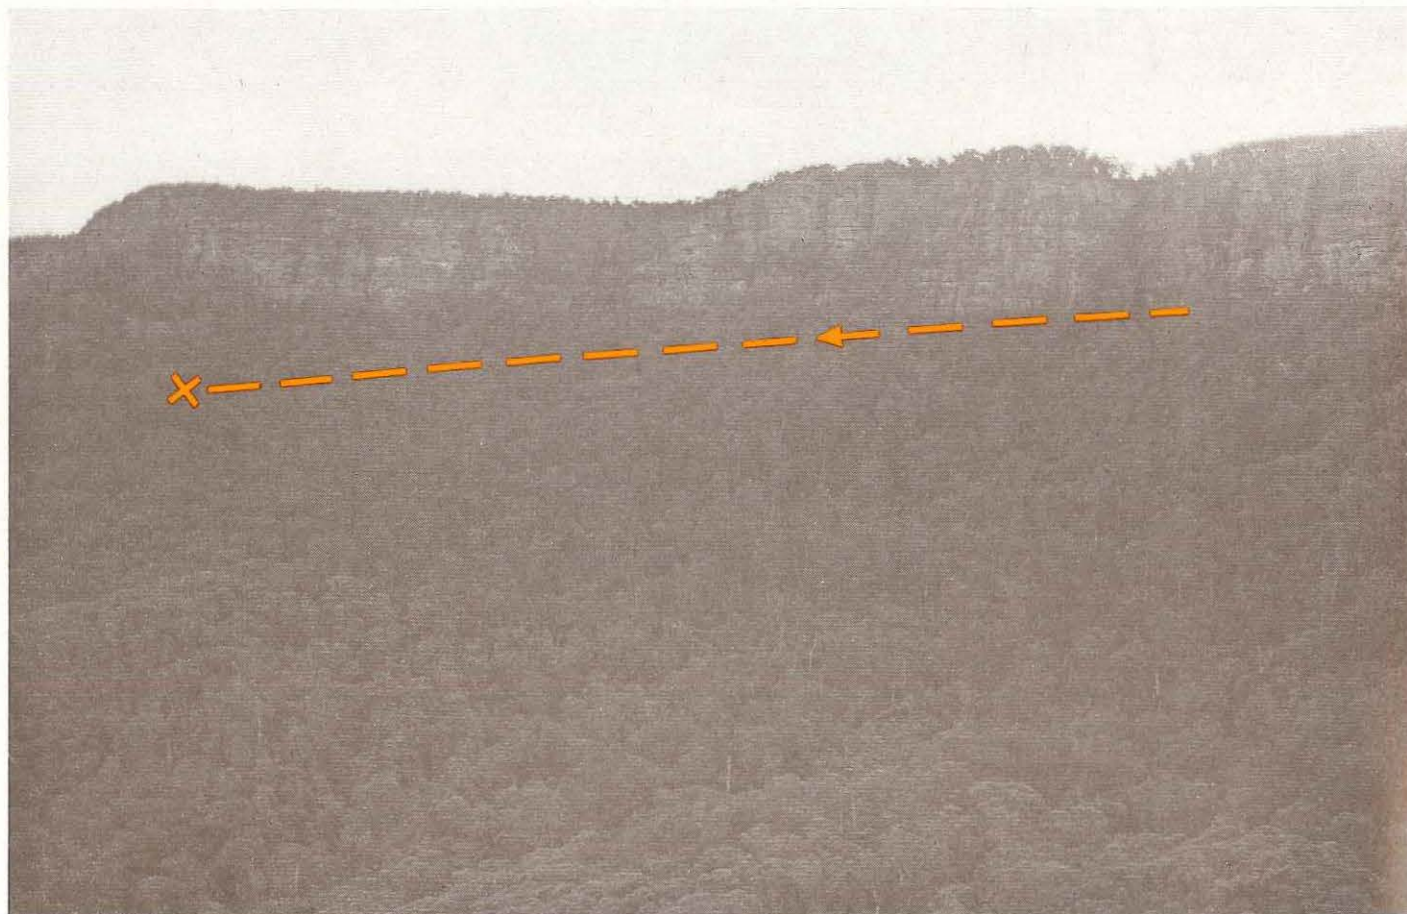
The valley in which the accident occurred, showing the aircraft's approximate final flight path and the accident site close to the base of the cliff.

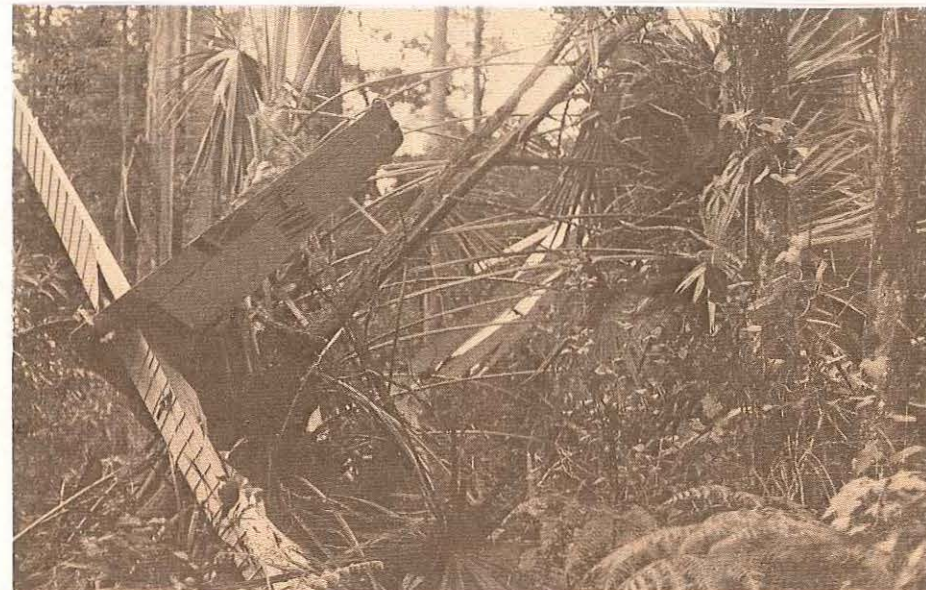
Rear view of the extensively damaged aircraft. The heavy timber and the dense undergrowth are clearly evident in this picture.

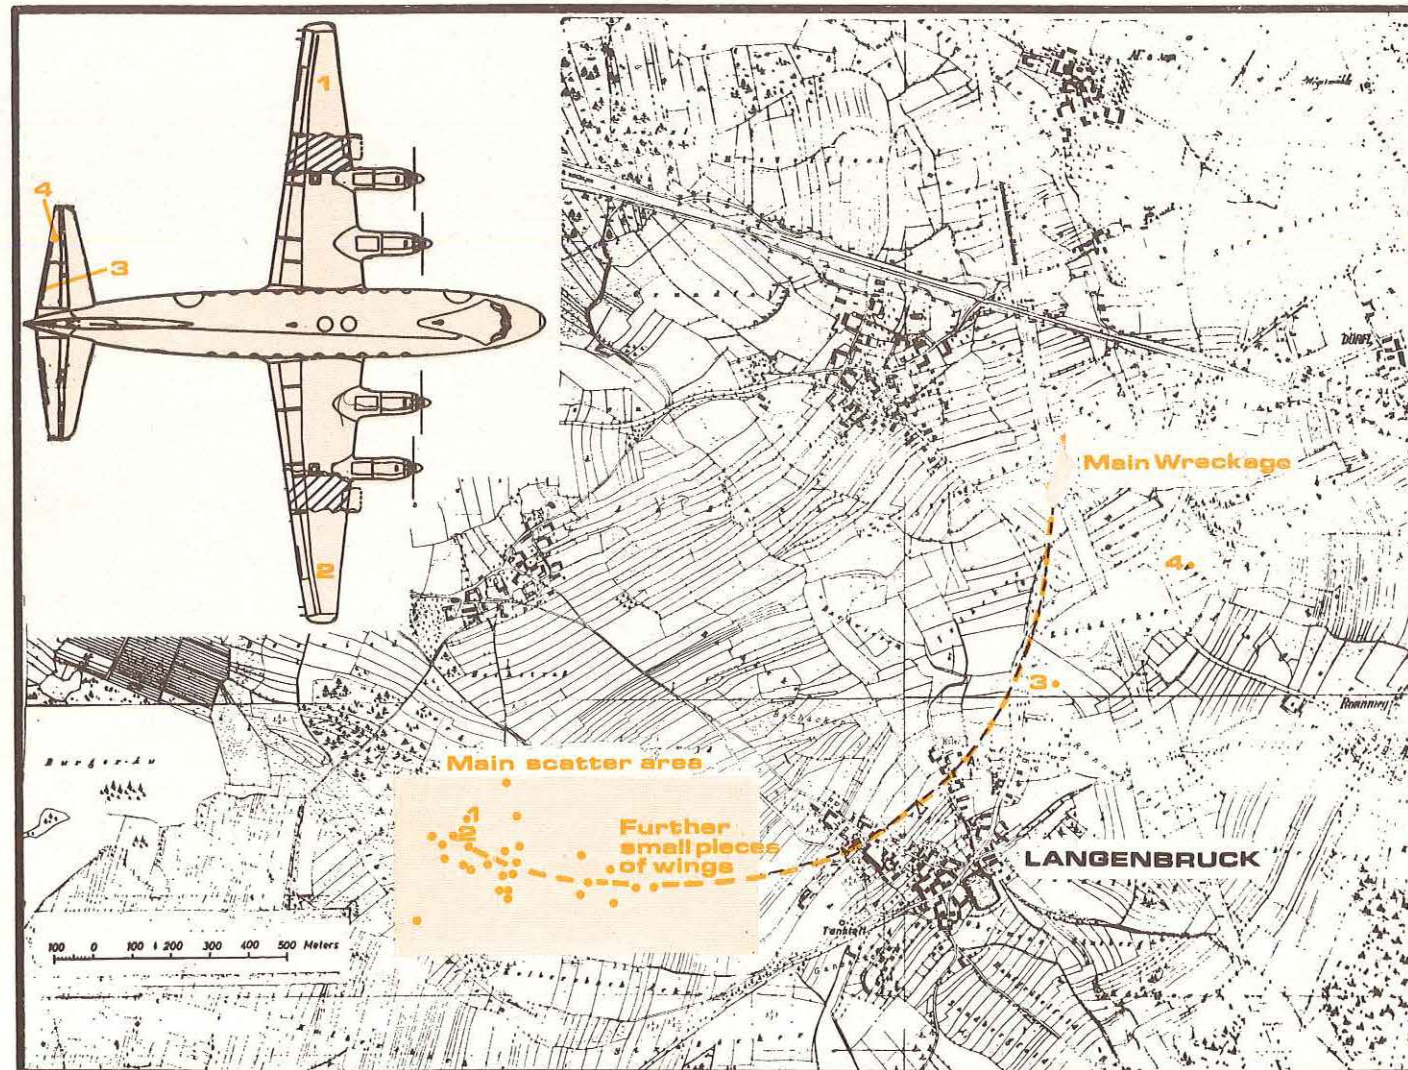
The aircraft had struck the ground on a northerly heading and, at the initial point of impact, marks of the four engines and an impression of the underside of the fuselage were clearly recognisable. From these impact marks, together with the height and position of a power line which crossed the aircraft's final descent path a short distance away, it was evident that it had struck the ground at an angle of at least 12.5 degrees. Some 6,000 feet back along the final flight path, both outer wing sections of the aircraft were found, together with a number of smaller pieces of wreckage. Part of the port elevator and elevator anti-balance tab were also found some 1,200 and 1,500 feet respectively from the main impact point (see diagram). It

Map of area in which accident occurred, showing final flight path and general distribution of wreckage.

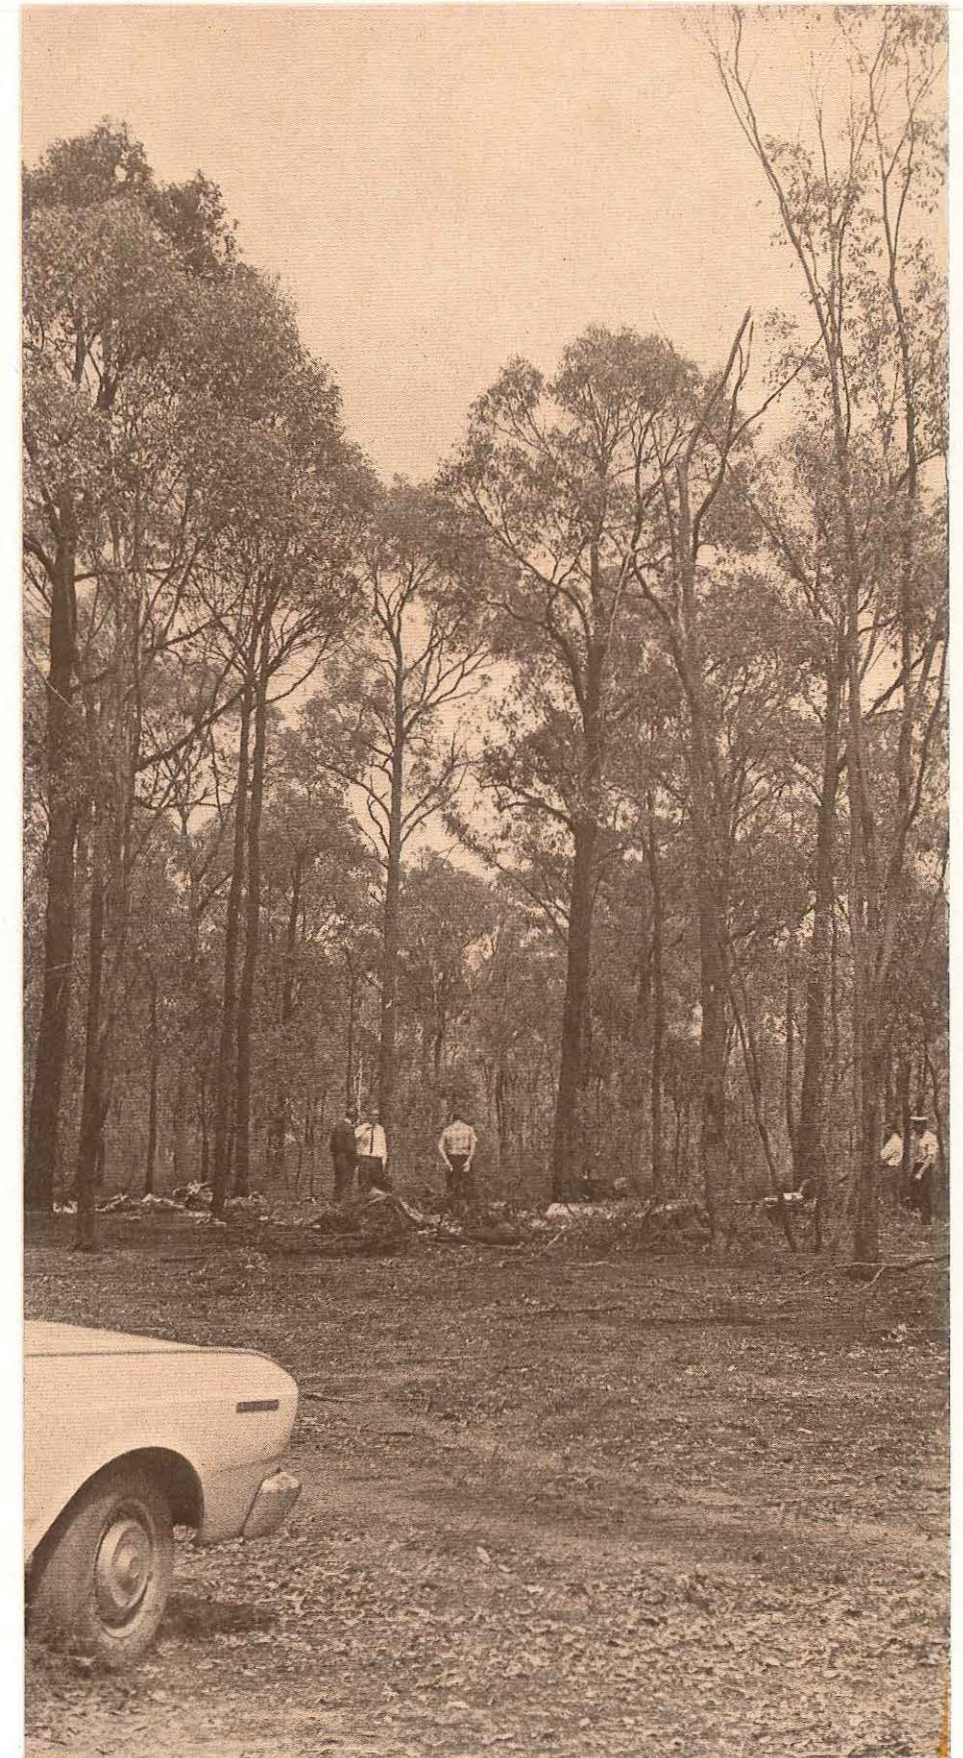
General view of accident site, looking in approximate direction of impact. The aircraft's near vertical descent is evident from the broken upper branches of the tree on the right of the picture.

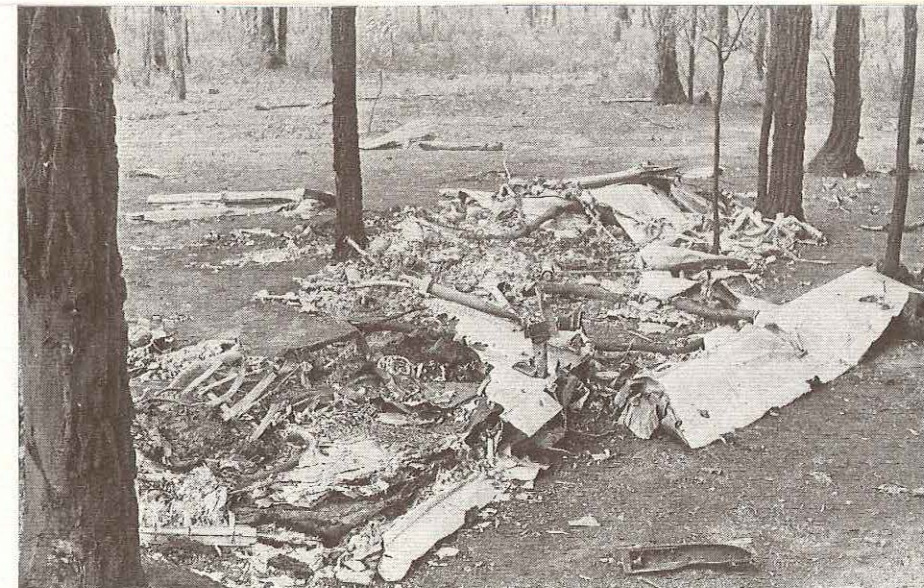
Wreckage of the central fuselage and cockpit area, with the remains of the rear fuselage in the background. The aircraft struck the ground in a flat attitude and, apart from cuts made by the propeller, left no ground marks of significance.

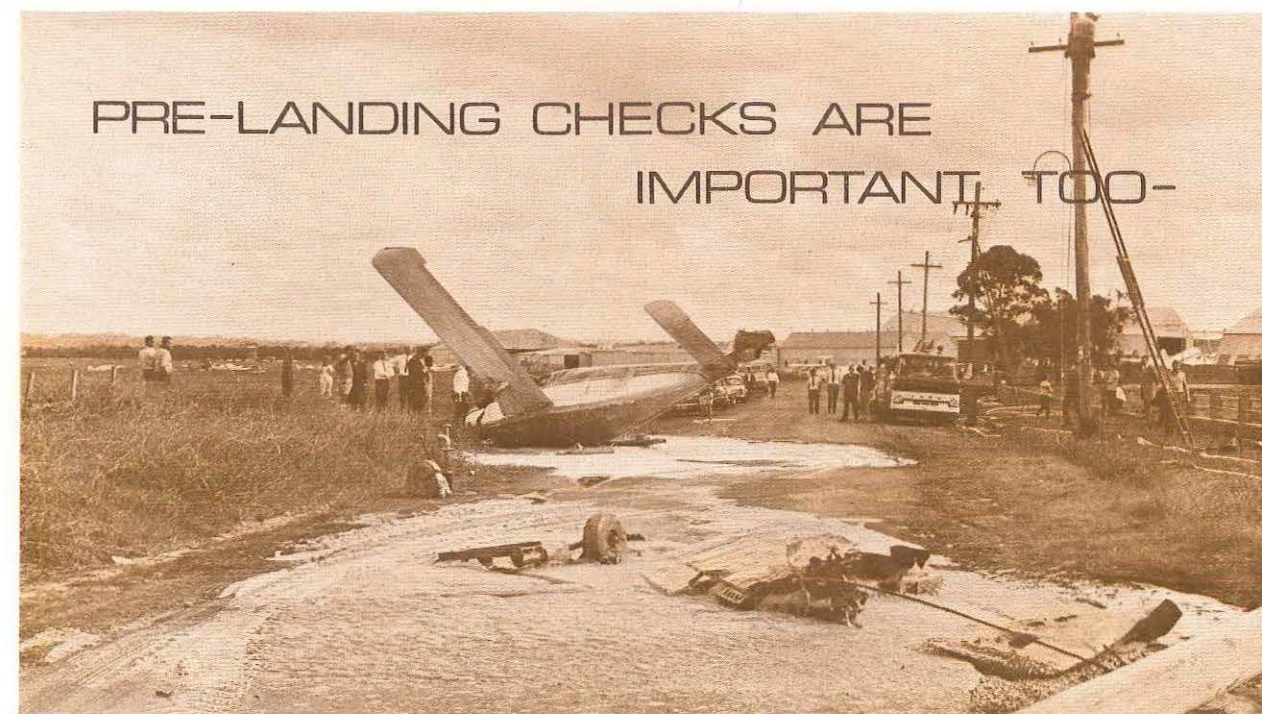
Fuel starvation on final approach can be even more embarrassing than at cruising height!
