AVIATION SAFETY DIGEST

No. 76 September • November 1971

DEPARTMENT OF CIVIL AVIATION AUSTRALIA

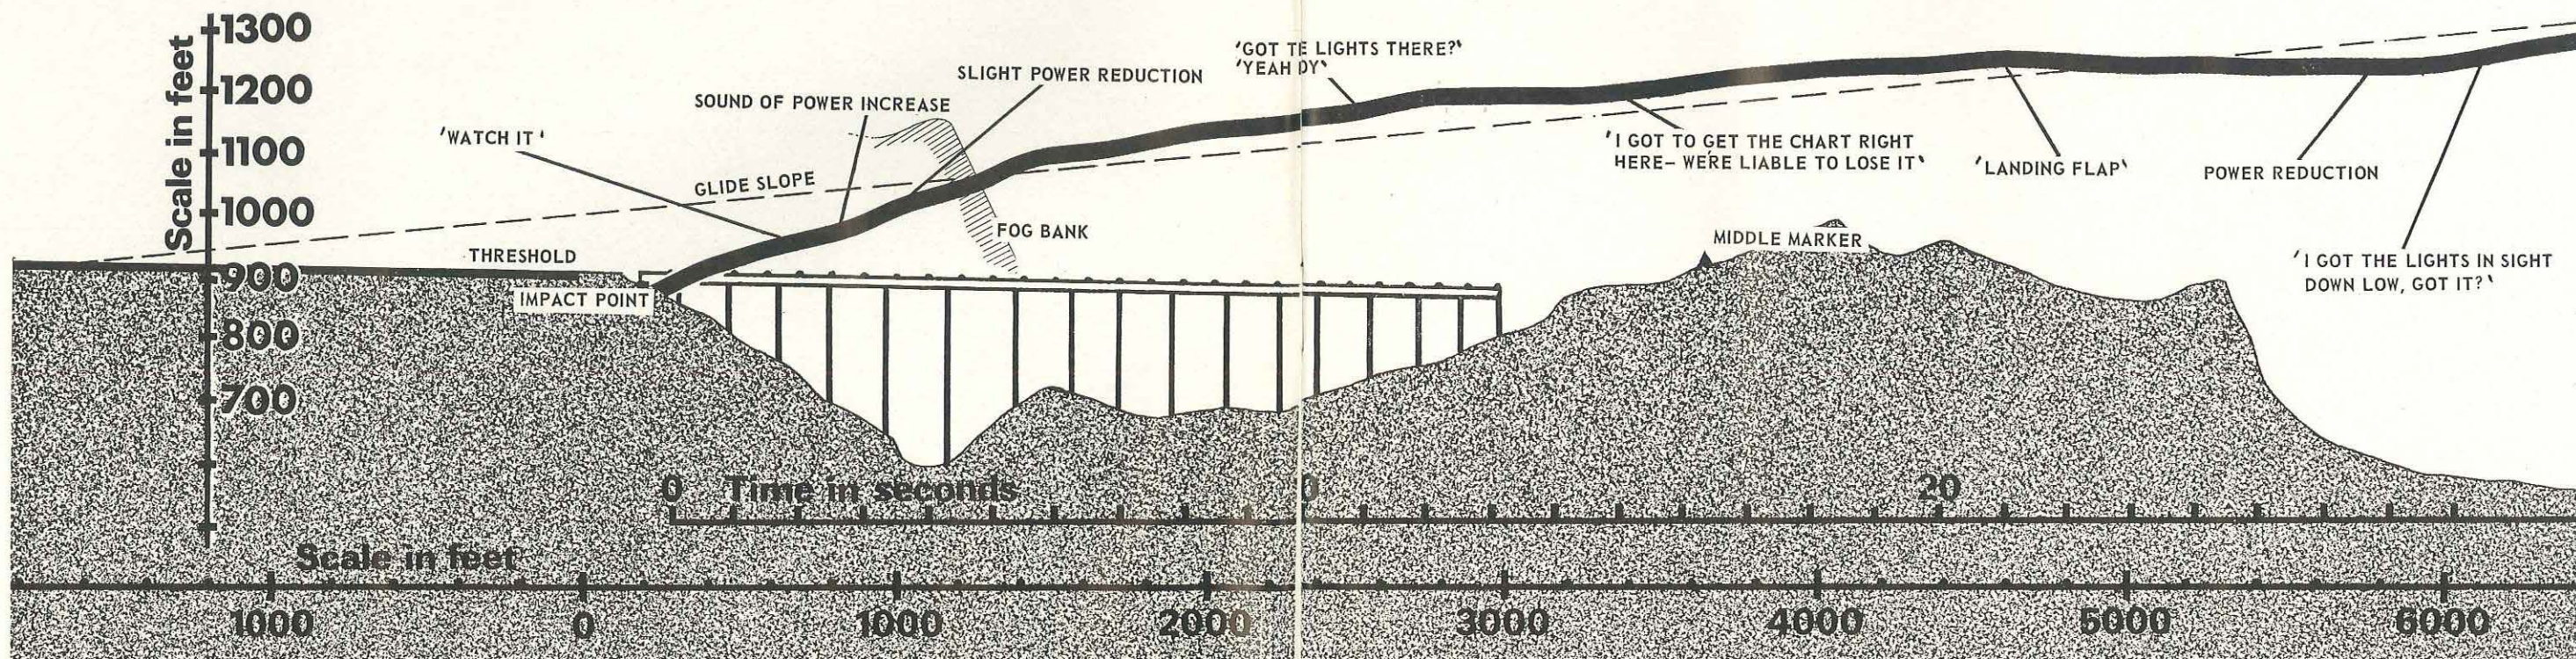
FIG 1: Profile of aircraft's final approach path as derived from flight data and cockpit voice recorders. The diagram shows terrain below approach path, approach lighting structure extending into the valley, runway threshold above valley slope, and estimated position of fog bank.

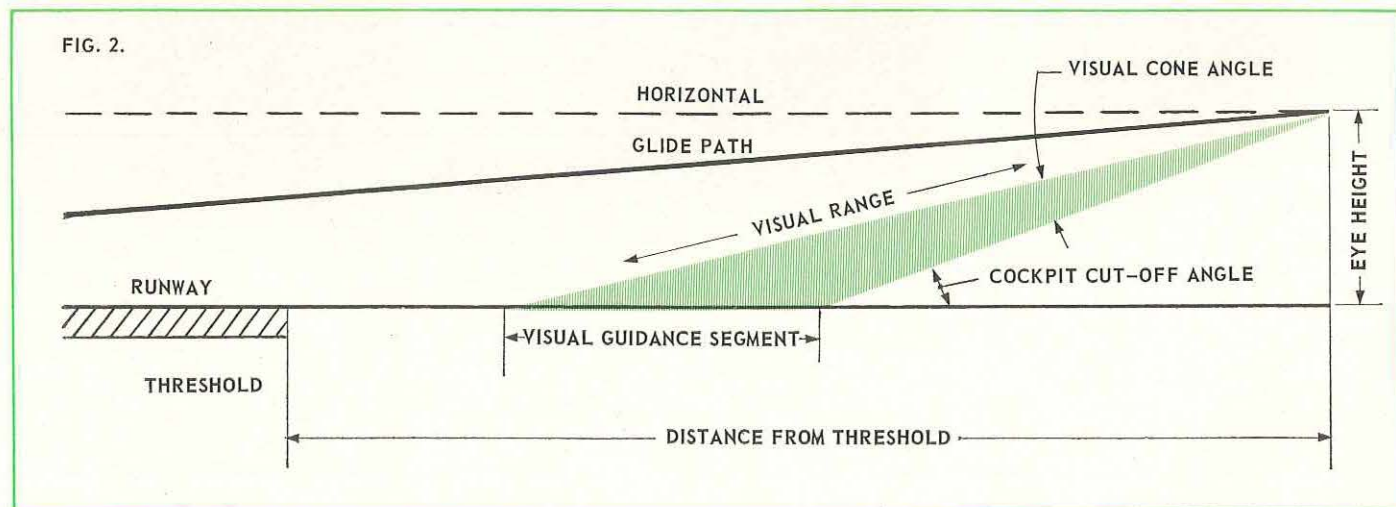
Diagram illustrating "Visual Guidance Segment".

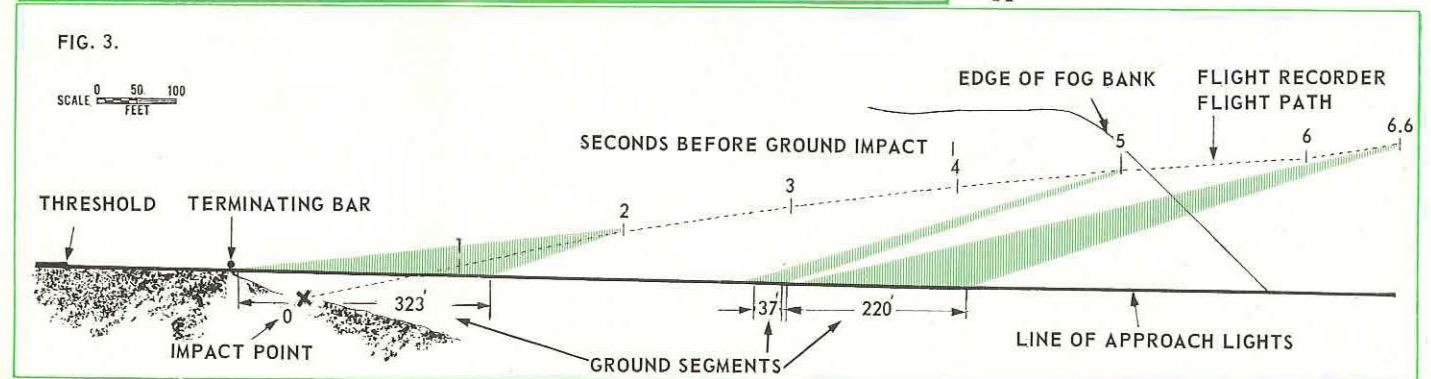
Table and diagram compiled during investigation to determine visual guidance segment available to crew during various stages of approach.

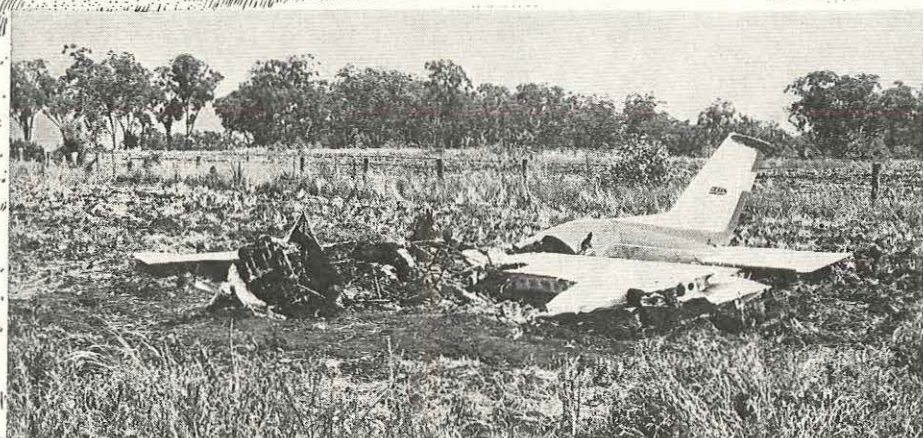
BURNT-OUT WRECKAGE OF AIRCRAFT LOOKING IN DIRECTION OF INITIAL CLIMB

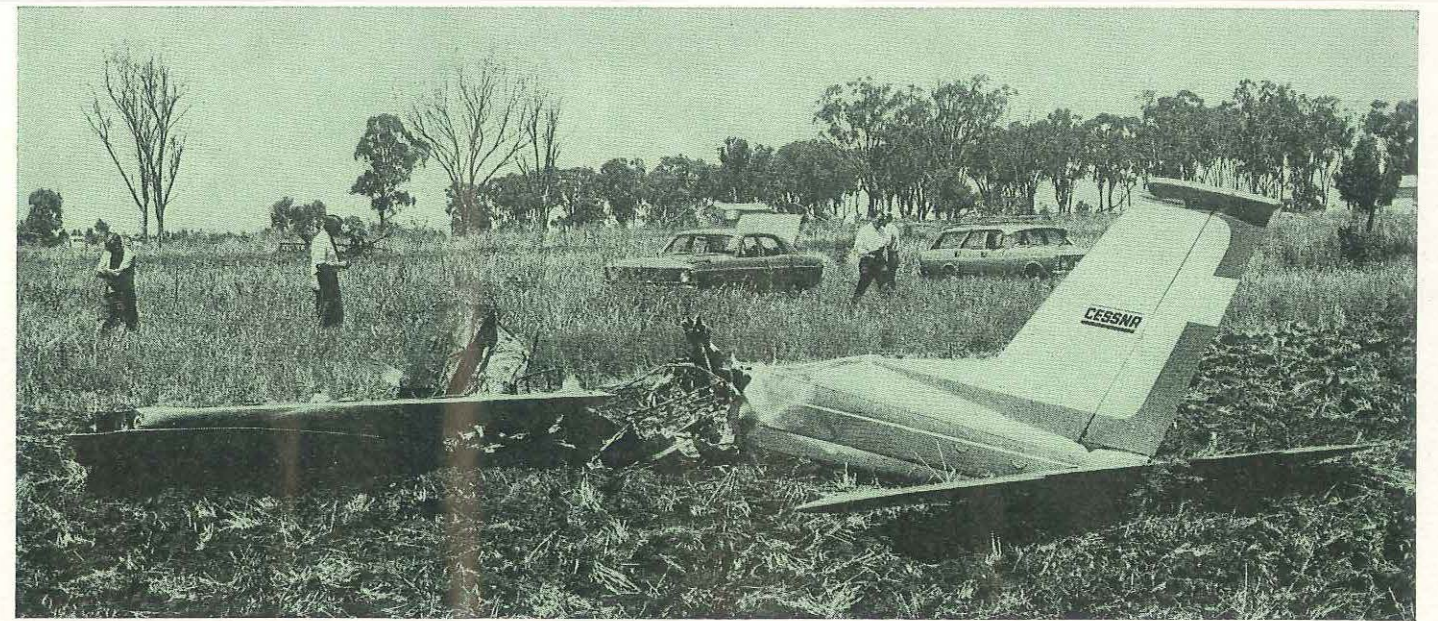
Although the passenger's evidence clearly indicates that the pilot set the flaps to the normal take-off setting during his cockpit check, the wreckage examination showed that the flaps were almost retracted when the aircraft was destroyed by the fire after impact. It is perhaps possible that the flap switch could have been moved to the "up" position at impact, energising the flap motor until the electrical circuit was destroyed by fire but it seems much more likely that the flaps would have been retracted deliberately by the pilot before he lost control of the aircraft. The aircraft at this stage had reached a height

View of wreckage looking in direction of impact. The flaps are almost fully retracted.

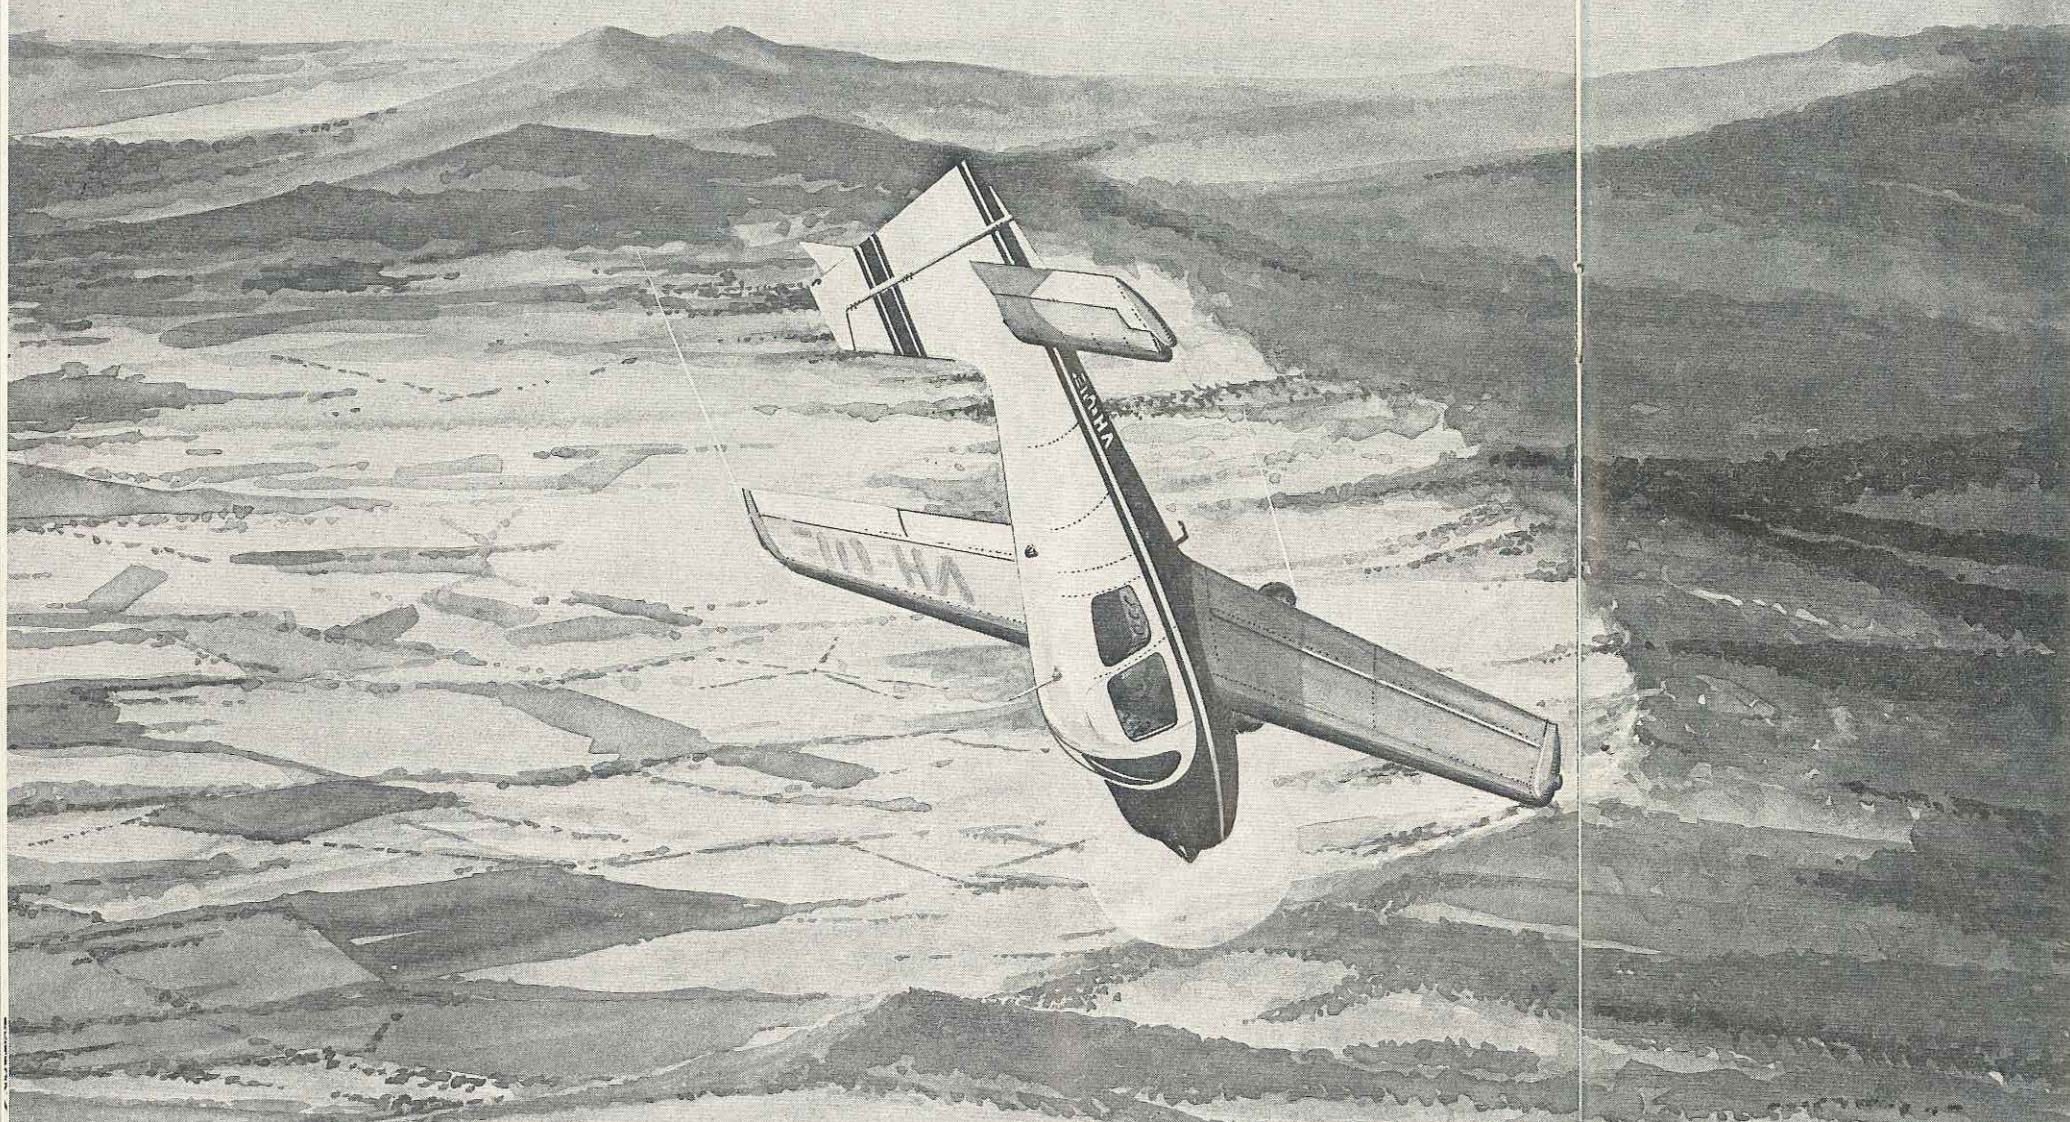
RECENTLY, while an inspection was being carried out on a Beagle Pup, cracks were found in panels on the top surfaces of each wing near the outboard ends of the fuel tanks. Further investigation disclosed a number of loose rivets in both the upper and lower wing surfaces.

This particular aircraft was operated by a flying training school and had been used regularly for aerobatic training. Although the actual circumstances in which the damage had been incurred could not be positively established, the aircraft had clearly been subjected to flight loads considerably in excess of those for which the

structure is designed. The damage was in fact, typical of that which would be expected from especially harsh aerobatic or flick manoeuvres.

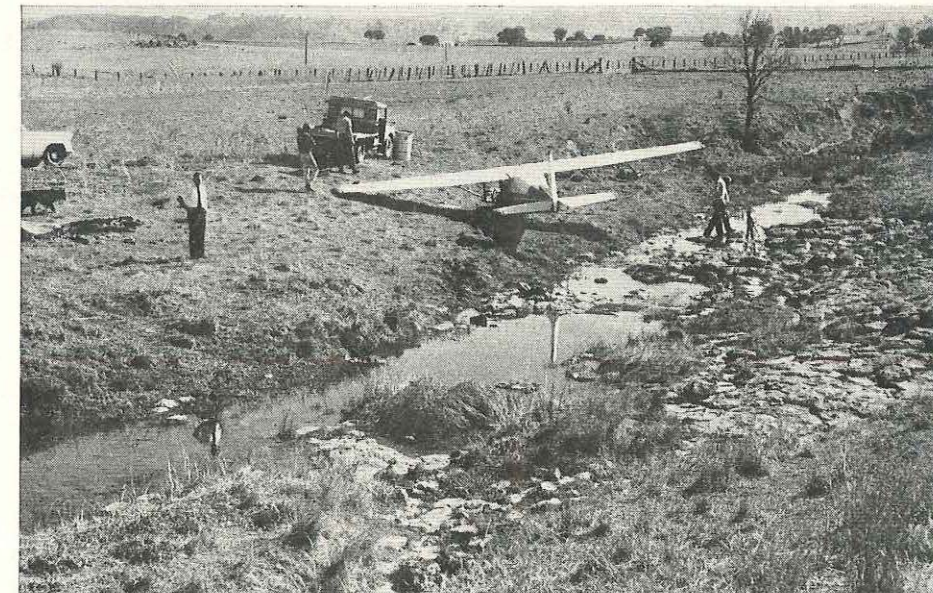
- The owner of the Cessna 150 pictured below was preparing for a flight from his country property. When he found there was hardly enough charge in the battery to start the engine, he set the throttle, pulled on the hand brake and chocked the wheels with three pieces of 4 x 2 inch timber. After turning on the switches, the pilot swung the propeller. As the engine came to life, the pilot realised the aircraft was going to jump the makeshift chocks, and ran around to switch off the engine. He grabbed the strut to restrain the aircraft while he climbed aboard but it swung, and he missed his footing on the cabin step and was thrown to the ground. While he watched helplessly, the aircraft gathered speed, ran beyond the confines of the landing area, crossed a road, tore its way successively through three fences and finally crossed a creek-bed, before coming to rest on the other side of the creek damaged beyond repair.

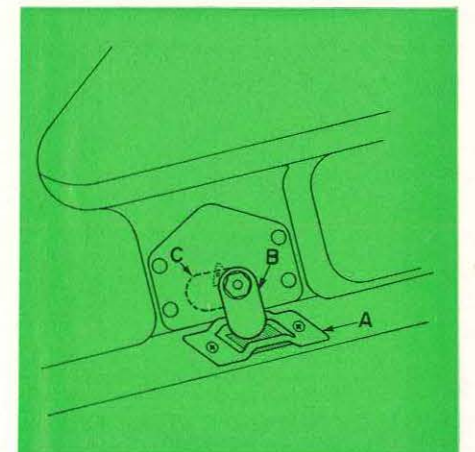
Cherokee Six door lock assembly showing (a) slotted striker plate, (b) locking tongue in vertical, fully locked position and (c) locking tongue in unlocked position.

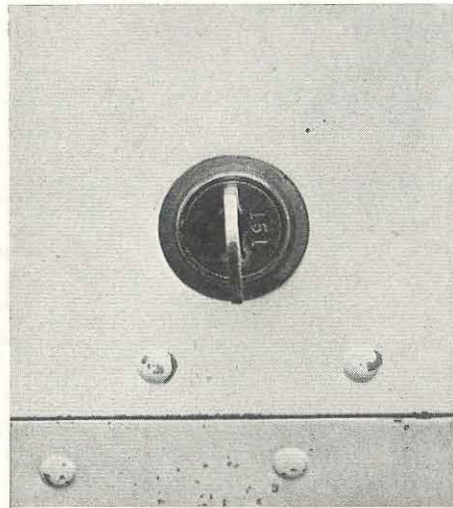
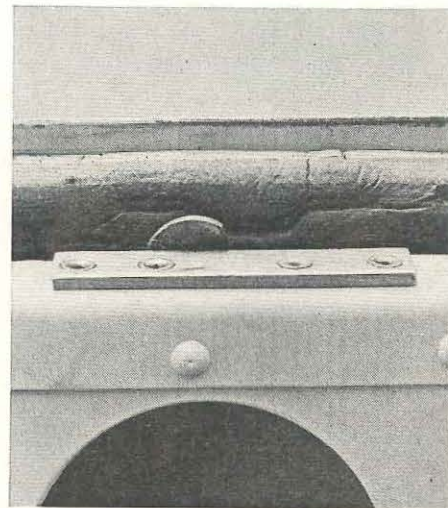
Left and right: In these pictures, the nose locker door is in an unsafe condition. Although the key is very close to the locked position the imprint of the striker plate on the rubber door seal shows that the locking tongue is barely engaging the plate.

When loading the nose compartment before flight, pilots should take care that no unrestrained articles are placed in a position where they could bear against the door panel. It is obviously also good practice not to rely on a visual inspection alone, to ensure that the door is securely locked! —————>

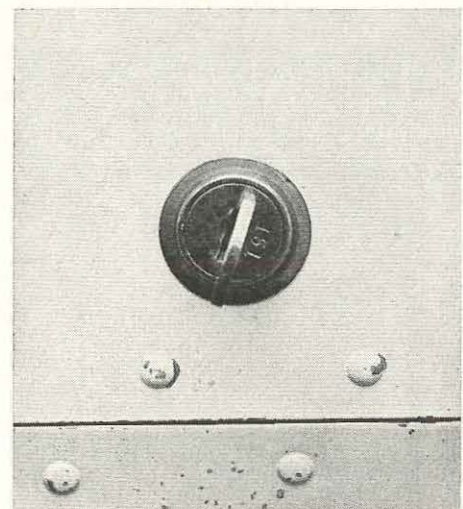
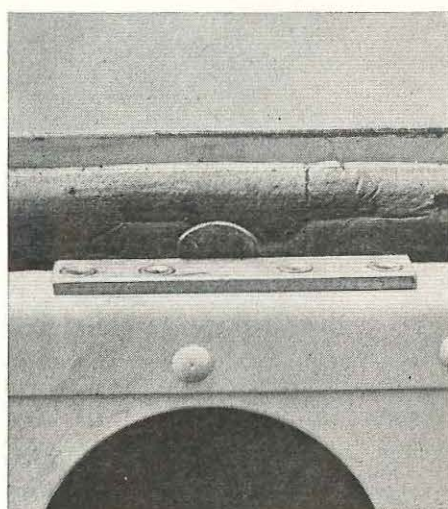
Left and right: The nose door fully locked. Because of wear in the lock, the key must be turned past the vertical position to ensure the locking tongue is fully engaged in the striker plate.

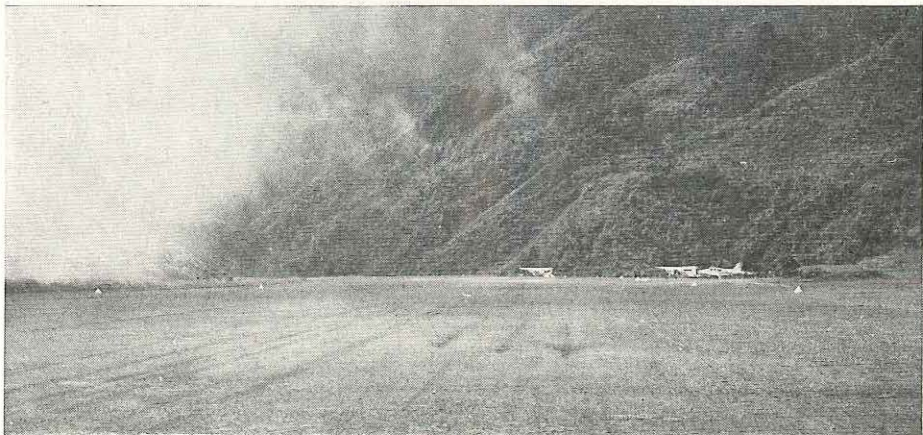
View looking in landing direction showing marks of heavy braking. The damaged aircraft can be seen at the end of the strip. Note the cloud rolling in from the left side of the strip.

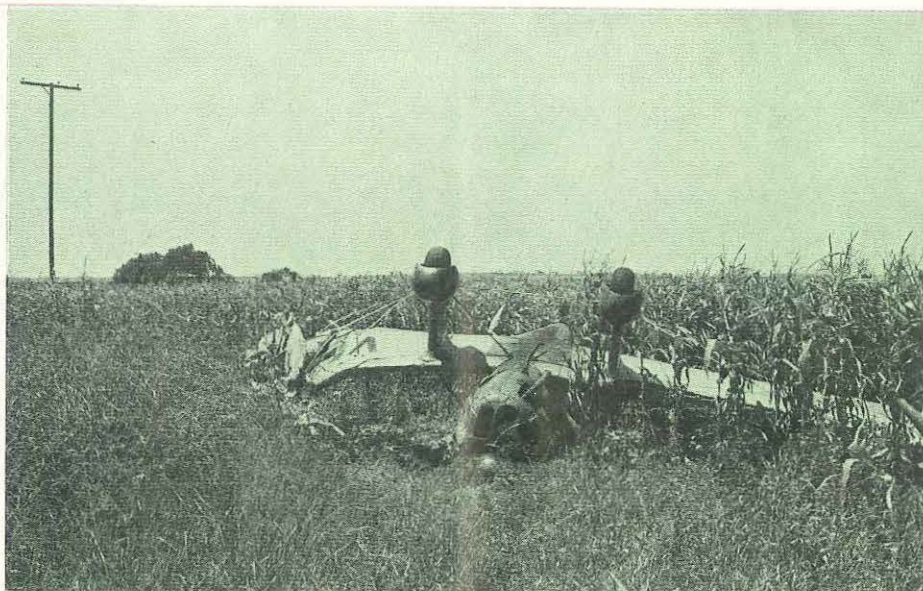
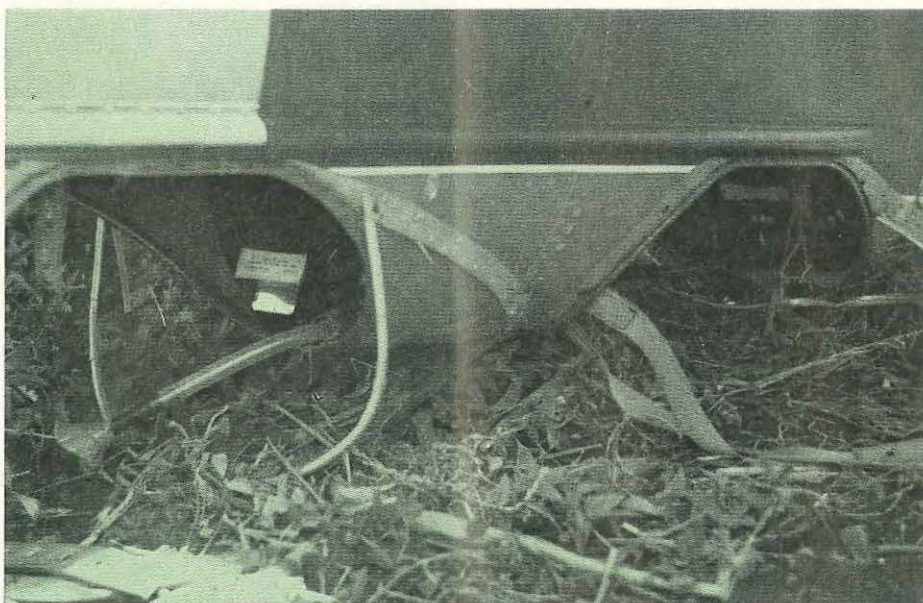
The Ryan as it came to rest inverted. The initial impact damage to the port wing is clearly evident. The lower photograph shows the tandem cockpits and speaking tubes.
