Number 78 March 1972

DEPARTMENT OF CIVIL AVIATION AUSTRALIA

AVIATION SAFETY DIGEST

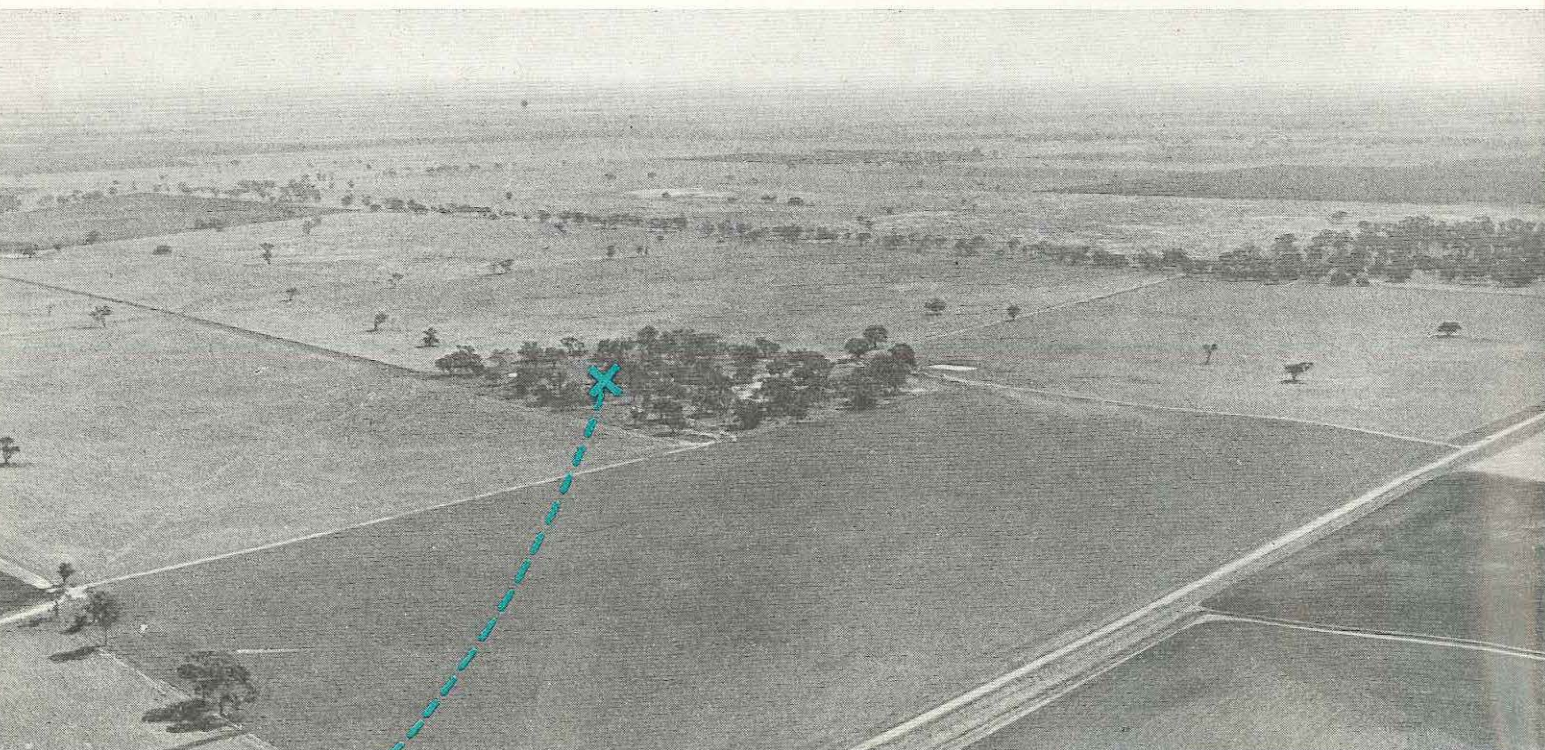
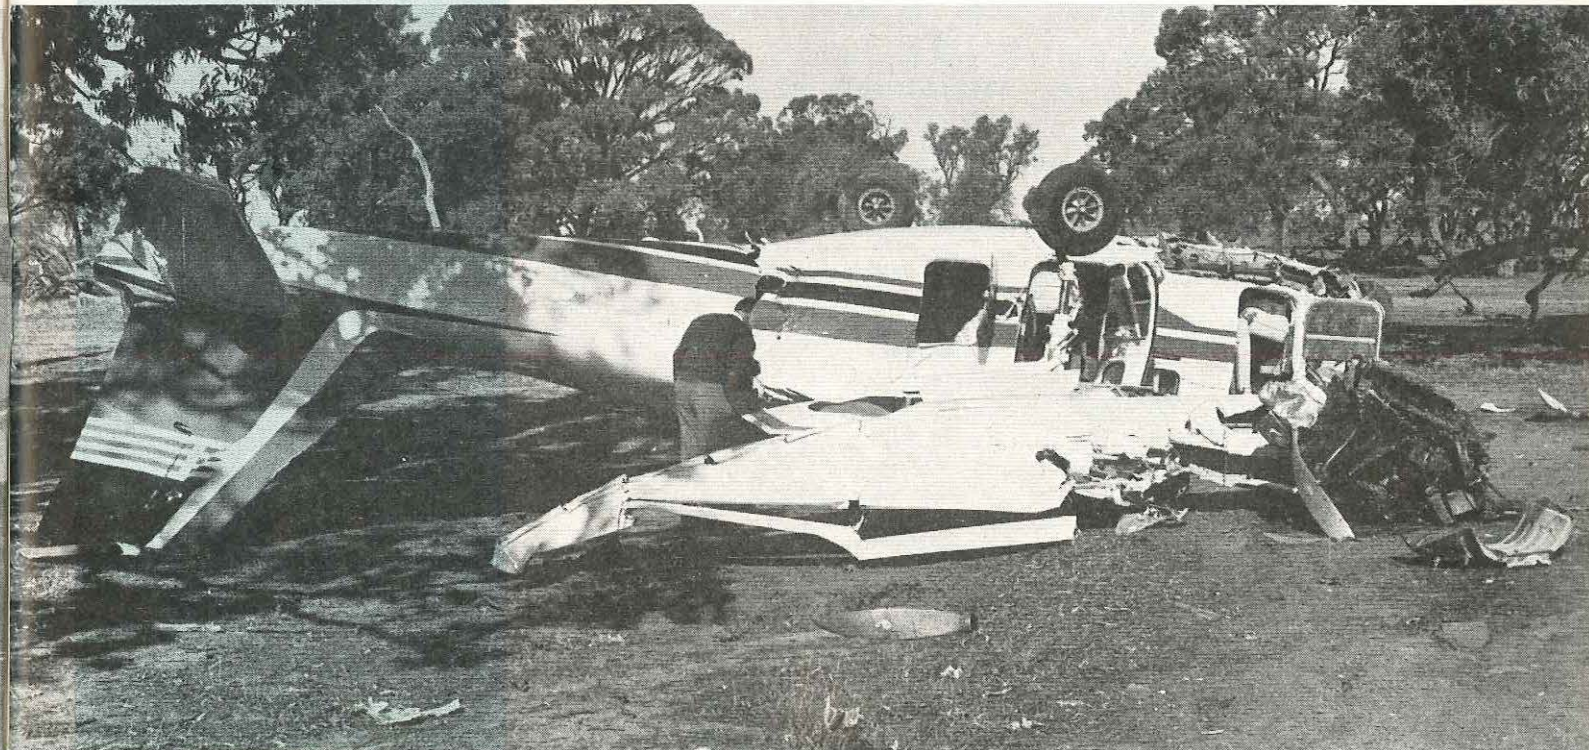
It was evident from an examination of the wreckage, that all structural damage had been caused by impact forces. There was no evidence of any airframe or engine malfunction which could have contributed to the accident. At the time of impact, the undercarriage was extended and locked down and a quarter flap was lowered.

When recovered from the wreckage, both altimeters were found to be giving erroneous readings. Detailed examination of these instruments however, showed that each had been capable of normal operation before the accident, and that the errors were the result of impact damage.

It was found that the static pressure system connected to the altimeters in this aircraft was fitted with a selector valve that provided for an alternative source of static pressure. The selector valve was mounted on the left hand side of the cockpit, immediately below the instrument panel and adjacent to the cabin air controls. Tests conducted in a similarly equipped aircraft of the same type showed that it was possible for the valve to be placed in a mid-position where no static pressure was available to the system from either source. This had the effect of locking the altimeters at the height they were indicating when the mid-position selection was made, and caused the airspeed indicators to over-read with any subsequent reduction in altitude. Because of impact damage however, it was not possible to determine the position of the aircraft's static system selector valve at the time of the accident.

Right: The Aero Commander as it came to rest inverted in the timbered area visible in the centre of the photograph on the opposite page.

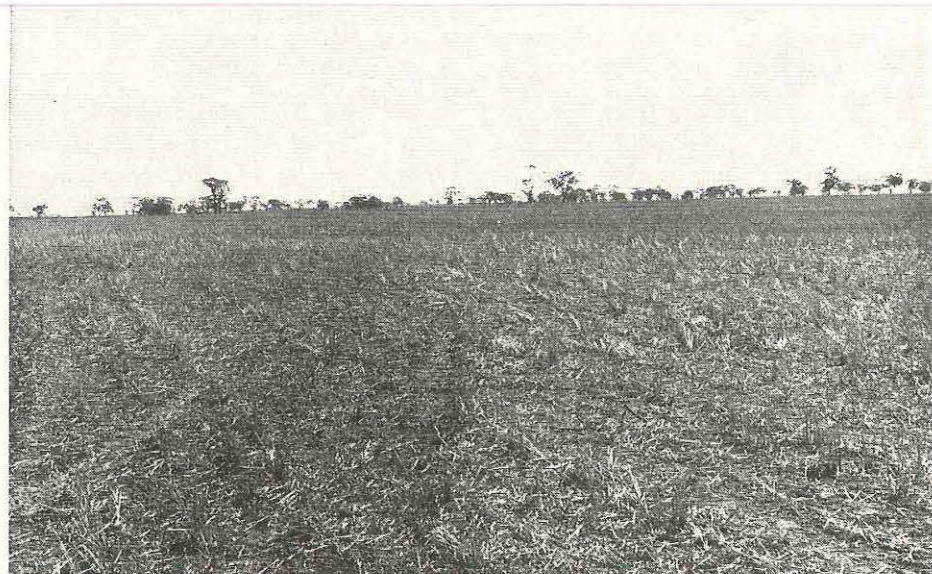
The stubble paddock in which the aircraft first struck the ground, looking back along flight path. The initial impact marks made by the aircraft's undercarriage can be seen in the foreground.

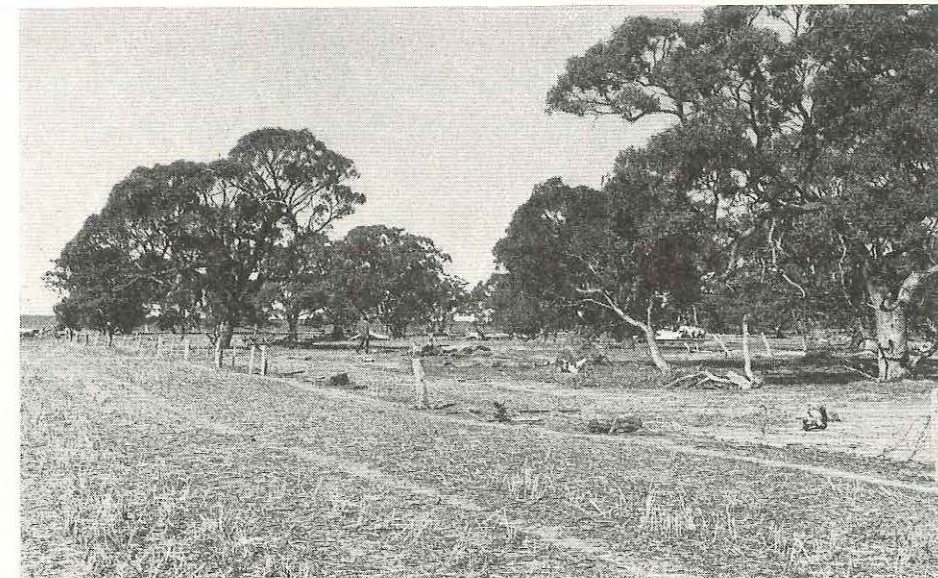
View looking along impact path as seen from point at which aircraft first struck the ground. The main wreckage can be seen in the middle distance amongst the trees.

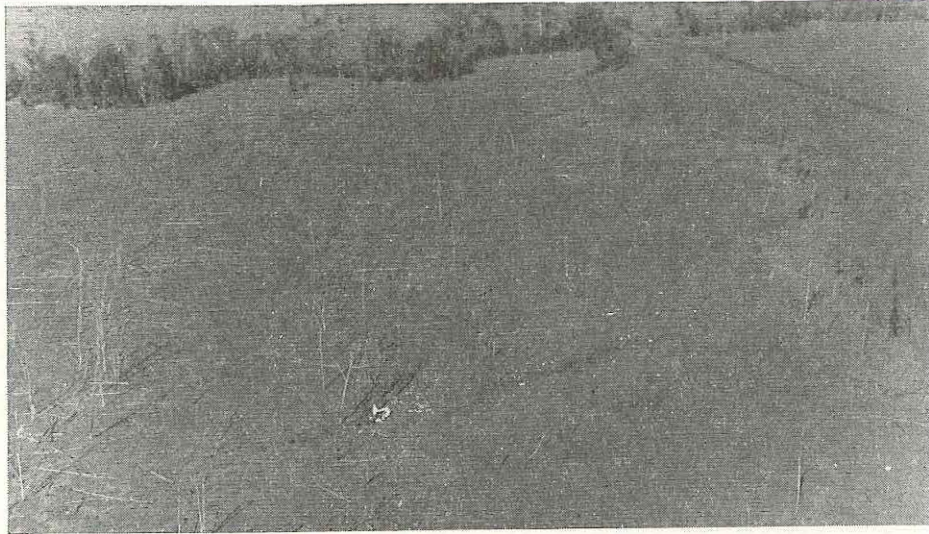
Examination of the scattered wreckage and ground marks showed that initial impact had occurred with the trunk of a dead tree, 40 feet above the ground. The tree had broken off at this point and the aircraft had continued for another 170 feet before striking the ground and disintegrating. A trail of wreckage was scattered for more than 500 feet, the main section coming to rest 340 feet from ground impact point. Analysis of the cine film record of the aircraft's final two and a half seconds of flight established that it attained a speed of 200 knots shortly before its impact with the tree, and that it would have been subjected to a positive load factor of 4.3g during the attempt to recover from the dive.

Top: Aerial view of Aztec accident site showing wreckage trail. The point of impact is at the right of the picture.

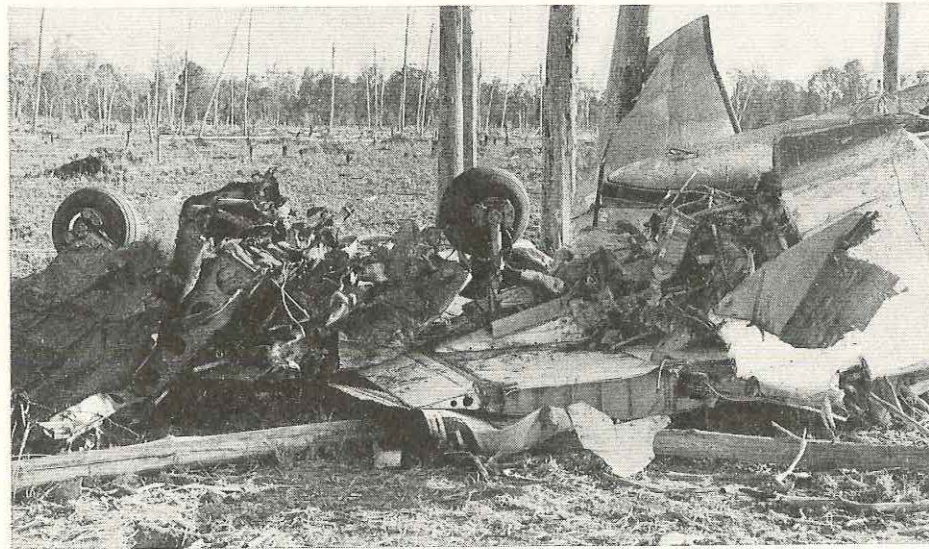
Bottom: All that remained of the aircraft's structure. The severity of the impact forces is clearly evident from the degree of disintegration.

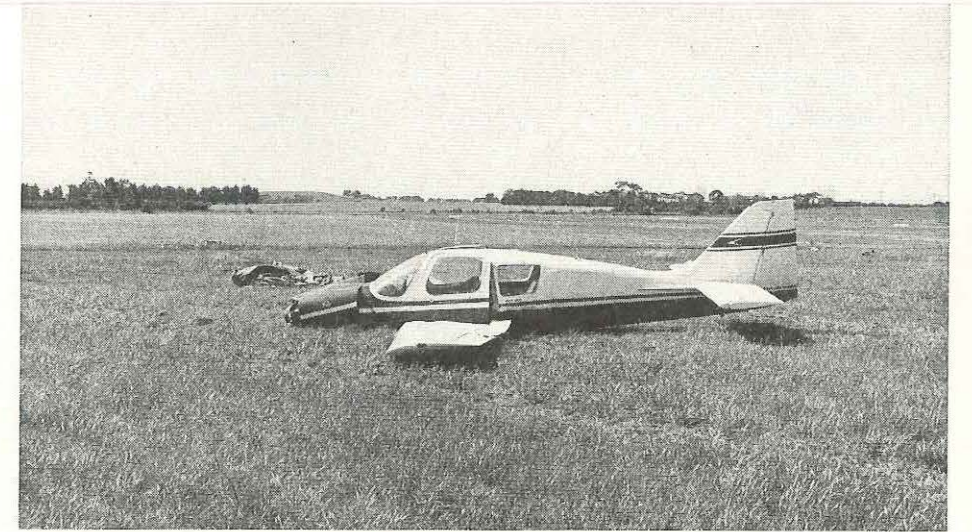
Right: Though at first glance the Beagle Pup appears relatively intact, the high vertical deceleration forces of the impact are evident on closer inspection.

It was clear from the subsequent examination of the wreckage that there had been no defect or malfunction in the aircraft which could have contributed to the accident. The examination showed that the impact had produced extremely high vertical deceleration forces which had distorted almost the entire structure and had undoubtedly been responsible for the fatal injuries to the occupants.

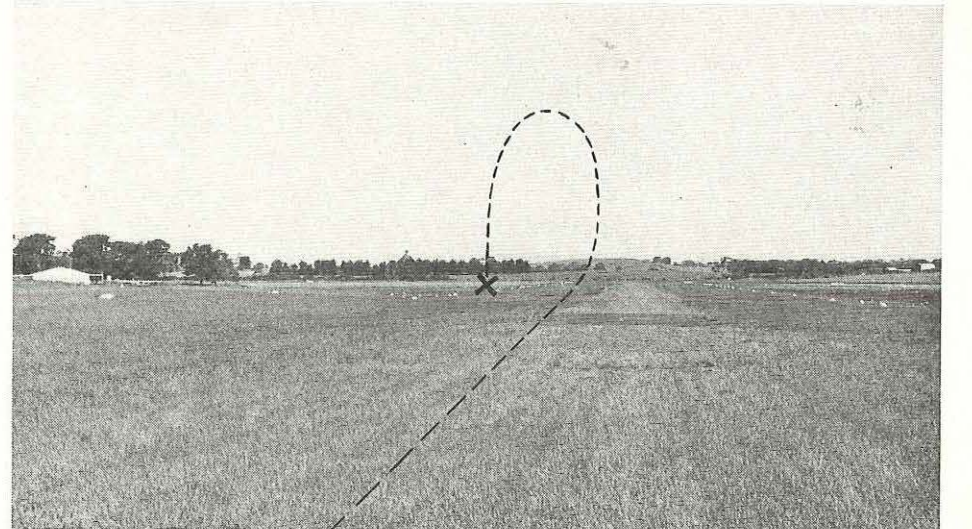
View looking along runway in direction of low run showing approximate final flight path and point of impact. The height at which the aircraft commenced the manoeuvre was estimated to be only 20 feet.

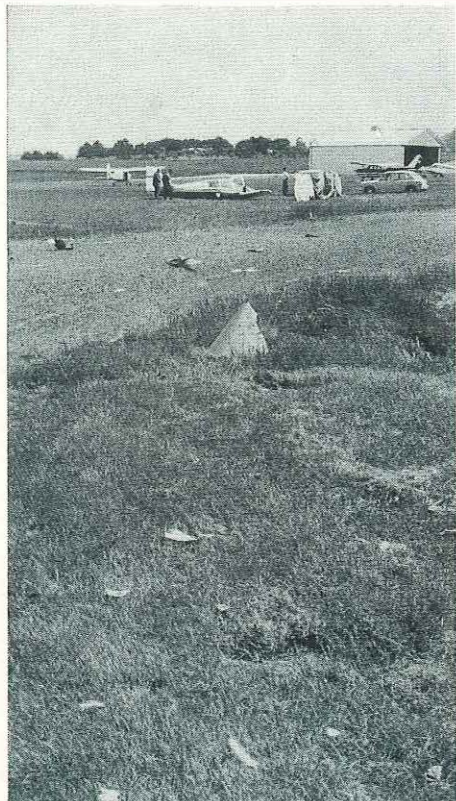
View of Beagle's wreckage trail as seen from point of impact.

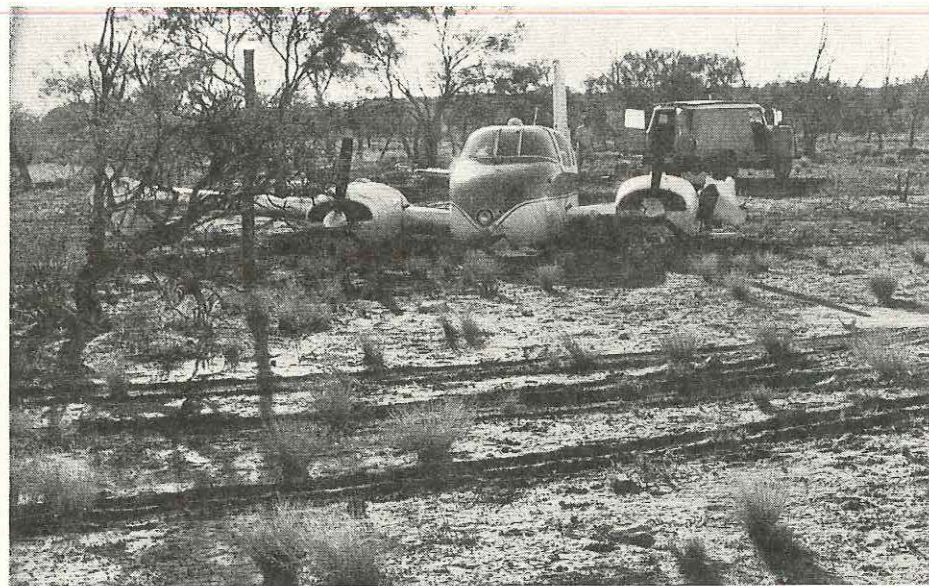
Top: View of accident site showing the aircraft as it came to rest with the port wing and tailplane torn off. The wheel tracks in the foreground are those of the salvage vehicle.

access panels, or other sections of the airframe were missing, and apart from impact damage, the engines and propellers should have been capable of functioning normally. But on the starboard wing inboard of the engine nacelle, the non-slip walkway, which is normally secured to the upper surface of the wing with adhesive, had separated from the wing at its forward edge. It seemed likely that this section of the wing-walk, protruding into the slipstream, could have created a turbulent airflow over the starboard tailplane and caused the vibration experienced by the pilot.

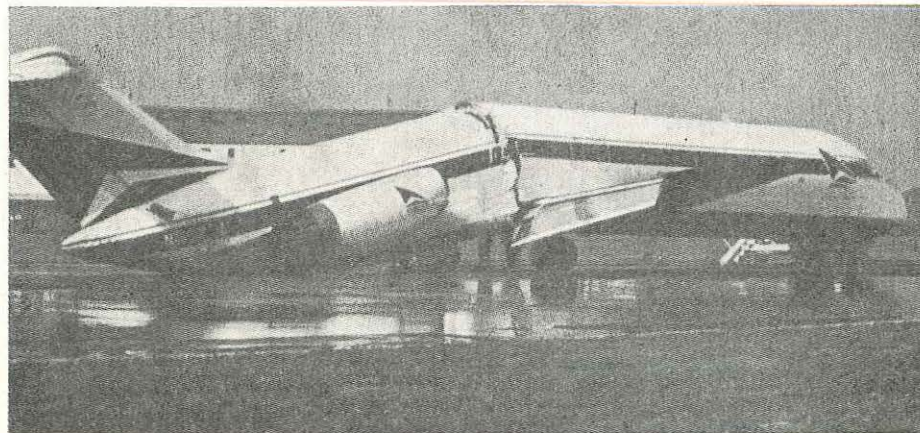
Examination of the aircraft showed that the fuselage had buckled and fractured symmetrically immediately aft of the wing, between fuselage stations 737 and 794. The tailcone rested on the runway and its underside had been worn flat with heat discoloration visible on both sides. There was no apparent damage to the undercarriage or its supporting structure but both port undercarriage tyres had flat spots, which had penetrated the casings, worn on them.

The loads and forces necessary to cause the failure sustained by the fuselage were analysed by the manufacturer, and it was concluded that the increase in effective sink rate, resulting from the landing on the upward slope, was the primary cause of the damage. If the aircraft had landed on the level runway at the same actual rate of sink, it would probably not have been damaged.

The DC-9 with its back broken as it came to a stop on the runway.

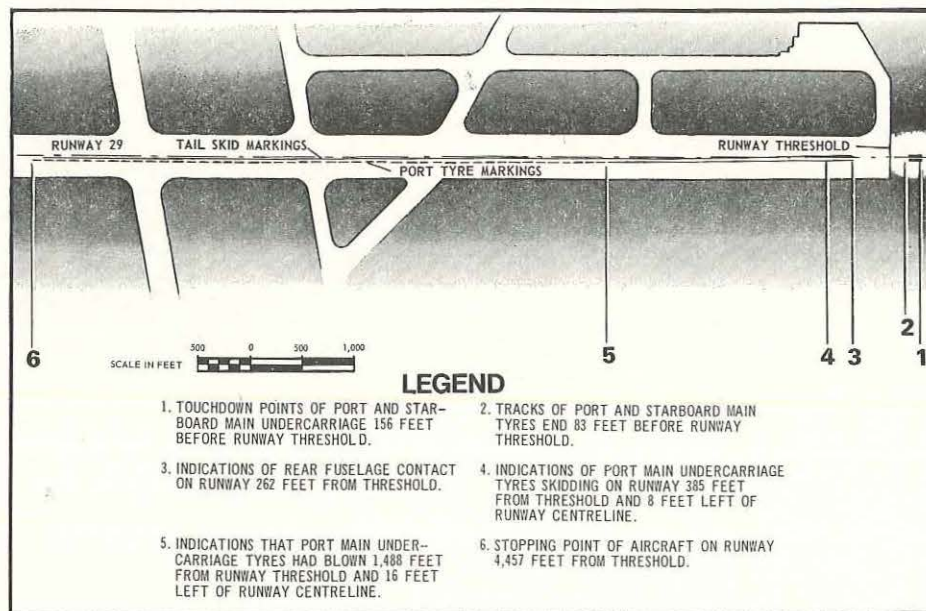
Diagram of approach end of runway showing point of touchdown and impact marks.

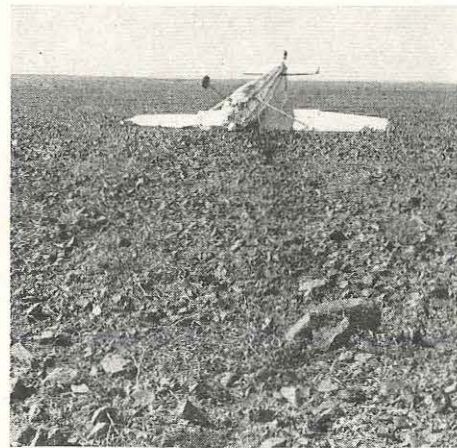
Top: The extremely rough surface of the area on which the pilot chose to land. The starboard wheel broke off when it struck the large boulder in the foreground.

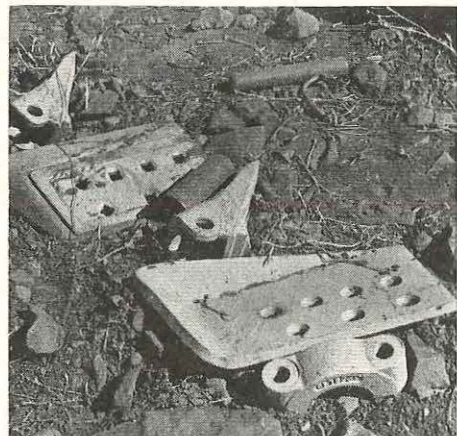
Bottom: Some of the heavy ferrous metal spare parts that were carried in the aircraft. This cargo, stowed under the front seats, probably affected the aircraft's compass.

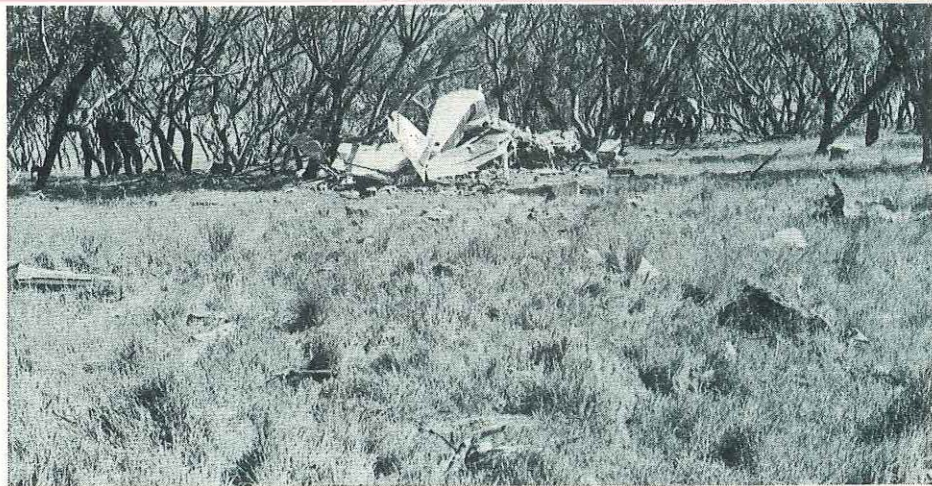
The main wreckage of the Cessna, with both wings torn off, as it came to rest on the down-slope of the hill. The initial impact point, shown in the photograph on the previous page, was higher up the slope.

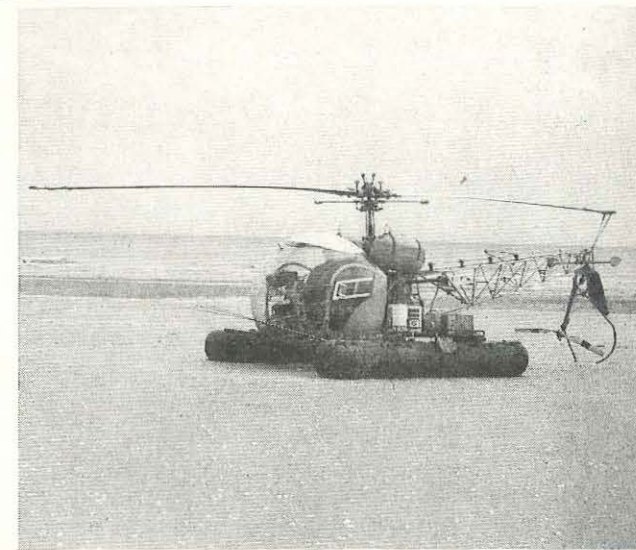
Despite the serious tailplane damage shown in the picture, the aircraft returned to Lae and made a safe landing.
