AVIATION
SAFETY
DIGEST

A MATTER OF TIME!

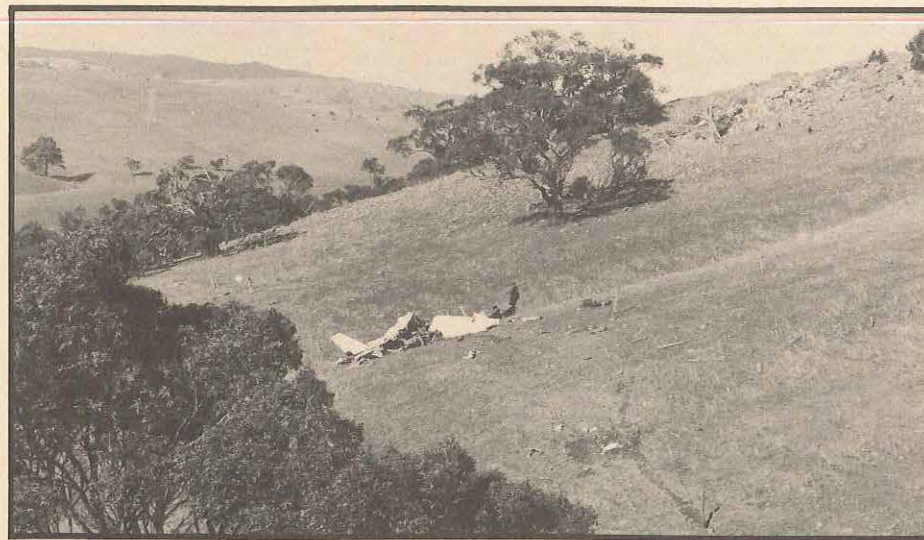
General view of accident site looking in direction of impact. The point at which the aircraft struck the hill-side can be seen in the right foreground.

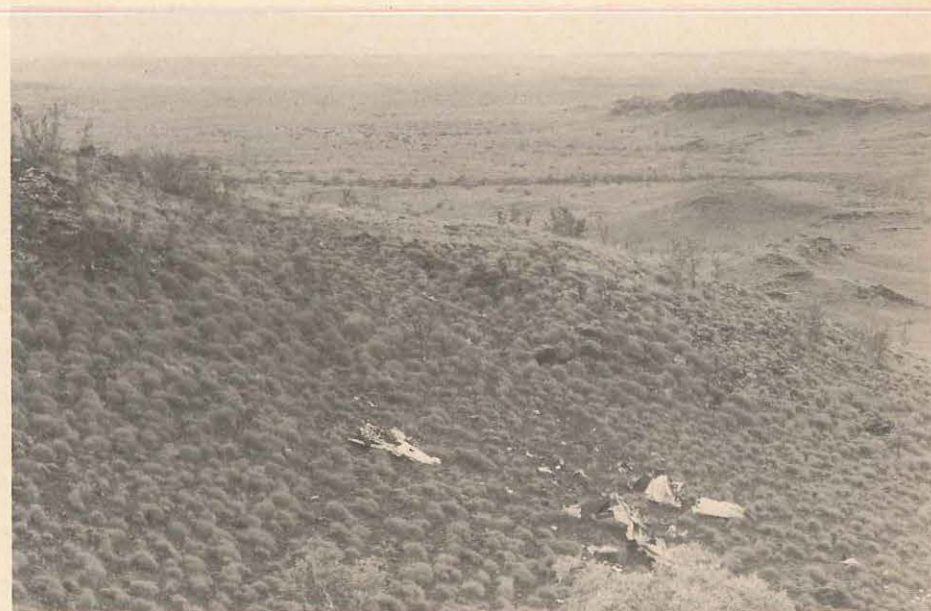
Above: View from accident site looking back in direction of flight. The plateau on which the Shay Gap airstrip is situated is just visible on the horizon.

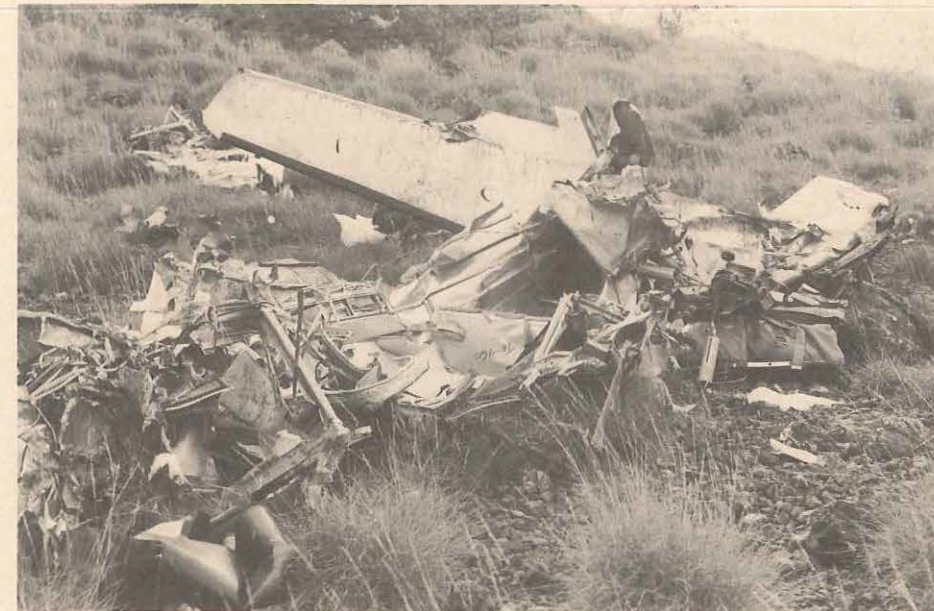
Total destruction : The end result of a high-speed encounter with obstructing terrain.

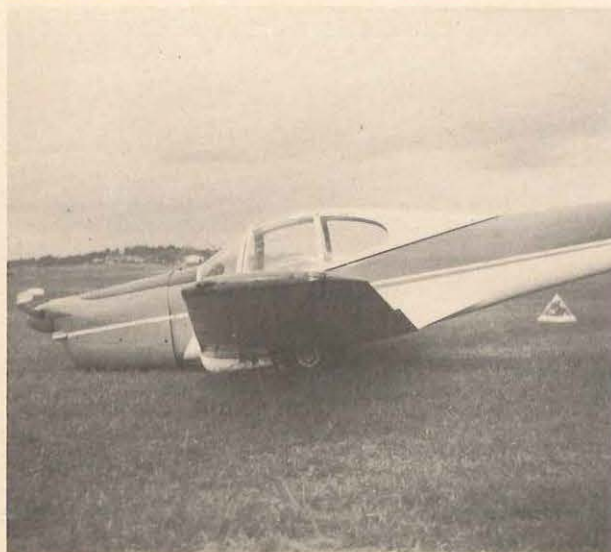
The owner-pilot of the Meta Sokol in the picture had flown it from Canberra to Bankstown to have a new radio fitted. Later that afternoon, when the installation was completed, the pilot boarded his aircraft, taxied out and departed. Shortly after lift-off however, he was alarmed to see that the fuel pressure indication had dropped to zero. He immediately changed tanks and began operating the wobble pump, but the needle only flickered. He advised Bankstown Tower of the problem and said he was returning for an immediate landing. Once on down wind leg he carried out a pre-landing check, but not realising that he had failed to raise the undercarriage after take-off because of his preoccupation with the loss of fuel pressure, he inadvertently selected it up. Still manipulating the wobble pump, he completed an approach, and it was not until after rounding out, when the propeller struck the ground, that he realised his mistake. The cause of the loss of fuel pressure indication was later traced to a loose electrical plug.

During the subsequent investigation, it was found that the pilot had based his endurance calculations on a consumption rate of 7.5 GPH, and had documentary evidence based on the aircraft "owners manual" to support his use of this figure. He had leaned the mixture but, even so, had not reduced the consumption rate to 7.5 GPH. As well as this the fuel tank capacity proved to be one gallon less than the figure specified in the Flight Manual. A head wind component five to ten knots greater than forecast provided the "last straw". Had the pilot not been misled by the low fuel consumption rate quoted to him and planned the flight on a more realistic figure, he would have seen that a refuelling stop was necessary if the flight was to be completed with the statutory 45 minutes reserve intact. Even so, a more experienced pilot would probably have landed at the nearest available aerodrome to check the tank contents when the fuel gauges indicated abnormally low readings.

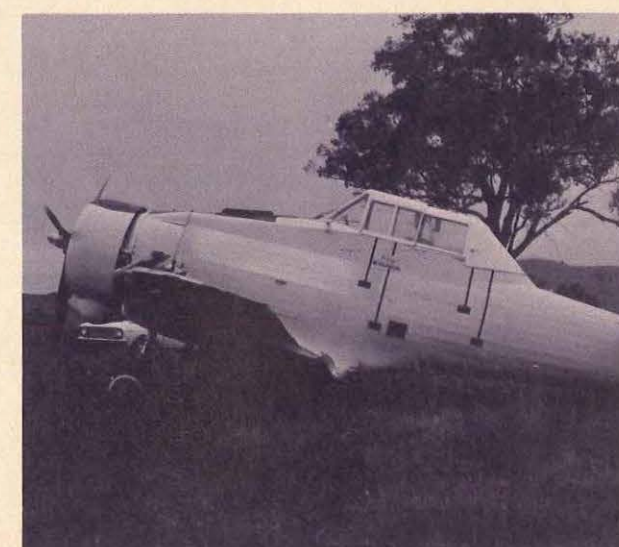
The pilot of this CA 28 Ceres had been engaged to carry out some aerial spraying on a property in inland N.S.W. He was to operate from a one-way agricultural strip situated on the property, and because he had not used it before, he rang the owner and discussed the strip with him. Although it had an overall slope of no more than five per cent, this consisted of three separate "humps" which meant that the top end of the strip was lost to view during more than half the landing run. After flying from his base aerodrome the pilot sighted the area and saw that the loader vehicle was parked on the top end of the strip. Following a normal approach, the aircraft touched down 150 feet inside the threshold. As it decelerated up the slope, the pilot lost sight of the loader vehicle and, when about 600 feet from the end of the strip he applied the brakes. The grass was wet, the brakes locked without appreciably slowing the aircraft and when the pilot next caught sight of the loader vehicle the aircraft was rapidly sliding towards it. Although the pilot attempted to turn away to starboard, the aircraft continued on and struck the truck with its port wing. The aircraft sustained substantial damage.

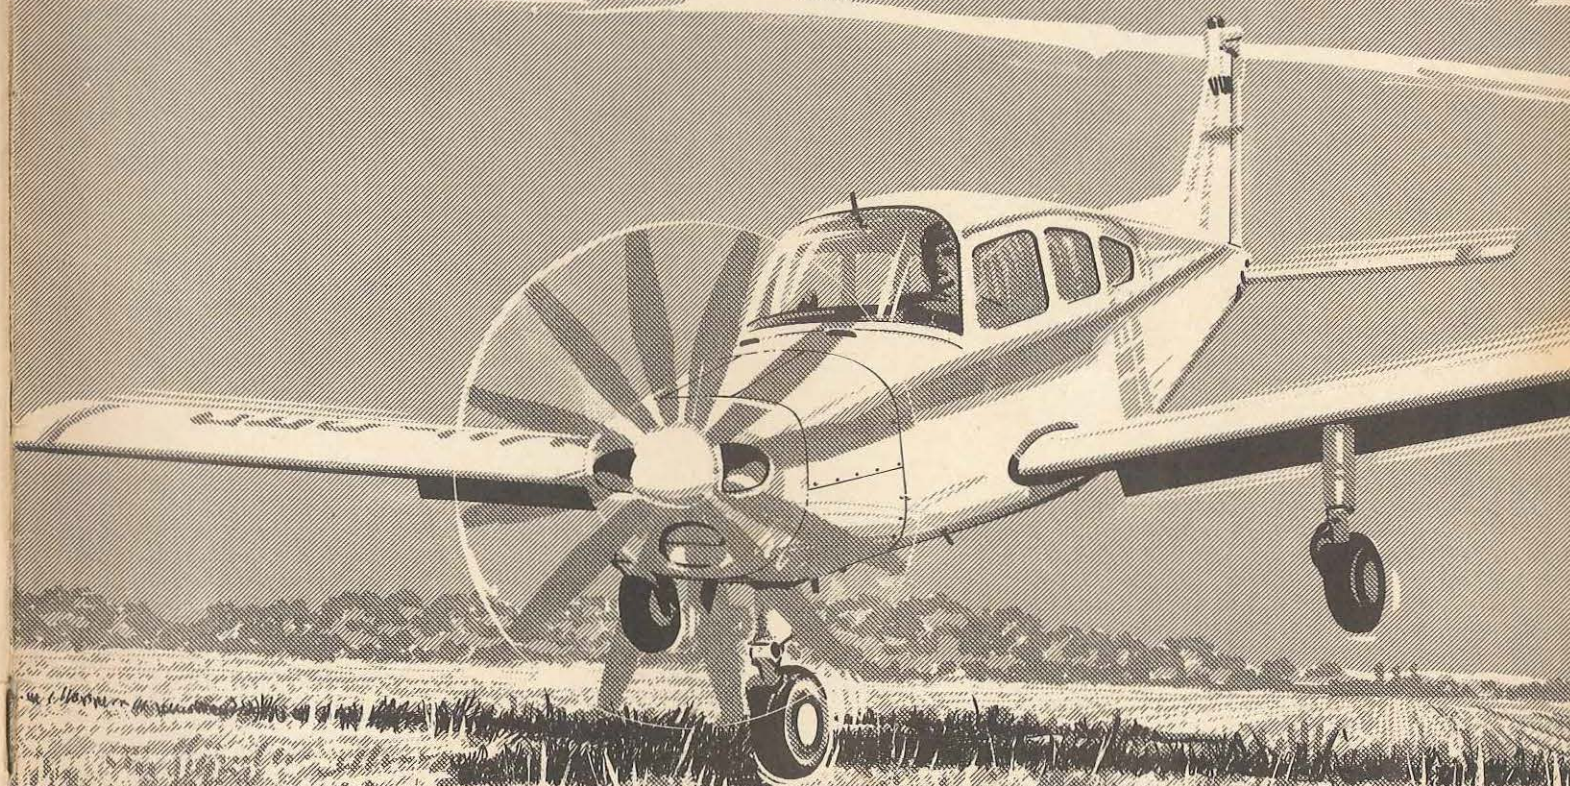
Nose legs are vulnerable to this sort of treatment — it's much safer to go around!
