AVIATION
SAFETY
DIGEST

Number 90 1975
CONTENTS

LIBELLE

SHEDS WINGS IN FLIGHT

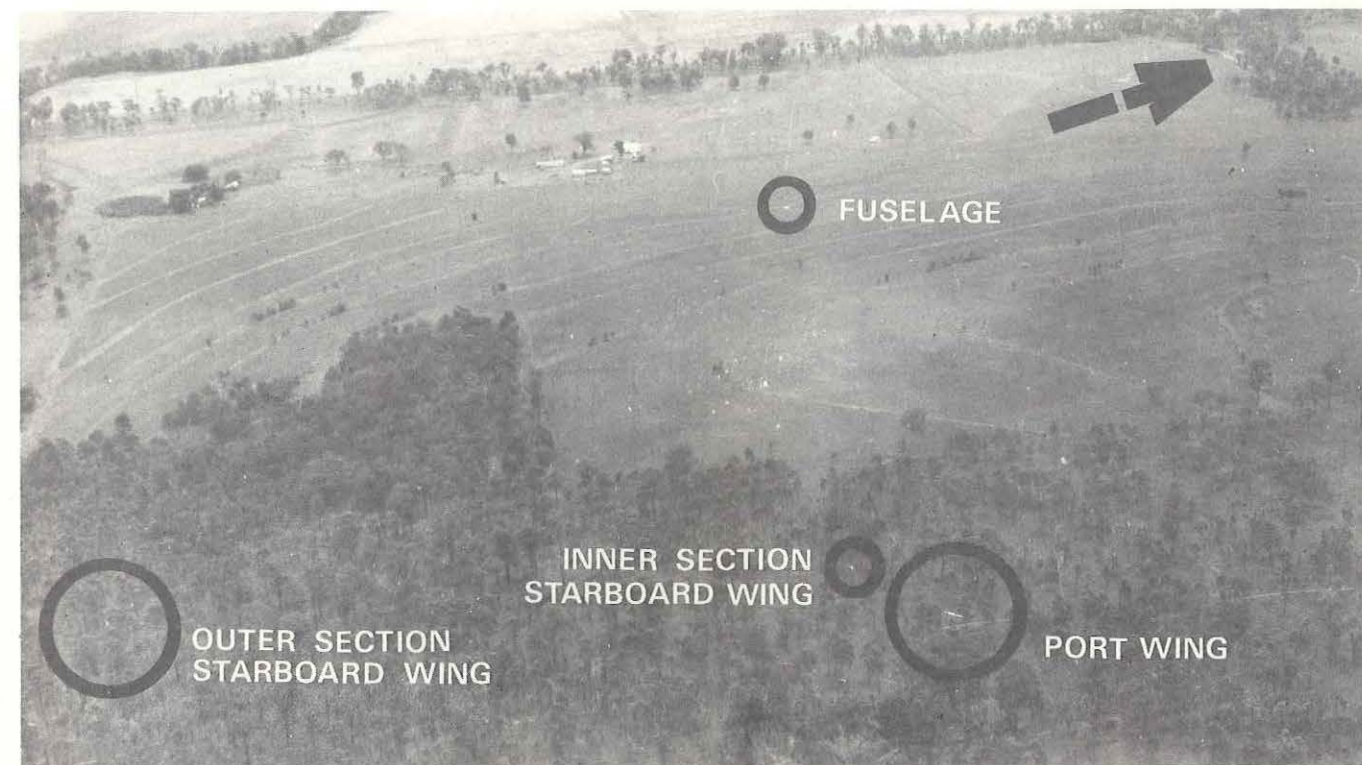
Aerial view of accident area showing wide scattering of wreckage. The direction of the aerodrome is indicated.

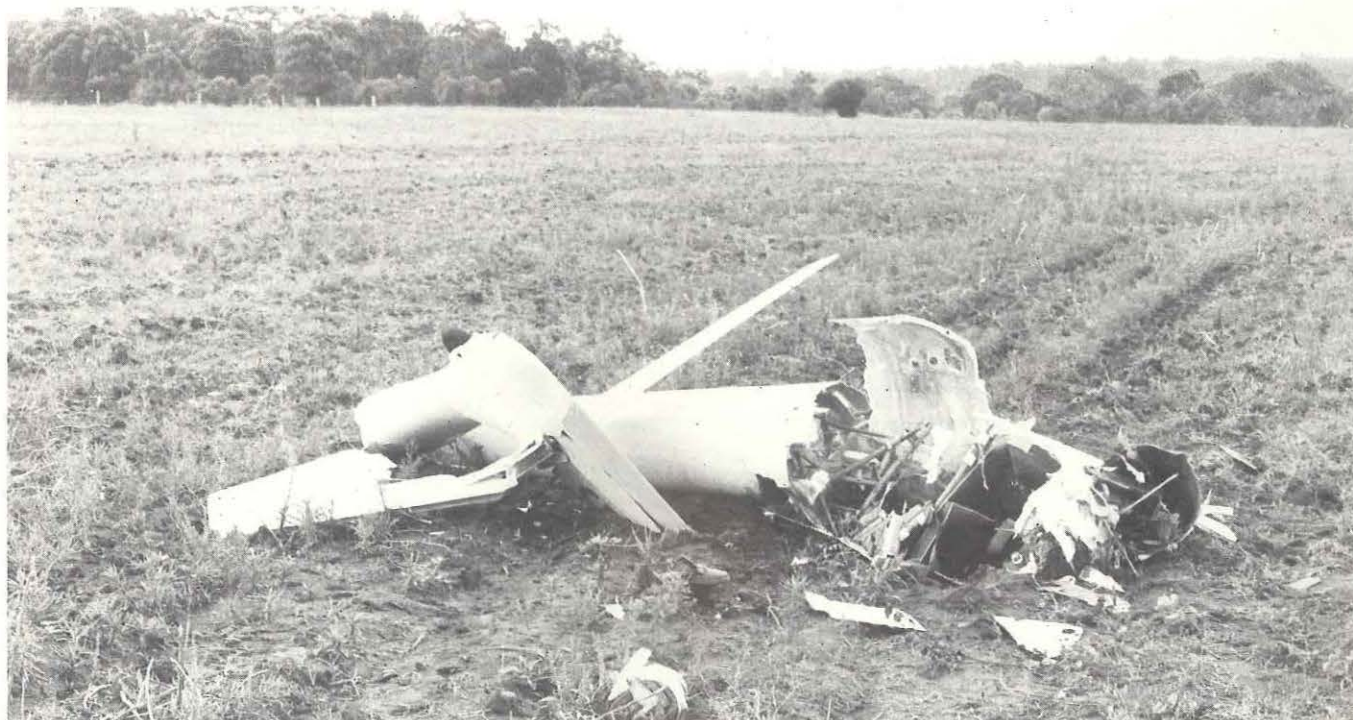
Above: Wreckage of glider's fuselage. The remains of the cockpit are at right.

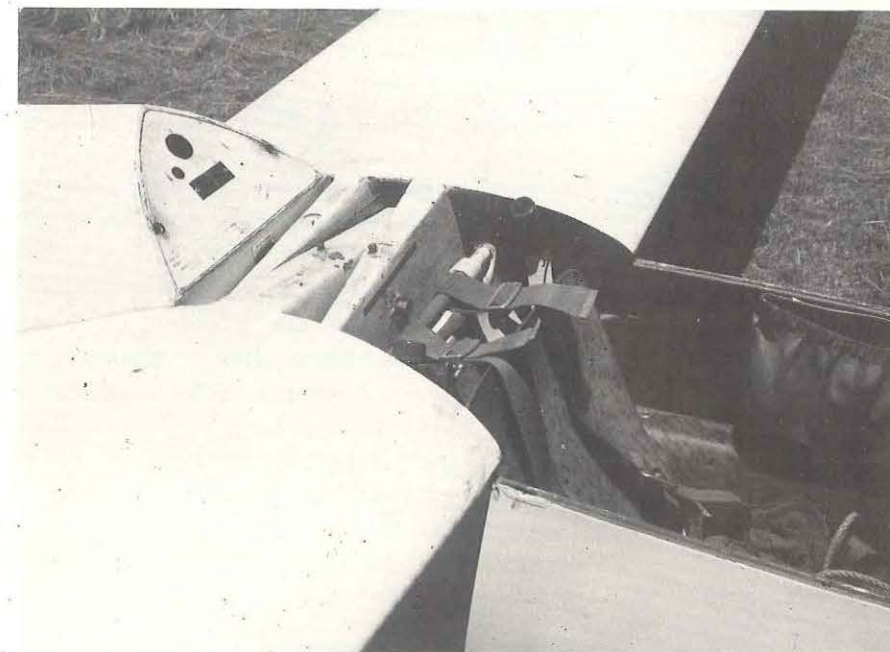
Opposite Page — Top: Libelle centre-section showing how single spar root of starboard wing, mates with forked, double spar root of port wing. Spigotted end fittings on each of the three spar roots insert into matching bushes in the opposite wing section and both wings are held together in position by a single central locking pin which passes through all three spar roots. The complete mainplane thus formed is attached to the fuselage by transverse rods ahead of and behind the three spar roots, which mate with matching fittings in the respective wing sections.

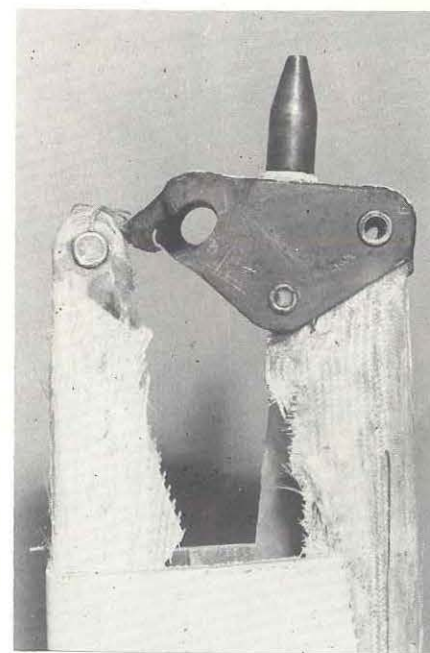
There was no evidence of aerodynamic flutter having contributed to the failure. The wreckage examination revealed that the aircraft structure had been subjected to a positive aerodynamic overload in excess of its ultimate design strength. This had caused the metal end-fitting on the inboard end of the starboard wing to fail. The horizontal rigging pin which locks the two mainplane assemblies in position had then

Centre Left: Spigotted end fitting of single starboard wing spar root, showing tearing of structure and shearing of metal side plate at lower attachment bush.

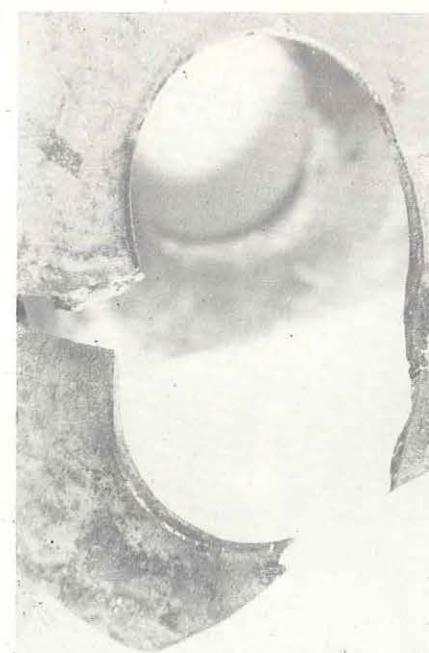
Centre Right: Enlargement of side plate damage showing both shear failure and tensile failure.

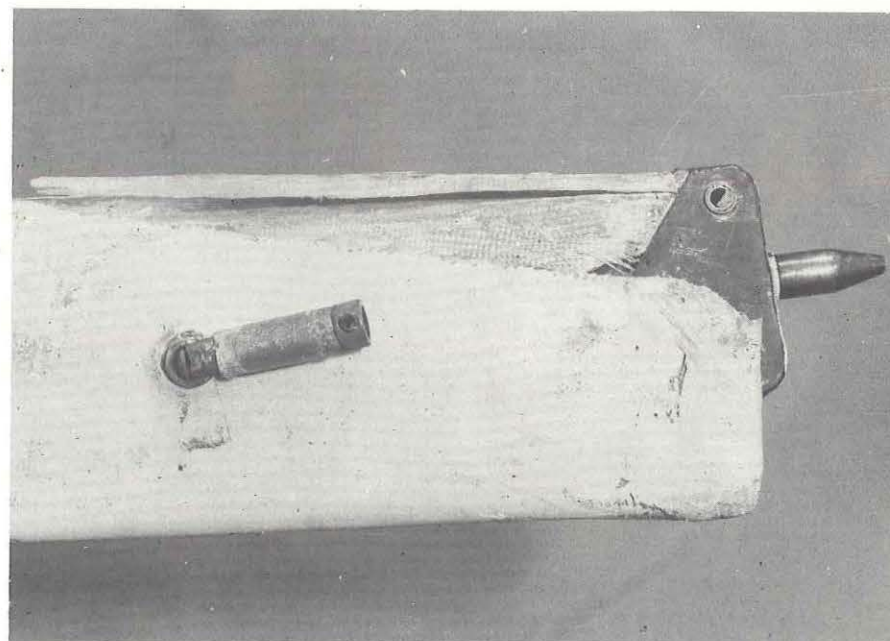
sheared, allowing both wings to separate from the fuselage. The outboard overload failure in the starboard wing would have occurred almost simultaneously. Despite a most careful inspection of the failed components however, no evidence could be found of any pre-existing defect in the structure.

Bottom: Opposite side of starboard wing spar root, showing that locking pin had been fully inserted. The bush, still attached to the severely bent pin, was torn from the forward portion of the forked port wing spar root.

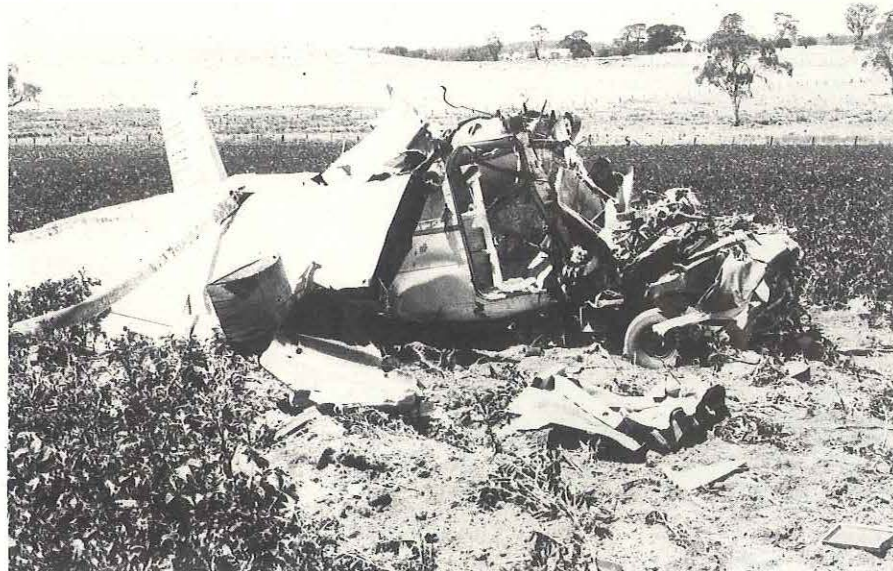
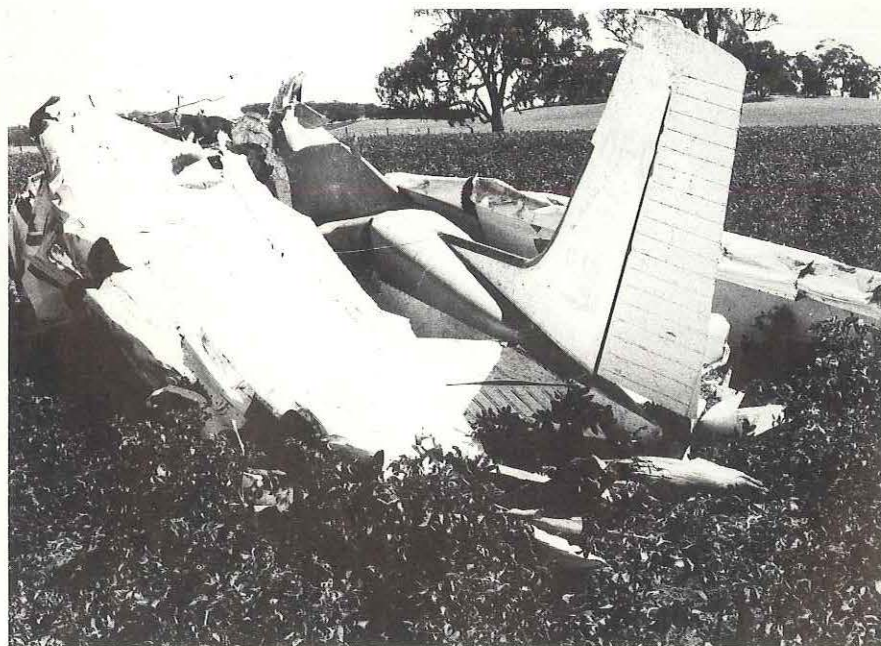
Above and Below: The remains of the Cessna 180 as it came to rest. The upper picture was taken looking in the direction of impact and portion of the wreckage trail can be seen in the foreground. Note the almost complete destruction of the forward section of the fuselage.

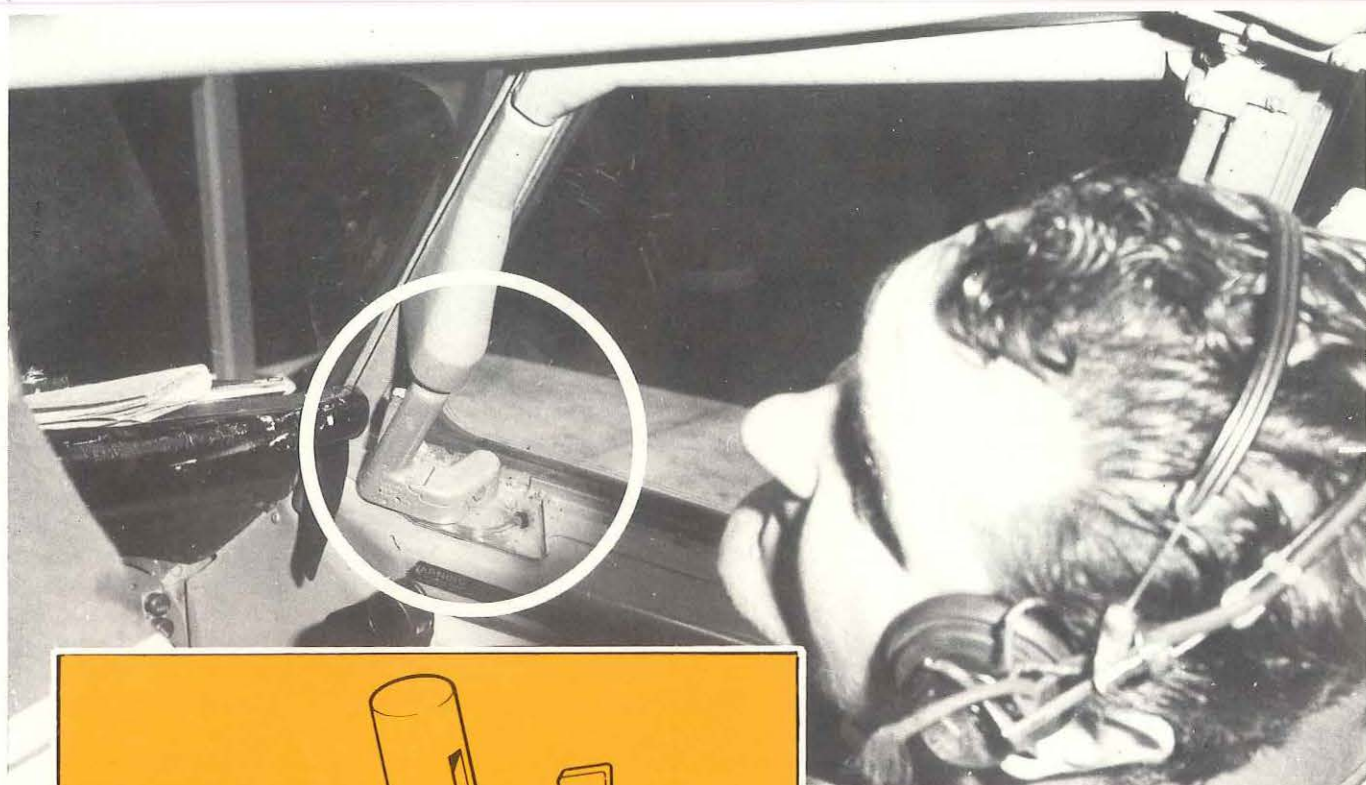
During the subsequent investigation, the co-pilot's sliding window, which had sprung open during the take-off, was examined. It was found that the roll pin, which secures the window handle to its shaft, was withdrawn about seven millimetres. The trigger lock bolt was worn, and the window adjusting rod shortened by one full turn. As well, there was excessive play in the window handle mechanism. The window was checked for operation and it was found that a force of 22 to 27 kg was required to lock the window, as against the normal force of about 20 kg. The spring-loaded trigger in the handle hung in a mid-travel position and the associated trigger lock bolt did not fully engage the lock plate hole. In this condition, though the window appeared to be in a closed and locked position, any pressure applied to the handle would disengage the trigger lock bolt, enabling the window to open.

take-off. The condition of the locking mechanism of the window was such that, to all outward appearances, the window was closed and locked. In fact however, the locking mechanism was out of adjustment and as a result, the locking bolt was not fully in place.

Top: View of starboard side of Boeing 707 cockpit showing co-pilot's sliding window and spring loaded trigger.

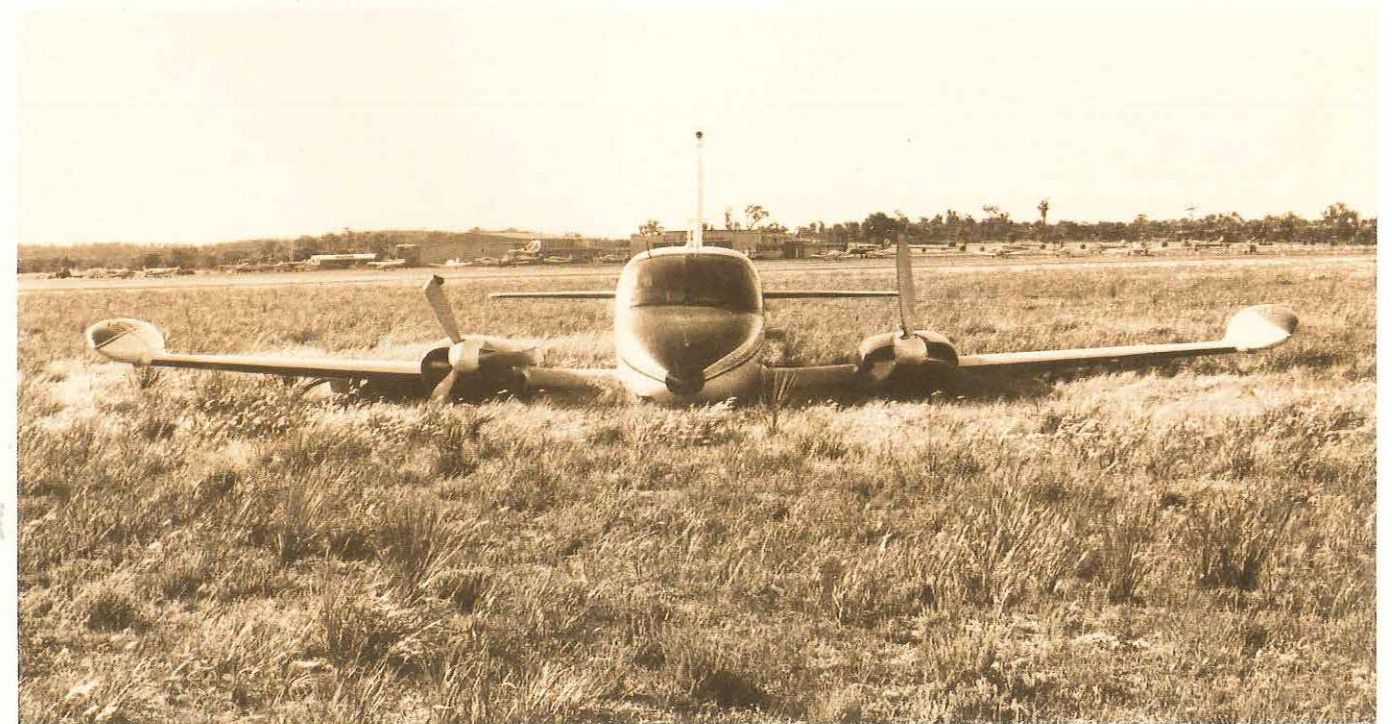
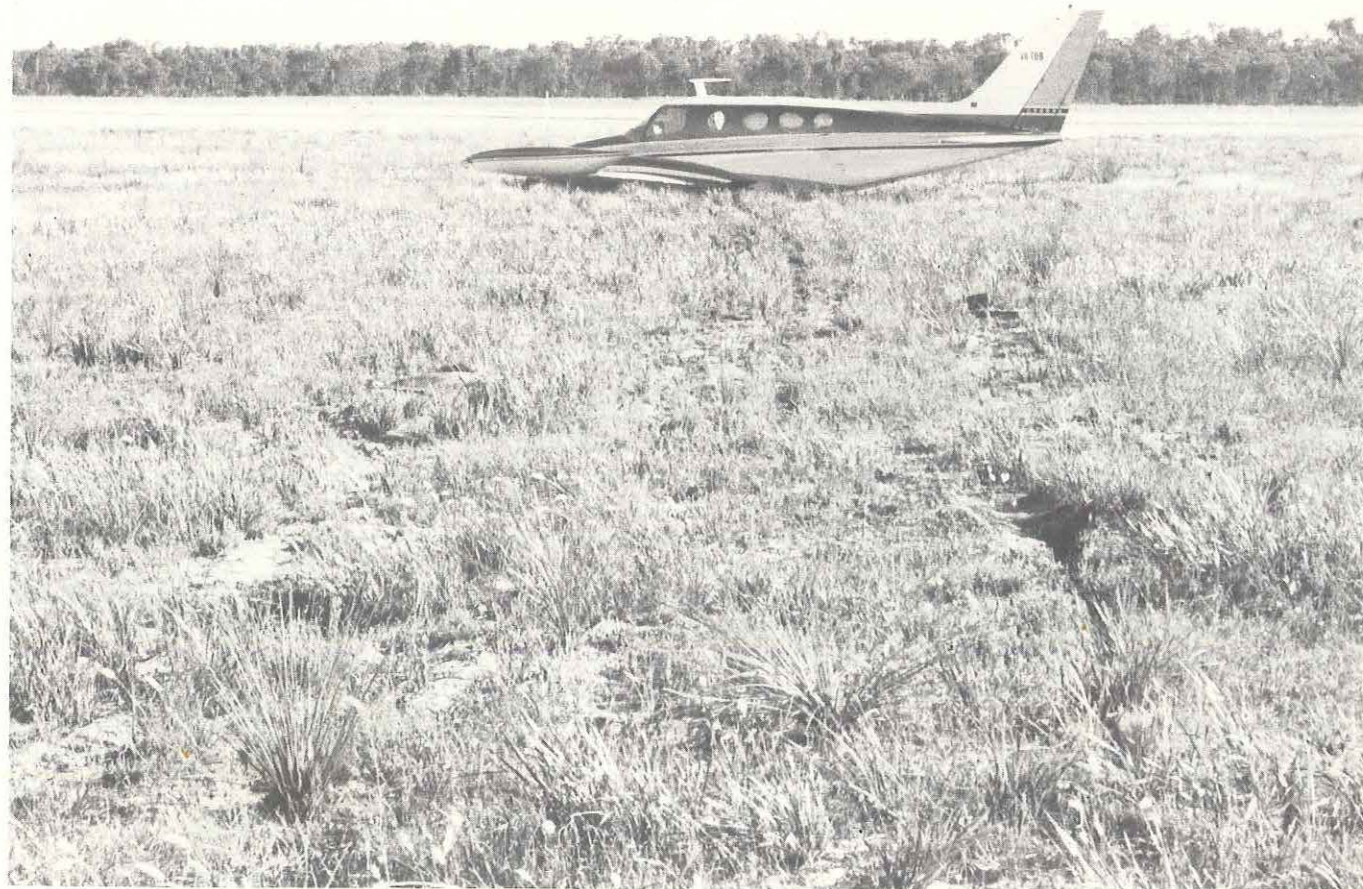
The condition of the Cessna 411's propellers tell their own story better than any words.

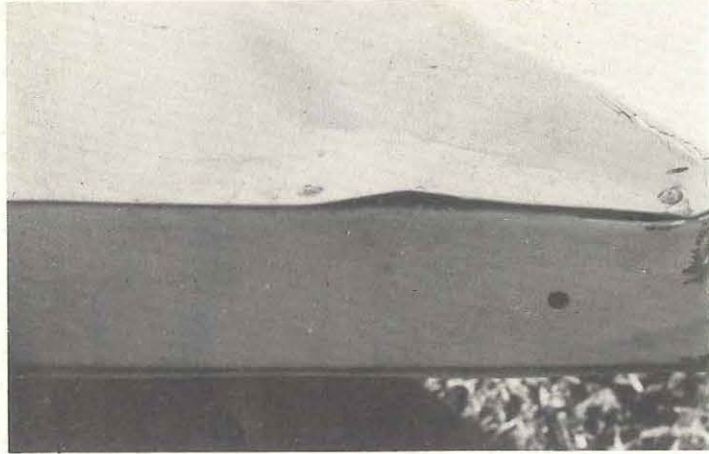
Top
Outboard edge of starboard tailplane showing buckling of skin. The tailplane is upside-down in the picture.

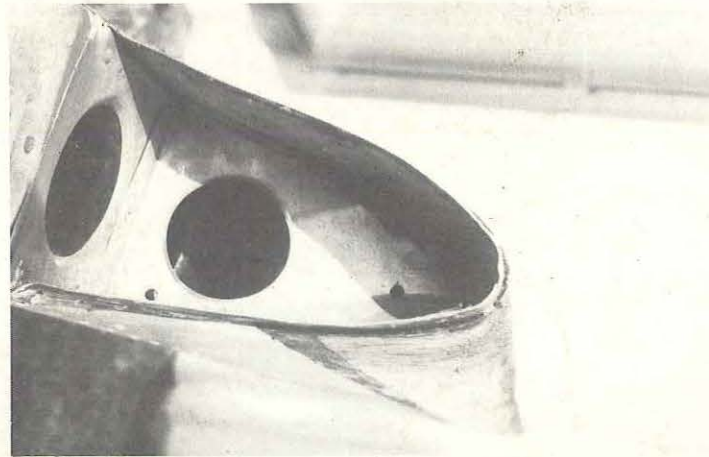
Centre
Hidden damage revealed after tailplane was removed from aircraft, the leading edge rib is buckled and has separated from spar.
