AVIATION
SAFETY
DIGEST

Number 91 1975

AUSTRALIAN DEPARTMENT OF TRANSPORT

A TRAGEDY of ERRORS

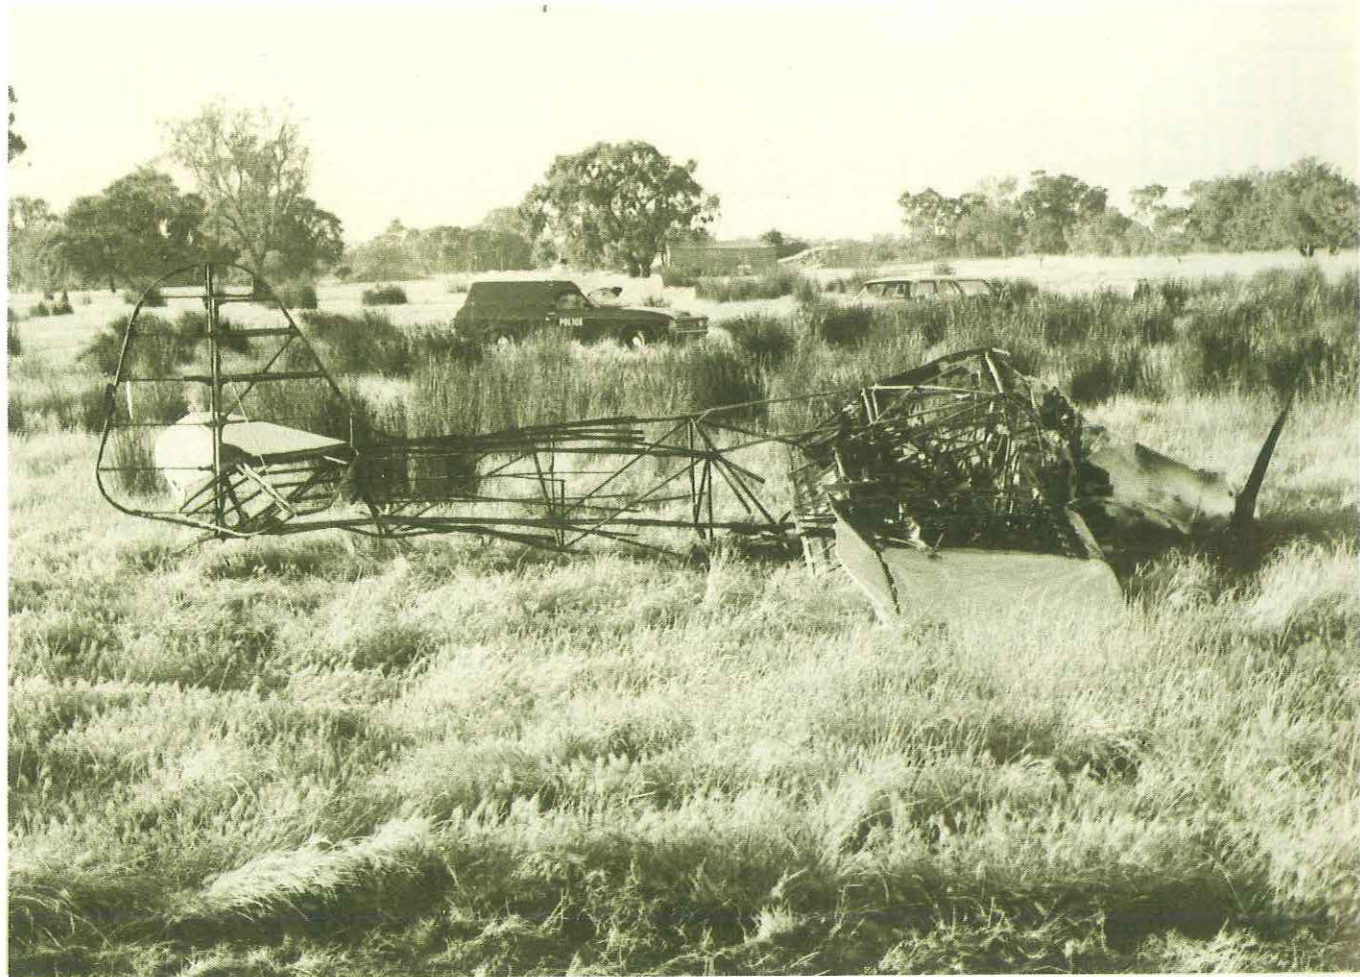
Opposite page: The burnt-out wreckage looking back in the direction from which the aircraft approached. The deformation of the forward fuselage and the fact that the engine was not under power are clearly evident.

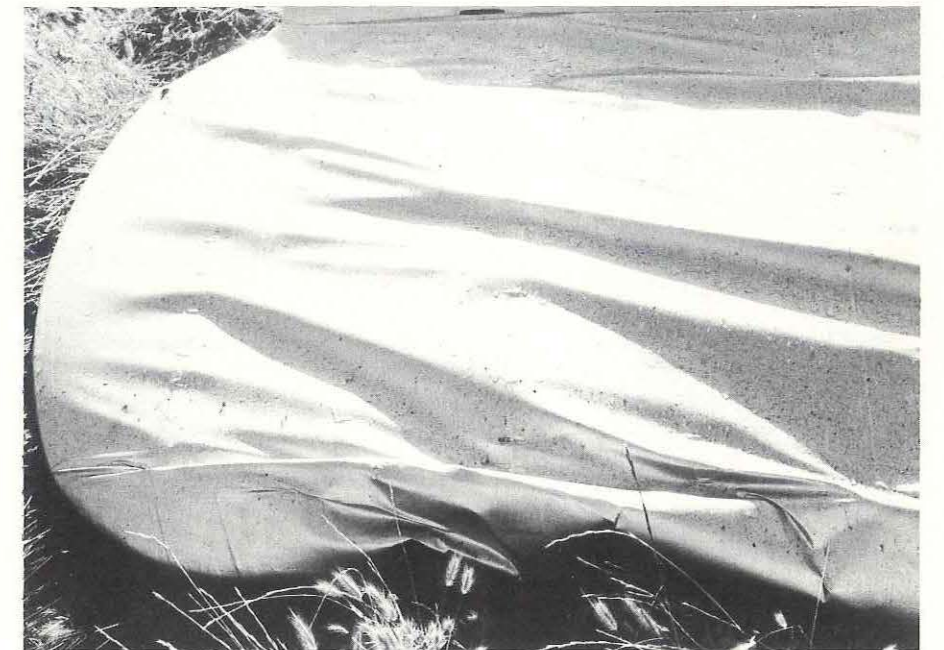
Above right: The violence of the aircraft's impact with the ground can be gauged from the chordwise compression of the starboard wing.

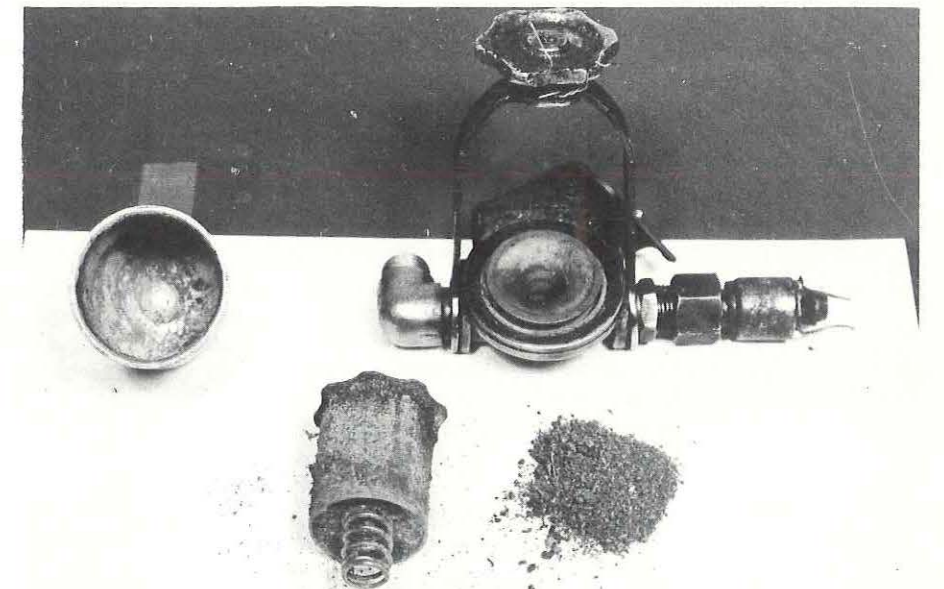
Below right: The aircraft's fuel filter after it had been dismantled showing the sediment found and the clogged filter screen. On examination the sediment proved to be weevil remains.

Examination of the wreckage indicated that the aircraft had struck the ground at low forward speed in a nose-down attitude consistent with a stalled condition. The intense fire had been fed by the contents of the almost full main fuel tank, immediately behind the fire-wall, which had ruptured on impact. It was evident that although the airframe and engine were structurally and mechanically sound at the time of the crash, the operation of the engine would have been impaired by the fact that the fuel filter screen was almost completely blocked by compacted insect remains and sand. Expert examination of this foreign matter showed that it was composed principally of weevil remains. Similar remains were found in the long-range fuel tank on the under-side of the fuselage, and which had been found selected ON during the wreckage examination. It was evident that the weevil bodies had been drawn from the tank and had progressively built up on the fuel filter screen during the 80 or so hours the engine had operated since

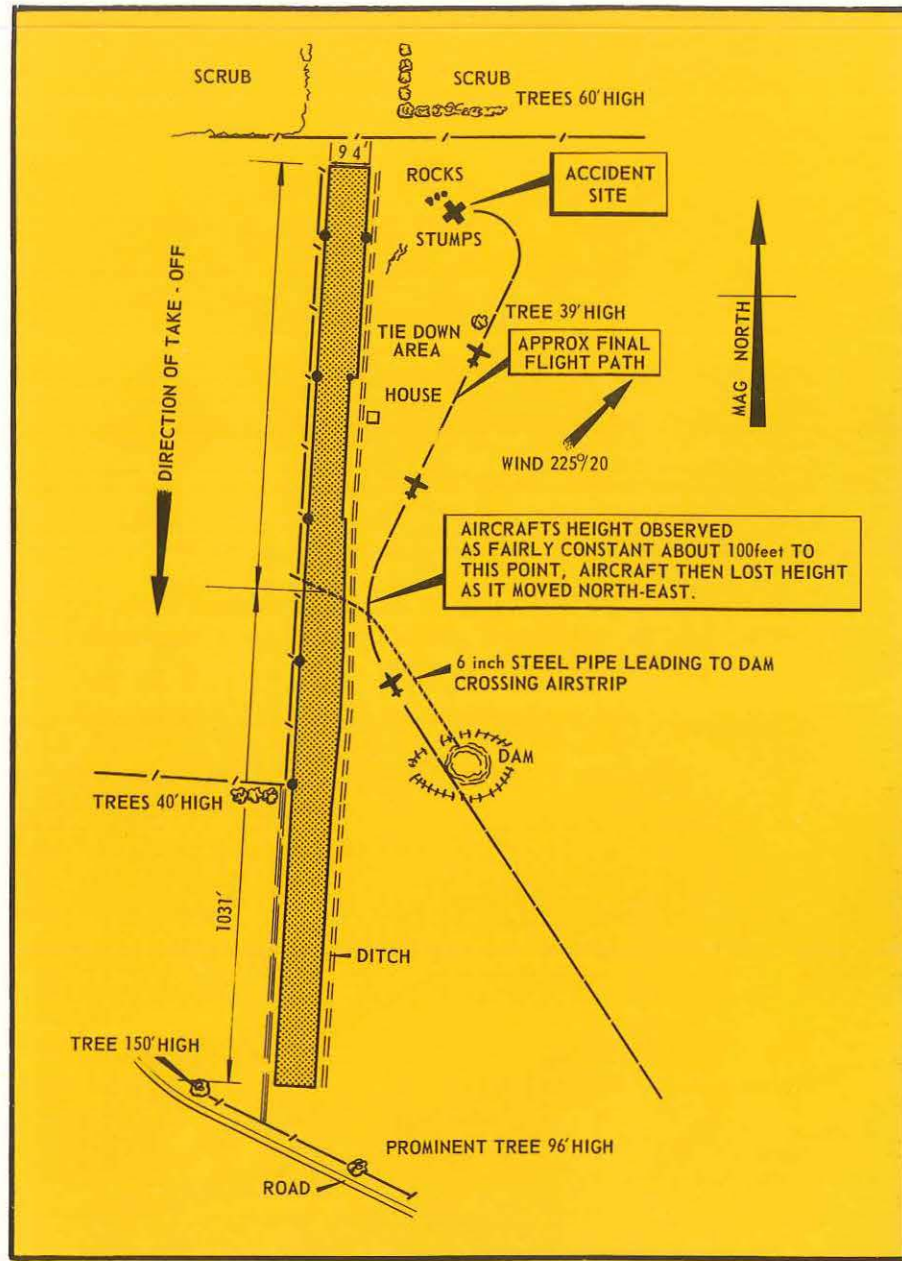
Left: Diagram of airstrip showing final flight path and accident site.

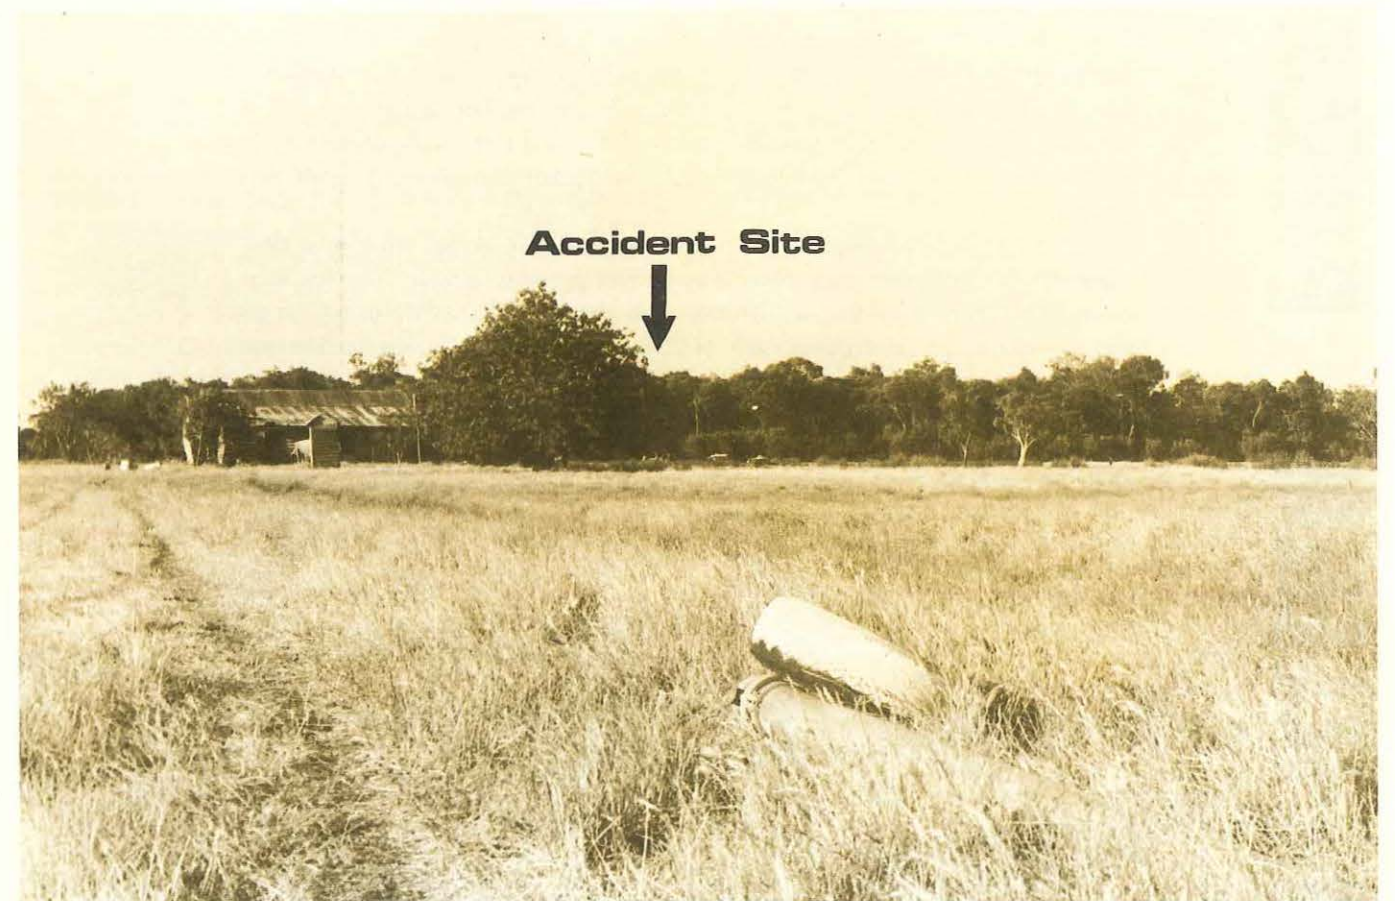
Opposite page: General view of airstrip showing the irrigation pipe which crossed the strip at about its mid-point.

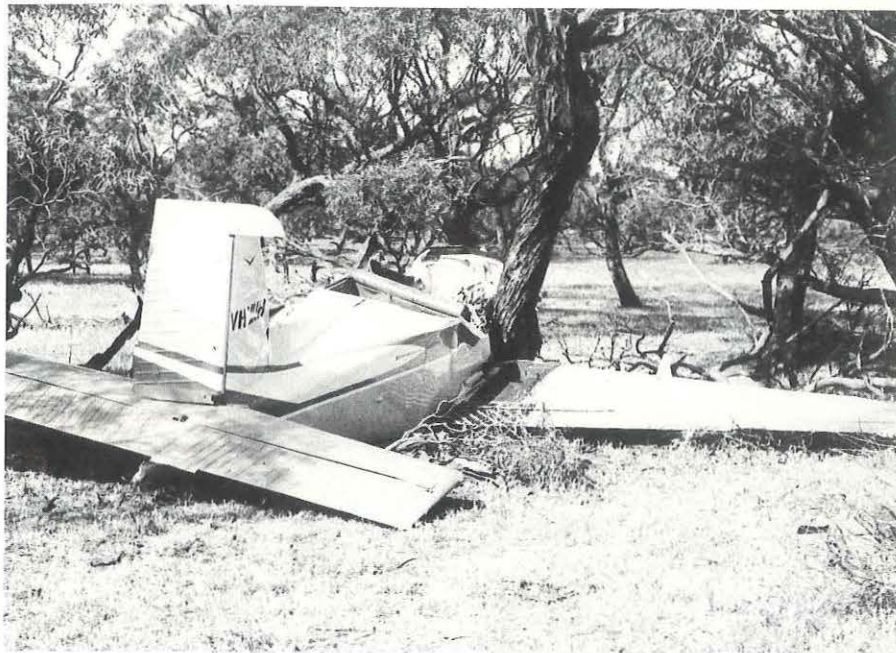
Above: The final impact site. Note the tree which has penetrated the cockpit area on the starboard side.

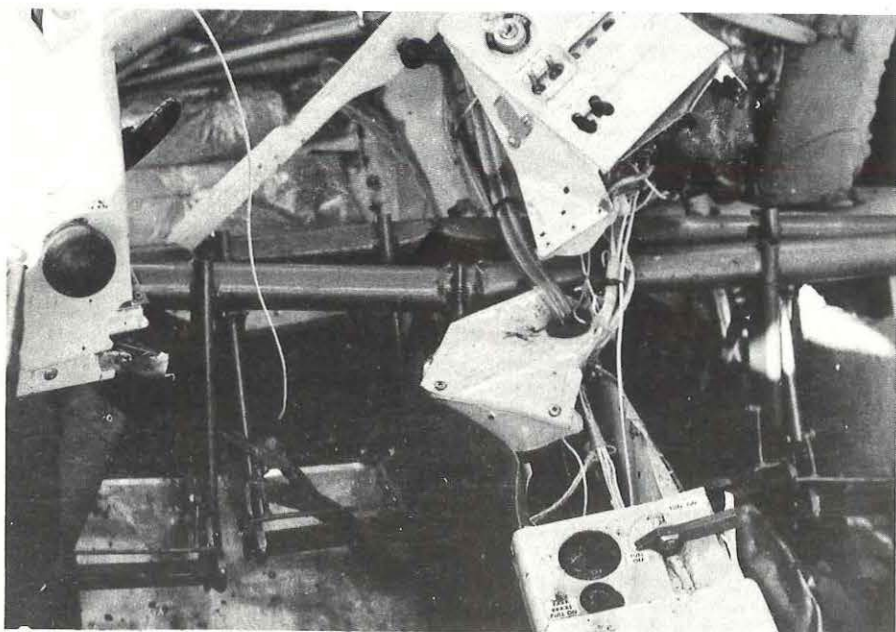
Wreckage

Below: Photograph of cockpit area looking forward showing almost complete destruction of forward section.

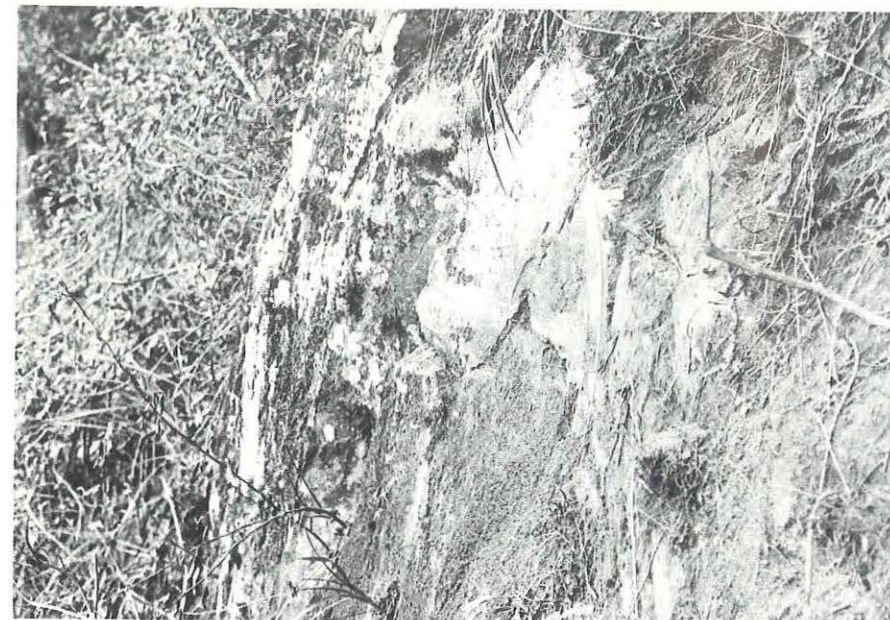
Above: The near vertical rock face against which the aircraft crashed. Following the main impact the wreckage fell down the slope and caught fire.

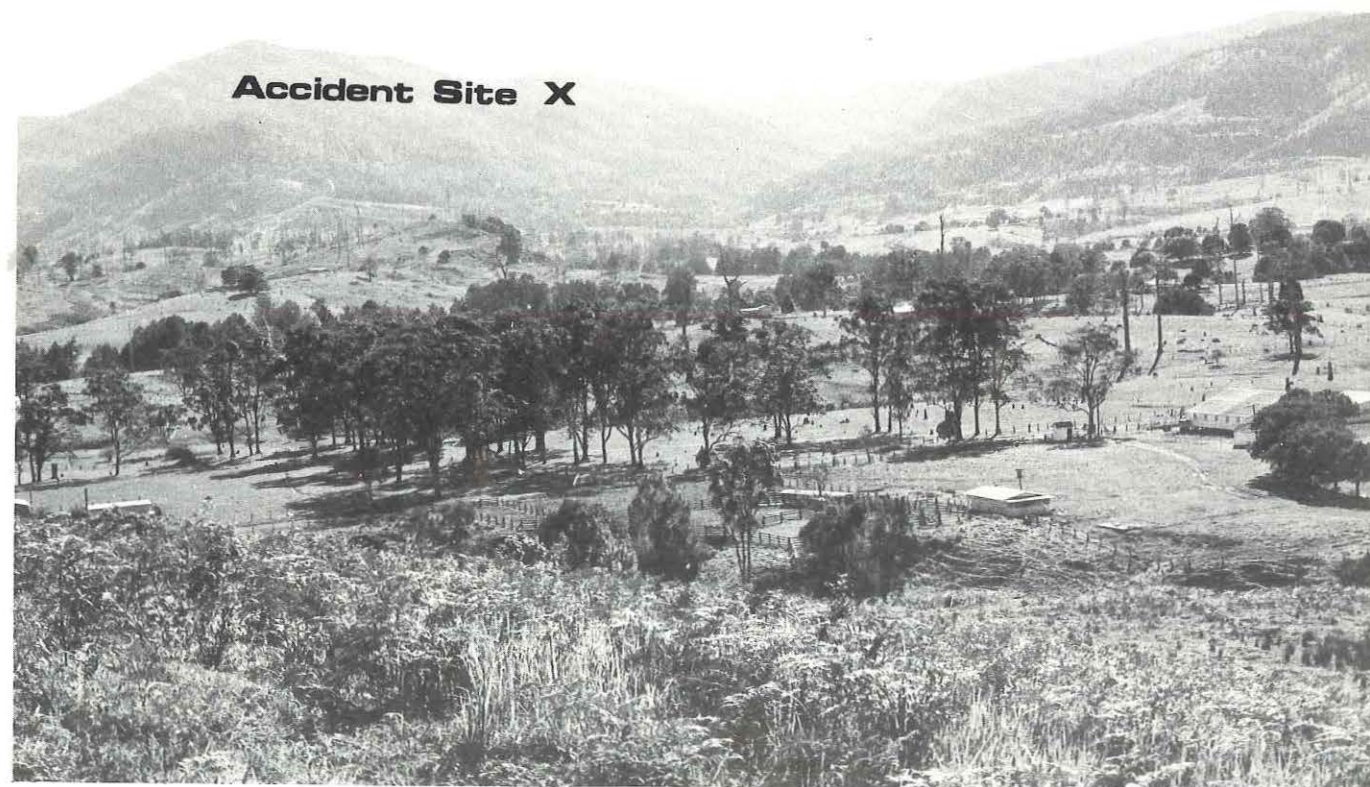
Below: The same terrain as it really is, as seen on a clear day. Mt. Neville, elevation 2950 feet, can be seen in the left background and the accident site on its southern slope is indicated.
