AVIATION
SAFETY
DIGEST

Number 92 1975

AUSTRALIAN DEPARTMENT OF TRANSPORT

CONTENTS

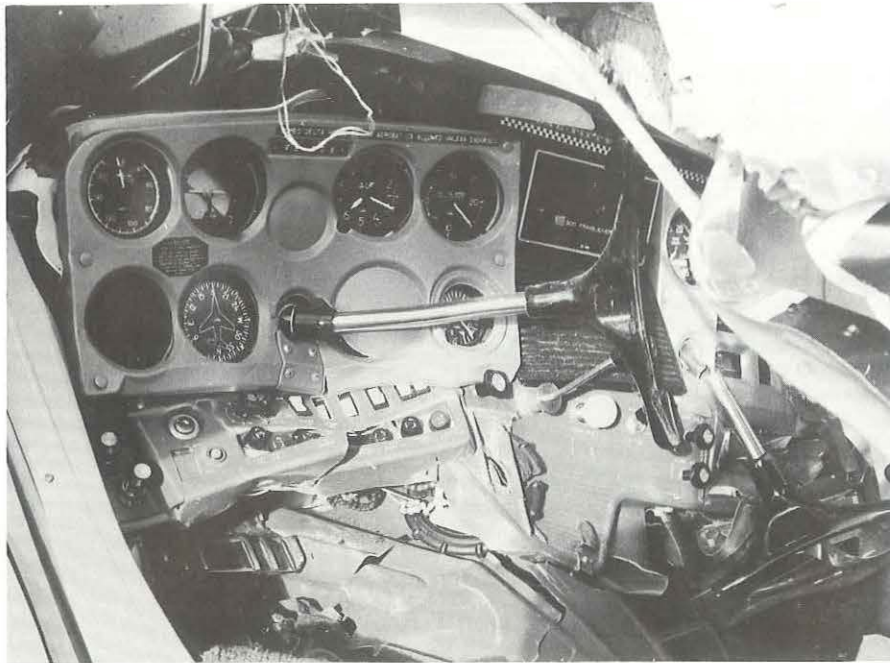
Left: Damaged cockpit of the Cessna Aerobat showing closed throttle and elevator control shaft bent in almost full up position.

A detailed technical examination of the aircraft, its engine and control systems did not disclose any evidence of malfunction or pre-existing defect. At the accident site, the throttle was found in the closed position and impact damage to the rudder was consistent with the application of spin recovery action. Damage to the elevator control shaft where it passed through the instrument panel indicated the elevators were almost in a full-up position at the moment of impact, but this would be expected as an involuntary action by the pilot with the aircraft in such a steep nose-down attitude so close to the ground. Taken altogether, the control positions on impact suggested that the pilot was not incapacitated and that an effort was being made to recover from an incipient spin situation.

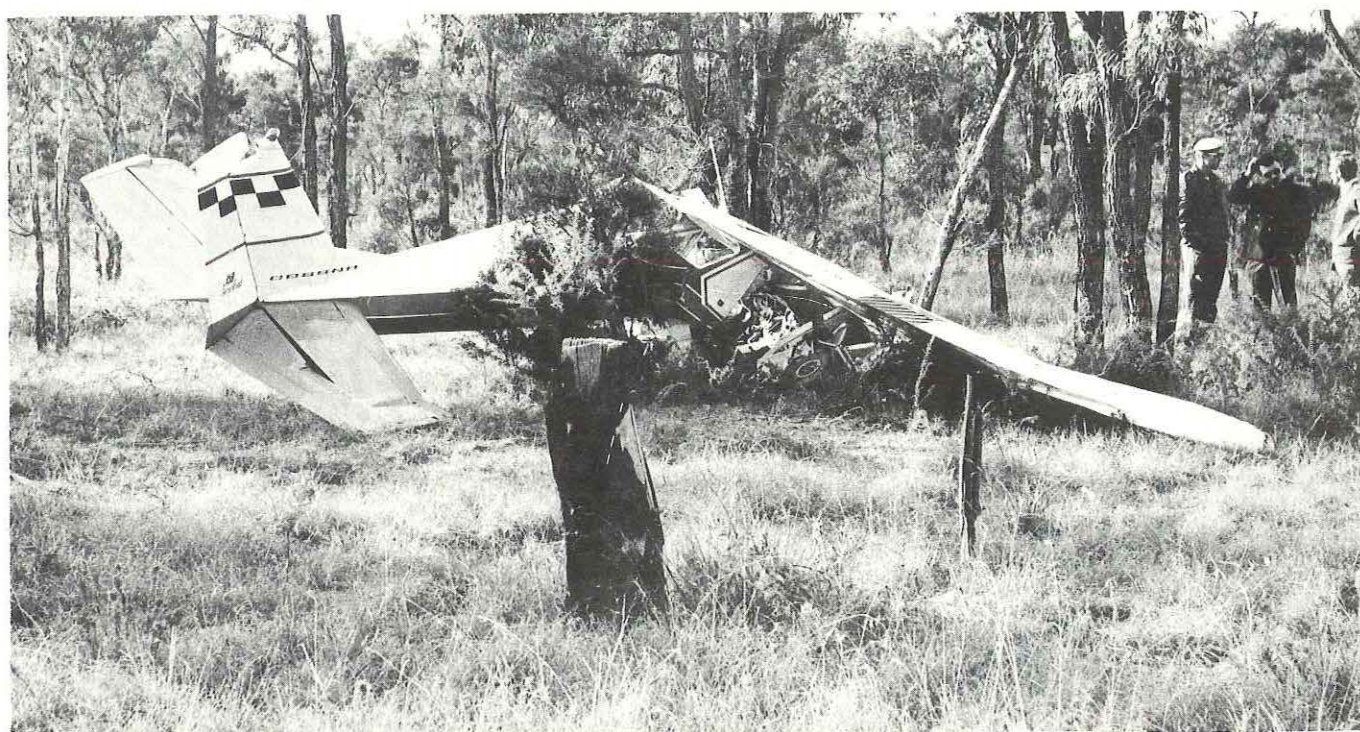
Examination of the wreckage confirmed that the aircraft had struck the ground at a high angle of attack while rotating to the left. While the aircraft had impacted in a 40 degree nose-down attitude, the actual angle of descent measured from strike damage to the surrounding trees, was 55 degrees below the horizontal. This would have produced an angle of attack in the vicinity of 15 degrees, which would certainly have placed the aircraft on,

The wreckage as it came to rest. The steep nose-down attitude on impact is clearly evident.

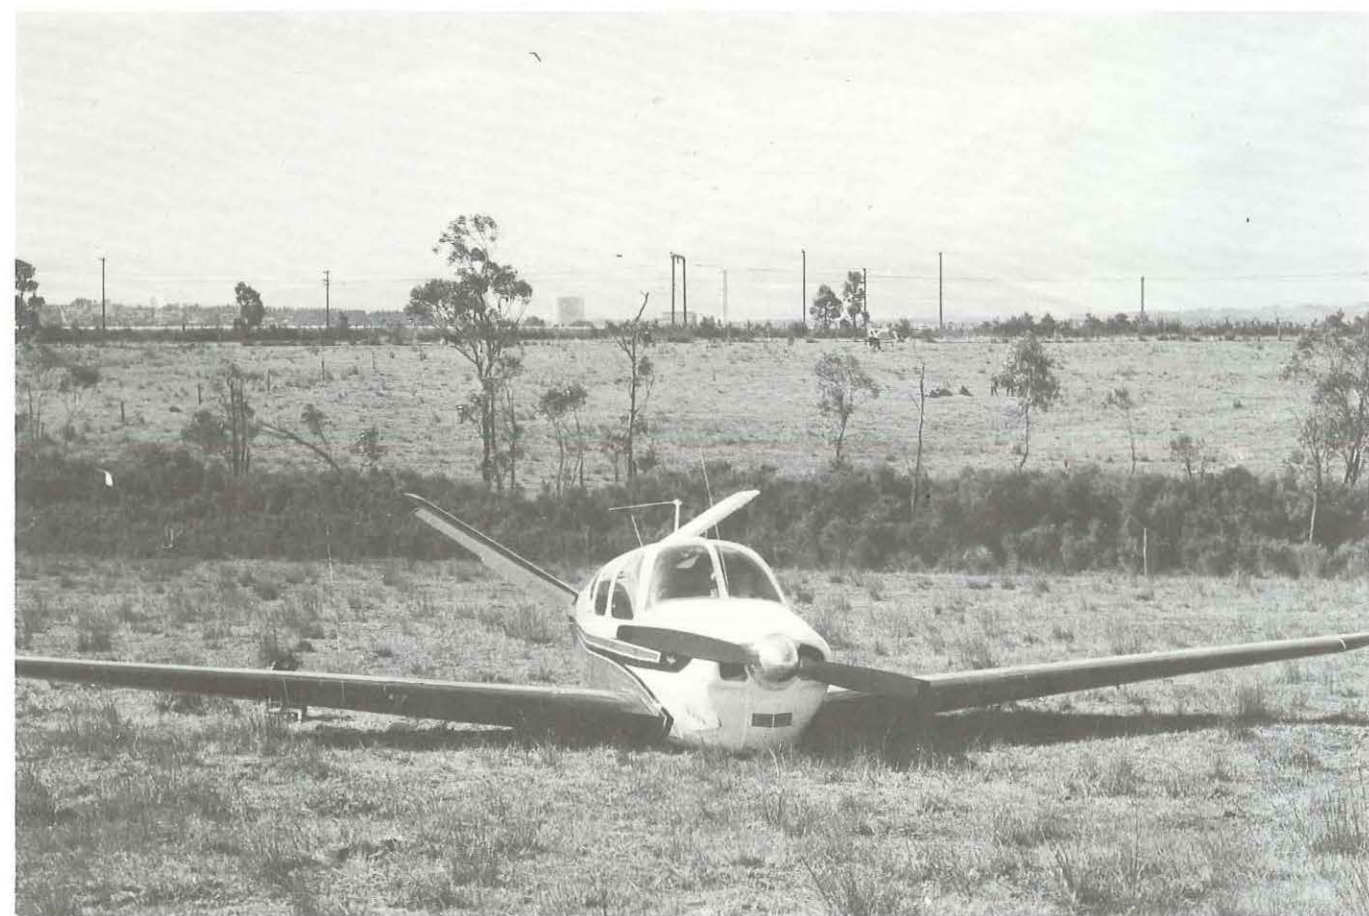
Opposite Page:—
Above: The aircraft as it came to rest in the paddock, looking in the landing direction. The touchdown marks are visible in the foreground.

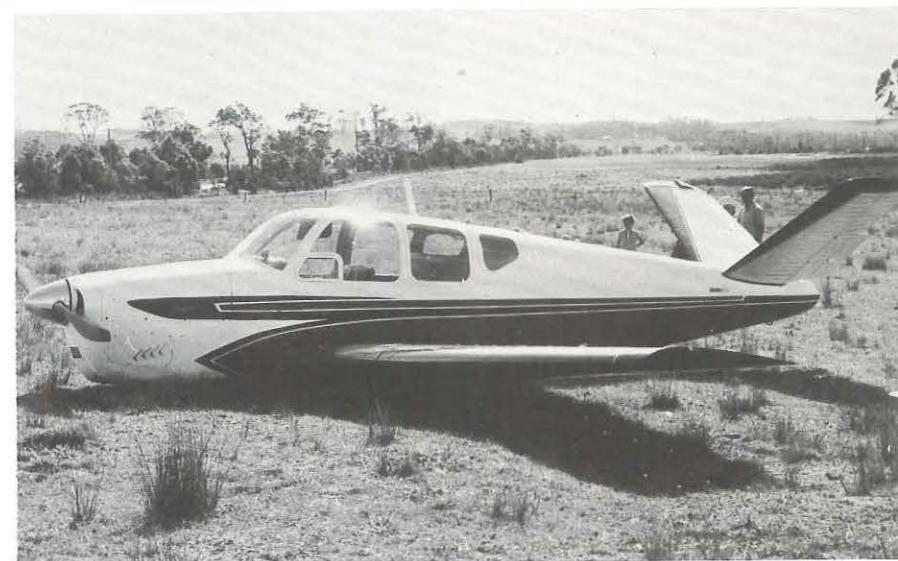
This Page: As is evident from this photograph, the aircraft sustained only slight structural damage in the forced landing. The fields over which the aircraft approached can be seen in the background.

Apart from the internal damage to the engine, which was entirely of a mechanical nature, the aircraft sustained little harm in the forced landing, as is clearly evident in the photographs.

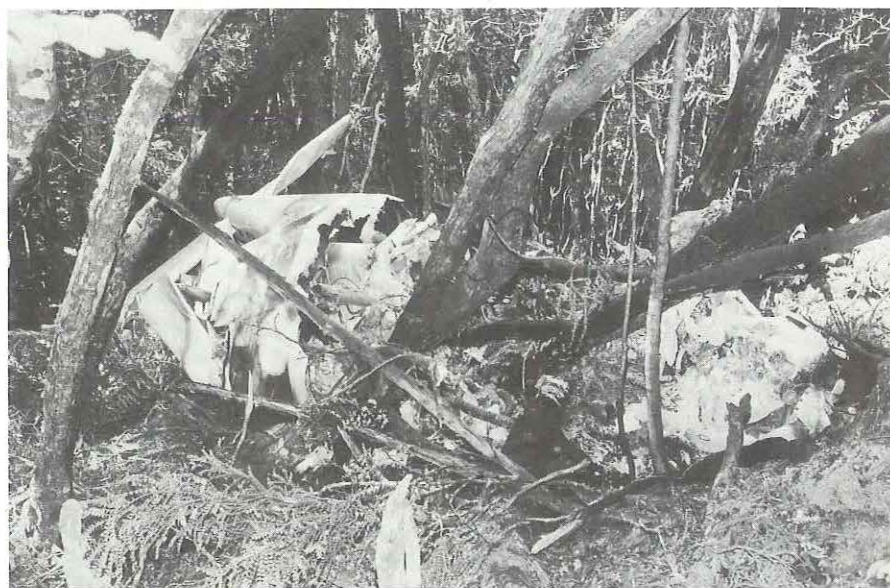
Two metres of the outer section of the port wing was found 30m down the slope from the main wreckage, and an impact mark on its leading edge showed that it had struck the trunk of a tree at a high angle of attack. A tree with its top snapped off was identified nearby.

Below Left: The outer section of the port wing, torn off as the aircraft descended into the trees, was found 30 metres from the main wreckage.

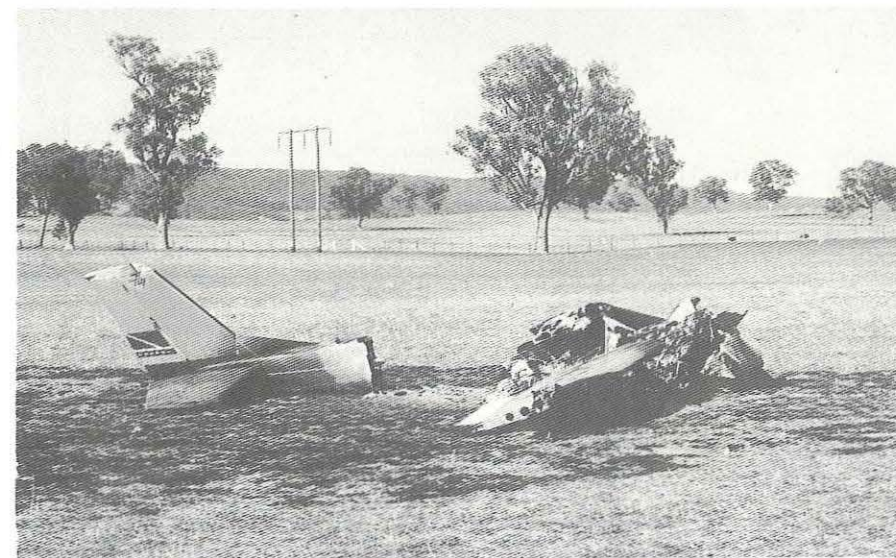
The gutted wreckage of the Cessna 150. It is possible that the power line and rising terrain in the background affected the pilot's judgement.

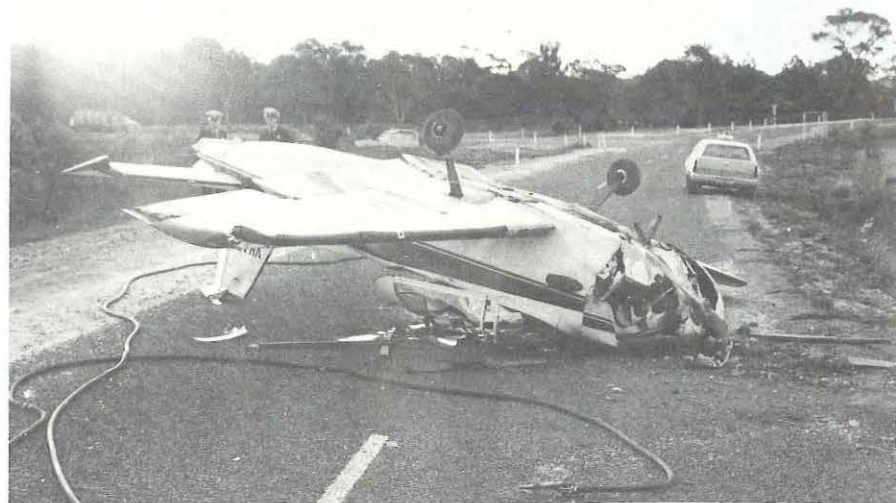
The remains of the Victa Airtourer involved in the other very similar accident.

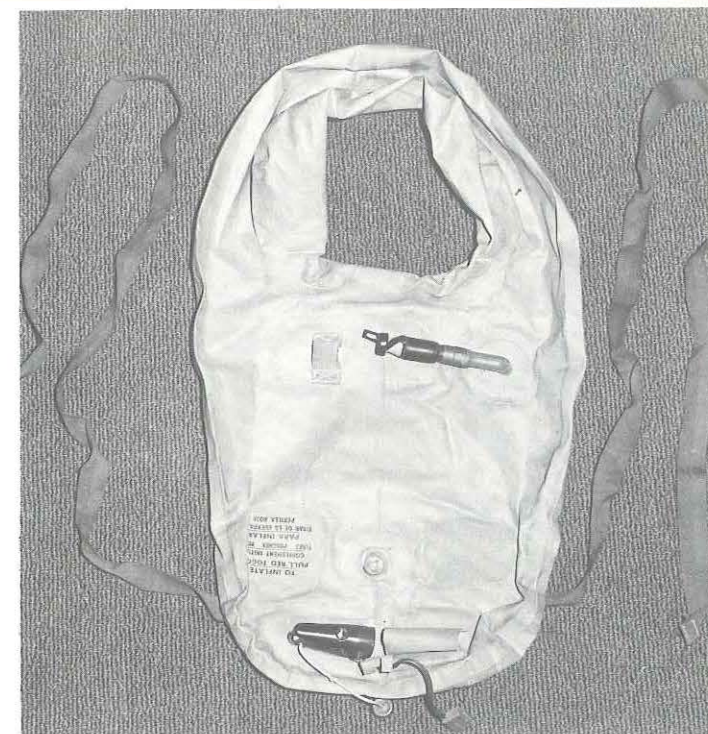
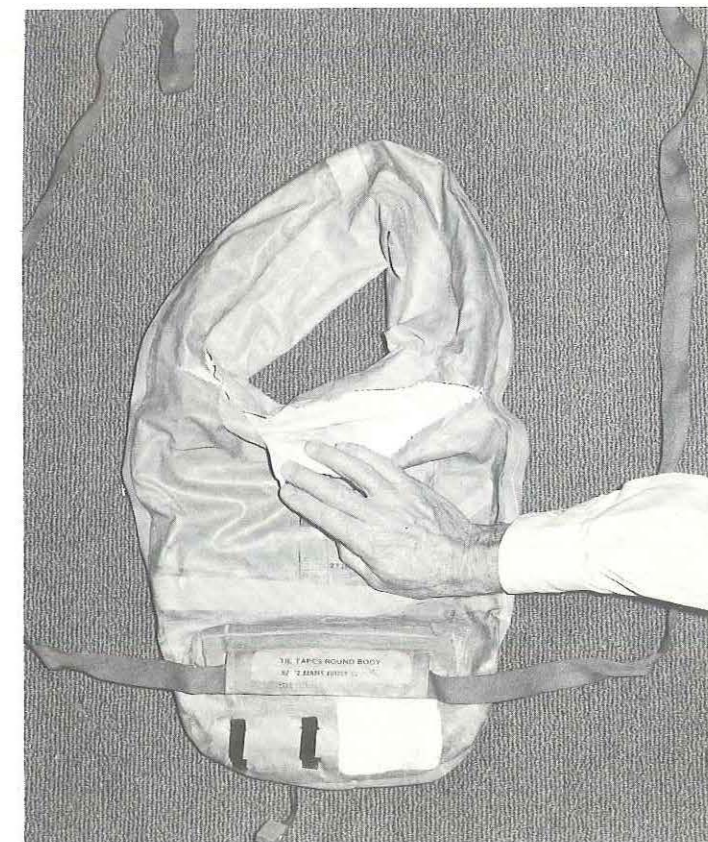
Above and Below: The inflatable life jacket used in the laboratory tests. After being inflated by mouth, the jacket's CO² cylinder was discharged and the fabric ruptured as shown.

The burst life jacket was recovered during the rescue and was later subjected to a laboratory examination to determine the cause of its failure. The jacket had burst along a seam at the neck but though the fabric was checked for tensile strength

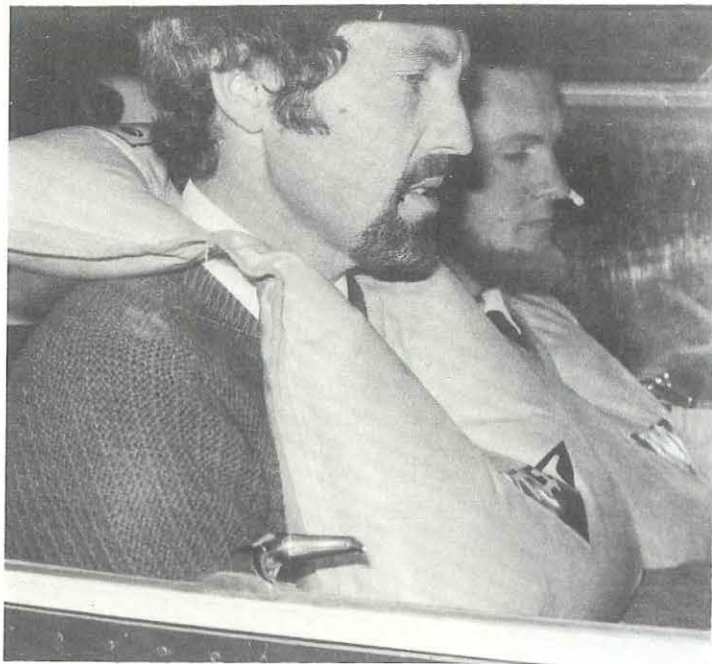
The type of non-inflatable life jackets worn in the accident to the Cessna 150. Note how the bulkiness of the jackets could hinder movement in a confined aircraft cabin.

When one stops to consider that the lives of all on board an aircraft could be at stake in an emergency, it is false economy indeed to substitute non-approved life jackets simply on the ground of convenience, or because they are slightly less expensive.

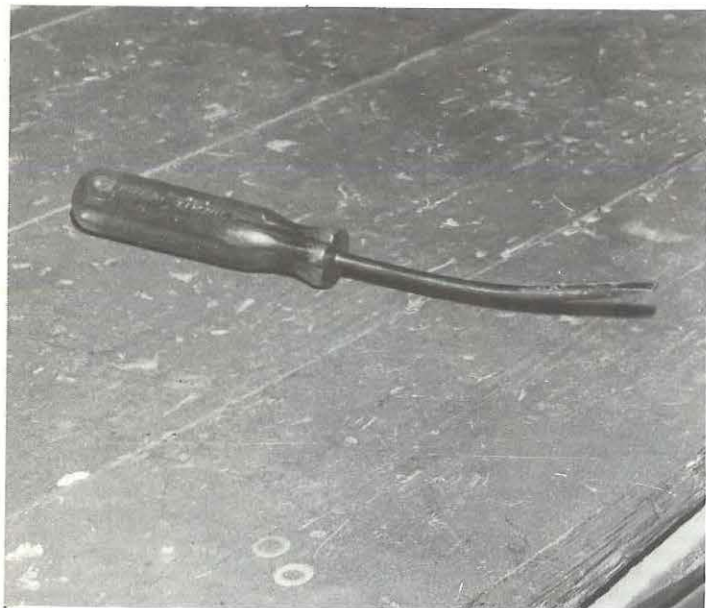
Above: Screwdriver found in the under-floor area of the Cessna 180. Note the bent blade, marks on which matched similar score marks on the elevator forward bell-crank.

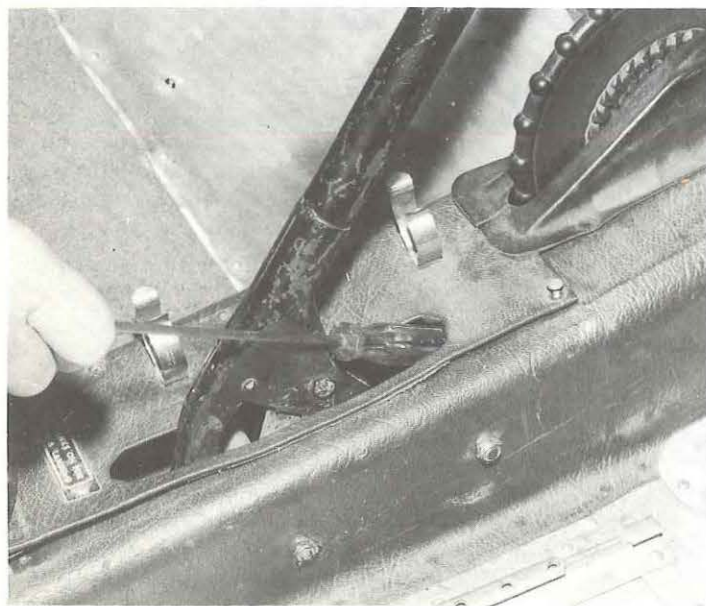
Left: The way in which the screwdriver could have entered the elevator control system with flap selected.

It was noticed, however, that when the manually operated flap lever was in any position other than fully up, it left an opening in the control cable tunnel through which the screwdriver could have passed quite readily. Had this occurred, the screwdriver would have been placed just where the elevator forward bell crank is located.
