AVIATION
SAFETY
DIGEST

Number 93 1975
CONTENTS

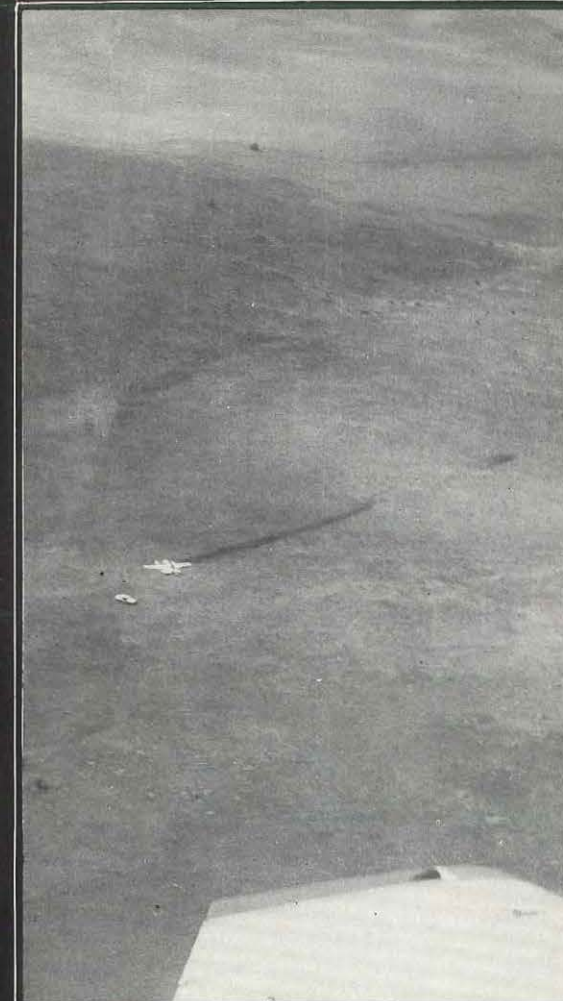
Top: Aerial view of accident site looking south-east. The initial impact point can be seen on the right of the picture.

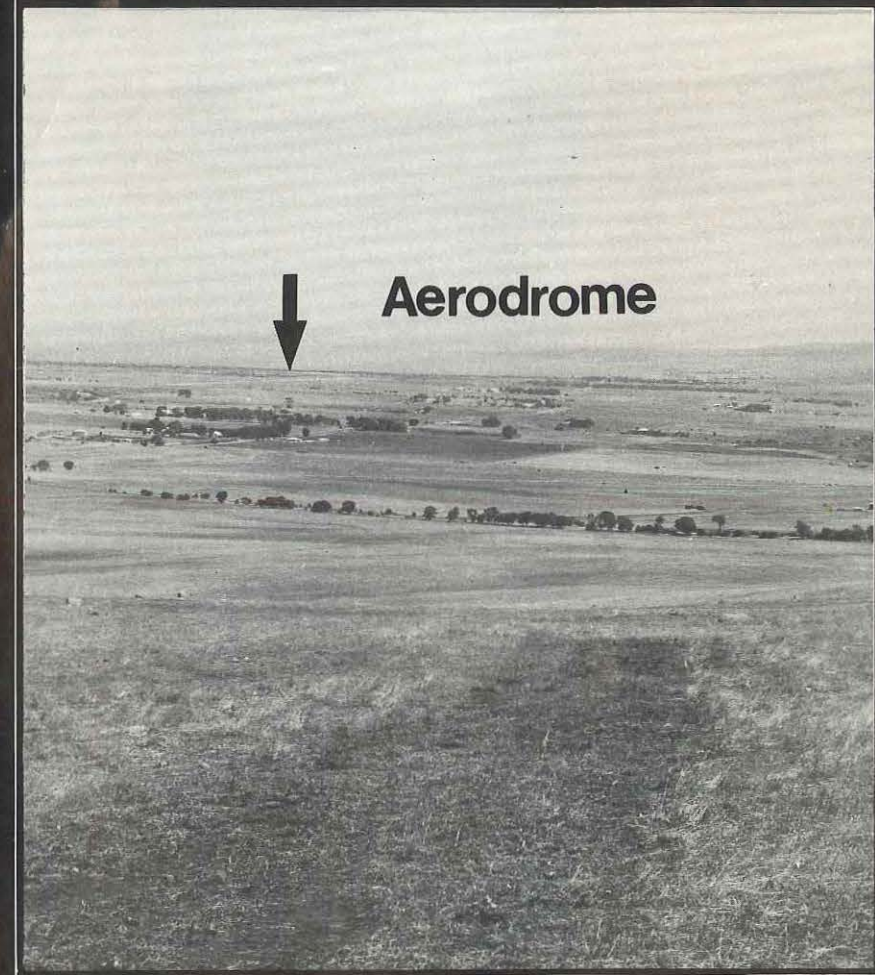
Below: View from hillside on which aircraft crashed, looking back in direction of approach. Runway 01/19 at Port Lincoln from which the aircraft took off can be seen in the distance. The initial impact point is in the foreground.

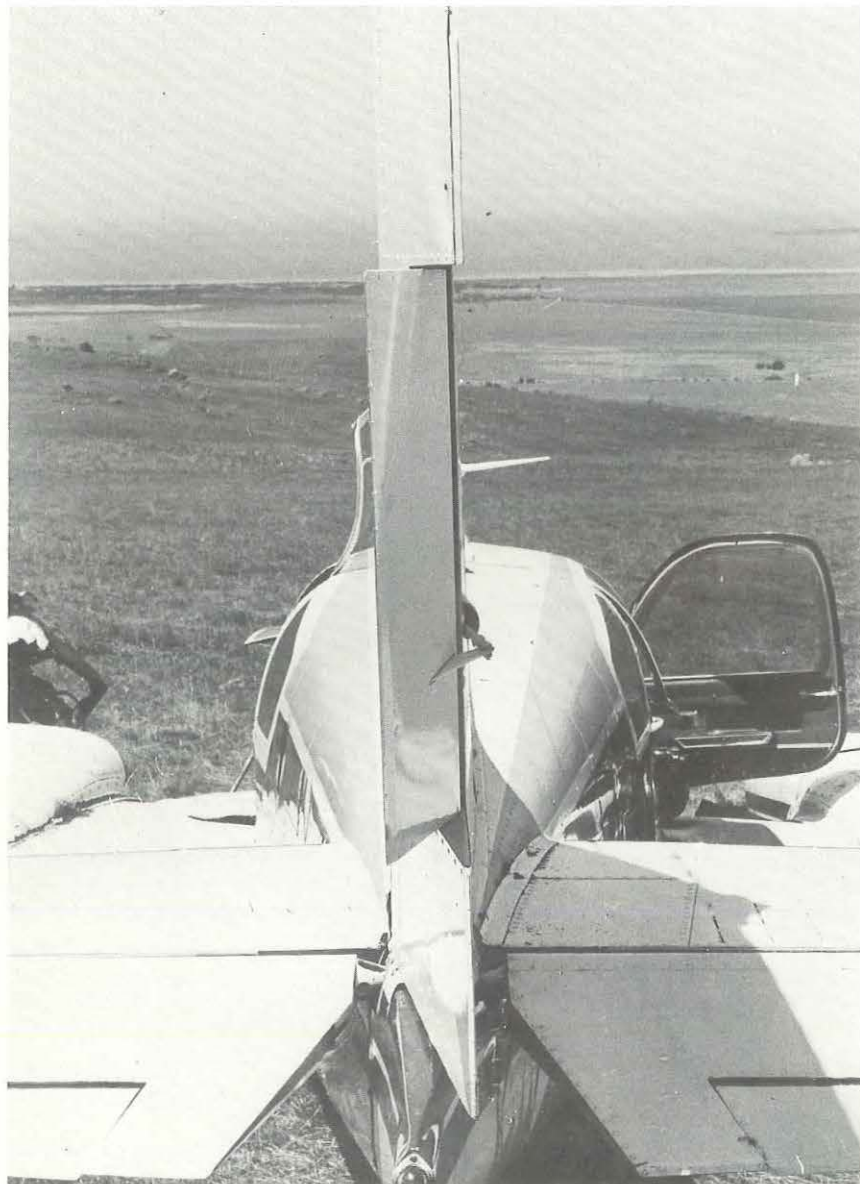
Above: Rear view of aircraft, showing rudder trim tab deflected to full 'right rudder' position.

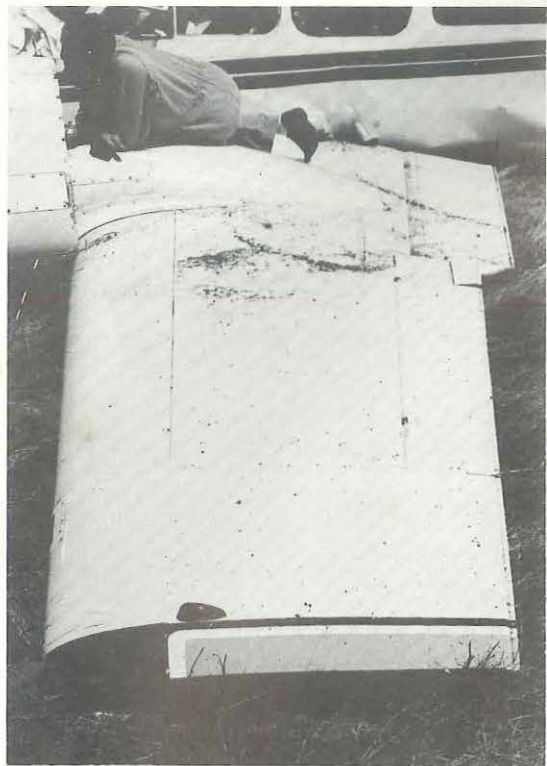
Right: Port wing showing aileron trim tab fully deflected 'right wing down'.

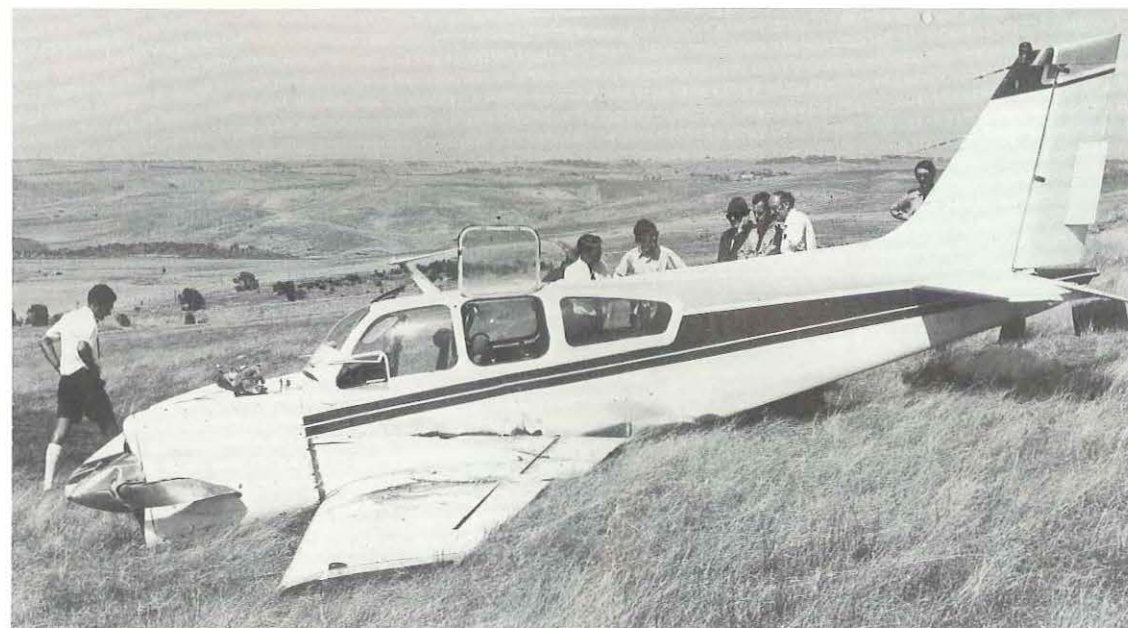
Left: General view of aircraft as found. The chart obscuring the port windscreen panel can be seen still in position. Note the surprisingly intact appearance of the aircraft for this type of accident.

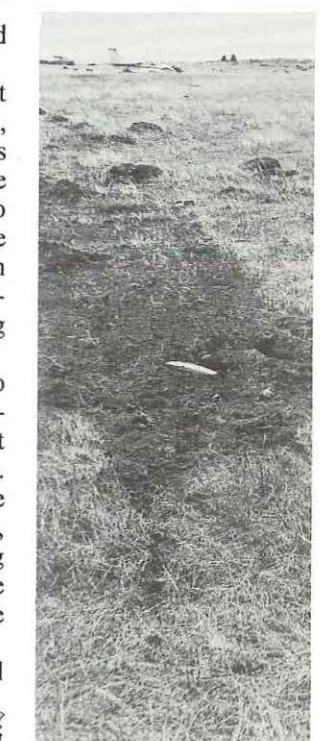
Below: Initial impact point on the hillside.

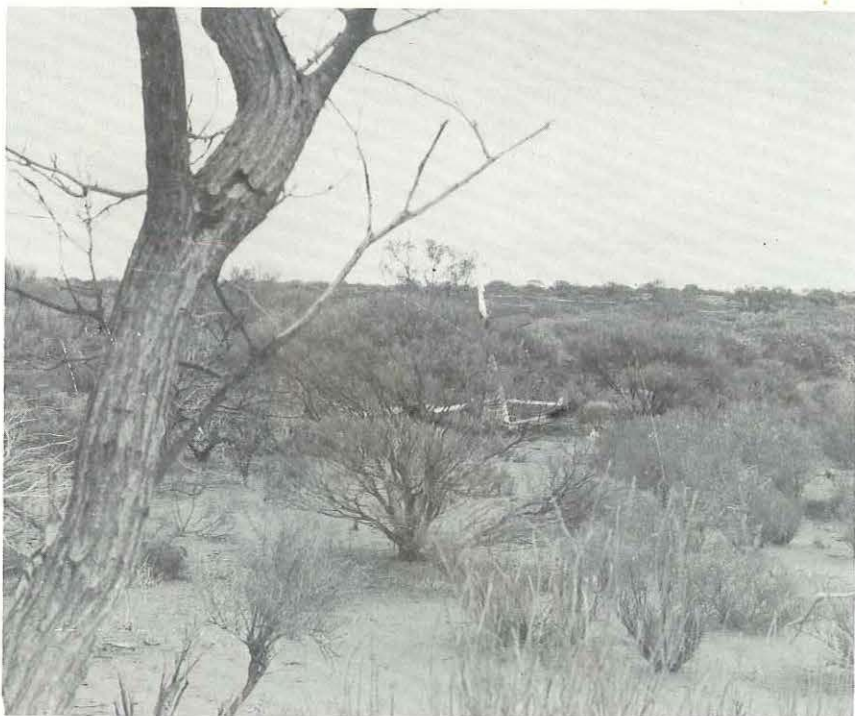
General view of terrain, showing low scrub typical of the country in which the accident occurred.

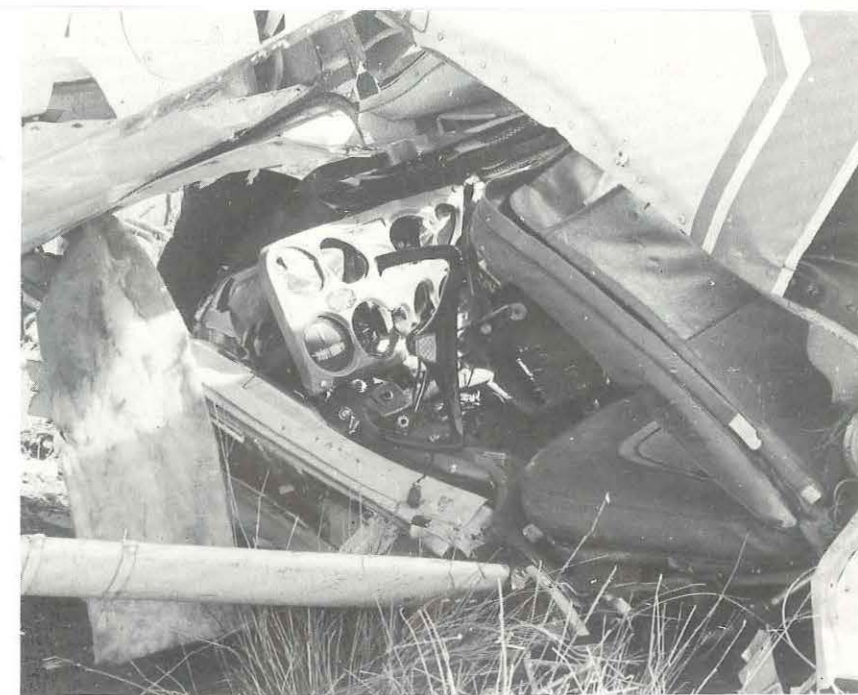
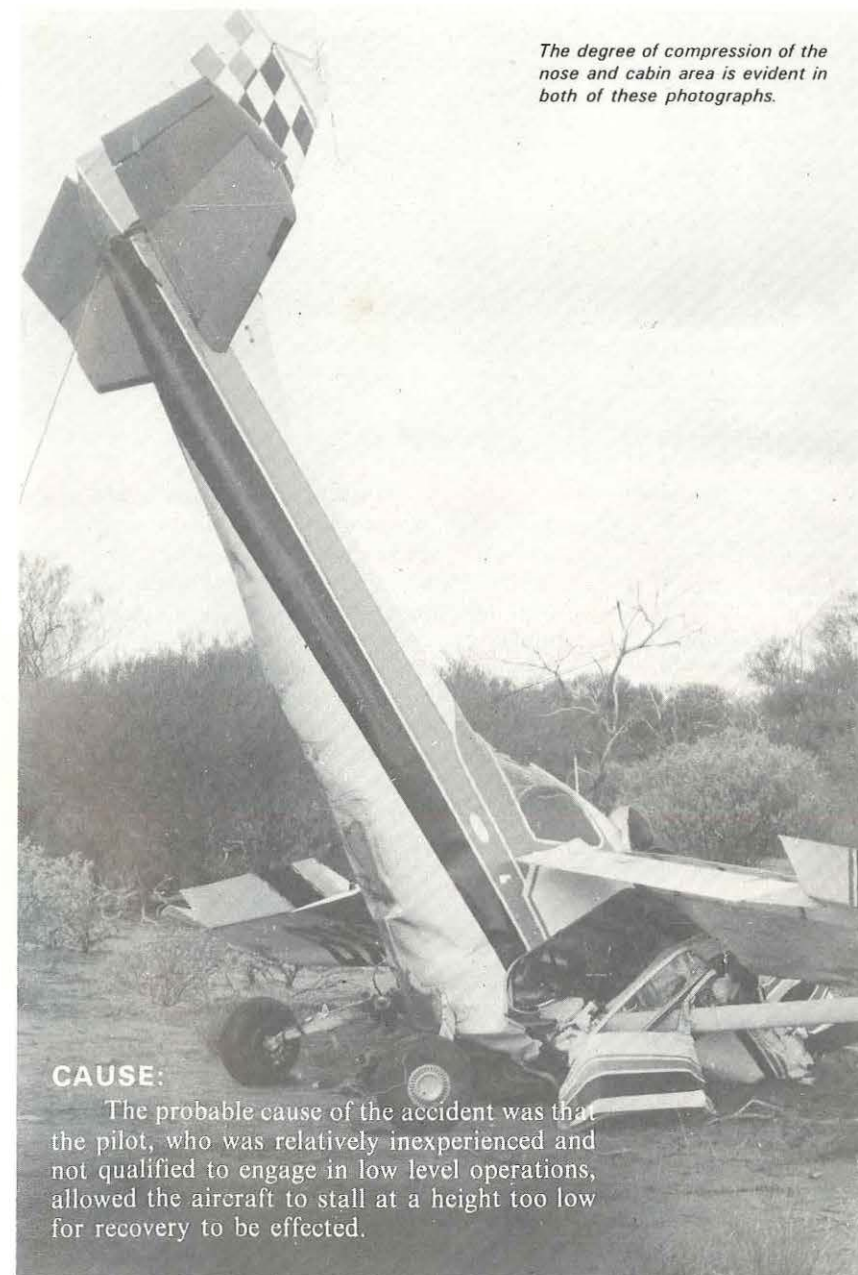
The degree of compression of the nose and cabin area is evident in both of these photographs.

The probable cause of the accident was that the pilot, who was relatively inexperienced and not qualified to engage in low level operations, allowed the aircraft to stall at a height too low for recovery to be effected.

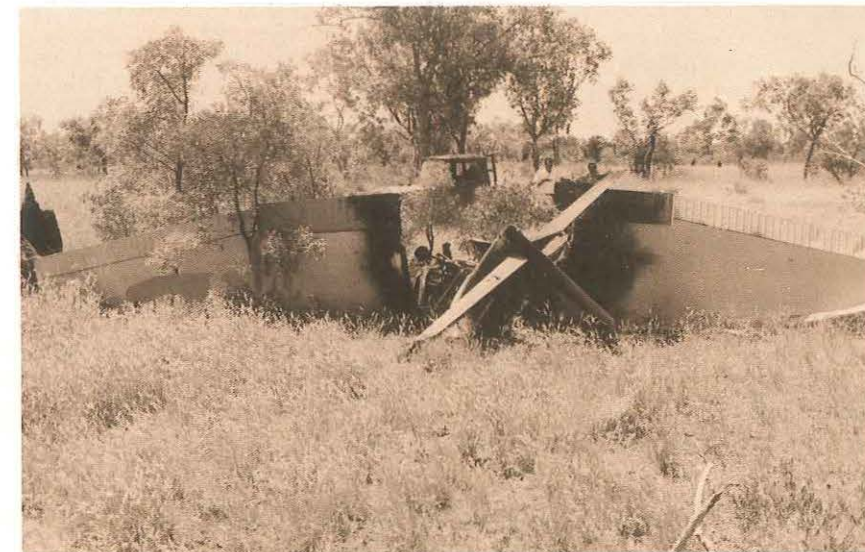
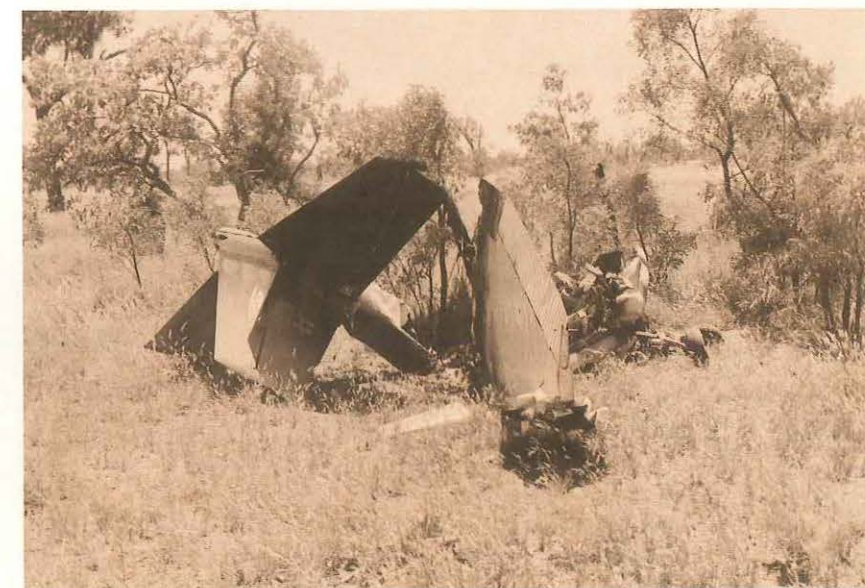
The photographs on these pages depict the other fatal mustering accidents referred to by our contributor.

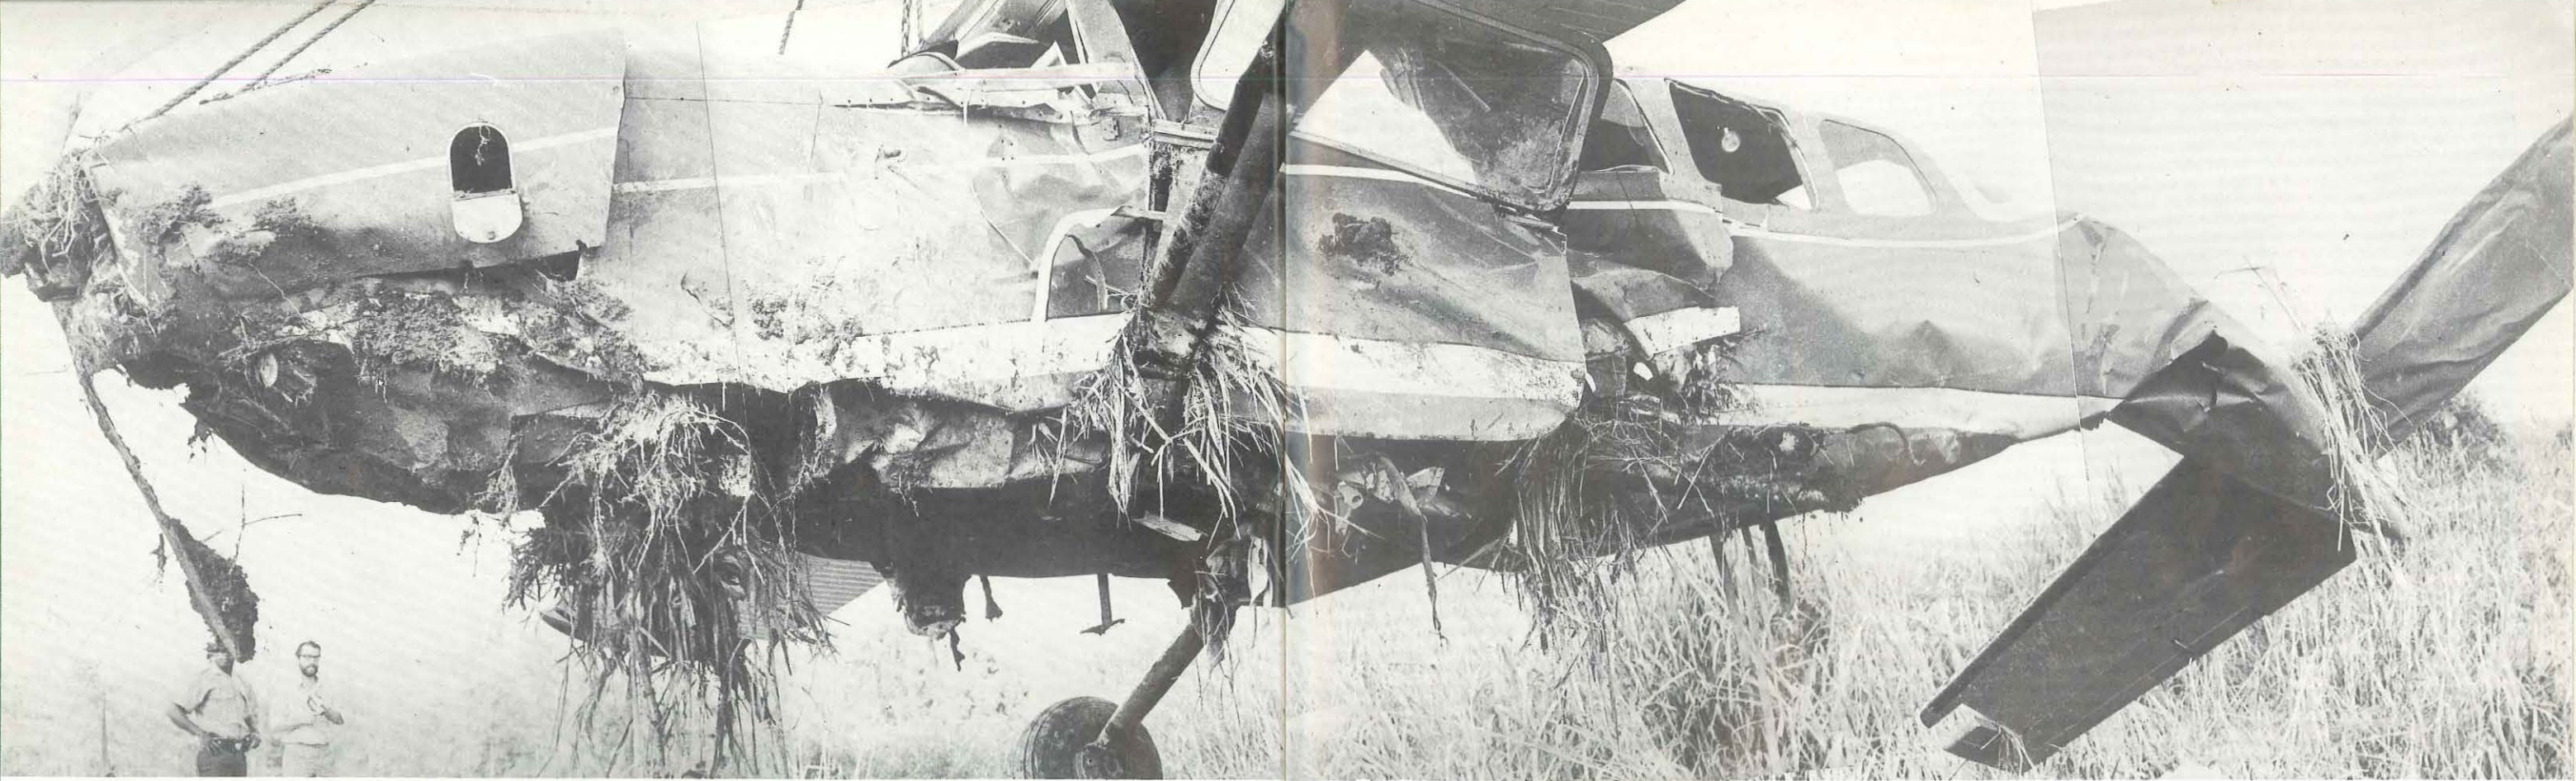
Above: The wreckage being hoisted from the accident site during the investigation.

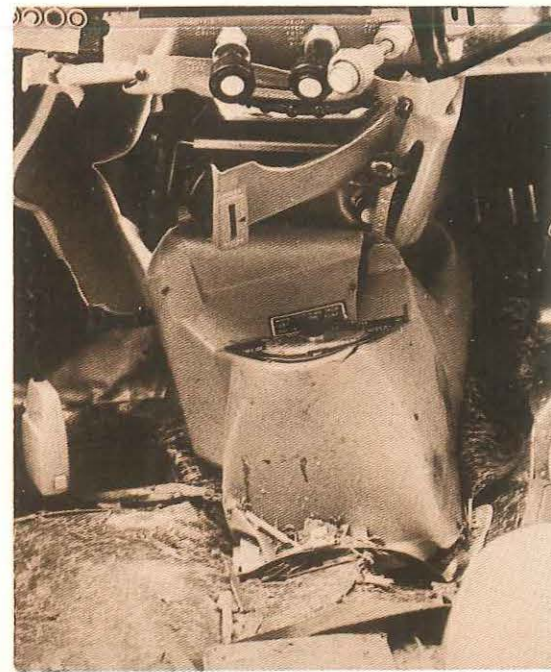
The fuel selector was found positioned to the starboard tank, which was empty. The port tank was also empty when it was inspected, but it had been damaged in the impact and showed evidence of having contained a considerable amount of fuel at the time of the crash. The fuel system itself was virtually devoid of fuel, but a detailed examination of the aircraft, including a full check of the fuel system and a strip inspection of the engine, failed to reveal any defect which could have contributed to the loss of

Top: View of fuel selector as found, positioned to the empty starboard tank.

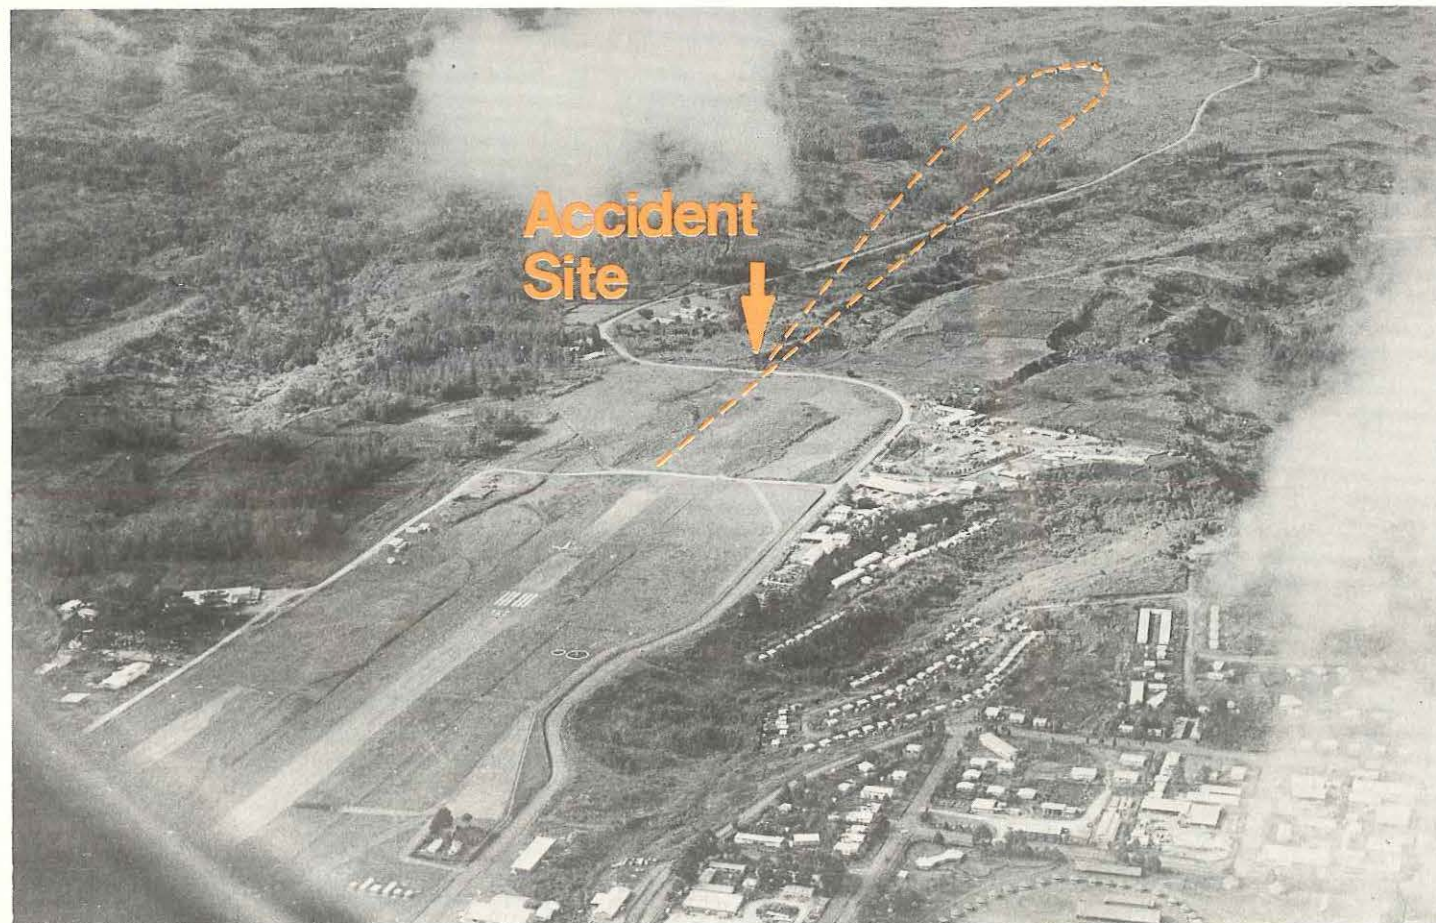
Below: View of southern end of Goroka aerodrome showing flight path and position of accident site.

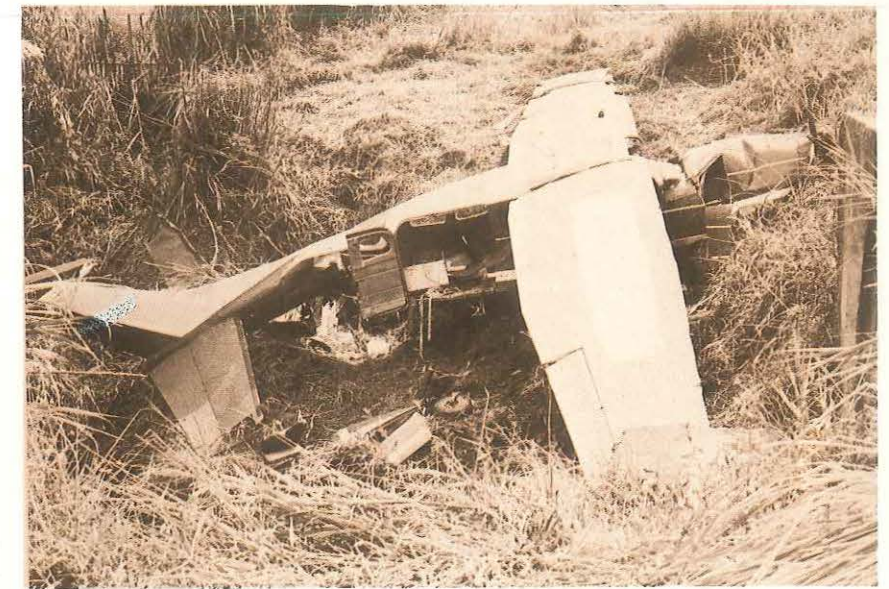
Above: The collapsed and distorted airframe as it came to rest against the creek bank.

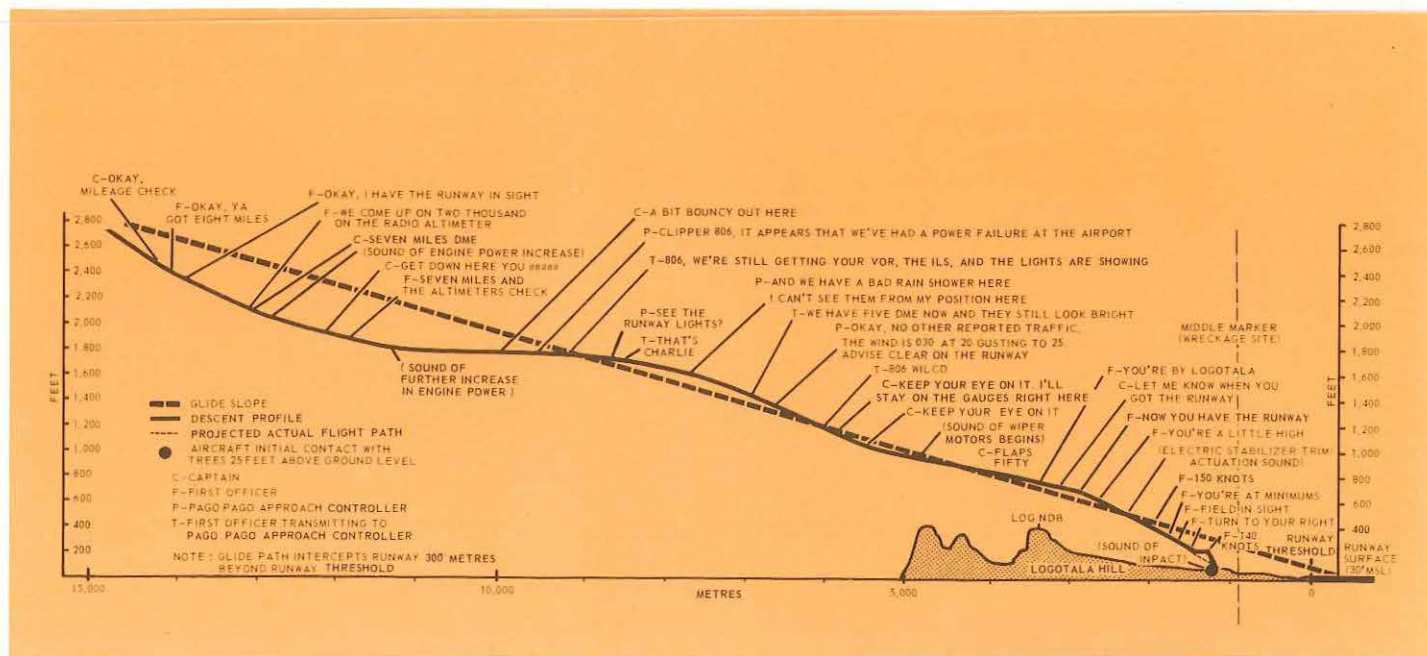
Descent profile of aircraft to impact point in comparison with the 3.25 degree glideslope of the Pago Pago ILS.

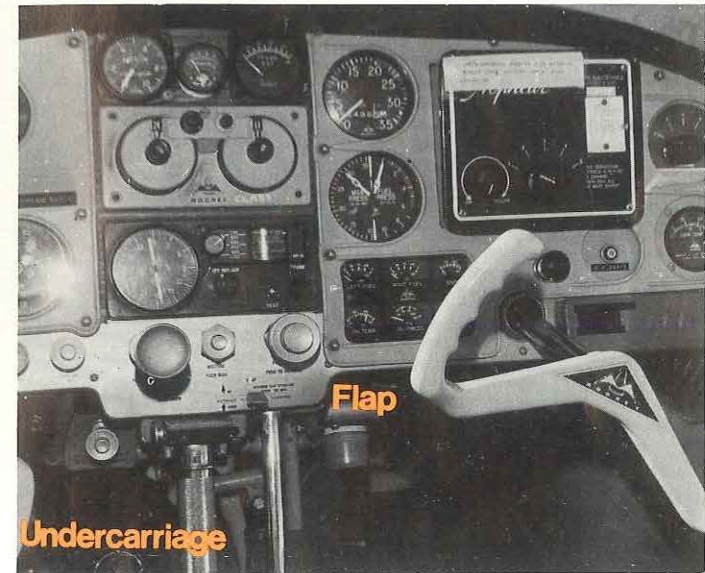
fully extended, the Cessna's flap lever is in a similar position to the Mooney's undercarriage lever with the undercarriage lowered. It is apparent that, intending to raise the flaps after the touch and go landing, the pupil subconsciously operated the undercarriage lever in error.

Right: View of cockpit showing undercarriage lever and flap selector.
