Department of Transport - Australia

Number 101 1978

Aviation Safety Digest

Disastrous Indecision	2
You — and Low Level Jet Routes	5
What Can Go Wrong — Will!	7
Cherokees Collide Head-on	8
Ooops!	10
Eyesight is Precious	11
A Nasty Situation	12
'What! You Threw Away the Ripcord?'	14
It's Good Advice For Us, Too!	17
The Wrong Side of the Power Curve	18
A Close Call!	19
Dust Devils and Aviation	20
Ask For Help — While You Still Can!	22
The Breath of Life	23
Counting Sheep?	24
Incredible!	25
Recognising and Handling Dangerous Goods	26
Your Role in Search and Rescue	28

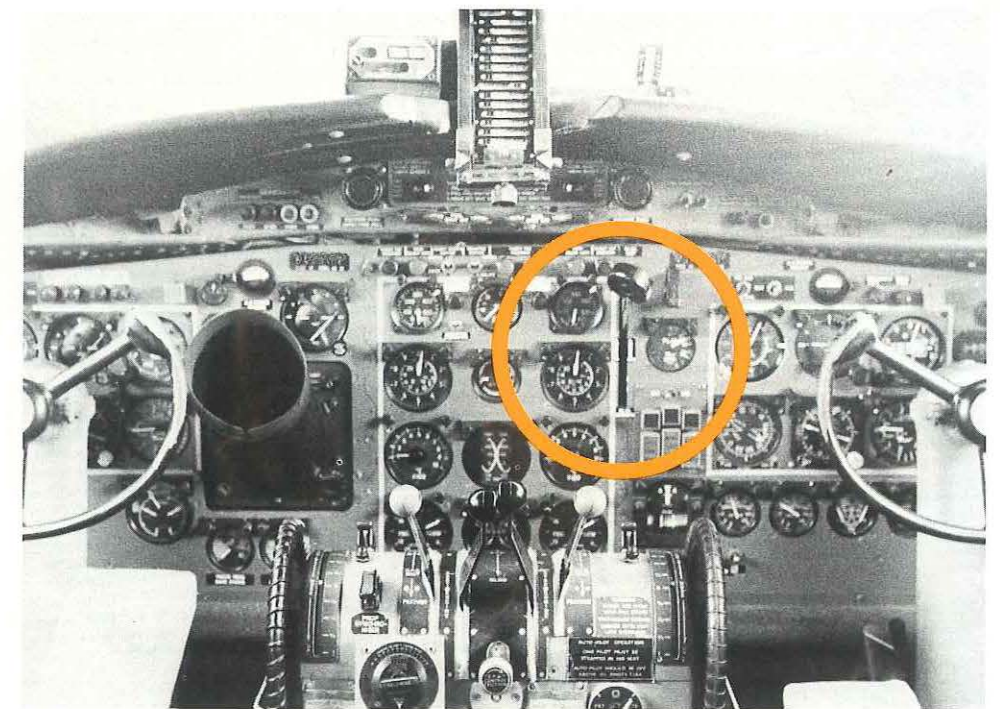
Instrument panel of the Friendship, showing the undercarriage selector handle in the raised position. The knob has been rotated 60 degrees to the left, allowing the locking lever which prevents inadvertent retraction to be over-ridden.

Ensuring that electrical power is off guards against an inadvertent UP selection of the complete undercarriage control handle, because the locking pawl is engaged with

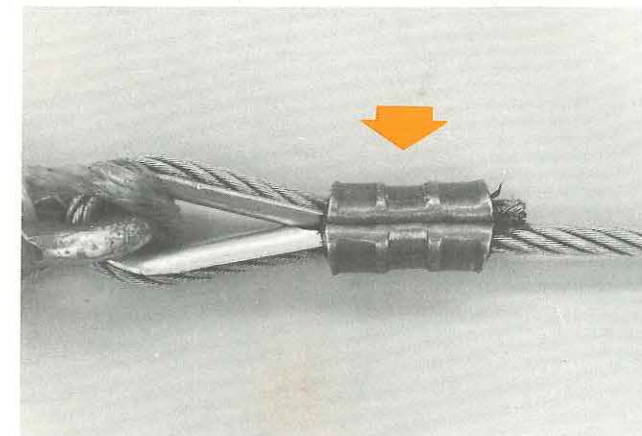
Instantly, I realised the rudder cable had given way. Believing at first the cable itself had parted and fearing the right cable would be pulled beyond my reach, I instinctively reached forward and grabbed the loose end before applying left rudder to recover. By this time the aircraft had rotated just over 360 degrees and I pulled out of the dive between 1000 and 1200 feet using elevator and aileron control. I took a moment to settle down, and then called Darwin Tower to tell them of my predicament. They alerted the emergency services and cleared me to land on runway 11. I had taken up a northerly heading across the airport and, while continuing on a wide left circuit, I had wrapped the loose rudder cable around my wrist and hand. By pulling on the cable, I was able to obtain some measure of right rudder control.

The right rudder pedal, with its toe brake, had shot forward with such force when the cable let go that it had dented the firewall and was now beyond my reach. So I knew that on landing, I would have no directional control once the slipstream effect on the rudder had diminished. Because of its tail-wheel undercarriage and very short fuselage, the Pitts requires maximum concentration and constant application of brakes to keep straight after touchdown, irrespective of the wind direction. It was unfortunate that the prevailing weather conditions would compound my problems, as the wind was gusting. I decided to carry out a powered approach at minimum speed.

Both rudder cables were removed from the aircraft, which had flown only 65 hours since new, for more detailed examination. The cables have similar eye fittings at each end and these were measured and compared with other sample end splices. It was found that, while the copper sleeves used to form the eyes were the correct type for 3.2 mm (1/8 inch) cable, all four end splices had been formed with a pressing tool appropriate to a cable diameter of 4 mm (5/32 inch). Thus the sleeve had not been properly compressed and the resulting clamping action was insufficient to provide a splice of adequate strength. During a series of laboratory tests, the rear end of the left rudder cable pulled through the sleeve when a load of 280 kg was applied. It appeared from marks on the fittings that the splice which failed in flight would have been significantly less effective than the one which failed on test. A correctly pressed sleeve withstood a load of 1090 kg without any sign of slipping.

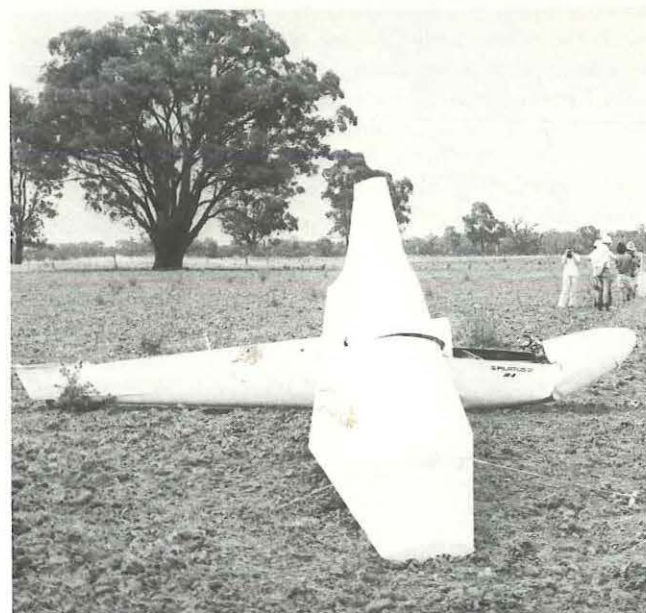
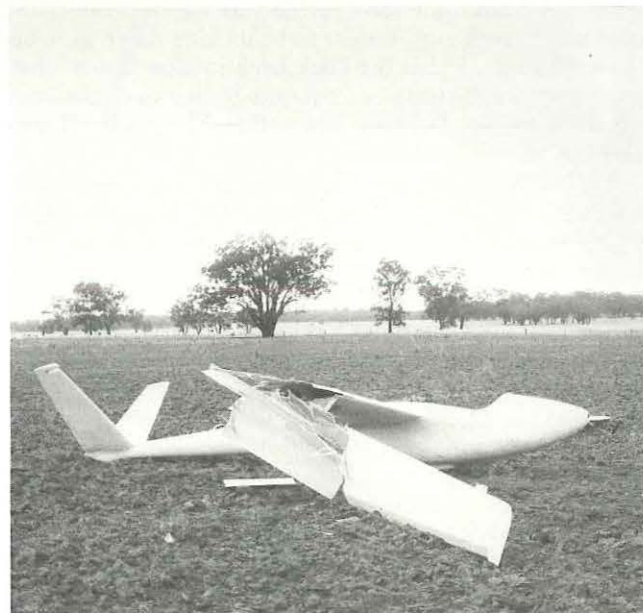
The wrecked Pilatus (left) and Salto (right) as they came to rest in open country after the collision. Note the entire tail section of the Pilatus has been torn away.

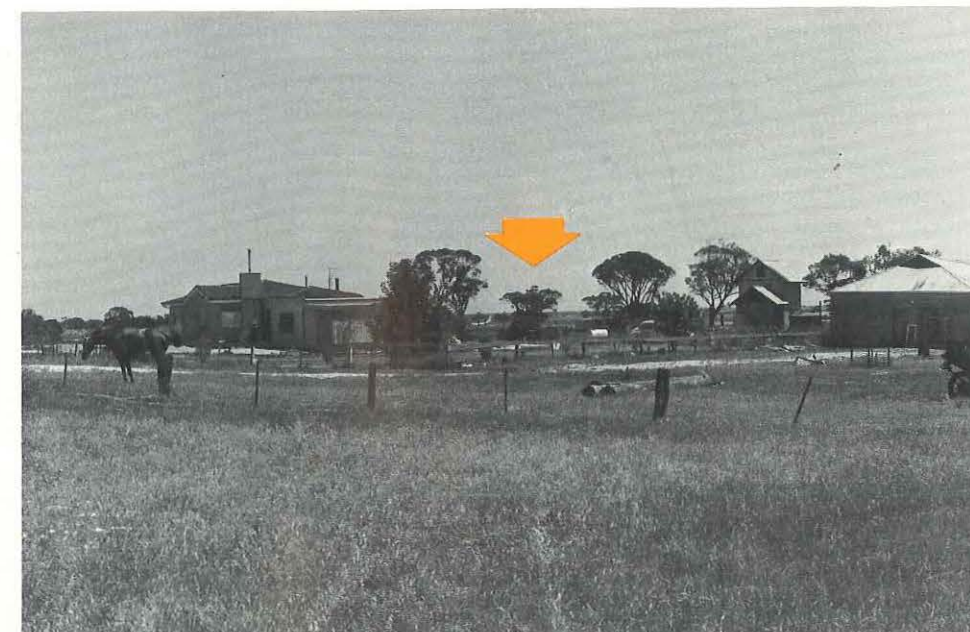
View looking in take-off direction as seen from a position close to where aircraft became airborne. The tree the aircraft struck is indicated. The wreckage is in the centre background of the picture.

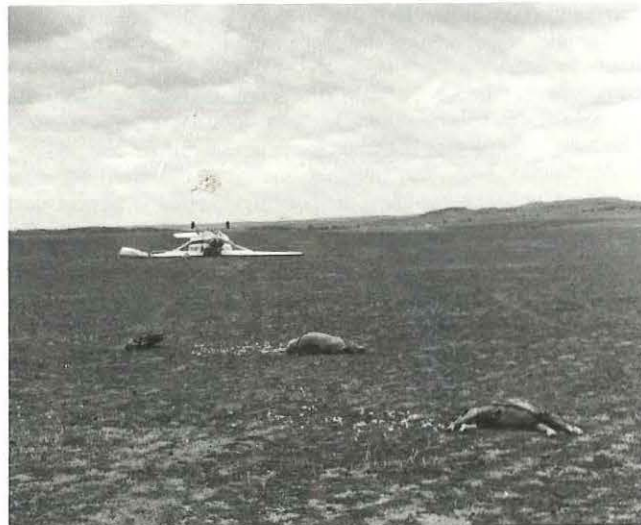
View of paddock from which Cessna was operating, looking in direction of take-off. Three of the four sheep the aircraft struck, and the dislodged nose wheel, can be seen in the picture.

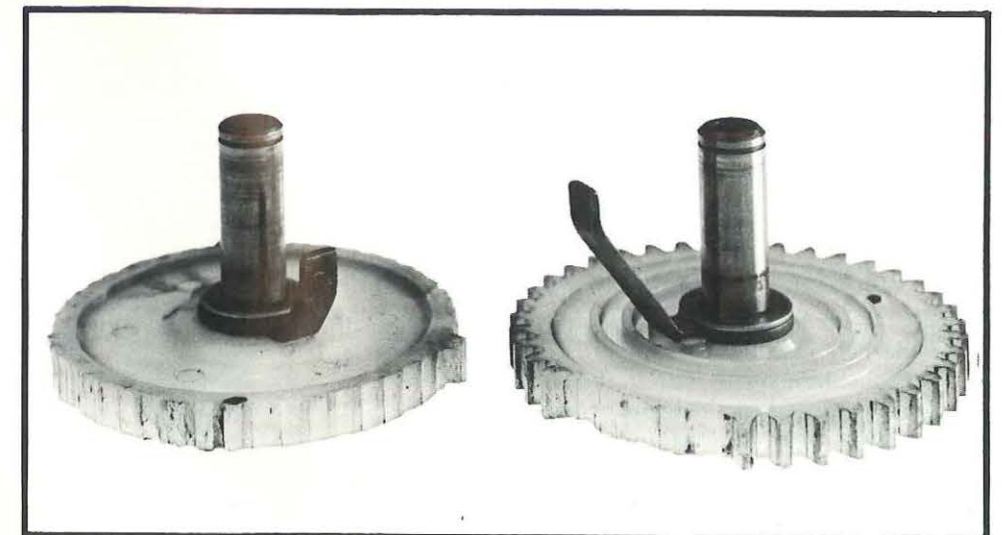
The practice of deliberately 'backfiring' an engine by switching the magnetos on and off imposes severe fatigue-inducing loads on the propeller, crankshaft, and gearing within the engine and the exhaust system. It may even strip the teeth of the plastic distributor gear in the magnetos themselves. Higher powered engines are even less tolerant to this type of abuse.

These two examples of failed plastic distributor gears testify to the consequences of deliberately causing an engine to backfire.
