Aviation Safety Digest

102/1978

Contents

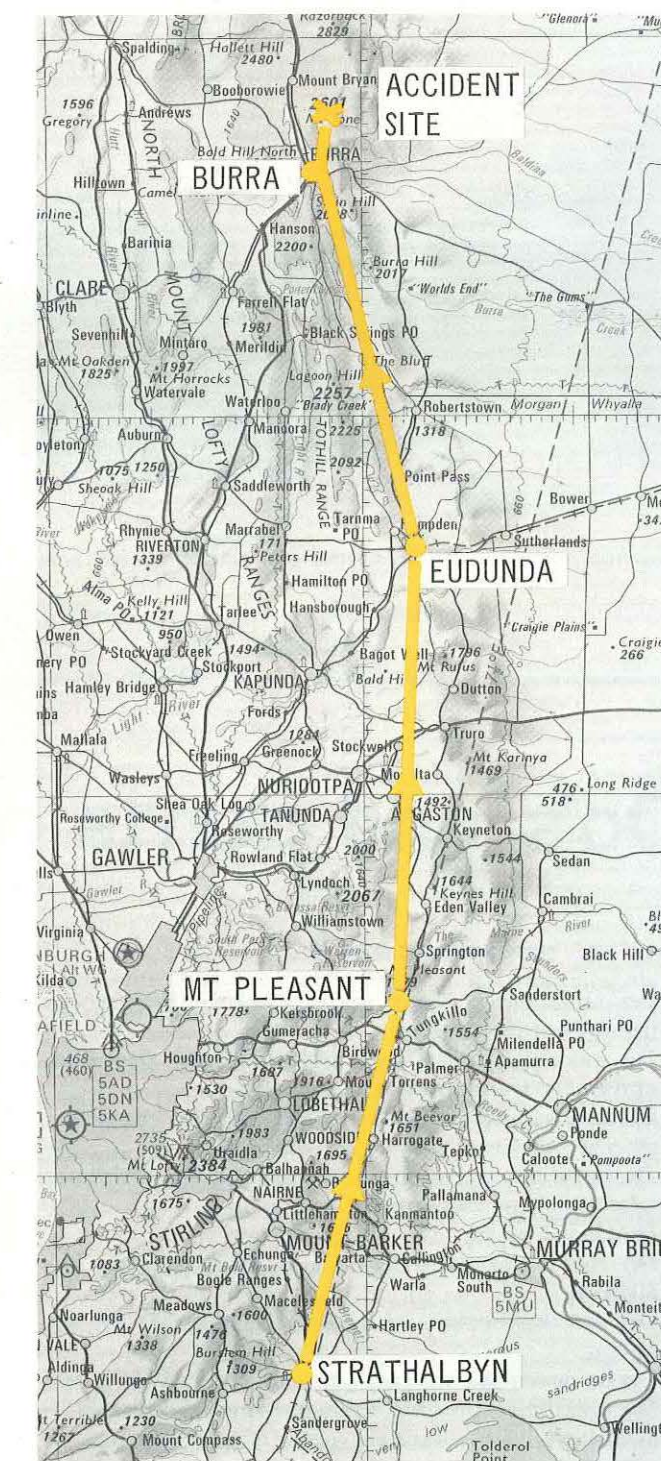
The aircraft had struck the northern slope of a hill at an elevation of 2225 feet. At the time of the crash it was in a steep nose-down attitude at high speed, and on a northerly heading. The Cherokee had virtually disintegrated and all four occupants had been killed on impact. The wreckage was examined in detail but nothing was found to indicate that the aircraft was incapable of normal operation immediately prior to the accident.

Map showing probable flight path and site of accident.

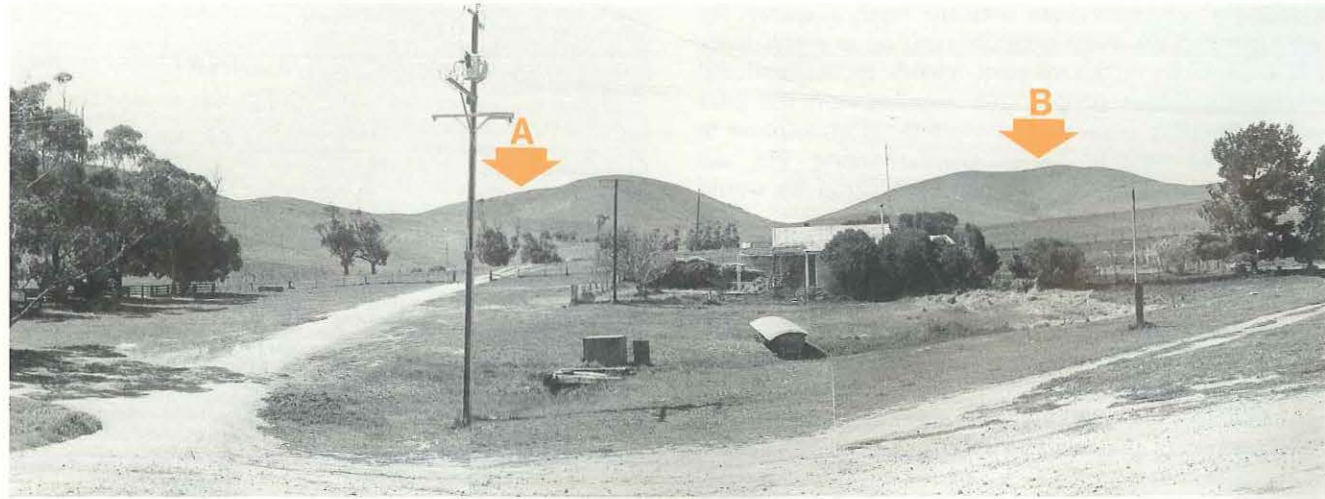
View from position of witnesses showing (A) hill behind which aircraft crashed and (B) Mount Cone.

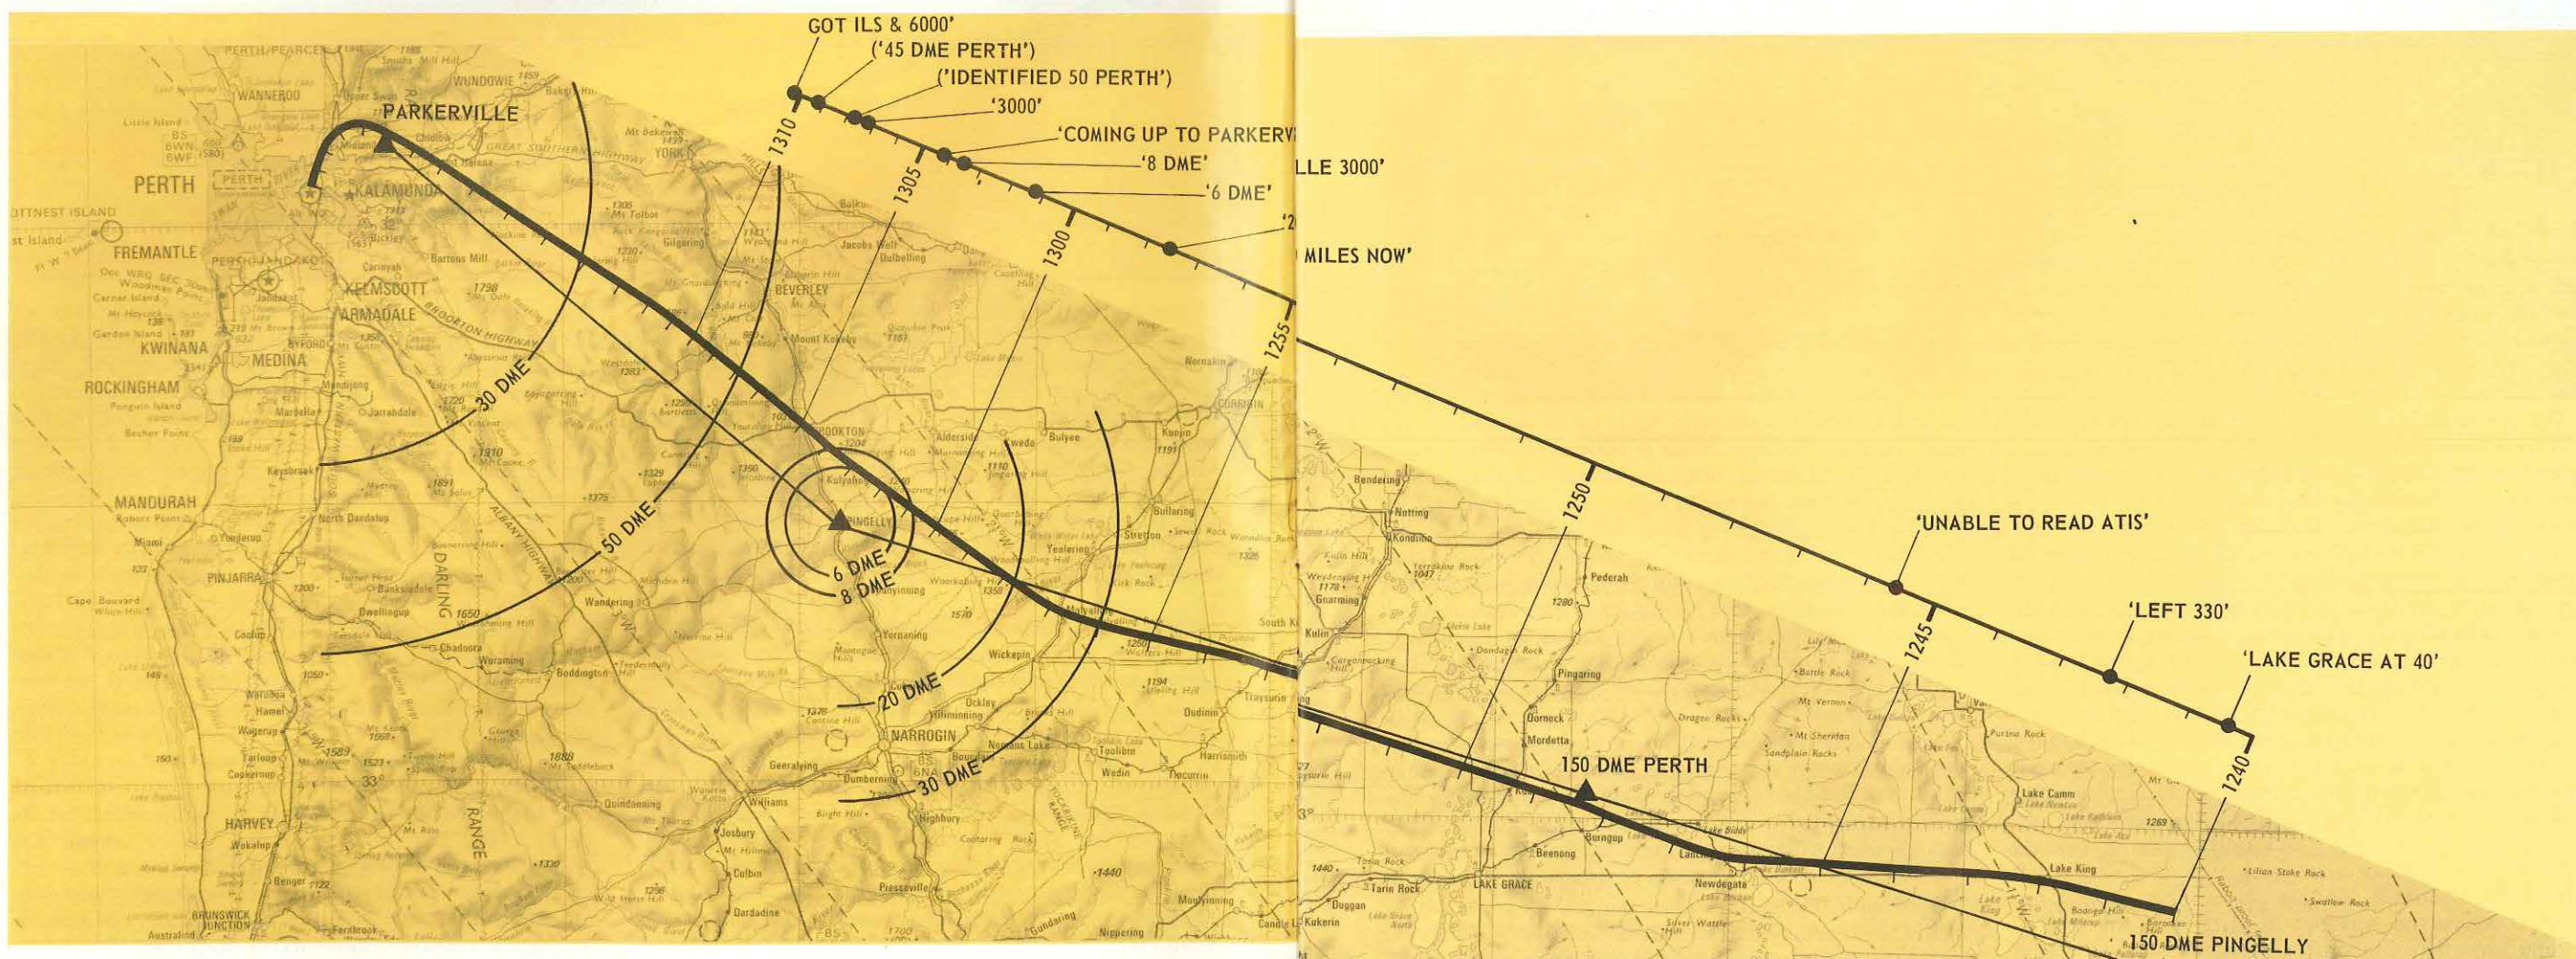
While it was not possible to determine precisely the procedures used by the crew in relation to navigation and the use of radio navigation aids, it is obvious that those procedures were inadequate and led directly to the incident. It is also apparent that an ATC requirement to radar-monitor aircraft approaching Perth would have resulted in the incident being detected at a much earlier stage of its development.

Fig. 2: Reconstruction of flight path from position at which aircraft commenced descent from flight level 330.

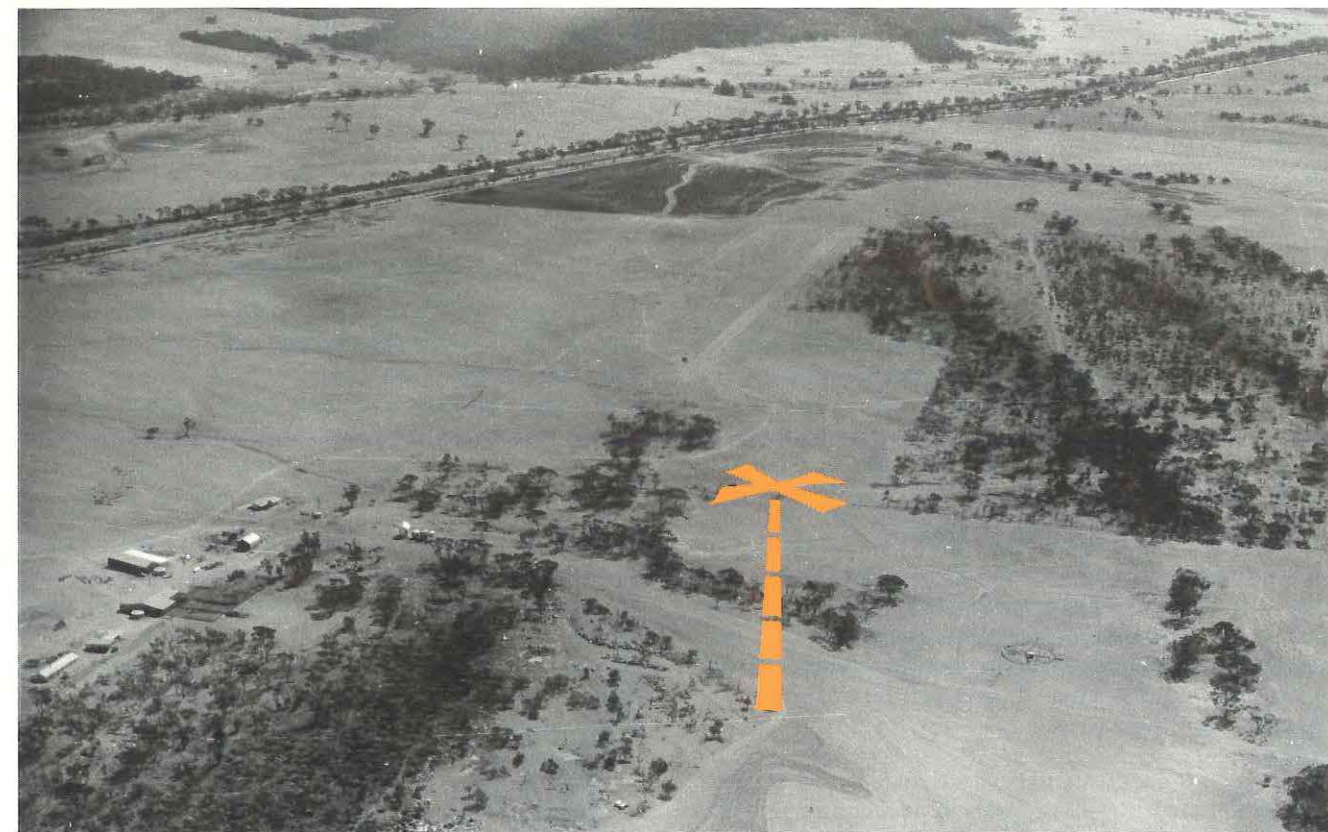
One of the two power cables had passed over the engine and under the port wing, cutting into the fuselage below the windscreen and breaking when it struck the windscreen pillar. This caused the aircraft to swing to the left. The other cable caught under the right hand door handle but did not break, thus bringing the aircraft down almost vertically.

Aerial view of agricultural strip looking in a northerly direction. The accident site and direction of approach are shown.

collide with electric transmission cables, the transmission system protective relays operate as designed. But there are circumstances where the transmission cables can remain alive, in which case contact with them, or with the aircraft if the cable is still attached, could be fatal. Electricity authorities have advised the Department that all dislodged transmission cables should be treated as alive until cleared as safe by the local electricity authority.

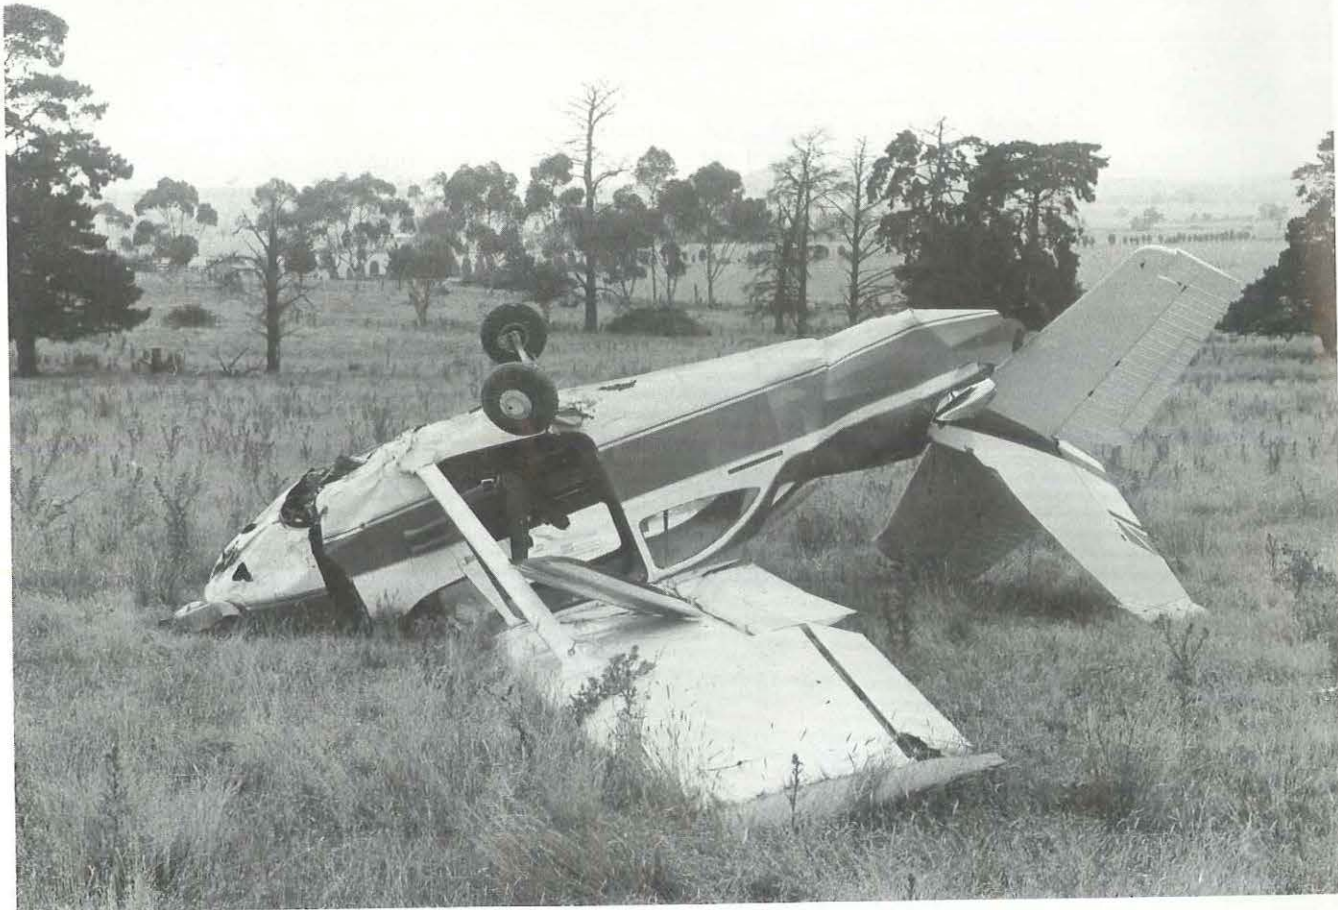
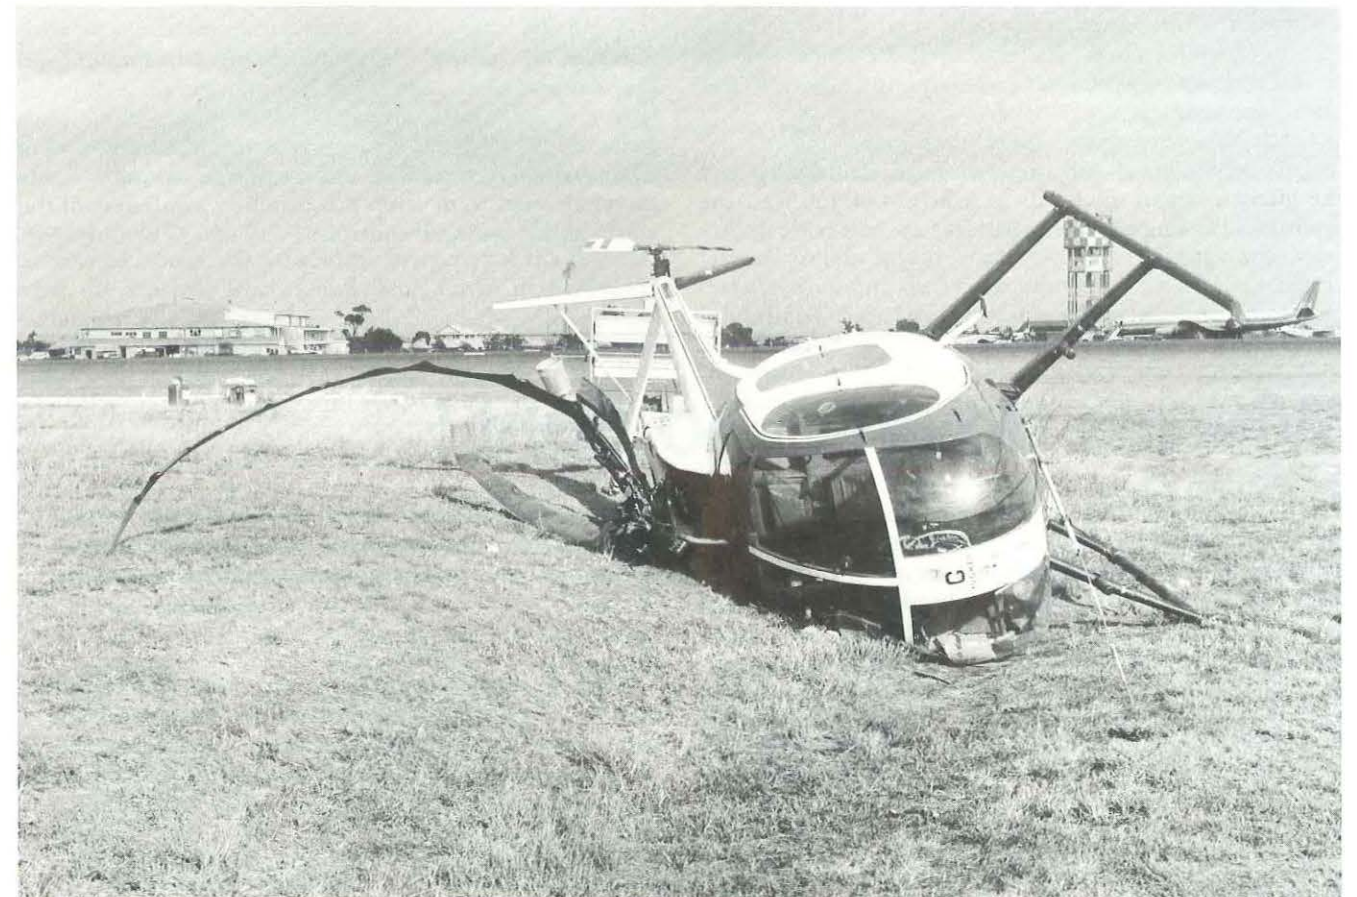
Don't let this happen to your aircraft! The Cessna and the Hughes helicopter on these pages were stolen by would-be pilots whose enthusiasm exceeded their expertise.

Aircraft are no less liable to interference and theft than any other means of transport. Effective security can be achieved only if all owners, operators and pilots cooperate in providing and using the measures available to them. There will then be no need to introduce legislation of the kind now applicable to motor cars and other earth-bound vehicles.
