# Aviation Safety Digest

# Solitary waves and low-altitude wind shear in Australia

# Engine failure on takeoff

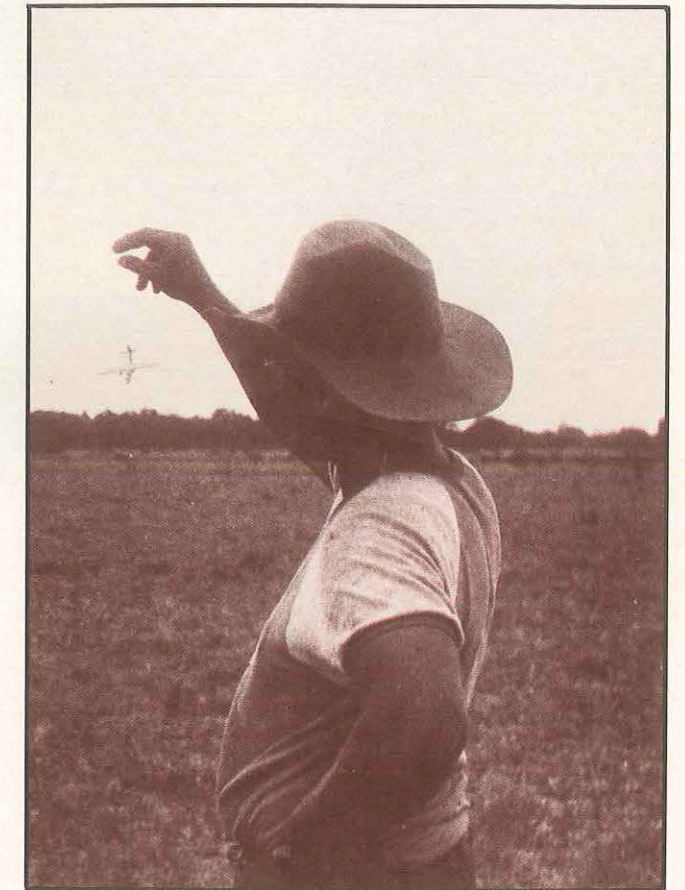
ground. It impacted at an angle of about 73 degrees and broke apart. The main wreckage bounced 28 metres before coming to rest against some trees. Both the pilot and the station manager, who was flying as spotter, were killed.

An investigation found no evidence of pre-existing aircraft mechanical defect or malfunction; nor was there any evidence of pilot incapacitation.

Using an aircraft model, a witness demonstrates for air safety investigators the aircraft's attitude and position immediately prior to impact.

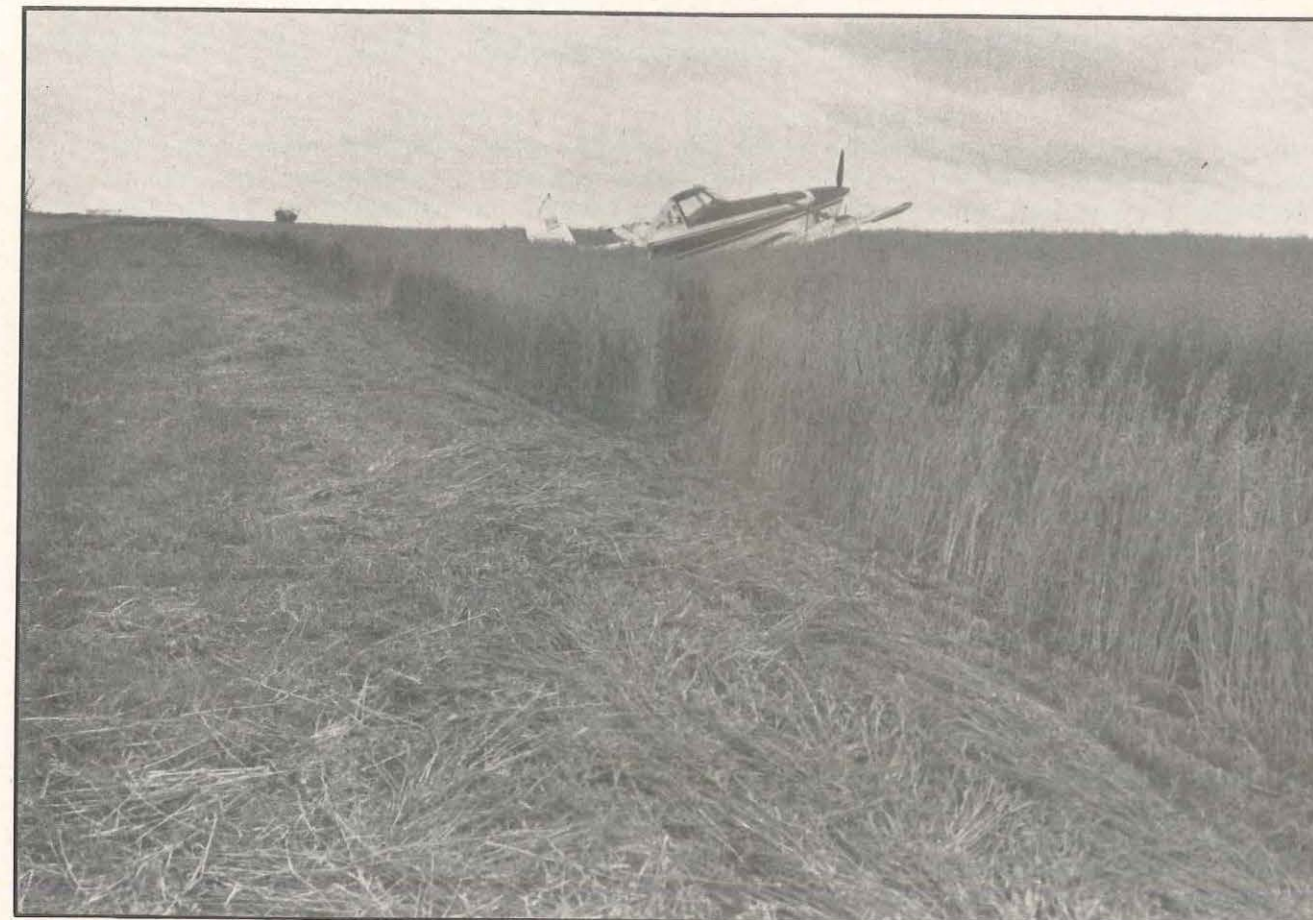
Figure 1. General view in direction of landing. Note initial entry point of aircraft into crop.

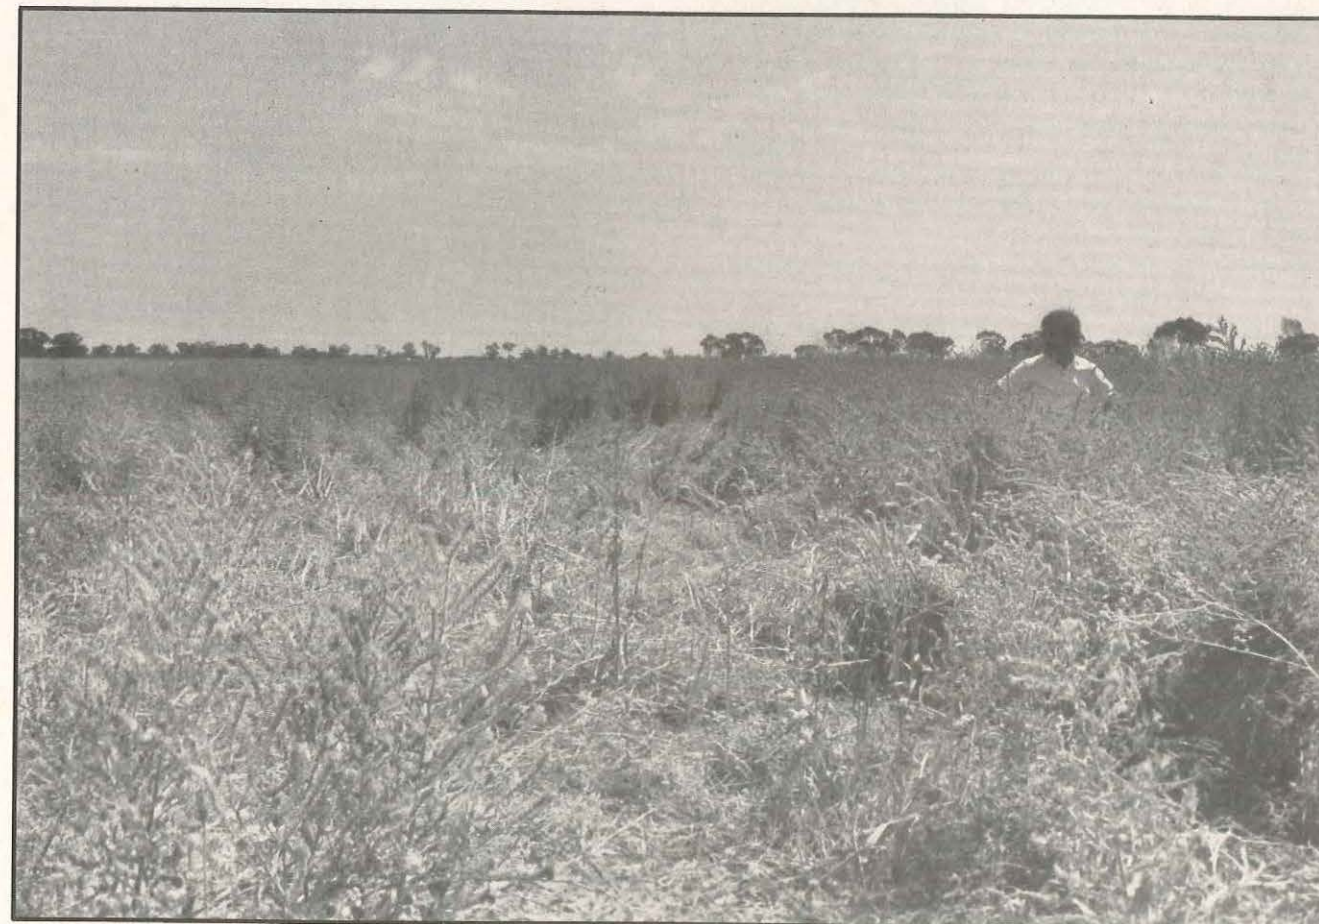
Figure 2. View back along aircraft's touchdown path, taken from accident site. Person standing amongst the 'grass' is 183 cms tall.

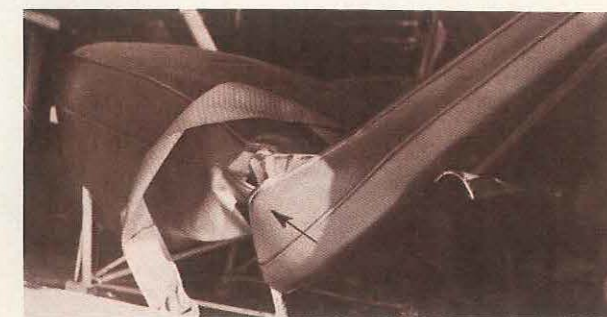
Examination showed that the left-hand support tube had a pre-existing fatigue crack over one-quarter of its circumference and it was from this that the total failure originated. The cause of this pre-existing crack should be of interest to all pilots, LAMEs and aircraft passengers.

The left-hand side of the seat back, together with a 'grab' handle on the forward door post, is generally used by people to haul themselves into the aircraft. Further, the front seat backs are hinged to allow access to rear seat passengers who also tend to lean

on those seat backs during entry to the cabin. It seems probable that this extra loading on the pilot's seat back, over a long period, caused the initial fatigue cracking of the support tube.

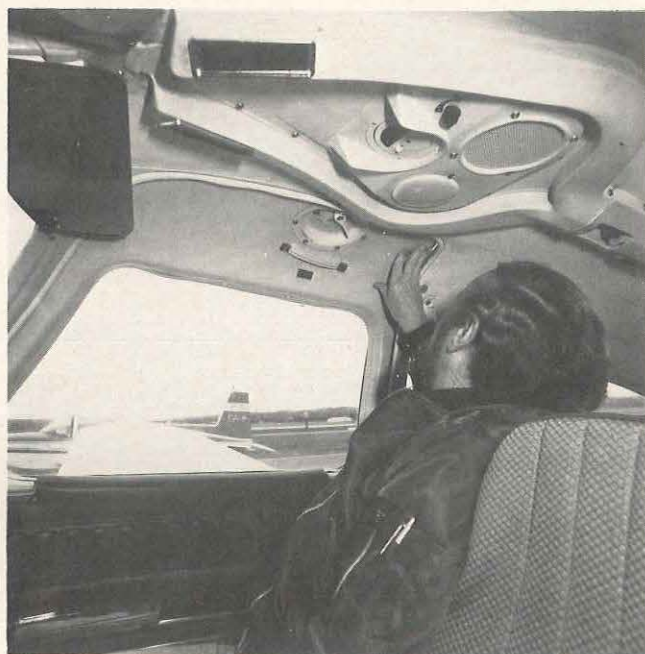
*Locking the door: While the door of this aircraft may seem locked (the latch at the top centre is in the CLOSED position) it is not. The application of gentle pressure at the top right corner has opened the door slightly, indicating that it was not properly shut when the latch was closed. For many GA aircraft applying a gentle pressure to the door as illustrated is a useful way of checking that it is secure.*
