# Lay-over landing involving Kavanagh Balloons E-240, VH-DUX

18 km E of Essendon Airport, Victoria, on 2 April 2018

**ATSB Transport Safety Report**  
Aviation Occurrence Investigation  
AO-2018-028  
Final – 30 August 2018

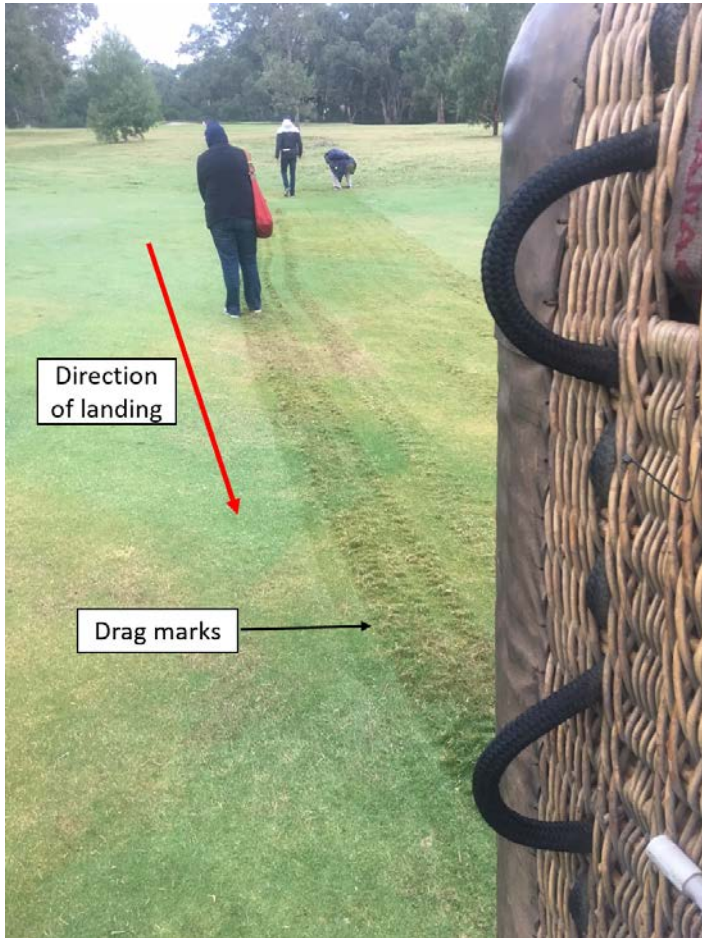
**Figure 2: Balloon drag marks**

The pilot later reported that all passengers adopted the correct position. About two minutes later, the pilot began descending the balloon slowly using the parachute vent.<sup>4</sup> At the beginning of the golf course, the pilot rapidly descended the balloon to land in the available space and the wind conditions, using the Lite Vent.<sup>5</sup> The balloon touched down and the pilot conducted a lay-over landing (Figure 2).

During the landing, one passenger sustained minor injuries and the aircraft was not damaged.

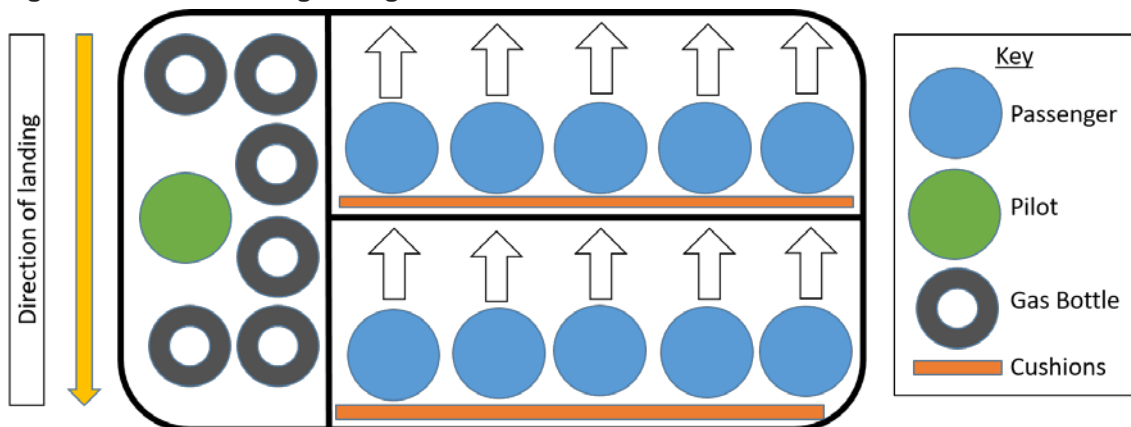
**Figure 3: Basket loading configuration**

The maximum passenger capacity of the balloon was 11 people. During the landing, the pilot and the passengers stood as shown in Figure 3, with the passengers facing the direction indicated by the white arrows.

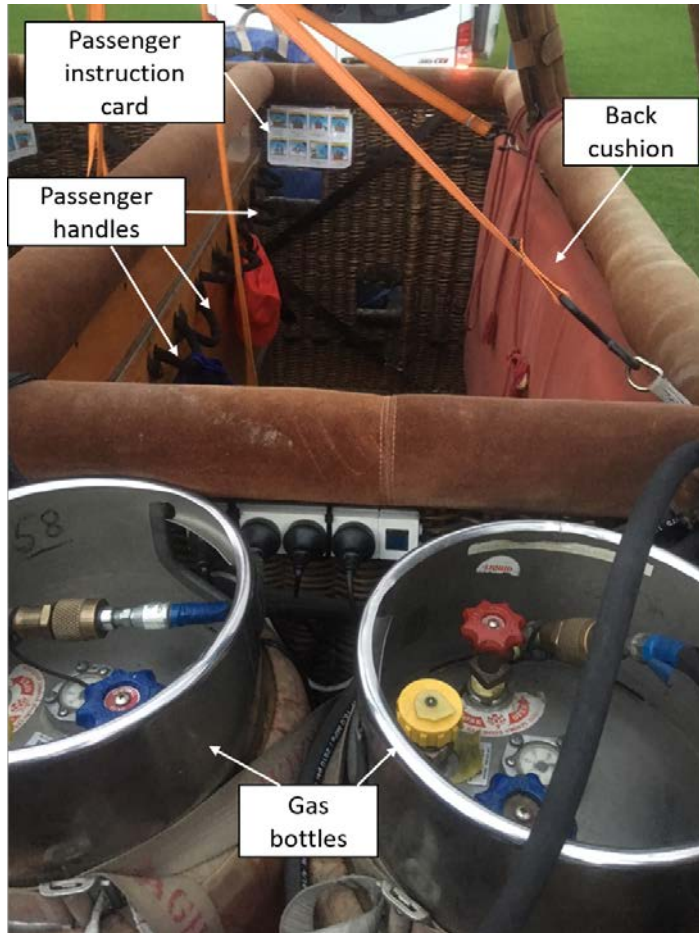
**Figure 4 Interior of basket**

The basket featured foam padding around the top bars and foam cushions for the passengers' backs with handles for the passengers to hold (Figure 4). When positioned for landing, the passengers' shoulders were roughly at the level of the top of the basket sides, or just below.

The passenger instruction cards were affixed to the interior of the basket (Figure 4).
