Reduced braking effectiveness during landing involving Boeing 737-800, VH-VOP

Christchurch, New Zealand | 11 May 2015

ATSB Transport Safety Report
Aviation Occurrence Investigation
AO-2015-046
Final – 18 September 2018

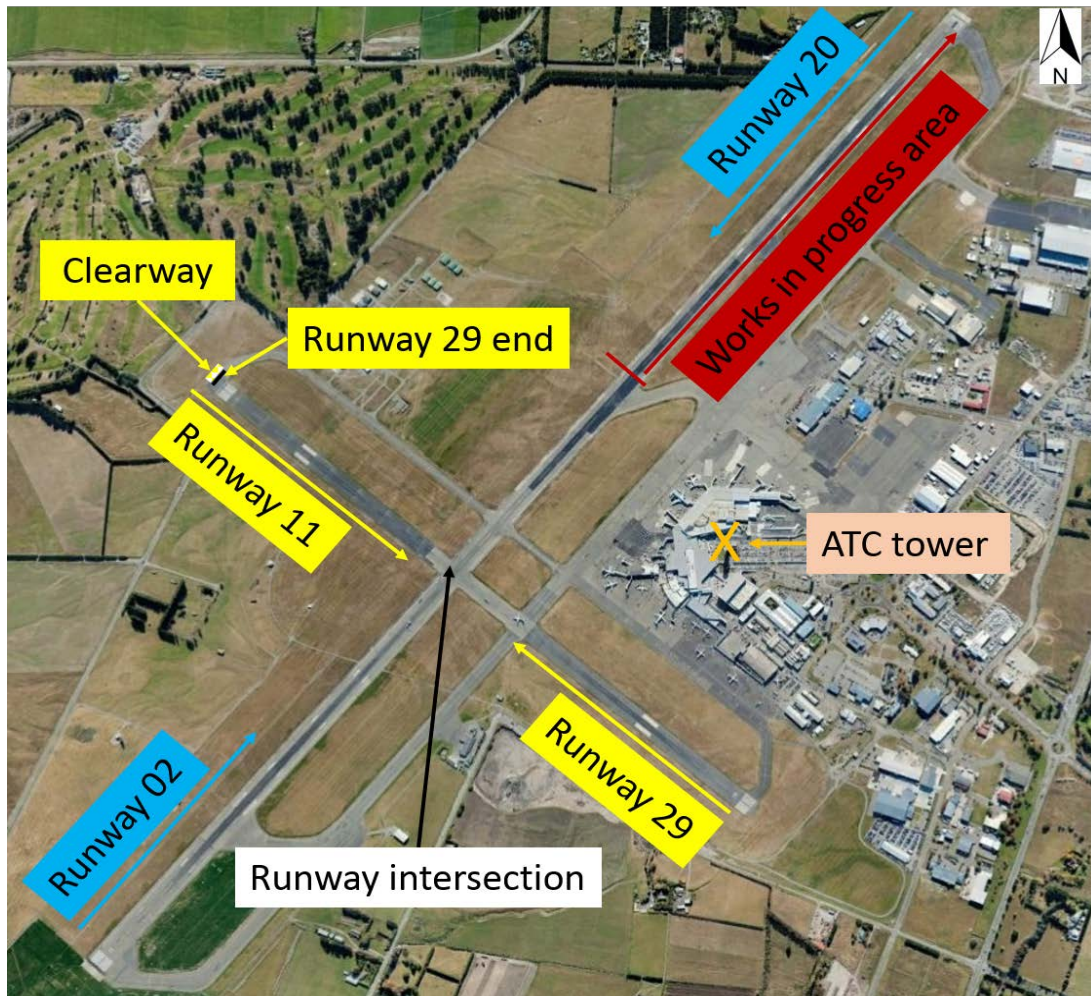
Figure 7: Christchurch Airport showing the runway directions and works in progress

Christchurch International Airport has two runways – runway 02/20 and 11/29 (Figure 7). Runway 02/20 was used for 93 per cent of all operations, while runway 11/29 was generally only used in north-westerly wind conditions. The captain, FO and Christchurch Tower controller also reported that runway 29 was infrequently used.

While an assessment of the runway condition was not done immediately following the incident, an inspection was conducted several days later. That inspection found that the runway intersection was relatively flat with a slight camber out from the centreline to the runway edges. There did not appear to be any wheel rutting or deformations in the runway surface that were conducive to the formation of standing water.

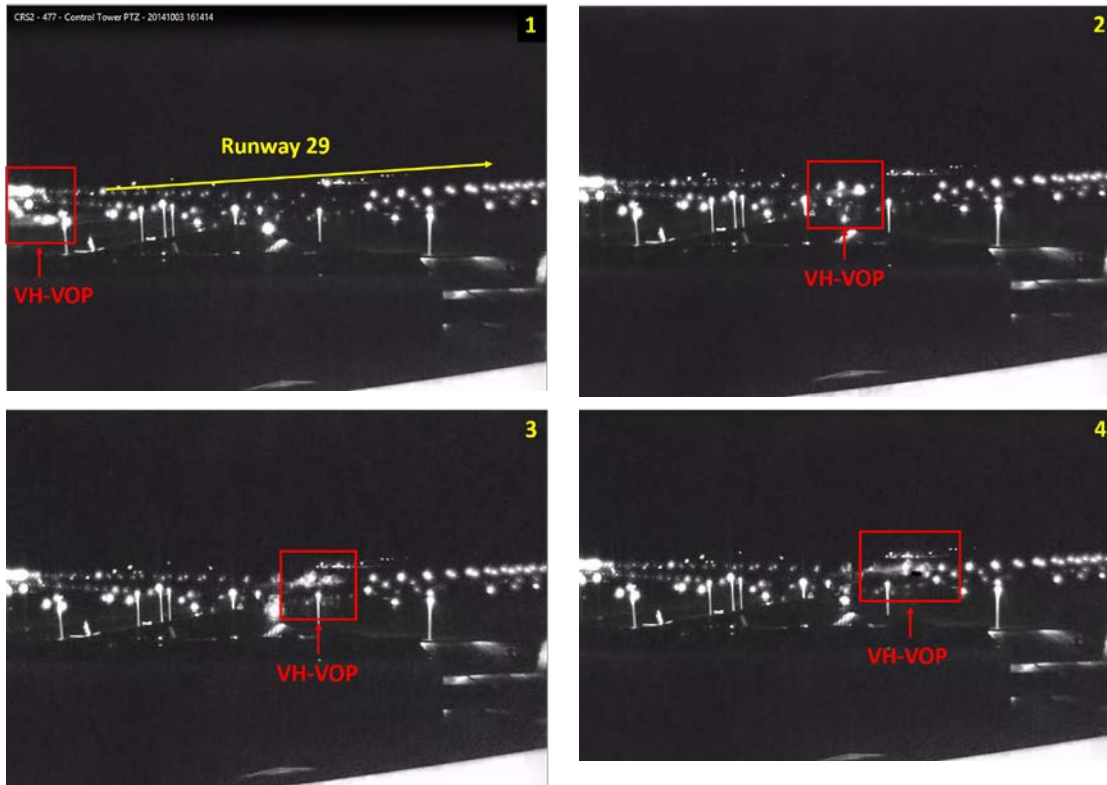
Figure 8: Screenshots of footage showing VH-VOP landing on runway 29

Closed-circuit television (CCTV) from the terminal showed the aircraft landing on runway 29 (Figure 8 – frames 1 and 2). While the quality of that footage was limited, around or shortly after crossing the runway 02/20 and 11/29 intersection, there was a spray of water observed coming from the aircraft (Figure 8 - frames 3 and 4).

Images show the spray of water first visible in frame 3 and then more apparent in frame 4. Source: Christchurch International Airport Limited, annotated by the ATSB

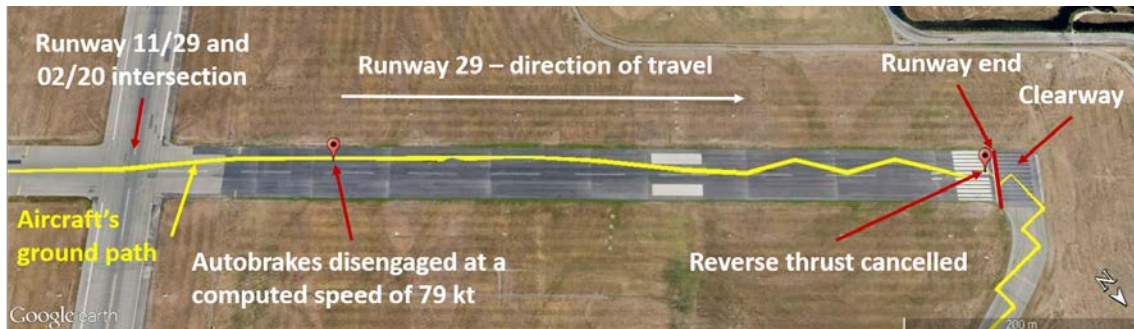
Figure 9: Aircraft's ground path and recorded data after crossing the runway 11/29 and 02/20 intersection

- A minor directional deviation was observed during the later stages of the landing to maintain runway heading, consistent with that reported by the FO (Figure 9).

Image shows the aircraft's ground path (in yellow) and recorded data after crossing the runway 11/29 and 02/20 intersection (the zigzag yellow line on the last section of the runway was the result of flight data recording limitations). Source: Google earth, annotated by the ATSB

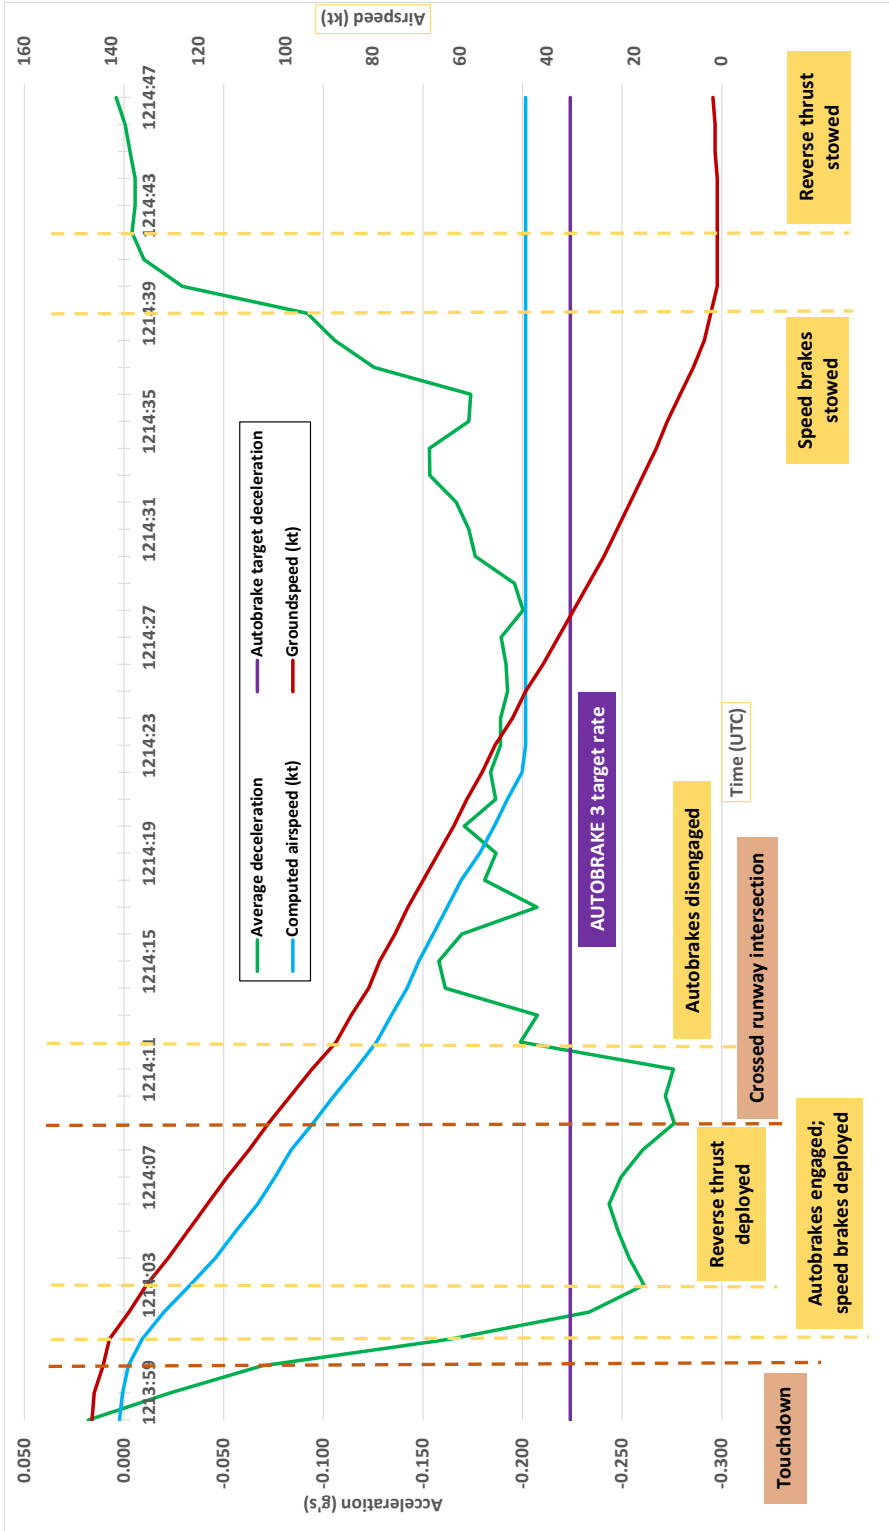
Appendix B – VH-VOP deceleration during landing

The AUTOBRAKE 3 target deceleration rate compared with the average deceleration for VH-VOP measured in g's, where negative values indicate deceleration (left axis), and the computed airspeed and groundspeed (right axis) from just prior to touchdown on runway 29 .
