Grounding of *ABFC* *Roebuck Bay*

Henry Reef, Queensland, on 30 September 2017

ATSB Transport Safety Report
Marine Occurrence Investigation
335-MO-2017-009
Interim – 9 October 2018

Interim factual report

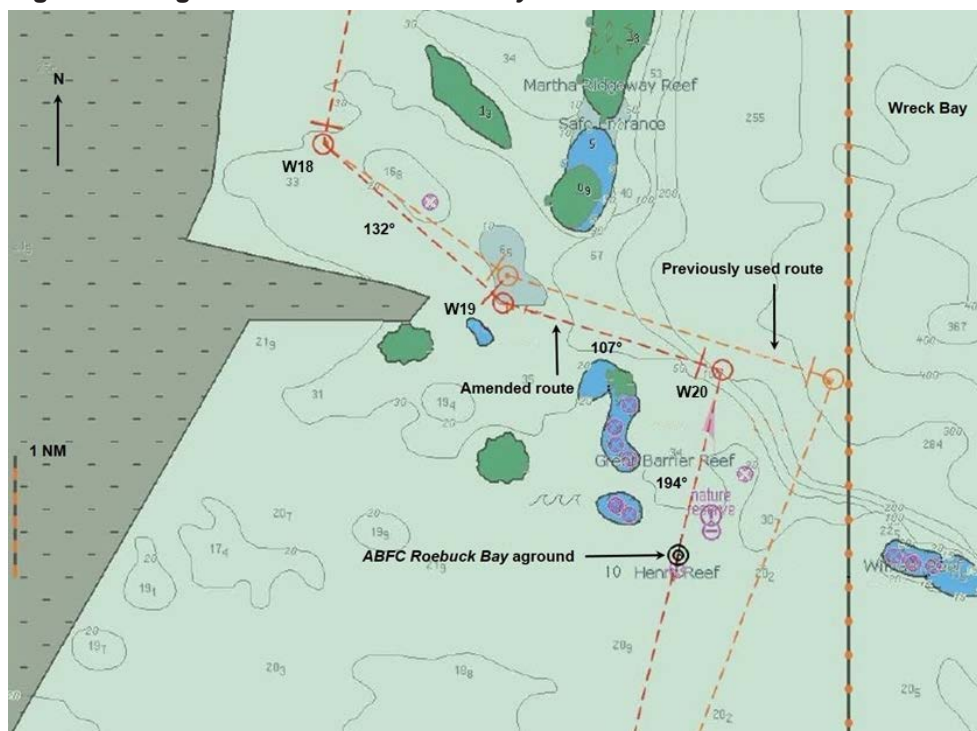
Figure 2: Image from *ABFC Roebuck Bay's* ECDIS

The master reviewed the planned route on the ECDIS and made a few amendments. One of these amendments included moving a planned course alteration position (waypoint) about 0.2 NM south of its original position and another about 1 NM west of its original position (Figure 2) in the vicinity of Wreck Bay in the Great Barrier Reef. The amended waypoints were designated waypoint 19 (W19) and waypoint 20 (W20) in the passage plan's waypoint list. When the master tried to save the amended route, the 'Errors' tab in the route tab folder of the ECDIS's 'Edit Route' menu turned yellow indicating an error in the route. The master advised the navigation officer of his desired amendments to the route and of the error encountered. The navigation officer reviewed the route's waypoint list in the ECDIS's route editor table and determined the error to be an incorrect turn radius for one of the waypoints. The turn radius was amended, which cleared the error and the error tab reverted to its normal grey colour and changed to 'No Error'. The master and navigation officer then reviewed the amended route visually and saved it with the master's initials suffixed to the route name.

Image from ABFC Roebuck Bay's ECDIS display taken after the grounding showing the previously used route and the amended route based on the changed waypoints W19 and W20.

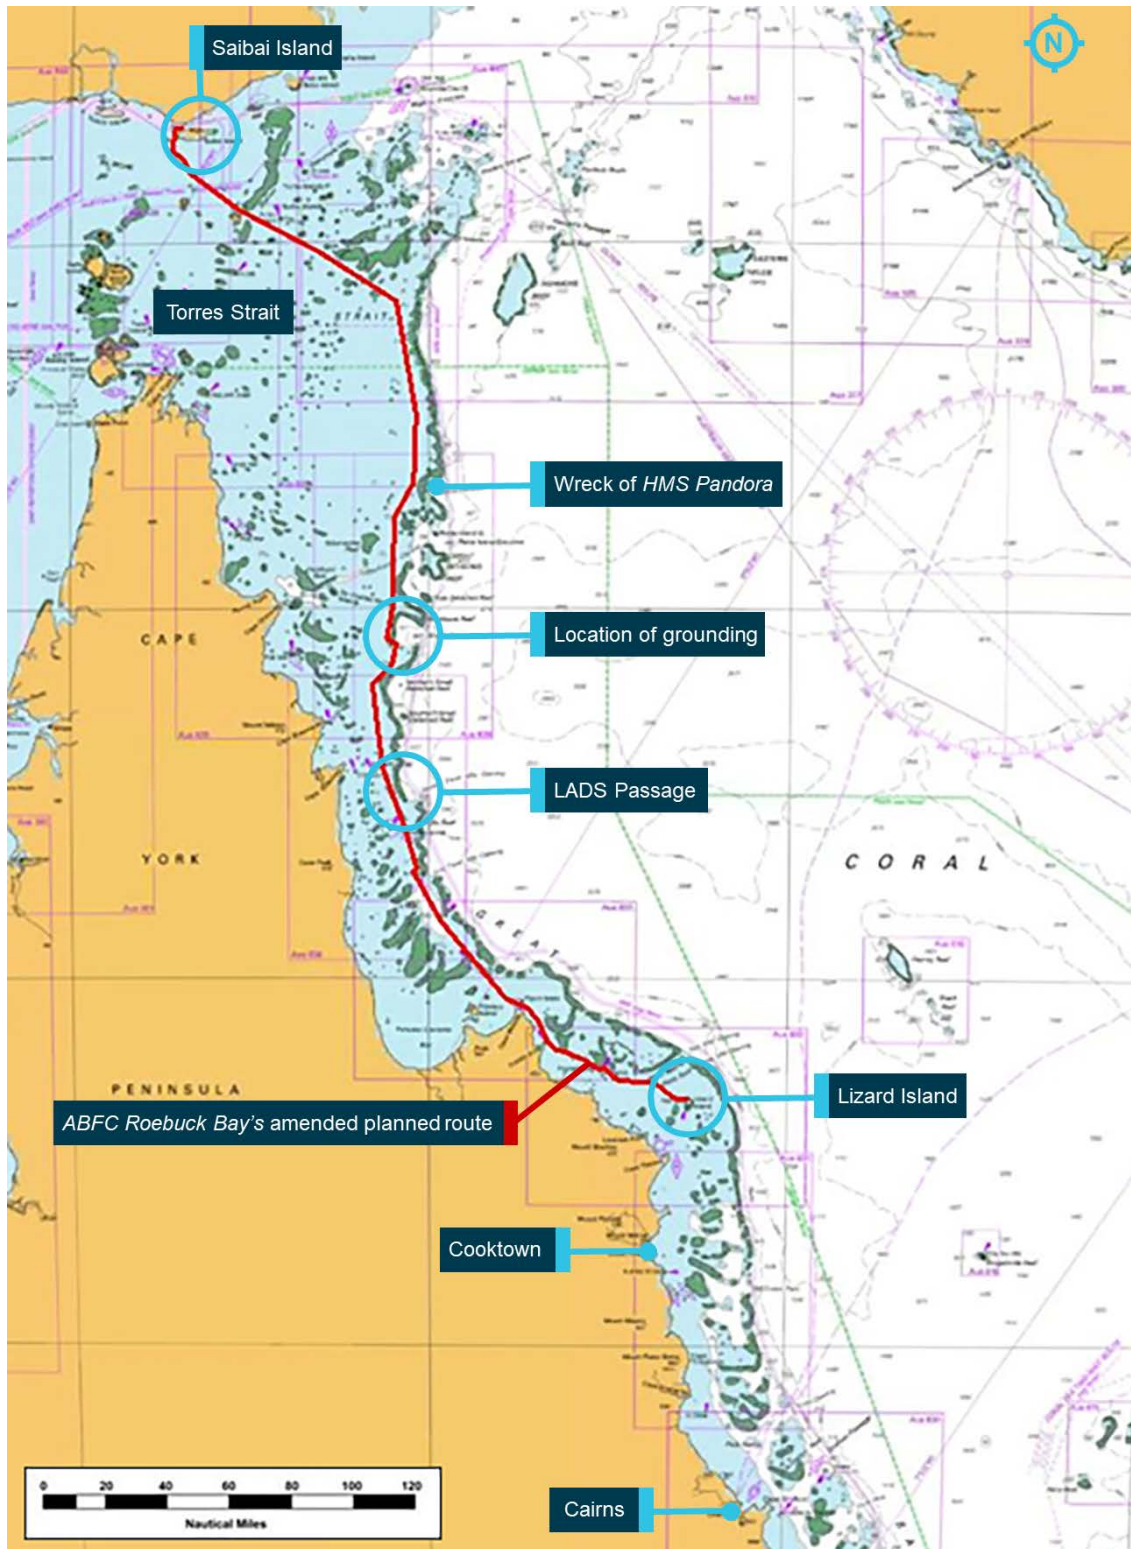
Figure 3: Section of navigational chart Aus 4620 showing ABFC Roebuck Bay's amended planned route and key locations

The master subsequently advised the navigation officer that the passage was to be split into two legs with a brief stop at Lizard Island, Queensland before continuing on to Cairns for the end of the patrol. The navigation officer split the master's amended route into two separate routes, from Saibai Island to Lizard Island (Figure 3) and then from Lizard Island to Cairns. No further changes were made to the route plan. The two routes were then saved on the cutter's ECDIS and named 'Saibai to Lizard via Outer Reef' and 'Lizard to Cairns'.

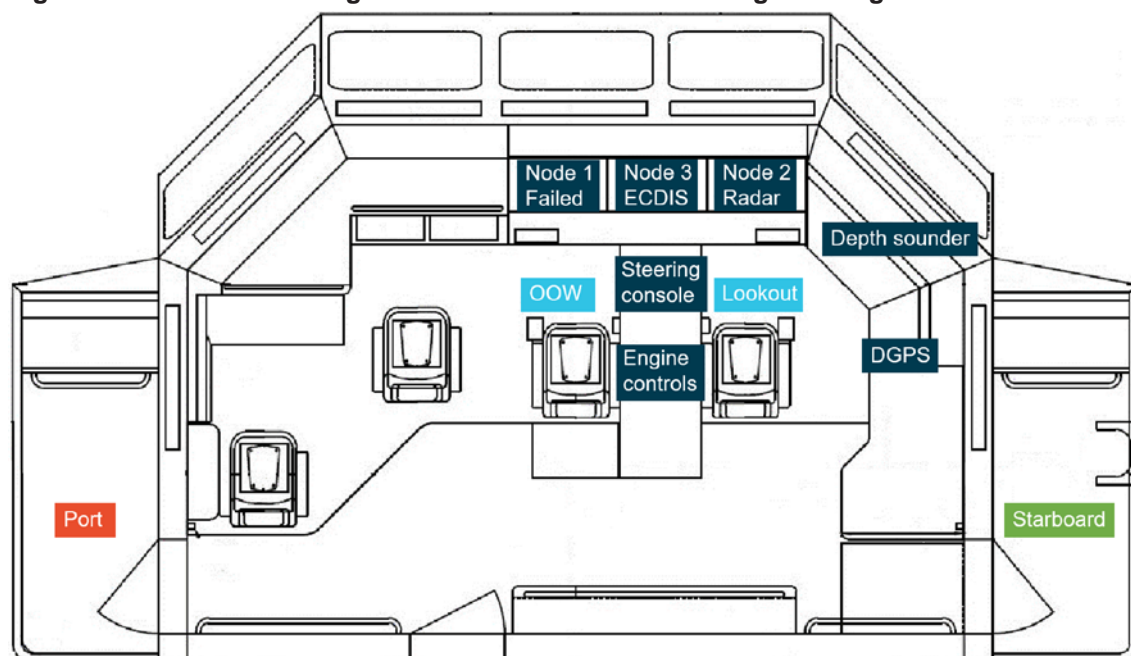
Figure 4: Locations of bridge team members at the time of grounding

While on watch, the OOW was seated with the non-functioning display to his front and slightly to his left with the ECDIS display to his front and slightly to the right. The lookout was seated in front of the radar display (Figure 4). The OOW used the ECDIS to gain an appreciation of the cutter's expected passage over their coming watch and briefed the lookout accordingly.

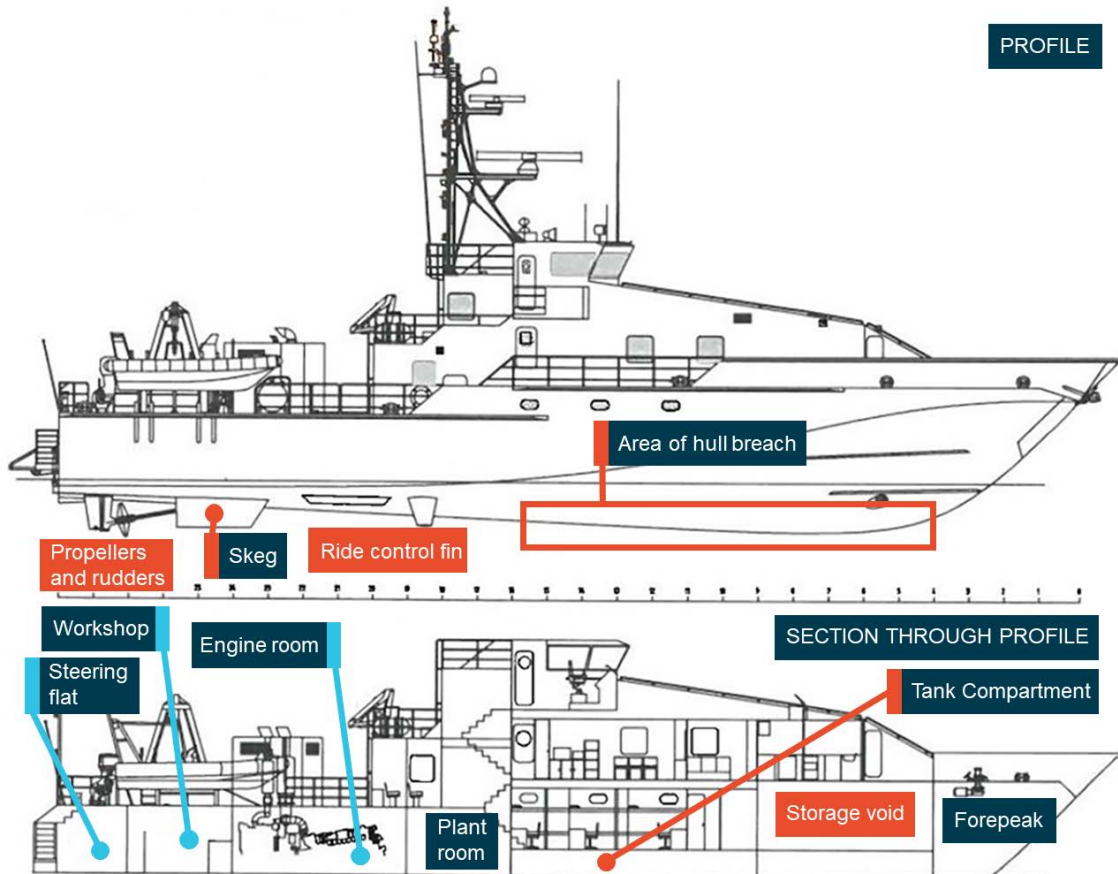
Figure 5: Section of general arrangement plan showing affected spaces

The master, woken by the impact of the grounding, went to the bridge and activated the general emergency alarm. The cutter's crew mustered, accounted for all personnel and immediately began implementing damage control measures. Initial damage reports indicated that there was water ingress to the storage void space and the tank compartment immediately aft of it, while other spaces and compartments appeared to be intact (Figure 5).

ABFC Roebuck Bay sustained serious damage as a result of the grounding rendering the cutter unseaworthy. The storage void space and tank compartment (Figure 5) were both breached and flooded in way of the keel section with significant seawater damage to all electrical fittings in the two spaces.

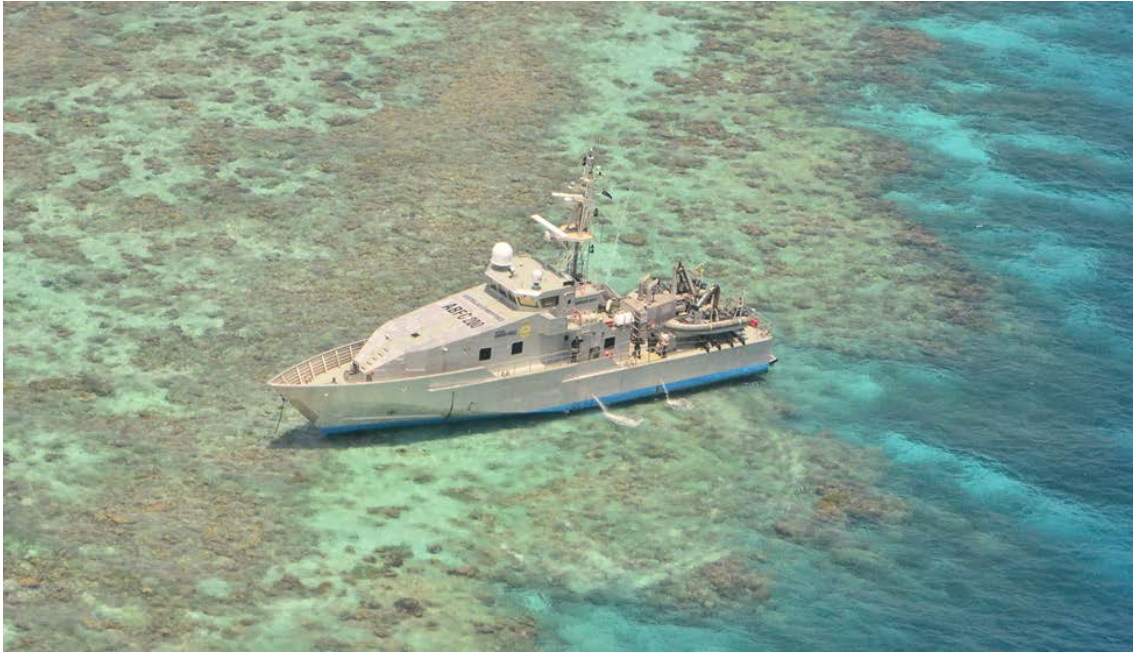
Figure 6: ABFC Roebuck Bay aground on Henry Reef

At 1127, an ABF aircraft conducted several passes of Henry Reef to obtain aerial photographs of *ABFC Roebuck Bay* aground (Figure 6). The weather remained relatively fair with the wind from the south-east at about 14 knots and a 1 m sea and swell.

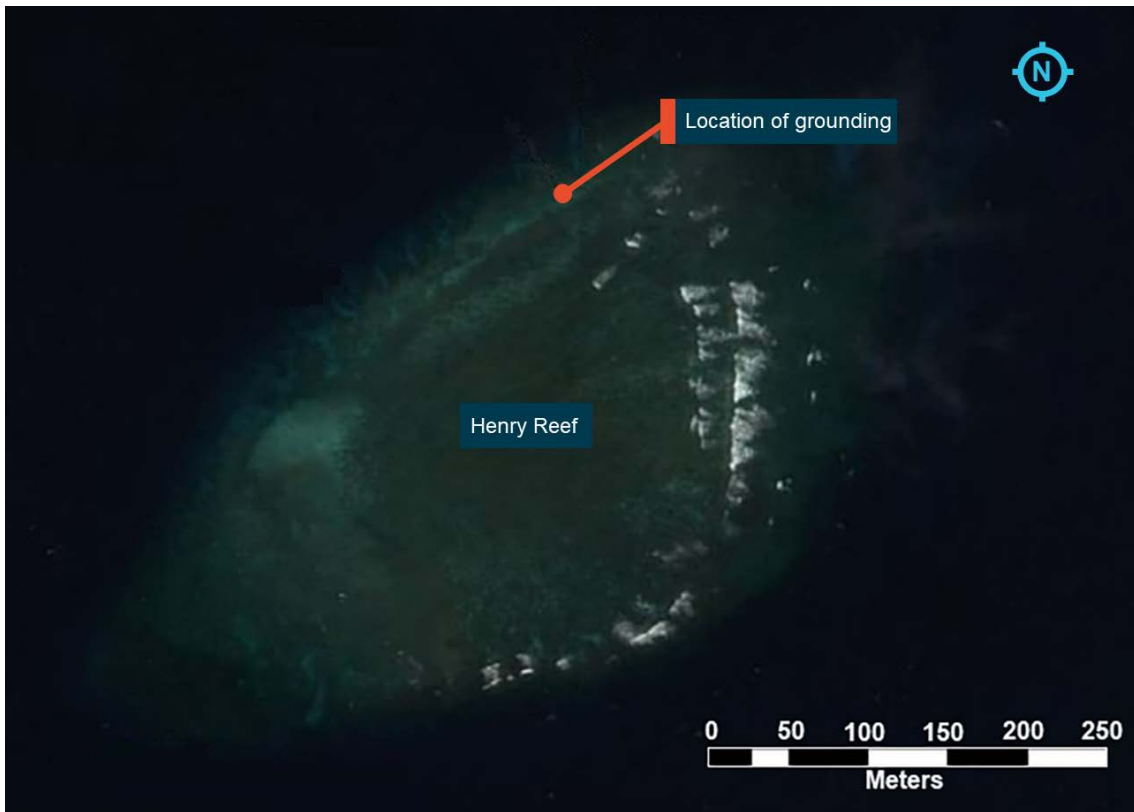
Figure 8: Aerial image of Henry Reef

Henry Reef (Figure 8) is located about 45 NM north-east of Lockhart River, Queensland on the south-western side of Wreck Bay in the outer Great Barrier Reef. The reef is roughly between 400 to 600 m in diameter and rises sharply out of the surrounding waters of a depth between 20 to 30 m. In places, the reef has a shallow shelf at a depth of about 5 to 8 m with the reef gently sloping up to the reef crest on the eastern flank at or about the lowest astronomical tide.
