Derailment of iron ore train M03544

near Walla, Western Australia | 3 December 2015

ATSB Transport Safety Report
Rail Occurrence Investigation
RO-2015-023
Final – 12 October 2018

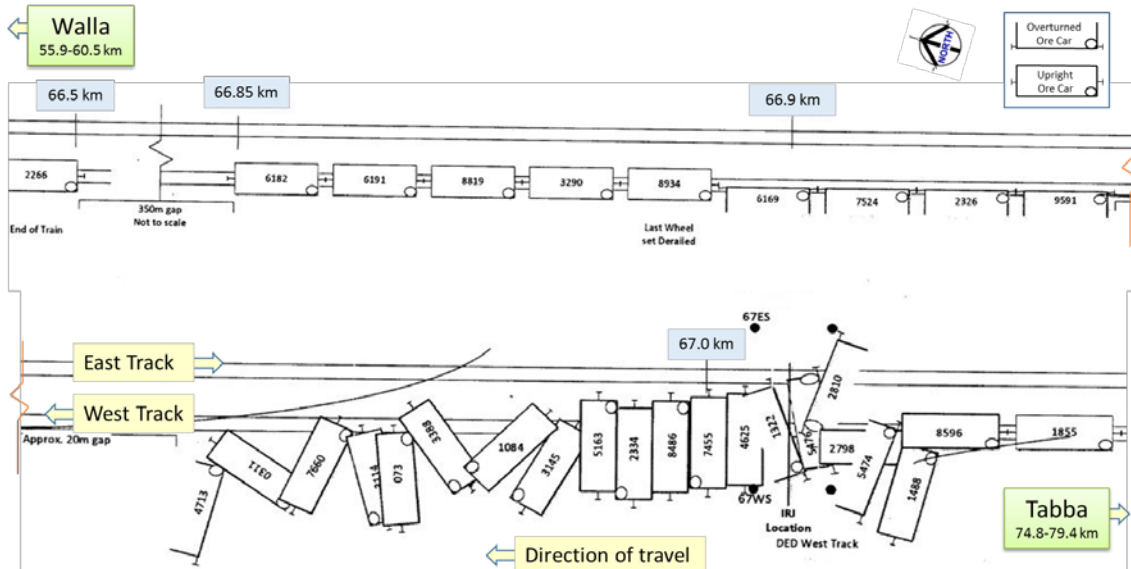
Figure 2: Diagram of the ore cars near the 67.0 km mark

The train driver found that two ore cars located at positions 80 (OC 2266) and 81 (OC 6182) in the 'B' rake portion of the train had separated (Figure 2). The gap between the cars was about 350 m but they had not derailed. At position 85 (OC 8934), the driver found the trailing axle on the trailing bogie had derailed. The next four ore cars (that is, immediately trailing OC 8934) had derailed and overturned onto the west side of the track but had remained coupled.

Trailing the four derailed cars on the west side of the track, there was a gap of about 20 m. The next group of 21 ore cars (positions 90 to 110) had derailed in the vicinity of the 66.950 km mark. The first 10 of these ore cars were severely damaged and had concertinaed to both the west and east sides of the west track. Some of the cars had come to rest at 90° to the direction of travel. A number of the derailed ore cars pushed the east track laterally out of alignment for about 10 m in an easterly direction.

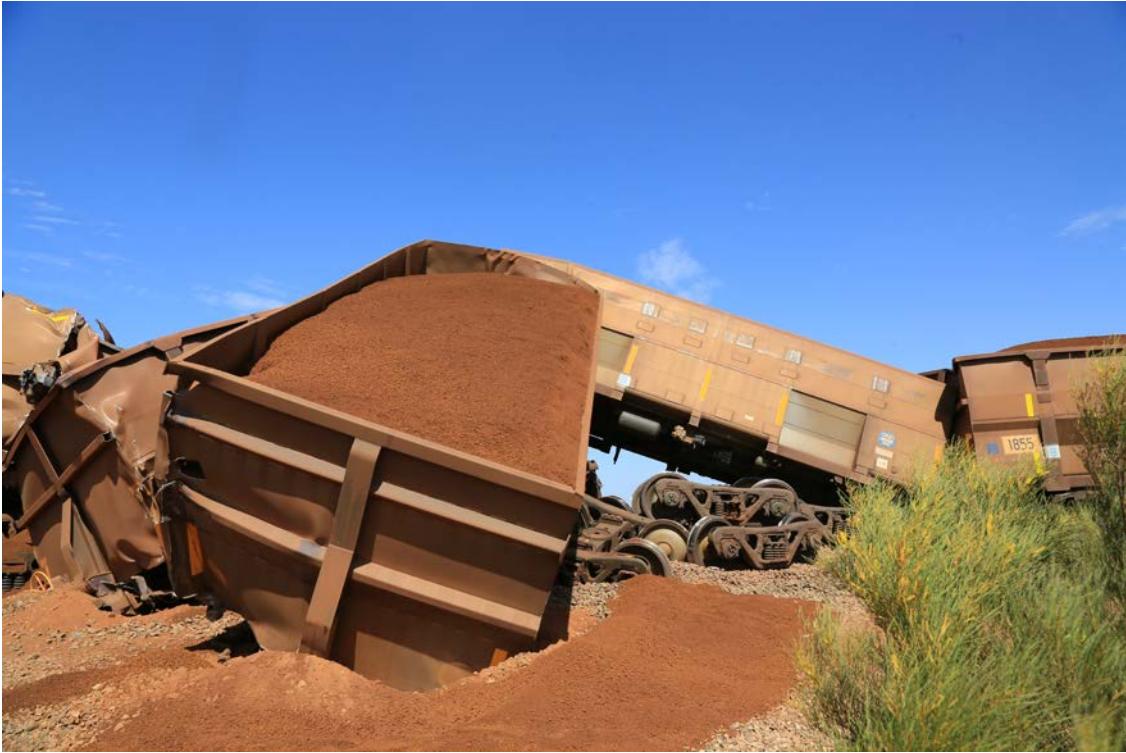
Figure 3: Derailed, loaded iron ore cars located in the rear portion of train M03544

The derailment resulted in significant damage to 26 ore cars (Figure 3) but no one was injured.

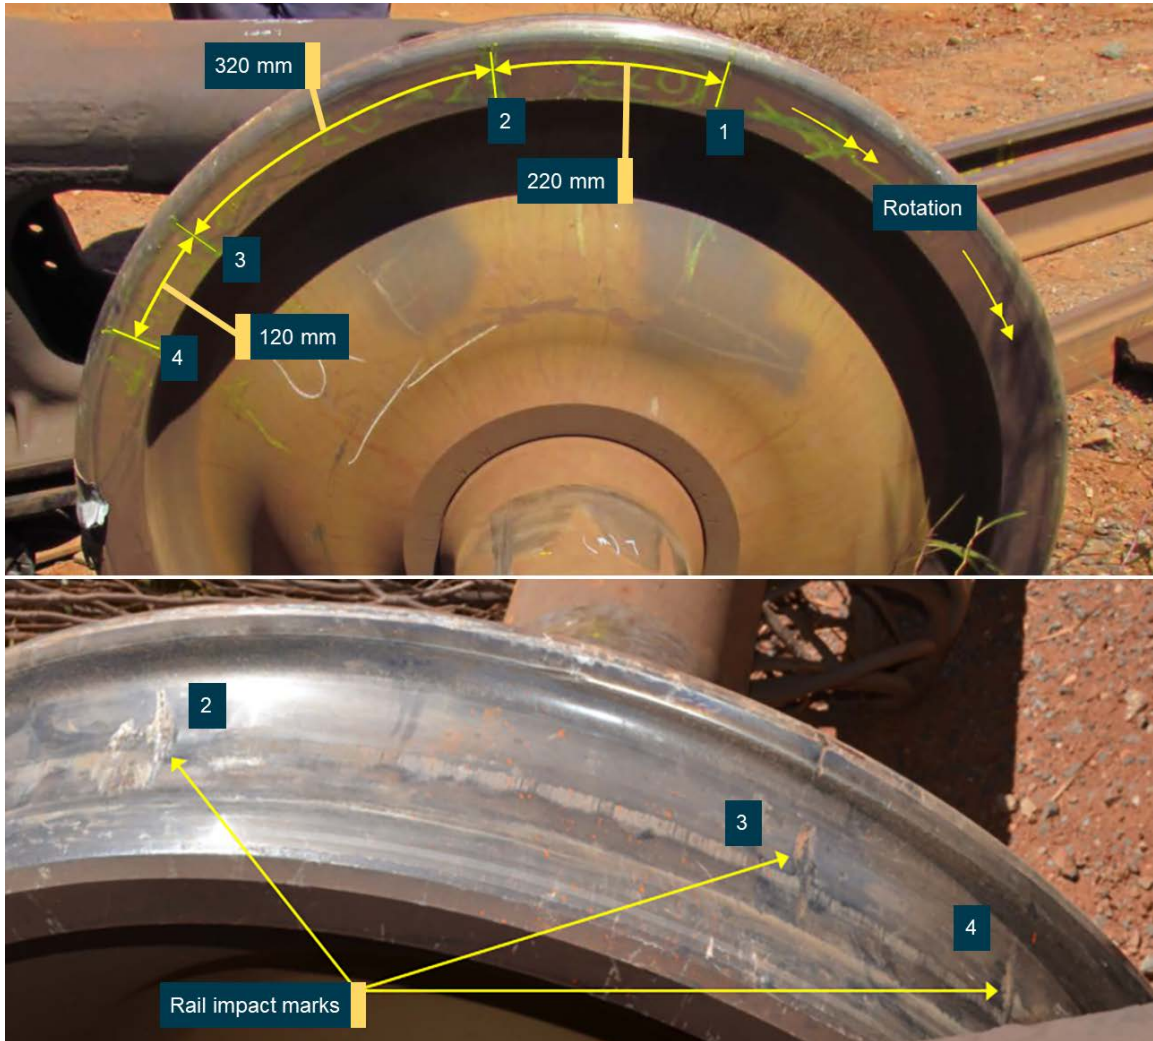
Figure 6: Ore car 8934 - wheelset 2L impact marks from broken rail segments

Wheelset number 2L of ore car 8934 showed four wheel tread surface impact marks (Figure 6 & Figure 7). In the direction of wheel travel/rotation, the impact marks were intermittently spaced, generally oval-shaped about 45 mm long and angled at about 90° to the wheel flange.

The top photo shows the radial spacing of the rail impact marks viewed from the back of the wheel. The bottom photo shows three of four corresponding rail impacts looking from the front of the wheel. Enlarged details of the four rail impact marks are shown in Figure 7. Source: BHP Billiton, annotated by ATSB.

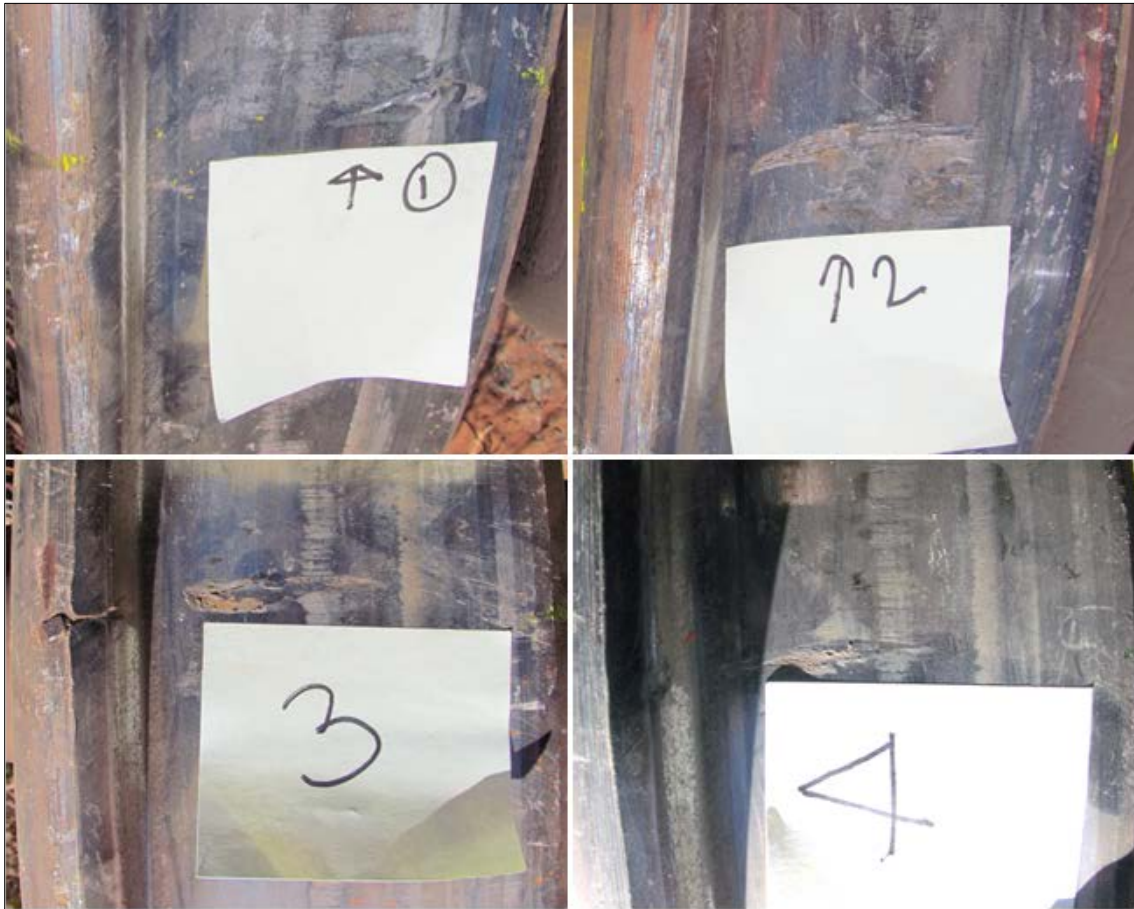
Figure 7: Enlargements of the four rail impact marks ore car 8934 - wheelset number 2L

Numbered 1 – 4, corresponding rail impact bruises on the wheel tread surface (Figure 6) on ore car 8934 - wheelset #2L. All impact marks are transverse, angled about 90° across the tread surface. - Source: BHP Billiton.

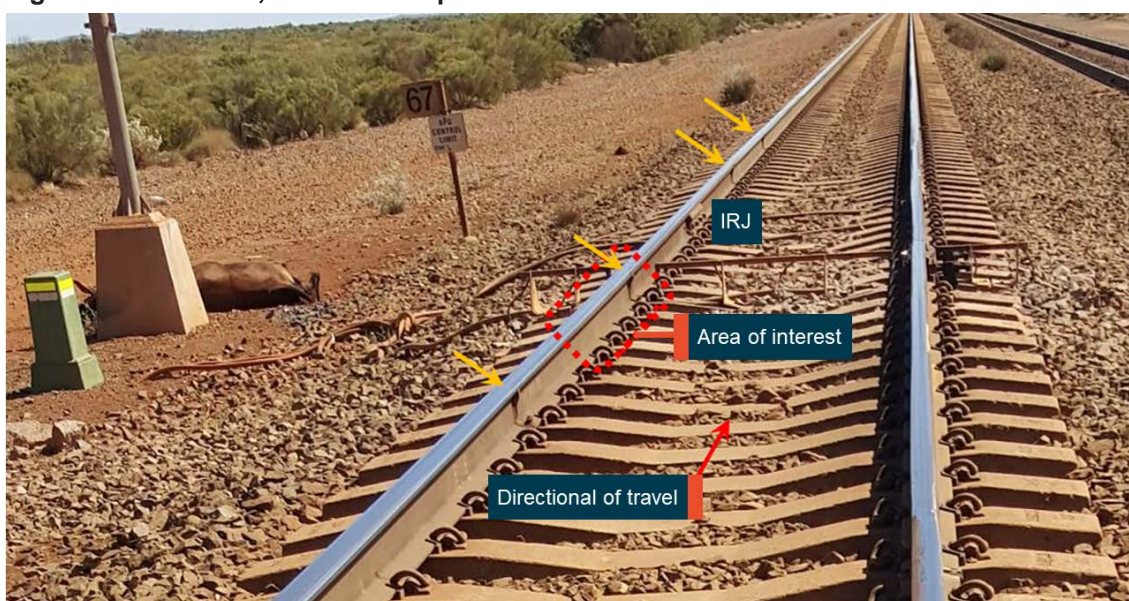
Figure 8: West track, location of repairs to rail sections near the 67 km mark

Welding records showed that the insulated rail joint⁸ (IRJ) located at the 67 km mark was replaced on 5 September 2015 (Figure 8).

Video image capture of the west track showing the east and west rail near the insulated rail joints at the 67 km mark. There were a number of welds in close proximity (orange arrows). Source: Rail Technology International, annotated by ATSB

Records showed repairs on the west rail were carried out on 5 September 2015 to the broken IRJ at the 67.00 km mark. The most recent previous break of the IRJ at the same location had occurred on 25 June 2015.

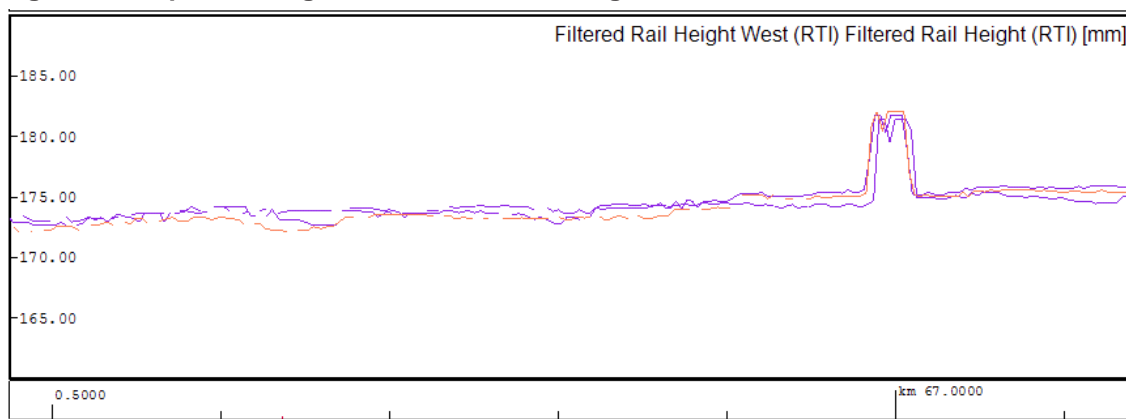
Figure 9: Graph showing the variation in rail height near the IRJ at the 67 km mark

On the Newman west track for a distance of up to 10 m either side of the IRJ at the 67.0 km mark, rail height was measured at about 183 mm. The rail height on each side of those higher rail sections was about 11 mm lower at 172 mm (Figure 9).

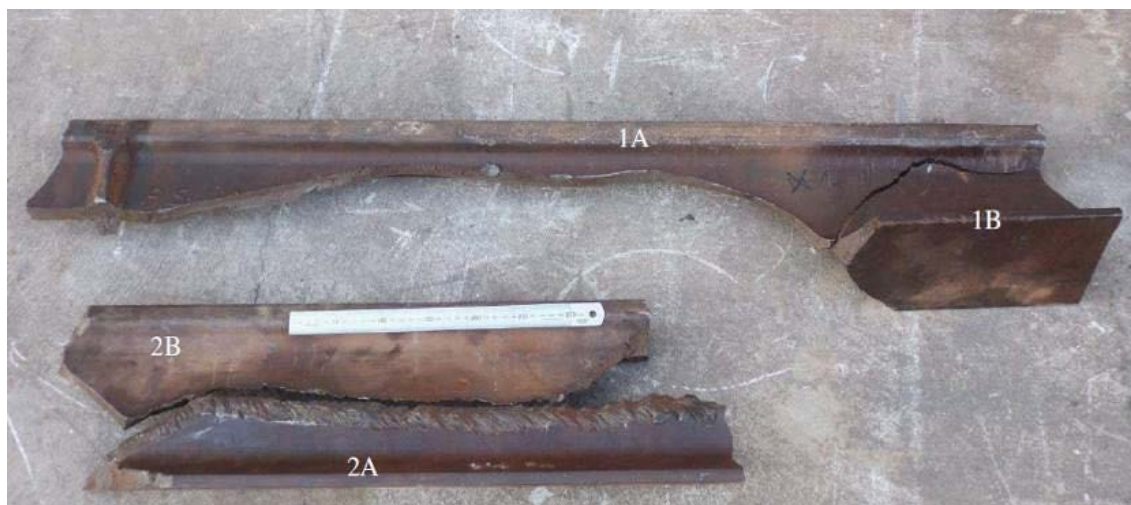
Figure 11: Broken rail with fatigue cracks

Following derailment of train M03544, BHP Billiton (BHPB) commissioned a series of investigations into the incident. The investigations concluded that the derailment most likely occurred due to a broken rail on the west track near the 67 km location. The cause of the broken rail was attributed to an undetected transverse defect that likely resulted from rolling contact fatigue (RCF). The defect was found in a 1.1 m length of rail retrieved from the derailment site (Figure 11).

The provider of ultrasonic rail testing for the occurrence track, Rail Technology International (RTI), disagreed with BHPB's finding as they concluded that that 1.1 m length of rail was 'highly unlikely' to have been in service at the time of the derailment. This conclusion was based on a number of factors such as weld finish, appearance/condition of the fracture surface, and size and number of defects. The ATSB conducted a review of the evidence and concluded:

- The weld finish in the 1.1 m section was consistent with welds in the vicinity of the 67 km mark.
- The oxidised appearance/condition of the fracture surfaces resulted from water being used onsite to wash the surface in preparation for detailed photography.
- Specialist metallurgical examination of the section concluded that the fracture surfaces were only lightly corroded. That was consistent with a relatively recent failure.

Considering all of the above, the ATSB concluded that the 1.1m broken section of rail was probably in service immediately prior to the derailment and not from a previous rail failure.

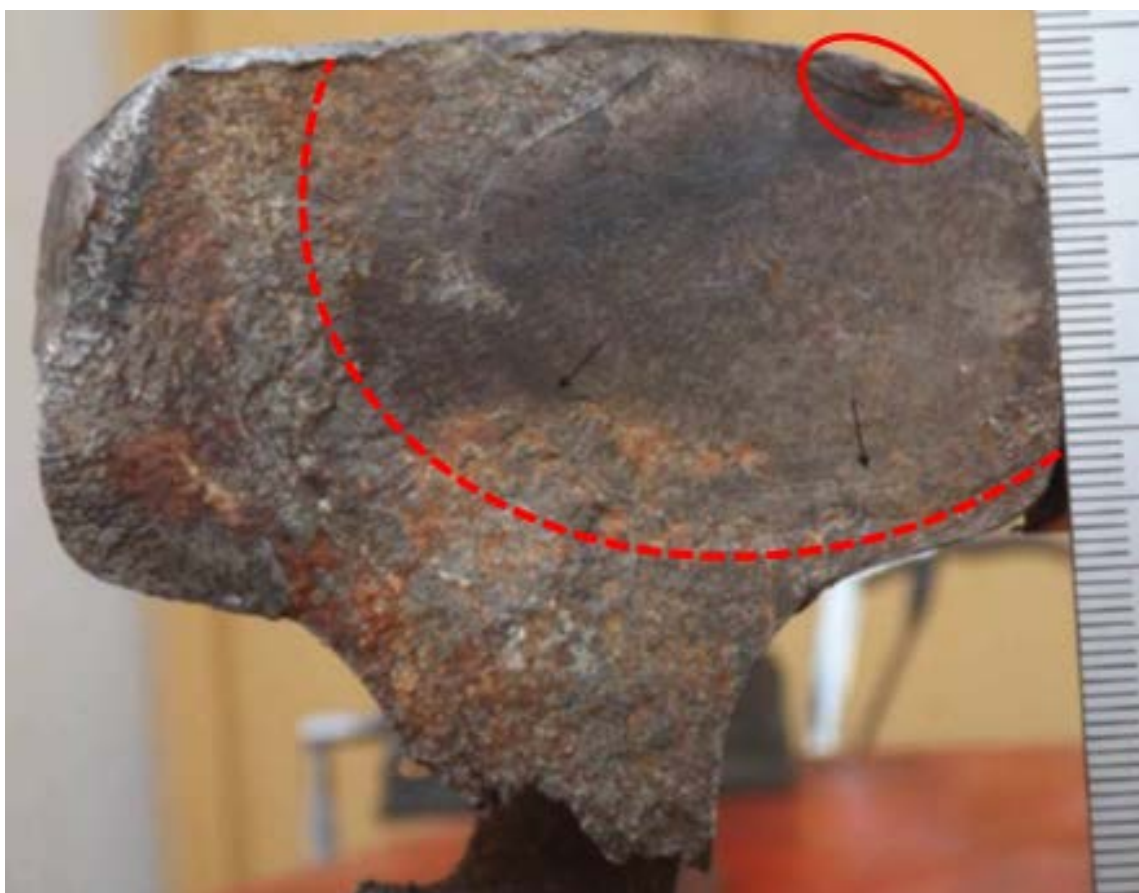
Figure 12: Large fatigue crack in rail section

Specialist analysis of the recovered rail found that the fracture initiated at two fatigue-related transverse defects (Figure 12), with the remainder of the fracture occurring relatively quickly due to overload associated with passage of train M03544.

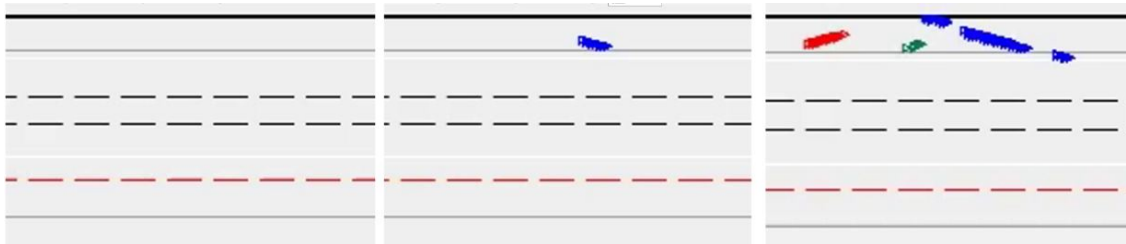
Figure 13: Ultrasonic indications

(left – 15 November, centre – 25 November, right – 29 November)

Specialist reports commissioned by BHPB, and authored by NTS Ultrasonics and Aben Technical Services, also assessed the variations in signatures at that location across the three dates in November 2015. Those reports both supported a conclusion that the signals were indicative of a developing transverse defect, with the NTS Ultrasonics report stating that:
