Runway lighting event involving Beech B200, VH-FDL

Cairns Airport, Queensland, 11 March 2018

ATSB Transport Safety Report
Aviation Occurrence Investigation
AO-2018-024
Final – 16 October 2018

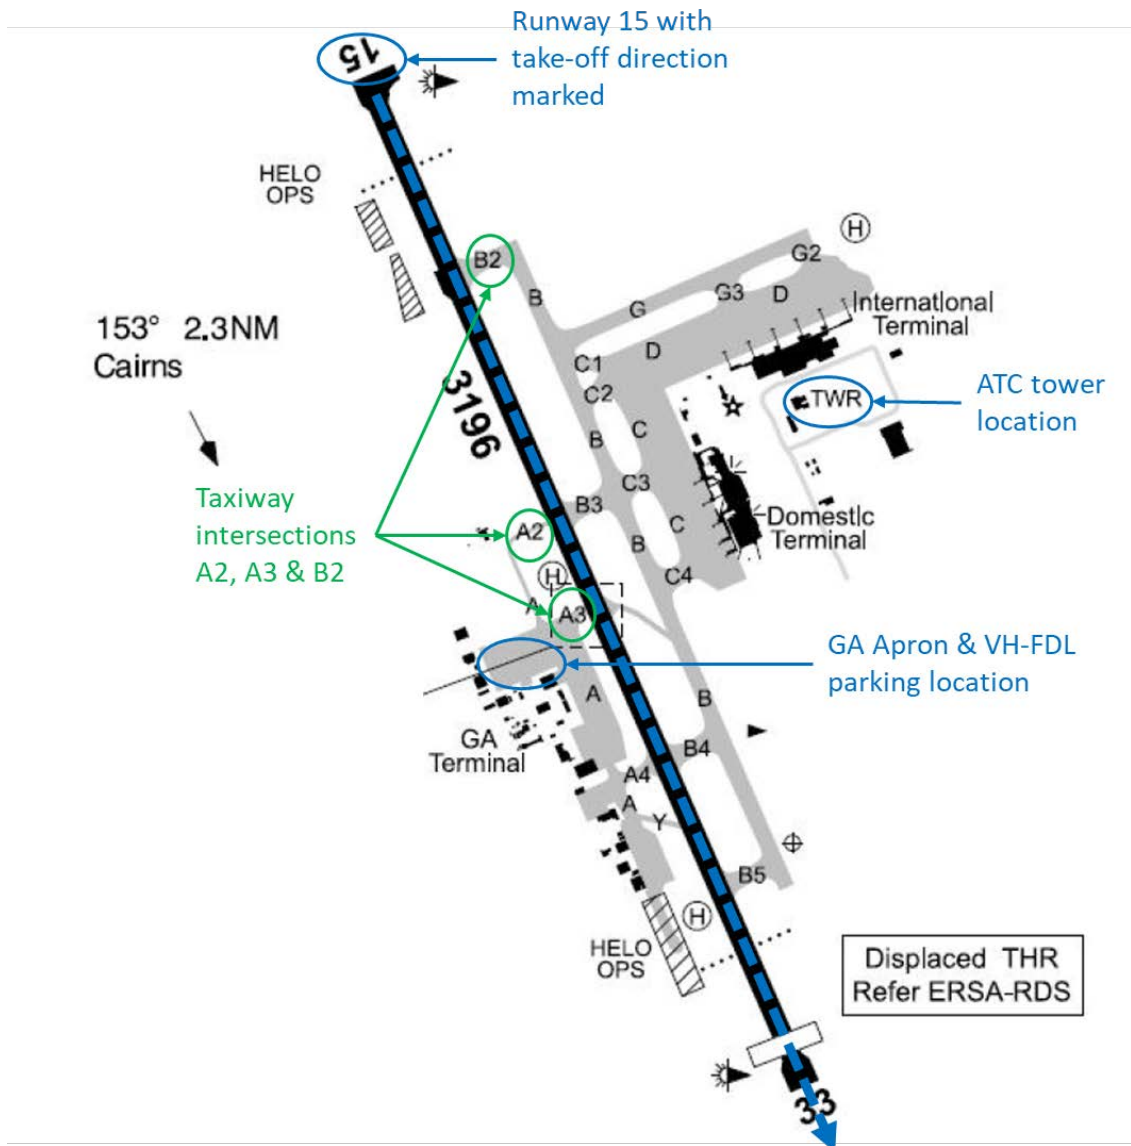
Figure 1: Cairns Airport runway, taxiway and terminal map

At about 0024, an emergency services helicopter departed Cairns with the crew using night vision goggles. The Cairns duty air traffic controller did not activate the runway lights for this departure as it may have interfered with the crew's night vision goggles. Eight minutes later, at 0032, the pilot of FDL requested clearance from the controller to conduct flight FD493, a medivac flight from Cairns to Townsville. The aircraft had five persons on board; the pilot, two medical crew members, a patient and a passenger (a relative of the patient). The controller granted the clearance and the pilot then requested permission to taxi and backtrack runway 15 to abeam taxiway A2 for departure. In response, the controller issued the instruction to taxi to holding point A3 (Figure 1).

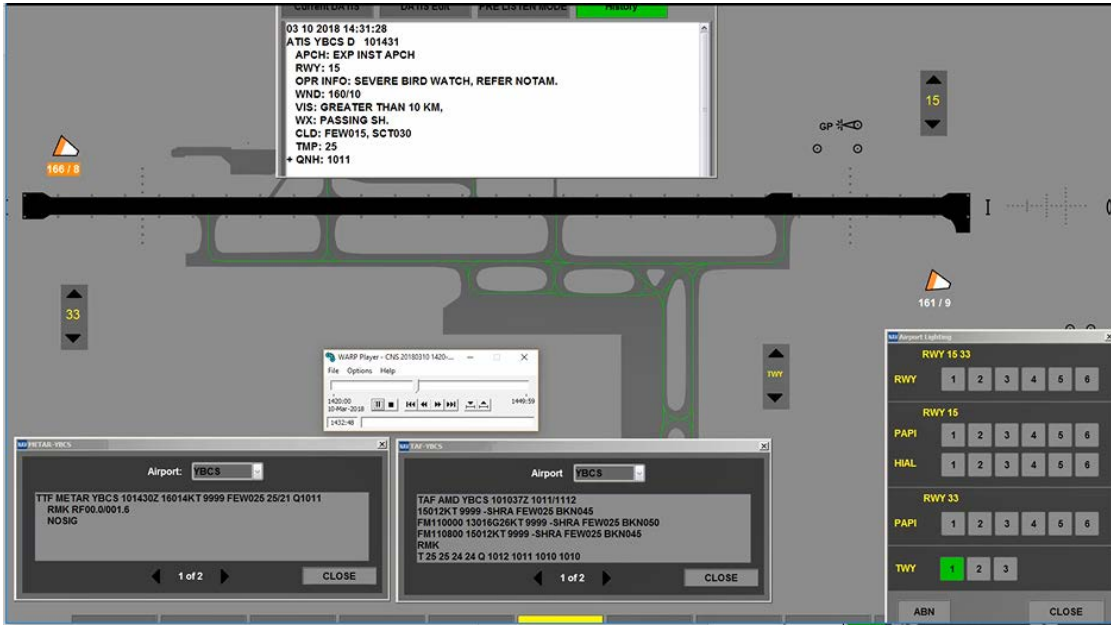
Figure 2: INTAS aerodrome layout display with field lighting popup

The runway lights were managed by air traffic control (ATC) via the INTAS system control panel. Confirmation of the system state (on/off and intensity) was presented on the INTAS aerodrome layout display and field lighting popup (shown together in Figure 2). The controller could also check the status of the runway lights by looking outside the tower, although HIRL can only be seen by looking towards the southern threshold due to the directionality of their light emission.

A part of the INTAS display, showing airfield lighting system status at time of the incident flight in the field lighting pop-up (bottom right). When activated, the selected light intensity level would have been displayed in green, for example, taxiway (TWY) light level 1 is active. Source: Airservices Australia

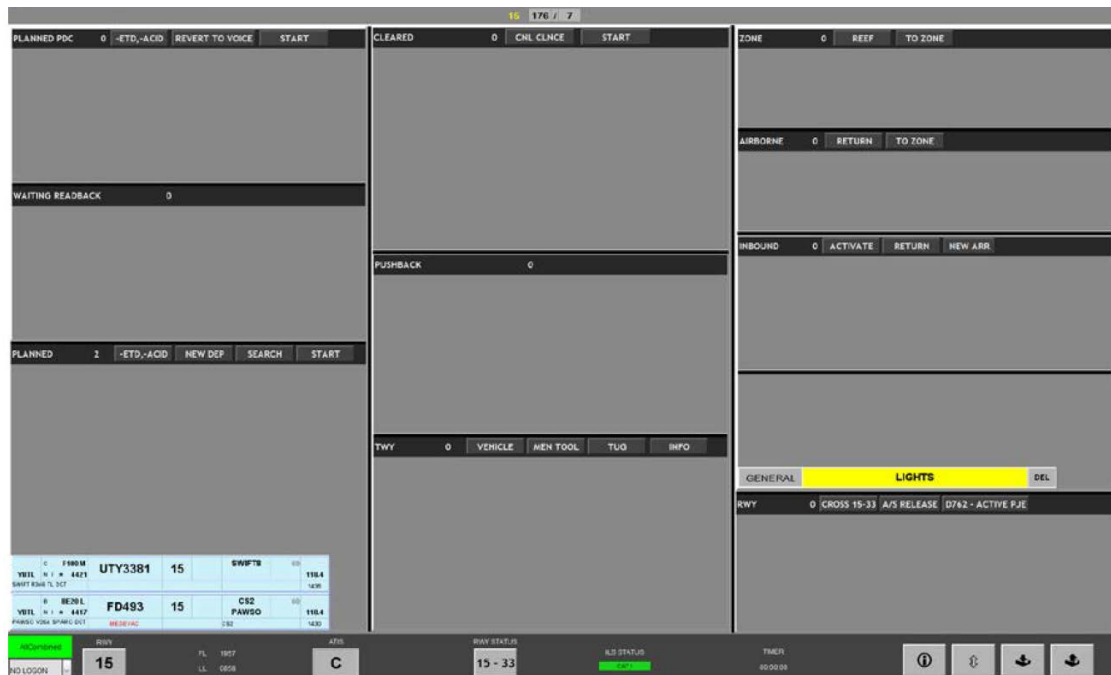
Figure 3: INTAS flight progress strip display

The controller reported that he used the 'LIGHTS' annunciation on the INTAS flight progress strip display as a memory prompt to aid him to perform the task (Figure 3). He reported that he continuously displayed the 'LIGHTS' memory prompt during night-time hours and that this display was independent of the status of the runway lights (on or off).

A part of the INTAS display, showing LIGHTS prompt in the right-hand column placed above the runway (RWY) panel. Source: Airservices Australia

The controller described his use of the 'LIGHTS' memory prompt in INTAS as a passive risk control measure. The memory prompt was left on screen for the entire period from last light to first light, independent of the status of the runway lights (on or off). In addition, the work flow in INTAS for a departing aircraft did not require the controller to pass the flight progress strip of this flight through the 'LIGHTS' prompt when it was moved from the taxiway to the runway.

Continuously displayed prompts, which do not require action or provide a barrier to other actions, may lead to user de-sensitisation. Over time, this may have resulted in the controller not processing the 'LIGHTS' prompt in his workflow.

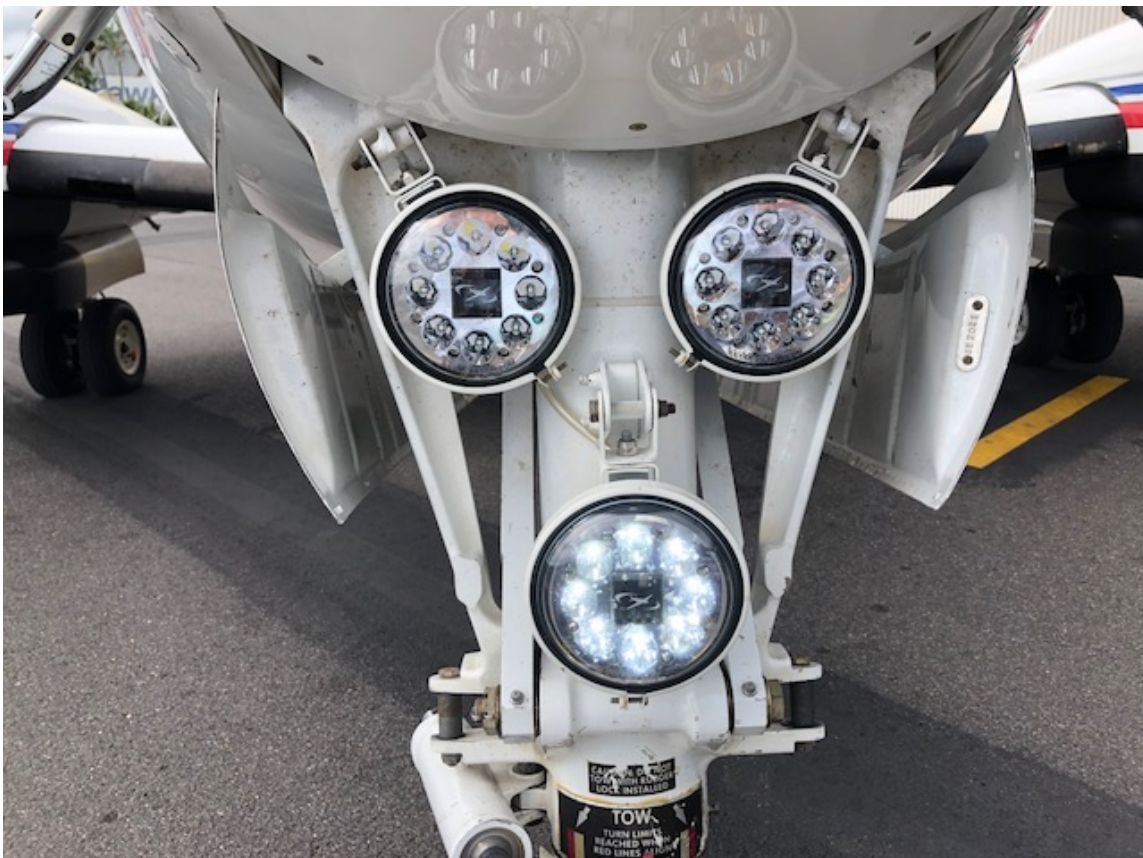
Figure 4: RFDS Beech B200 landing and taxi lights

The flight was operated with a single pilot, in line with RFDS practice. As such, the pilot in command conducted all communication, aircraft preparation and surface navigation tasks before and during taxi. The nature of the service provided by the RFDS frequently required operation into temporary or makeshift aircraft landing areas that had poor or no lighting. In response, the RFDS had equipped their fleet of B200 aircraft, including FDL, with upgraded LED landing and taxi lights that provide a significant increase in illumination (Figure 4).

The nose gear of a RFDS Beech B200 fitted with LED lights for landing (outer) and taxi (centre). Source: Royal Flying Doctors Service

The pilot's view from the cockpit of FDL, once aligned on the runway for backtrack and then take-off, would have included light from the strong aircraft landing lights reflected in the inactive HIRL. The presence of this reflected light along with that of several other light sources from a generally well-lit aerodrome would have resulted in significant light being presented to the pilot when conducting his visual scan.

This reflected and environmental light, along with the absence of a specific check for runway lights resulted in the pilot not realising that the runway lights were not active prior to commencing his take-off. When FDL rotated⁷ for take-off the aircraft lighting was directed away from the runway lighting, and the loss of the reflection provided an illusion to the pilot that the runway lighting extinguished as soon as the aircraft became airborne.
