# Derailment of freight train 1501S

Near Dry Creek, South Australia | 28 July 2017

**ATSB Transport Safety Report**  
Rail Occurrence Investigation  
RO-2017-008  
Final – 31 October 2018

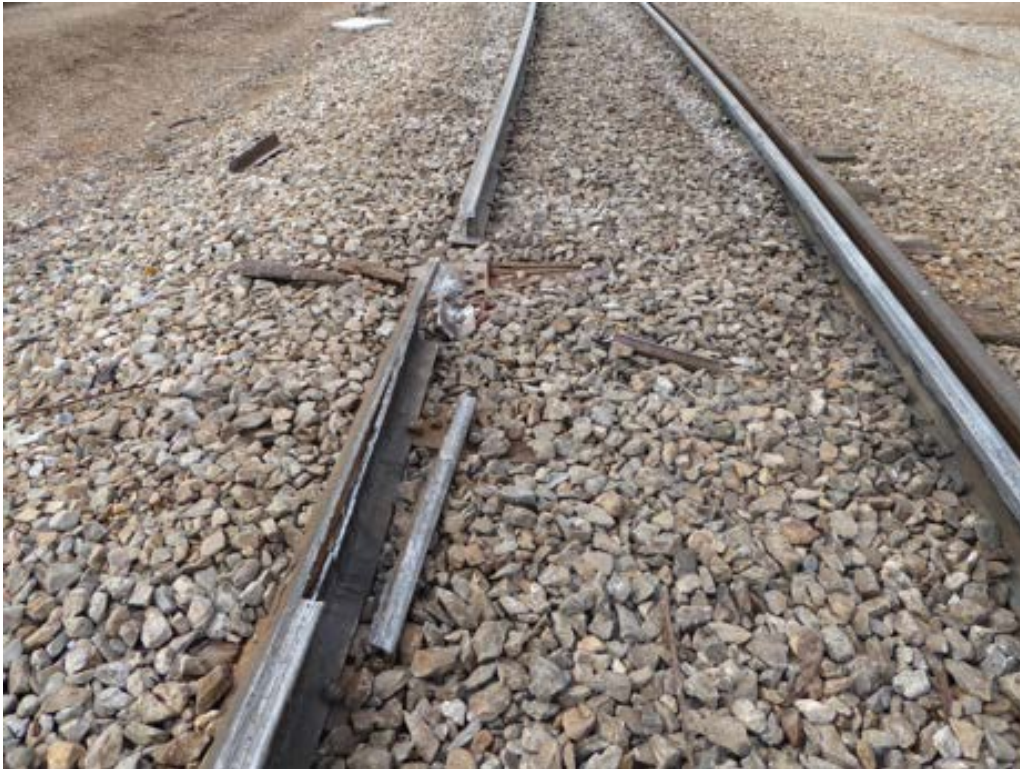
The ATSB found a vertical split head defect had developed undetected from imperfections introduced during the manufacture of the rail 90 years ago. The defect propagated vertically and longitudinally, roughly through the centre line of the lower leg rail in the curve approaching Dry Creek South.

**Fractured rail section in lower rail of curve**

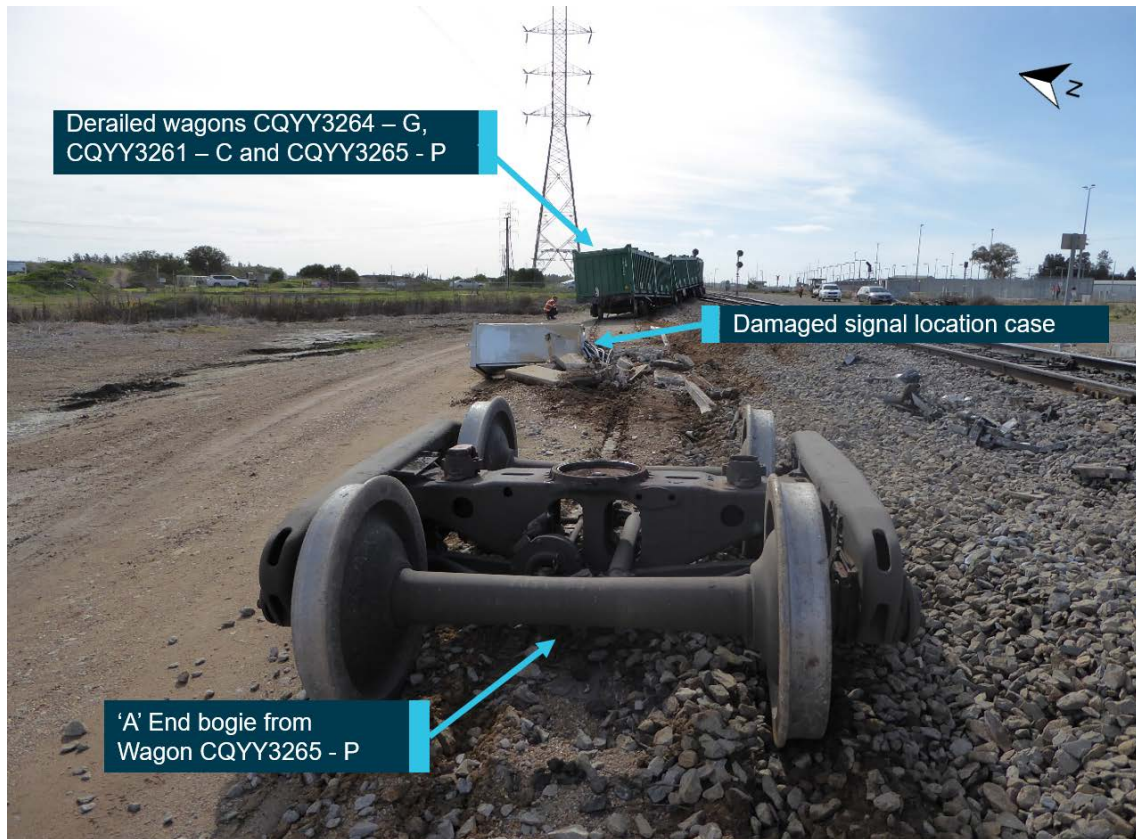
At about 0626, an ARTC signal maintainer arrived onsite to investigate the cause of an earlier reported fault; that is, signal 1 not clearing. Shortly after, the signal maintainer contacted the NCO advising that the rear of train 1501S had derailed and there was substantial damage to the wagons, track, location case<sup>6</sup> and other signalling infrastructure (Figure 2).

**Figure 2: Derailed rear three wagons of 1501S and damaged signal 5 location case**

At about 0627, the driver of train 1501S contacted the NCO confirming that the last three wagons (CQYY 3264-G, CQYY 3261-C and CQYY 3265-P) had derailed. The wagons had travelled about 285 m in a derailed state before train 1501S stopped.

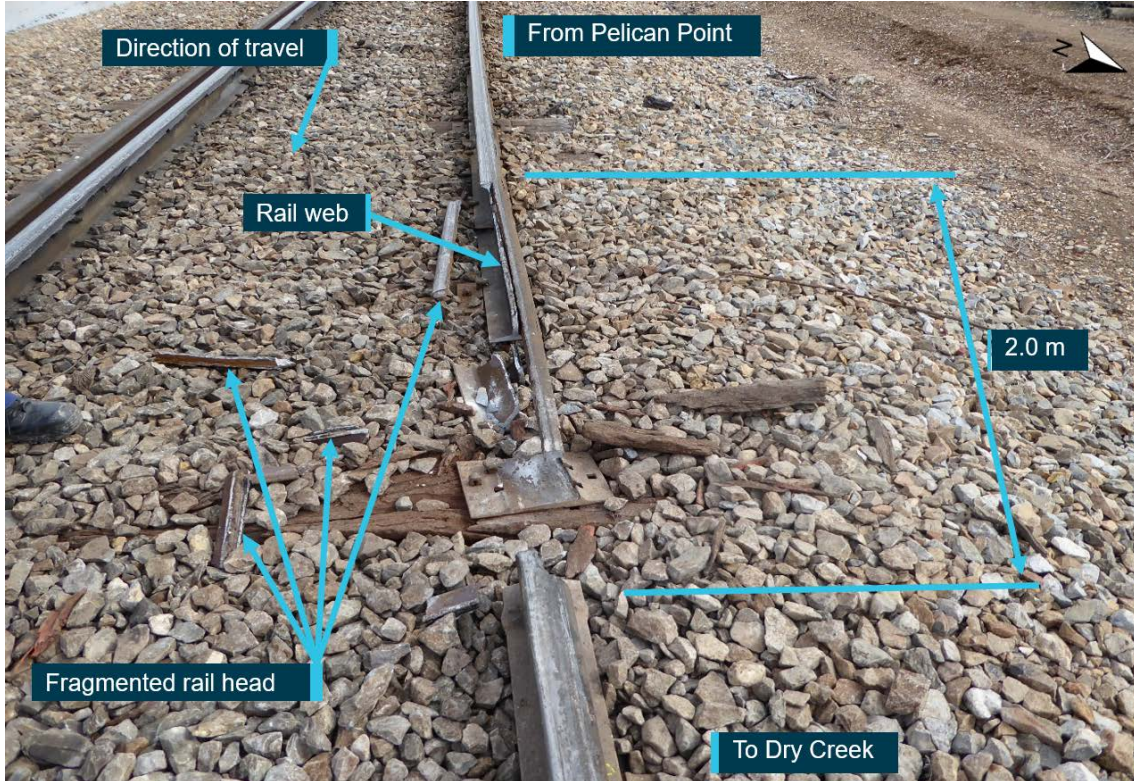
An inspection of the track identified a 2 m section of rail had fractured, on the lower leg of the left curve (Figure 3).

**Figure 3: Fractured section of rail**

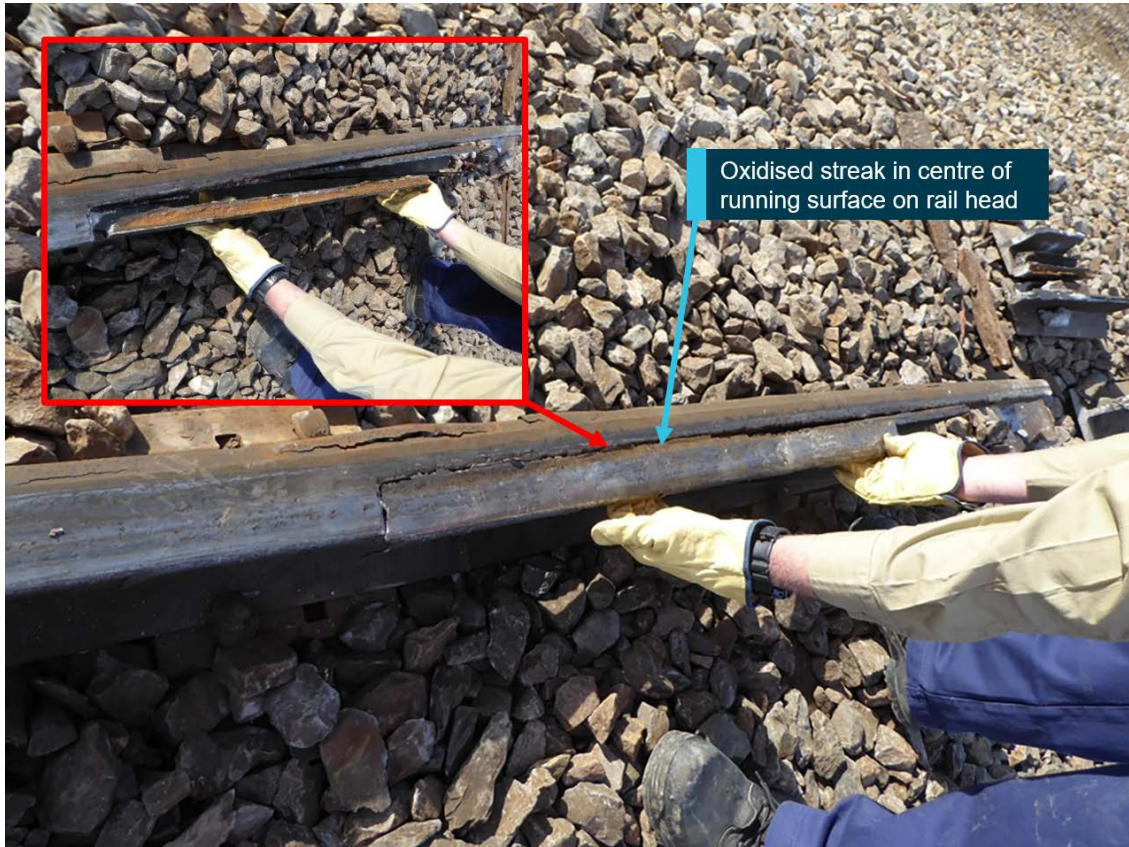
The railhead had split vertically and longitudinally, roughly through the centre line of the rail in the affected section. The split propagated through to the head/web transition region and outward through the railhead toward the gauge side of the rail, separating the head from the web<sup>7</sup> (Figure 4).

The web had also fractured at several points through the affected section. These breaks were predominately vertical through the web, and transverse in the foot of the rail. The breaks through the web were due to overstress, which probably occurred during the passage of the previous train 1122, and the subsequent passage of 1501S that derailed.

**Figure 4: Vertical split head section**

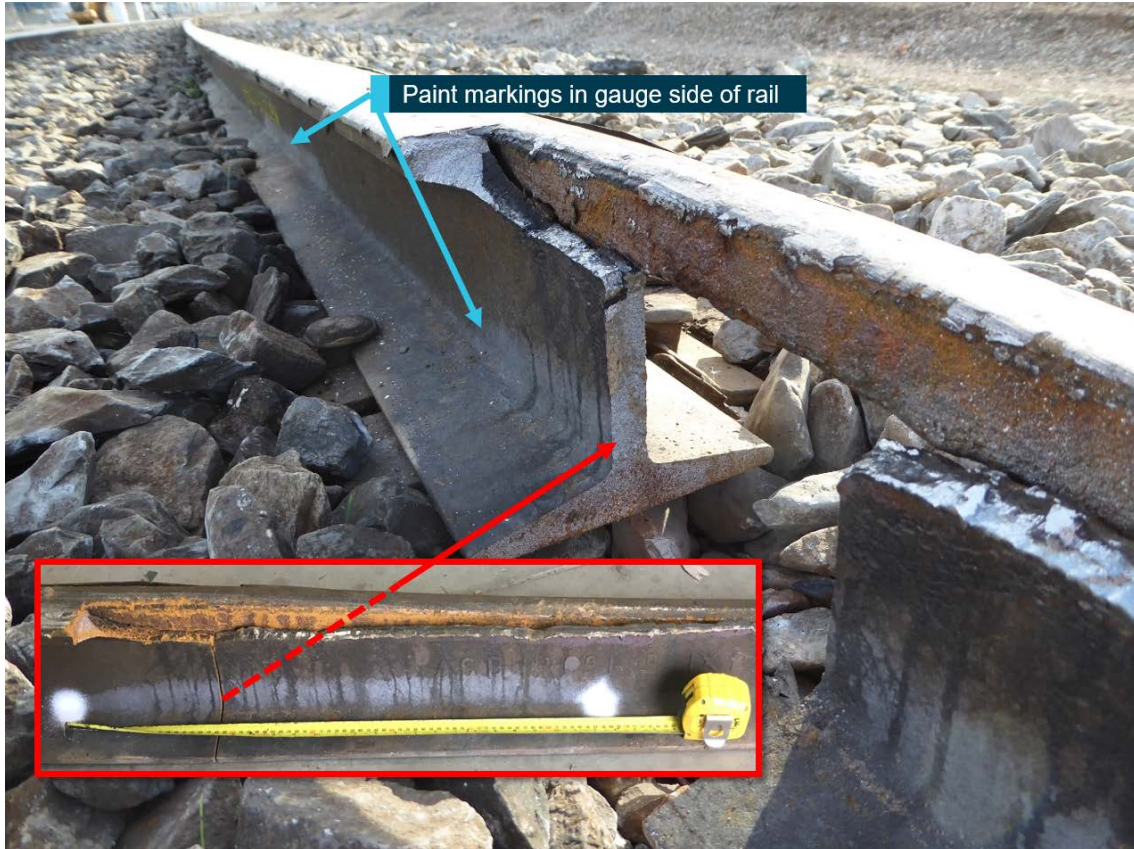
While the presence of a vertical split head defect may not display as a distinctive signature in the reflected signal on the operators screen, there are signature patterns that may indicate a potential issue. A vertical defect in the railhead may present as a loss of back wall echo (LBWE), where the signal from the 0° probe is deflected, thereby causing the reflected signal from the base of the rail (foot) to drop below a pre-defined level.

The prolonged LBWE event and continued difficulty experienced in testing should have triggered the next level of response action. If rail could not be tested or only partly tested, due to ultrasonic shielding, ARTC required the operator to test the affected area by hand or to forward a *Rail Surface Condition Report* detailing the circumstances that impeded the testing. Neither a response action nor a condition report was initiated in this case.

**Figure 8: Failed section of railhead showing markings from ultrasonic car testing**

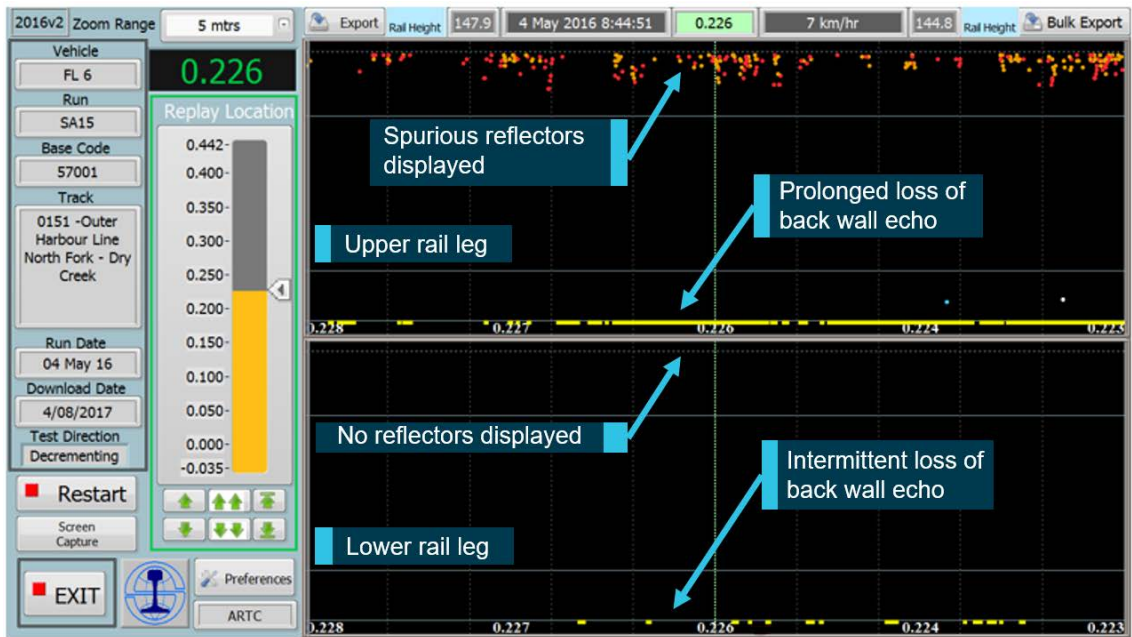
The previous ultrasonic test of rail in the Dry Creek area occurred in May of 2016. This test also recorded an intermittent LBWE in the same vicinity. Prolonged periods of LBWE also occurred on the opposite rail (Figure 9) illustrated at the 0.226 km mark. Similarly, there was also no record of retesting or the lodgement of a surface condition report. It is likely that the operator on this occasion also assessed the spurious reflectors and LBWE were, in the absence of defined defect signatures, due to the poor surface condition of the railhead.

Figure 9: Ultrasonic signatures at 0.226 km point 04 May 2016

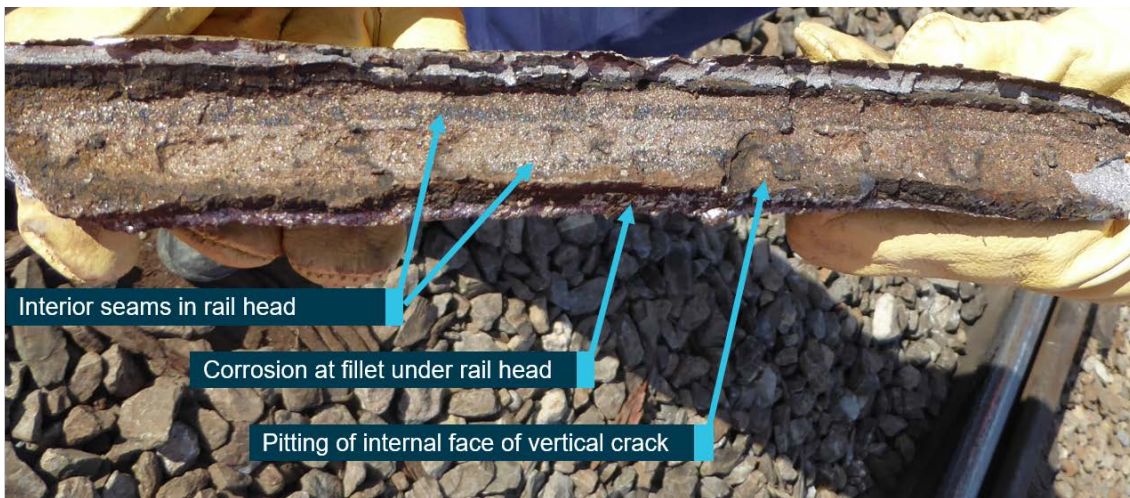
On-site examination of the section of rail showed evidence of an internal seam extending vertically within the centreline of the railhead. The seam surfaces were heavily corroded and punctuated by an elongated band of inclusions and oxidation located at a depth of around 10 mm from the running surface of the railhead (Figure 10). The general appearance and orientation of the inclusion banding indicated that it was pre-existing and very likely to have been produced when the rail was cast at the time of manufacture. Fatigue cracking had developed from the inclusion bands and had then propagated toward the railhead-running surface and the web transition region, creating a 'vertical split head'. Typically, longitudinal crack propagation is influenced by a combination of increasing axle loads, wheel impacts or eccentric loading on a railhead exhibiting a flattened profile.

**Figure 10: Railhead section detailing interior seam of inclusions/imperfections**

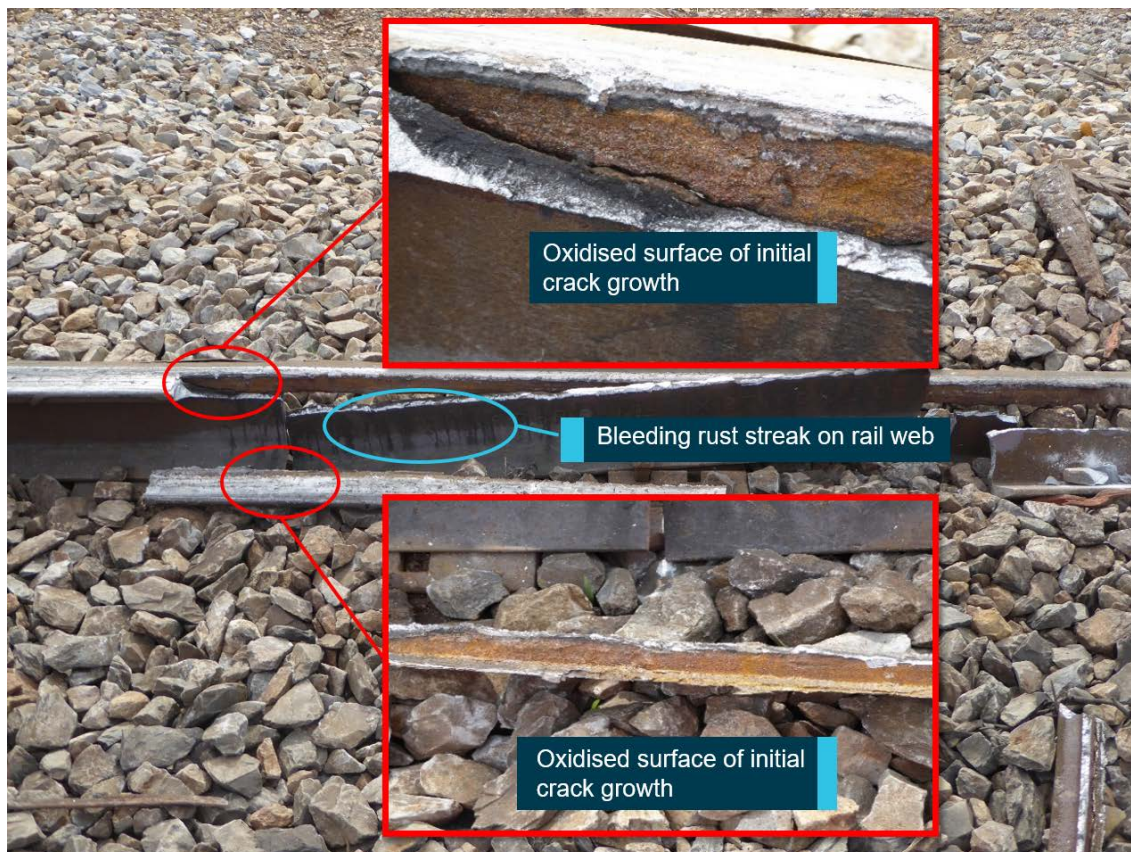
The vertical split head in this instance propagated undetected into a critical defect of around 2 m in length. The defect exhibited the typical visual indicators of well-developed dark oxide streaking on the centreline of the running surface and oxide streaks (bleeding) on the fillet area of the rail web under the defect (Figure 11). The forces exerted by the passage of train 1501S across the area of rail containing the vertical split defect (and broken rail) resulted in the fragmentation of that section of rail. The disruption of the rail running surface then led to the derailment of the last three wagons of train 1501S.

As neither the scheduled track patrol nor ultrasonic inspection identified the presence of a defect, it cannot be determined when the vertical split defect first propagated towards a critical size. The yearly ultrasonic inspection is heavily reliant on the ability of the individual operator to detect and interpret anomalies in the rail infrastructure (or displayed ultrasonic signatures) that signal the presence of a potential defect.

**Figure 11: Failed section of railhead**
