Hard landing involving Kavanagh B-350 hot-air balloon, VH-EUA

6 km east-north-east of Yarra Glen, Victoria | 8 February 2018

ATSB Transport Safety Report
Aviation Occurrence Investigation
AO-2018-016
Final – 30 October 2018

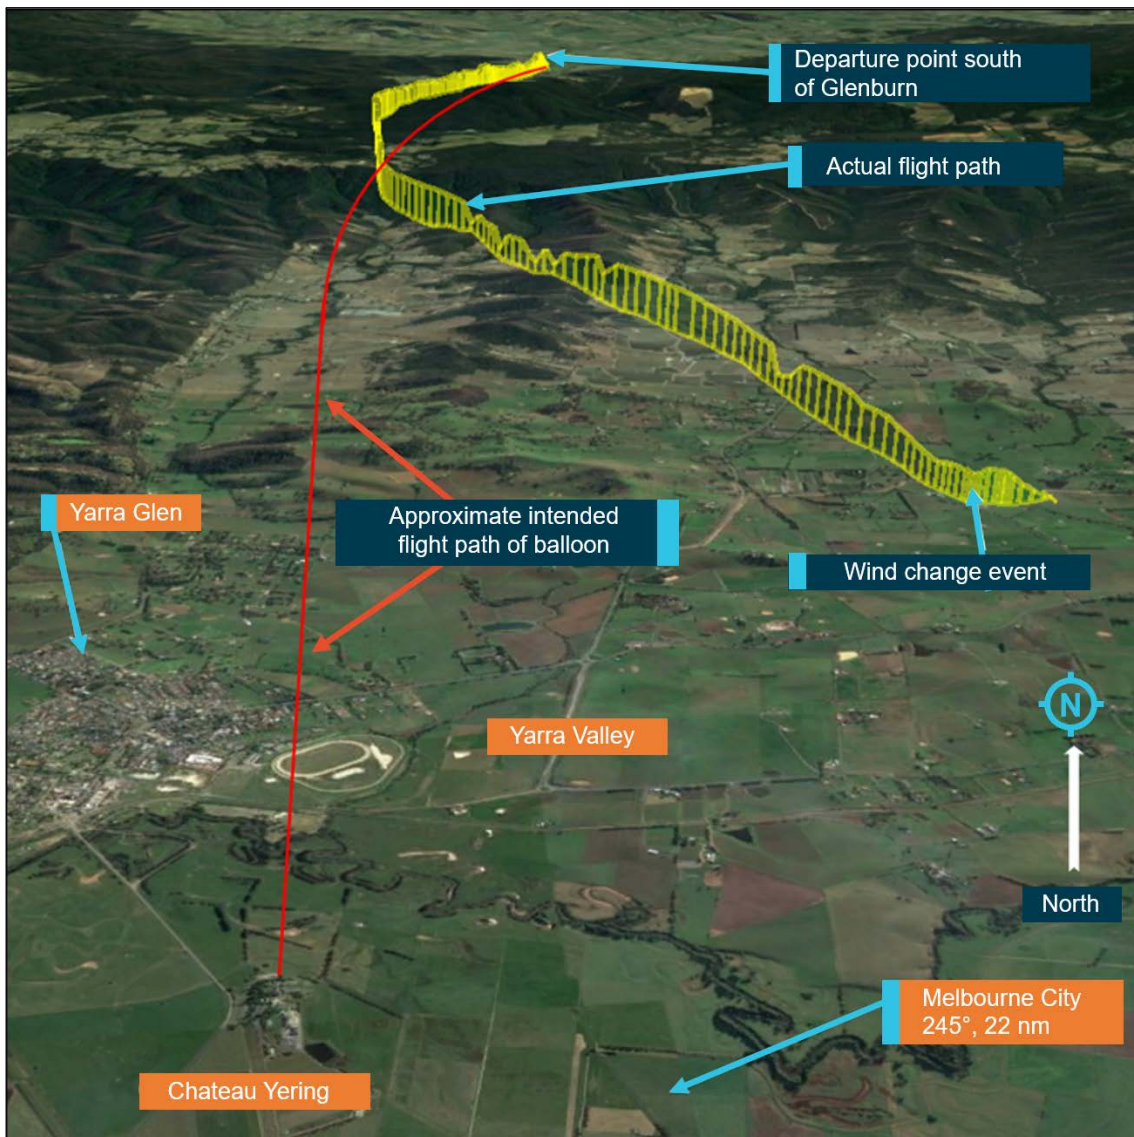
Figure 1: VH-EUA's approximate intended track (red) and actual flight path (yellow)

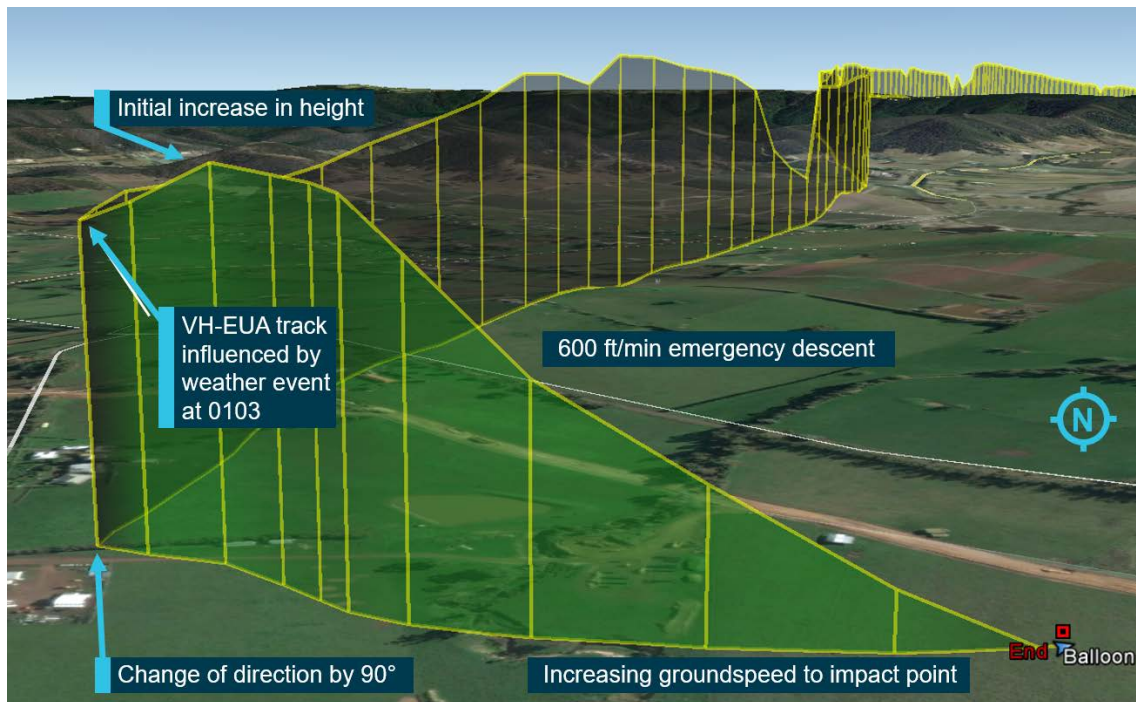
At 0703, when about 630 ft above ground level (AGL), the balloon encountered significant turbulence. There was also a significant change in the wind direction and speed, and the balloon started tracking about 90° to the left of its previous track (Figure 2).

Figure 2: VH-EUA actual flight path, showing change in track due to wind

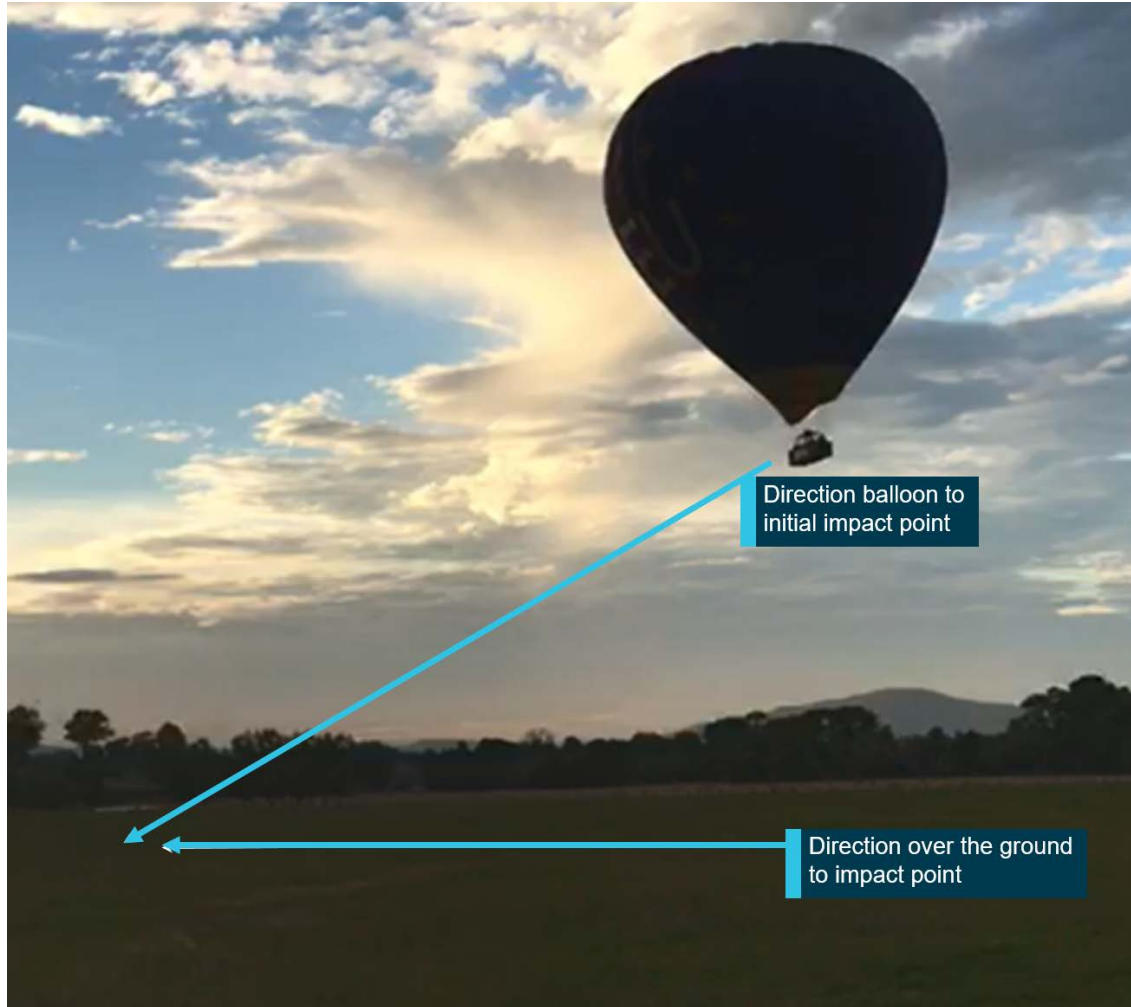
In the final stages of the flight (Figure 3), the balloon descended at about 600 ft/minute and accelerated to over a 16 kt⁴ groundspeed. Prior to impact, the pilot applied the burner, which reduced the descent rate to some extent. The pilot instructed the passengers to adopt the emergency landing position, but some passengers were initially confused about what to do.

Figure 3: VH-EUA final descent profile

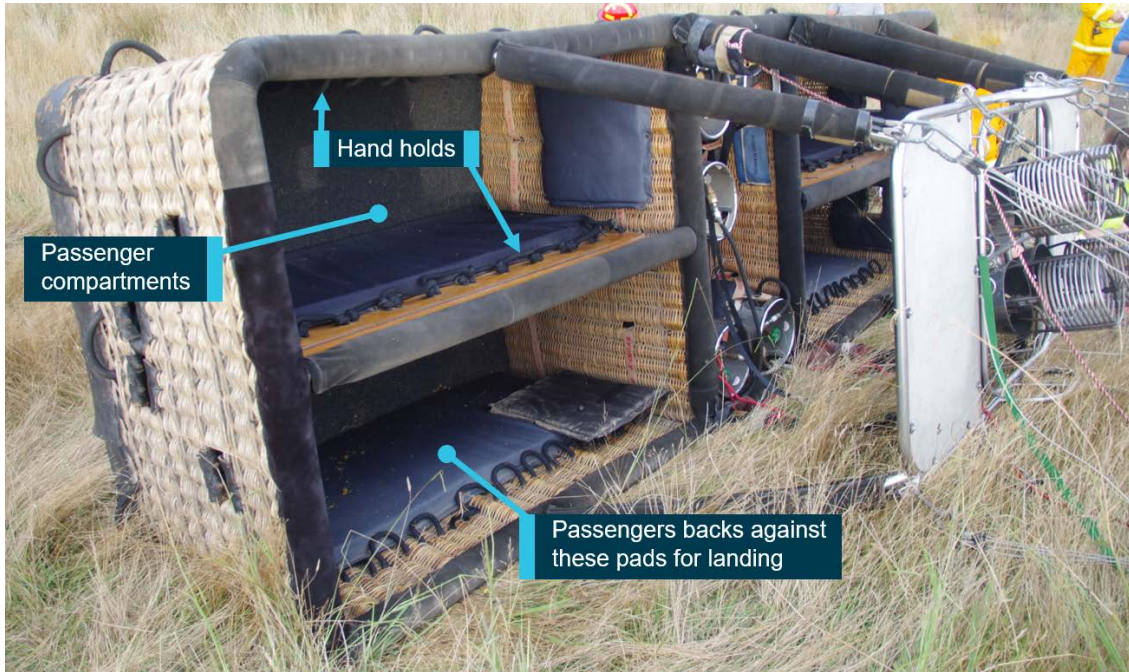
On approaching the ground, the pilot turned the burners off and opened the vent at the top of the balloon to deflate the balloon envelope. The basket landed hard, and the deflating balloon envelope began to act like a sail. The basket then dragged for 48 m, and then became airborne for another 56 m. After a secondary hard landing, it tipped over and dragged for another 7 m before coming to rest on its side (Figure 4). The pilot isolated the gas and began to check on the passengers.

Four passengers received serious injuries and seven received minor injuries. All of the serious injuries involved some form of spinal injury, three of which required hospitalisation. The balloon's basket sustained minor damage.

Figure 4: VH-EUA final resting position

Source: Victorian Police with annotations by ATSB to show passenger compartments, hand holds and passenger position for landing.
