# Collision between Pacific National train 9221 and Aurizon train 9T66

Oonoomurra, Queensland | 27 February 2018

**ATSB Transport Safety Report**  
Rail Occurrence Investigation  
RO-2018-006  
Final – 21 November 2018

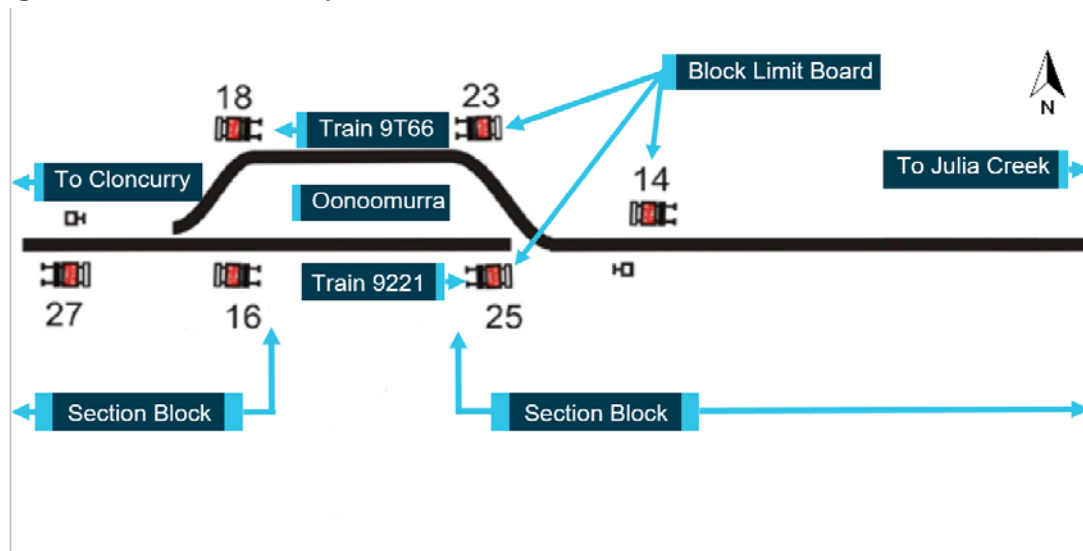
Figure 1: DTC Blocks and position of Block Limit Boards

Later that night at about 2334, the driver of 9221 advised the NCO that the train was approaching Oonoomurra, which was the limit of their authority. The driver reduced the train speed to around 18 km/h, crossed the Landsborough Highway level crossing before entering the western end of the Oonoomurra crossing location. The Oonoomurra crossing location is a directional travel station that is 1,033m long and equipped at each end with a trailable point<sup>3</sup> set to divert an approaching train to the right side track. Directional travel stations between Townsville and Mount Isa are typically of similar length, equipped with trackside location boards that mark the limits of the respective Station and Section blocks and configured to divert an approaching train to the right (Figure 1).

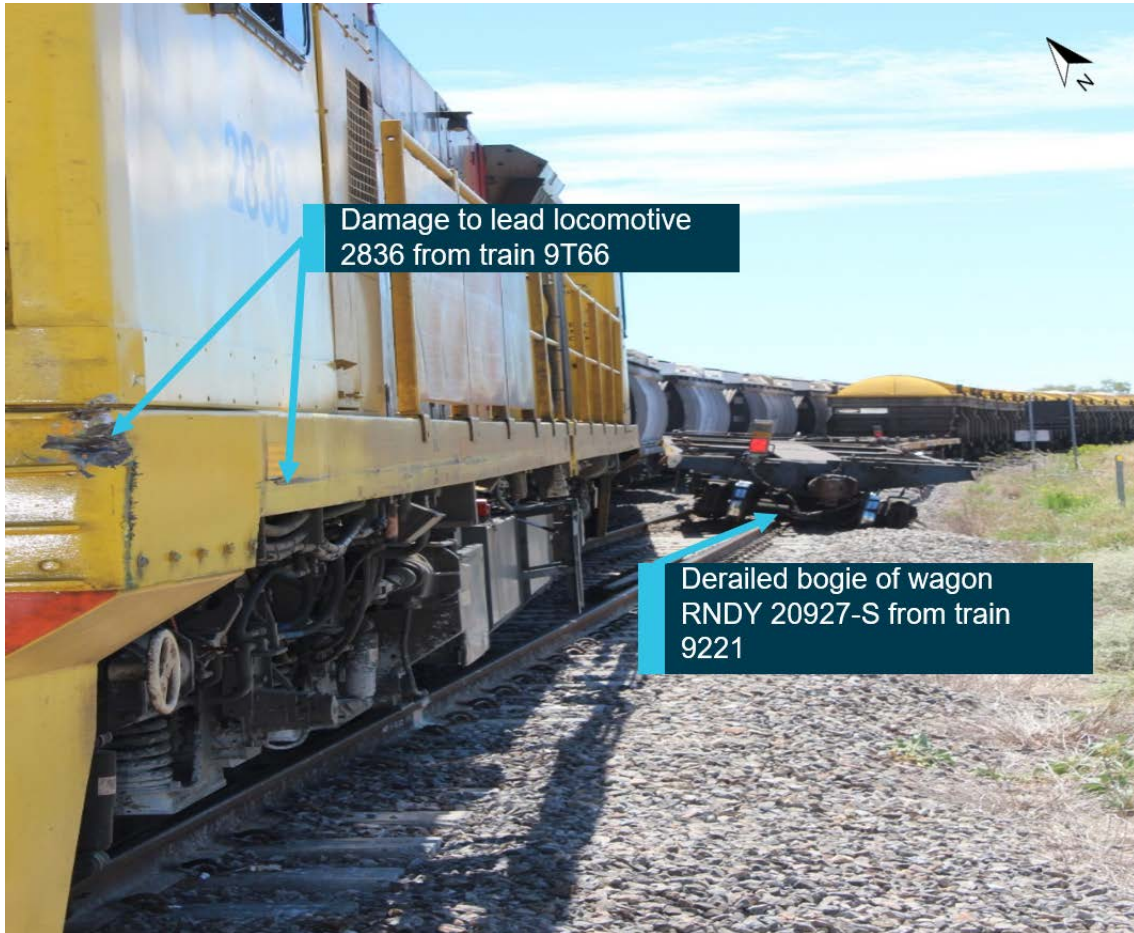
**Figure 2: Damage to locomotive 2838 and wagon RNDY 20927-S**

The driver made an emergency brake application shortly before locomotive 2838 collided with the middle of the last wagon of train 9221 (Figure 2). Locomotive 2838 was travelling at 25 km/h at the time of the collision and travelled about 104 m after the brake application.

The collision caused minor damage to the headstock of the locomotive and side frame of the wagon and the derailment of the wagon's trailing bogie. There was no injury to the rail traffic crew of either train.

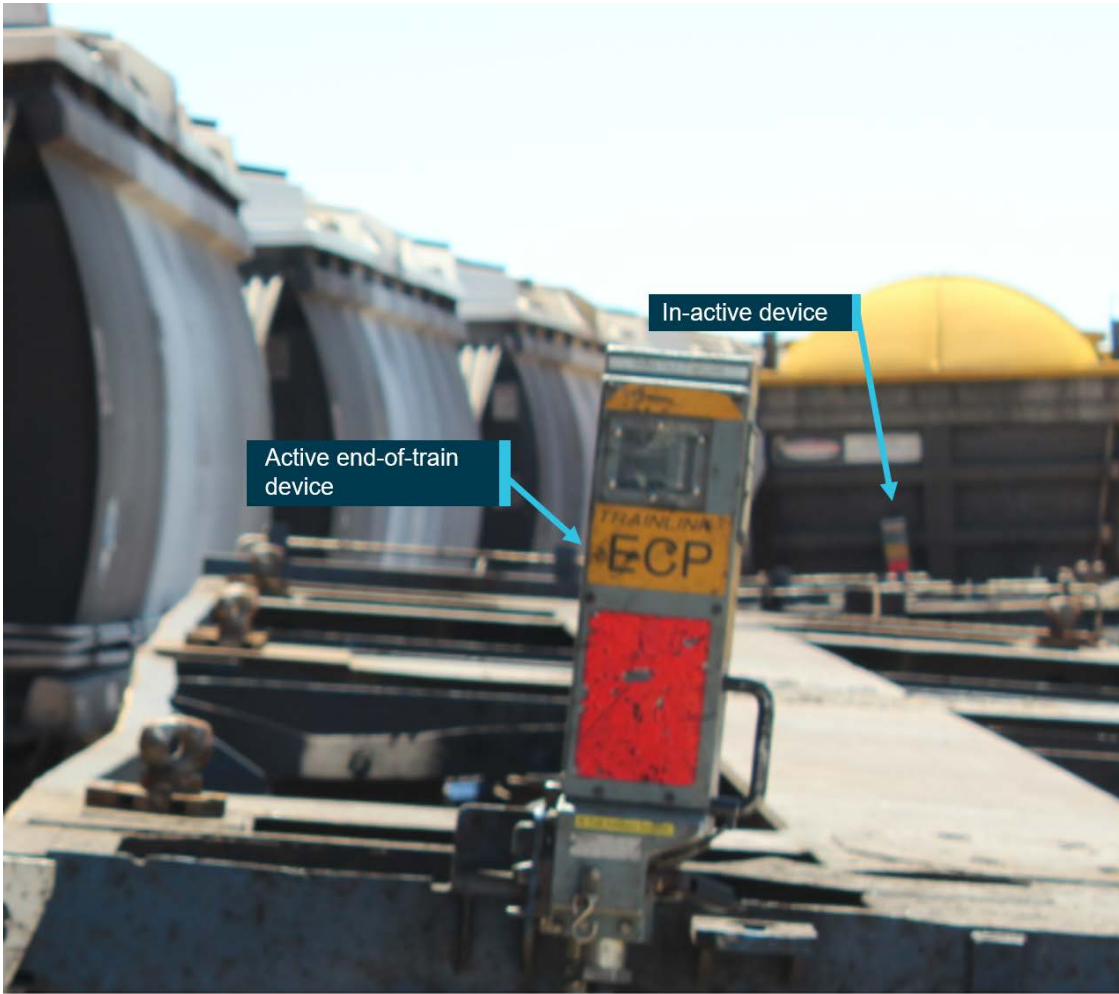
**Figure 3: End-of train marker devices located on train 9221**

Post occurrence inspection identified two end-of-train marker devices mounted on train 9221 (Figure 3). One marker, installed at the rear of the last wagon, was in use and connected to the brake pipe and the electronically controlled pneumatic braking system of the train. The other marker was not in use, but mounted at the rear of the fourth wagon from the end of the train. The operator had placed the additional (unused) end-of-train marker device to facilitate its operational requirements for that train service.

The QR interface standard<sup>8</sup> specified the requirement for operators to install at least one red tail light, or an approved end-of-train marker device to indicate the rear of the last vehicle of each train. However, the standard did not clearly preclude an operator placing additional (unused) markers in train. Post occurrence QR commenced a review into the phrasing of the interface standard to ensure their end-of-train marker device requirements are clear and operators do not place end-of-train marker devices on any part of the train apart from the last wagon.

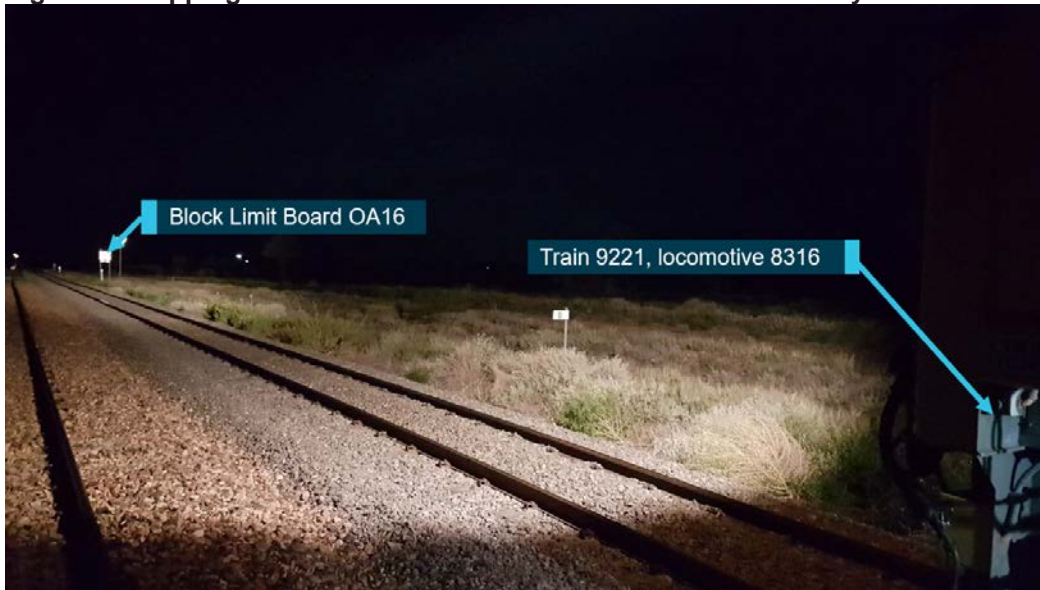
**Figure 4: Stopping location of train 9221 relative to limit of authority**

The disconnection of the ground radar meant that the on-board information system would not automatically calibrate speed and distance measurements. Although a calibration error existed, the maintainer considered it was within the allowable tolerance of 1 to 10 per cent. Testing by the operator found the error resulted in a lower than actual speed indication and a longer than actual length measurement. In this case, the displayed length measurement was around 120 m further than actually travelled.

Based on the displayed distance information, the driver stopped about 82 m from the limit of authority BLB OA25 (Figure 4) believing locomotive 8316 travelled around 1,070 m into the loop and the rear of the train was therefore in clear of BLB OA16.

- Verification of the Functionally Integrated Railroad Electronics (FIRE) systems on 83 class locomotives in the Pacific National fleet.
- Verify the message displayed to rail traffic crew when a ground radar fault occurs and determine arrangements to advise the rail traffic crew to use alternate methods to verify the accuracy of displayed information.
- Procedures for the maintainer to identify and qualify restrictions to locomotive operation to enable Pacific National to respond.
- Disseminate information to relevant staff reinforcing the procedures associated with the active identification of a stopping location.

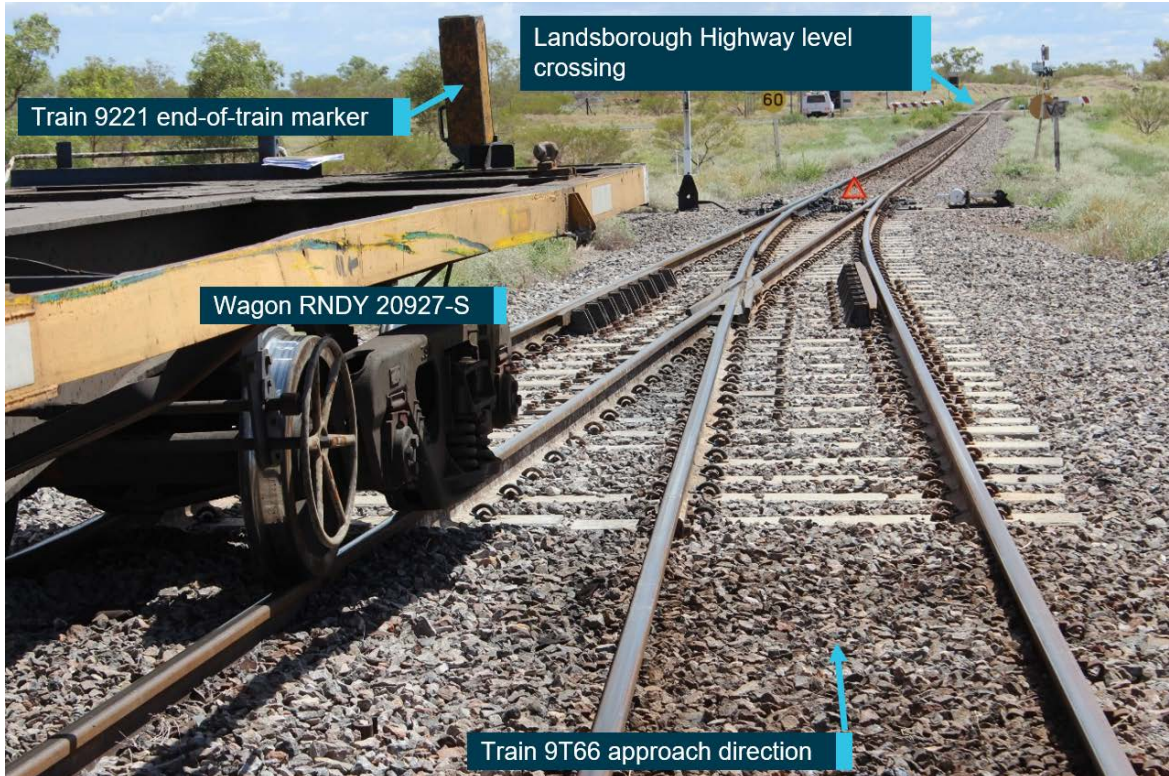
**Figure 5: Stopping location of wagon RNDY 20927-S relative to the adjacent track**

It was not until the track alignment transitioned to straight, approaching the Landsborough Highway level crossing, that the crew then sighted the last of three empty container wagons (RNDY class) at the rear of train 9221; the last was foul of their track (Figure 5). By this time, with

the train travelling at 25 km/h and despite the making an emergency brake application, a collision was unavoidable.

Image taken post collision of the re-railing of wagon RNDY 20927 illustrating the location of the wagon relative to the adjacent track and trailable point at the Western end of the Oonoomurra crossing location. Source: Queensland Rail annotated by ATSB
