Signal passed at danger and derailment of empty Tangara service 109D

Hornsby, New South Wales, 17 December 2015

ATSB Transport Safety Report
Rail Occurrence Investigation
RO-2015-026
Final – 14 December 2018

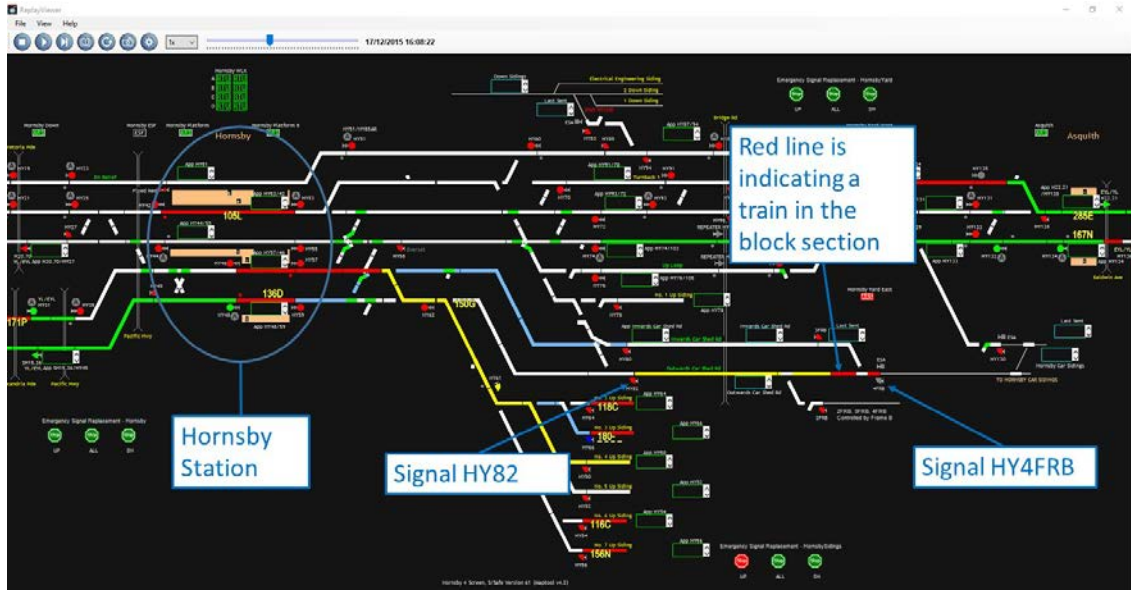
At 16:08:22, 109D departed from signal HY4FRB on the Outwards Car Shed Road (OCSR). See Figures 1 and 2.

Figure 1: Train detected in block section after Signal HY4FRB

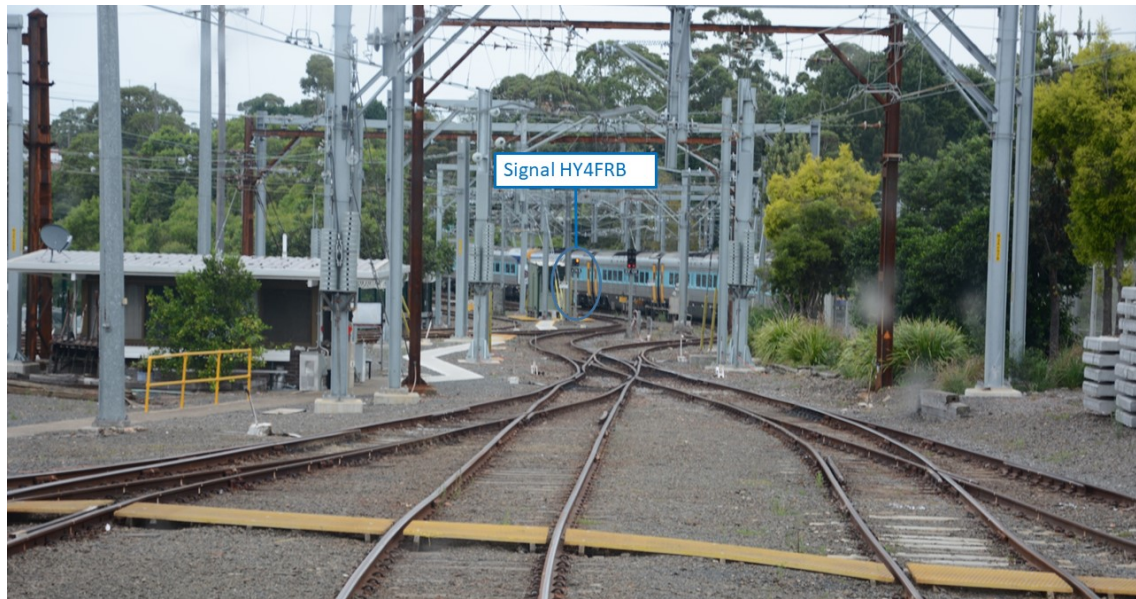
Figure 2: View from train driver’s cab to signal HY4FRB at HMC

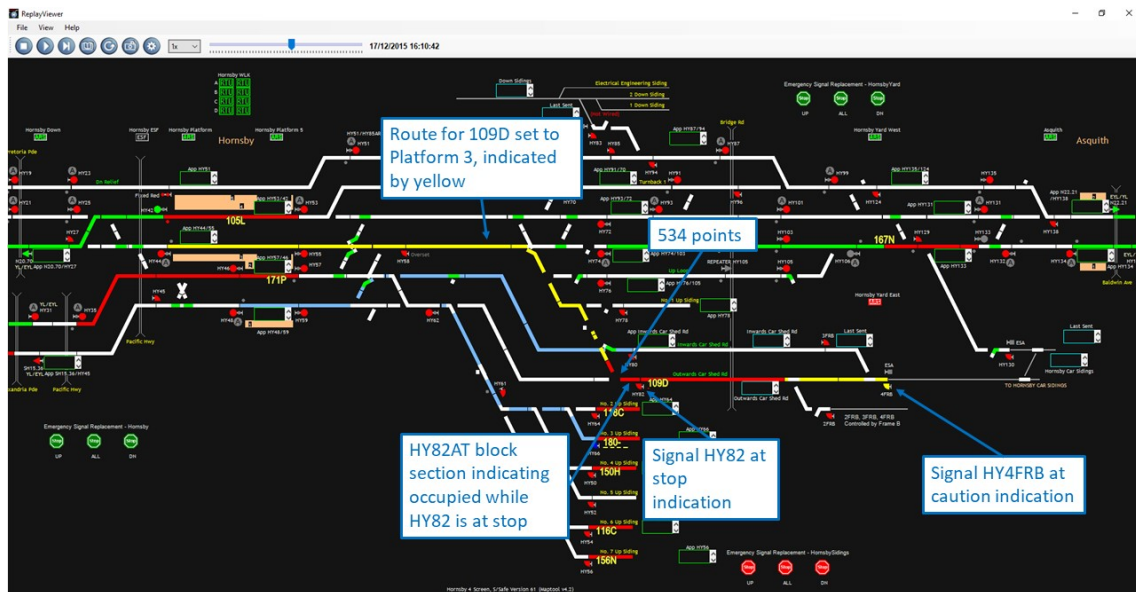
At 16:10:42, a yellow line from 534 points to Platform 3 Hornsby Station appeared on ATRICS, which indicated the Network Control Officer Hornsby Panel⁶ (NCOH) had requested the intended route for 109D. Additionally, ATRICS indicated 109D occupied the block section directly after signal HY82 (HY82AT) with signal HY82 displaying a stop indication. This was also reflected in the Weslock data log⁷. This meant 109D had passed signal HY82 at stop – Signal Passed at Danger (SPAD). See Figure 3.

Figure 3: Route set for Platform 3 and 109D is occupying block section HY82AT.

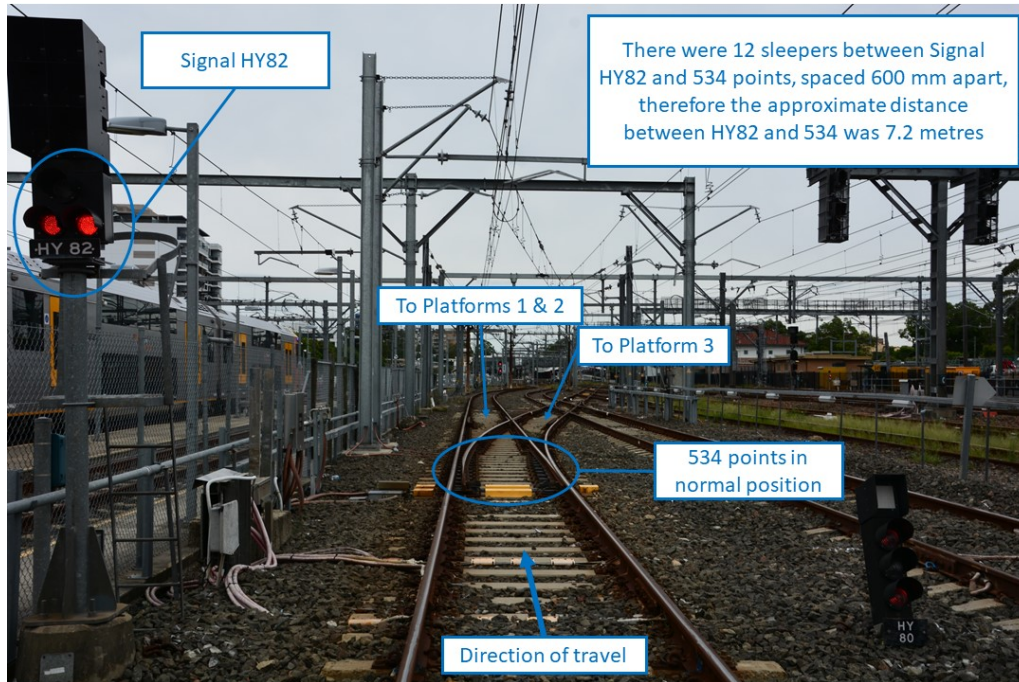
Examination of the ATRICS and Weslock data showed that signal HY82 was at stop and 534 points were set to direct traffic towards platforms 1 and 2 (normal position) as train 109D approached. See Figure 4.

Less than one second before 109D passed signal HY82 at stop, the NCOH had requested a route from signal HY82 towards Platform 3, requiring 534 points to move to the reverse position.

Figure 4: Signal HY82 and 534 points. 534 points set for movement straight ahead (normal position)

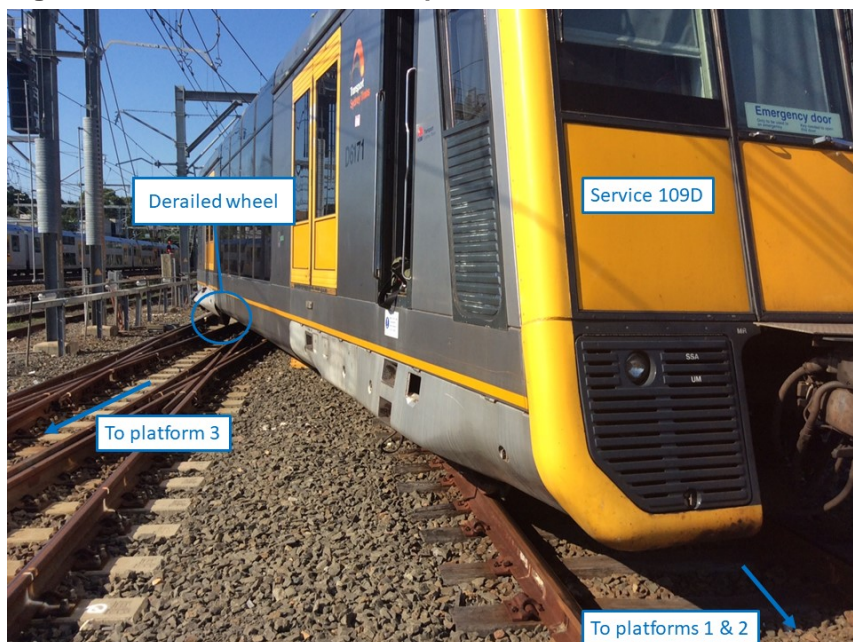
Train 109D was able to pass signal HY82 and travel the seven metres to 534 points before the points could change position. As the lead bogie of the first carriage travelled over 534 points (still in the normal position), the points started to reverse position, directing the trailing bogie towards Platform 3. The opposing movements of the leading and trailing bogies caused the carriage to twist and eventually derail the train. See Figure 5.

Figure 5: 109D derailed over 534 points

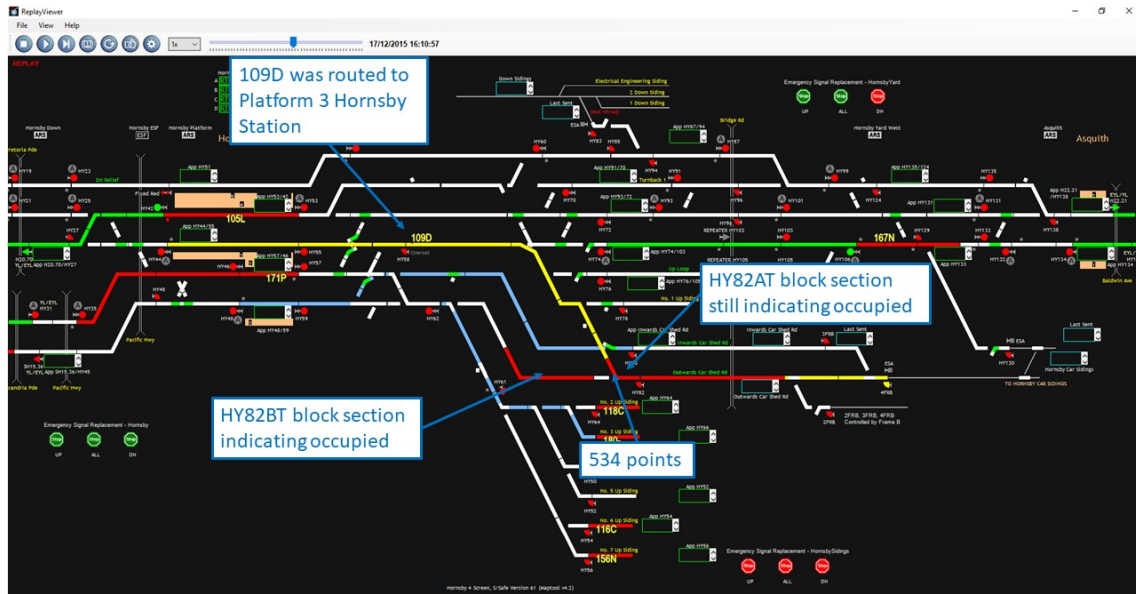
At 16:10:57, 109D is indicated on ATRICS as occupying block HY82AT and block HY82BT. See Figure 6.

Figure 6: 109D occupying section HY82AT and HY82BT

The leading bogie was confirmed to have travelled straight ahead as it triggered occupation of block section HY82BT. However, the trailing bogie of the first carriage and the remainder of the train had been diverted towards Platform 3 Hornsby Station (block section HY82AT).

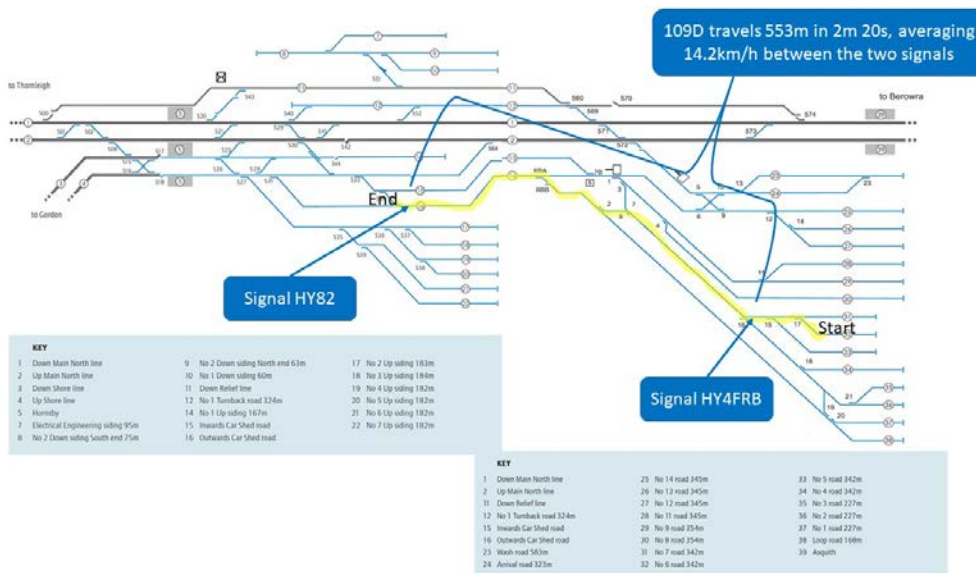
109D travelled 553 metres in 2 minutes and 20 seconds between Signal HY4FRB and Signal HY82, averaging a speed of 14.2 km/h. See Figure 7.

Figure 7: Path of 109D from OCSR to 534 points
