Flight below the minimum permitted altitude involving Pilatus PC-12, VH-FDJ

19 km north east of Adelaide Airport, South Australia | 18 July 2017

ATSB Transport Safety Report
Aviation Occurrence Investigation
AO-2017-075
Final – 18 December 2018

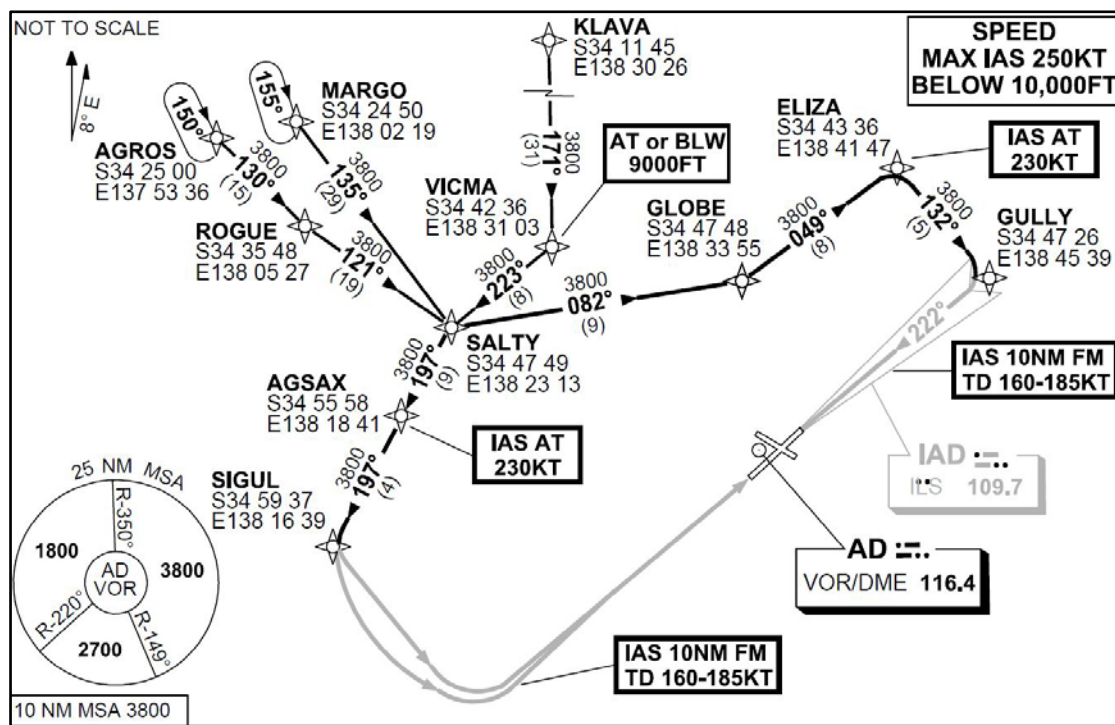
Figure 1: Extract from the Adelaide Standard Instrument Arrival

At about 1240 Central Standard Time,⁴ the aircraft left FL 250 to commence the Salty 1 STAR (Figure 1) and subsequently the runway 23⁵ ILS. The pilot reported that as he was unfamiliar with the Salty 1 STAR, he elected to utilise the aircraft's autoflight system and the Garmin 430 avionics system for navigation and descent.
