# Runaway of grain train 8960

Dombarton to Unanderra, NSW | 22 April 2017

**ATSB Transport Safety Report**  
Rail Occurrence Investigation  
RO-2017-001  
Final – 5 December 2018

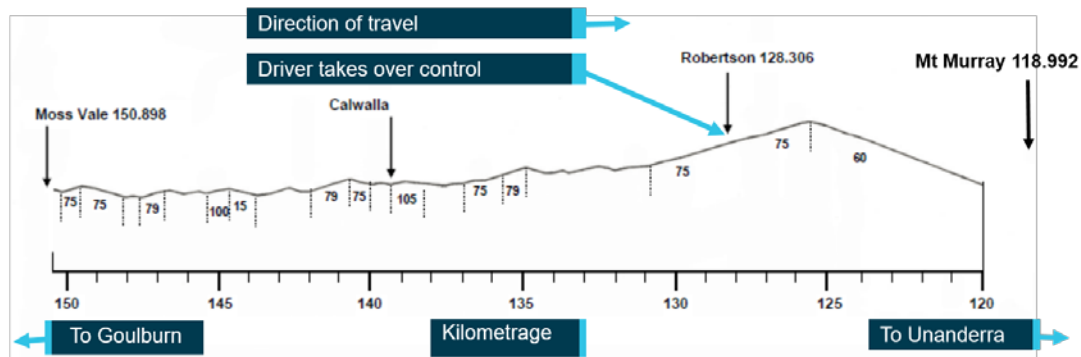
**Figure 1: Gradient diagram Moss Vale to Robertson**

At 0910, train 8960 departed Goulburn with the second person operating the train under the supervision of the driver. As the train departed Goulburn yard, a roll by inspection was performed to ensure that there were no visible or audible defects. The train then travelled on the Up Main line to Moss Vale where it branched off towards Unanderra and Inner Harbour. The train passed through Moss Vale at 1045. The second person continued to drive the train, under the supervision of the driver, from Goulburn to Robertson. At Robertson, the driver took over the controls from the second person in order to operate the train down the Illawarra Mountain (Figure 1).

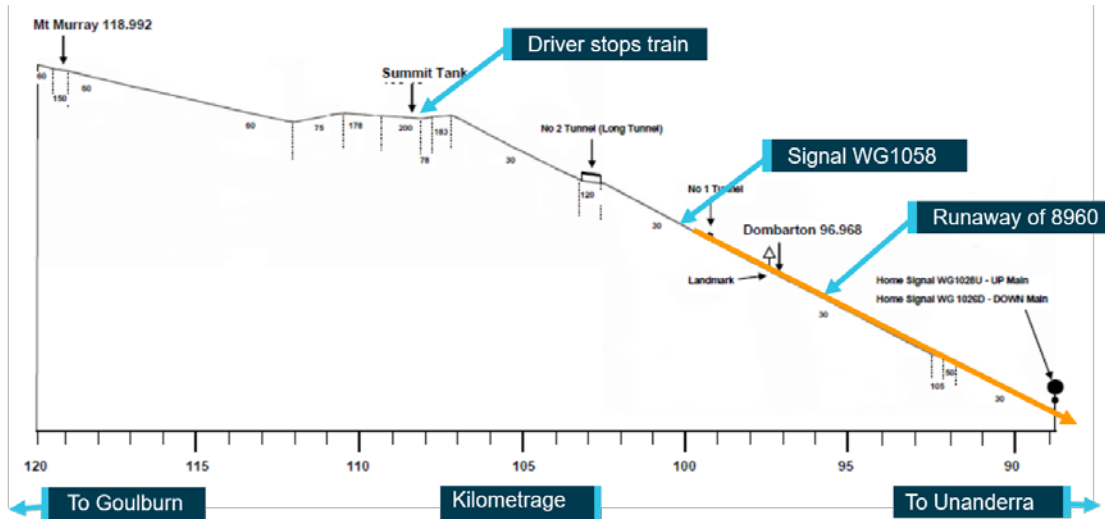
**Figure 2: Gradient diagram Mt Murray to Unanderra**

The track gradient between Summit Tank and Unanderra is one of the steepest in the New South Wales rail network and runs for approximately 18 km with a ruling gradient of 1 in 30. There is only one short intermediate shallow grade of 1 in 120 as the track passes through the Number 2

Tunnel (Figure 2). This means that once a train passes Summit Tank there are no rest points along the section where the train's brake system can be fully recharged.

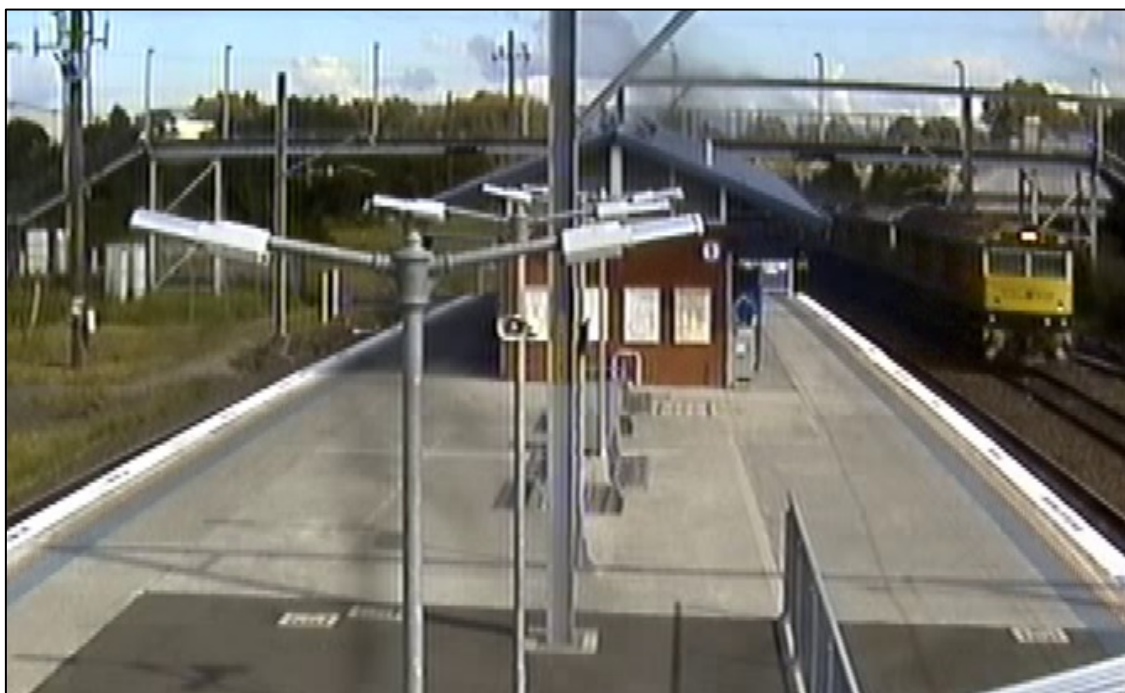
**Figure 3: Runaway train passing Unanderra station**

At 1252:11, the train reached a maximum speed of 107 km/h as it rounded a curve approaching Unanderra station. The track speed at this location was 100 km/h. The train passed through Unanderra railway station where it was captured on CCTV camera (Figure 3). At 1252:21, the train started to reduce speed once it had reached the rising gradient at Unanderra north junction. The ARTC network controller expressed his concern to STSCC train controller that the driver had been unable to get the train under control. Just as he was saying this, the driver announced that the speed had reduced to 95 km/h.

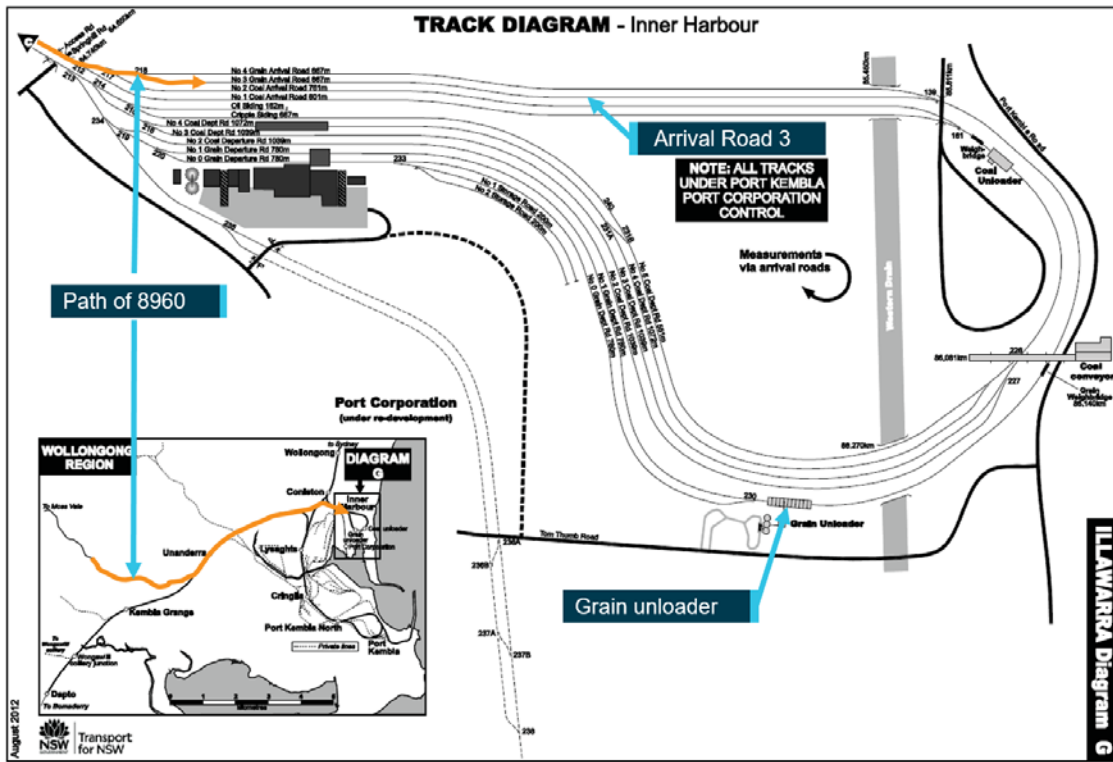
Figure 4: Inner Harbour track diagram

At 1306, the area controller then requested that the train crew ensure that the end of train marker (EOTM) was still present. The driver then moved the train at reduced speed forward while the second person conducted a roll by inspection of the train. After inspecting the train and confirming that the EOTM was intact at its rear, the second person called the driver on the radio to confirm that everything was in order. The driver then stopped the train and walked back to meet the second person approximately halfway along the train. They discussed what problems they had identified and noted that one wagon had an extended brake piston travel and that several brake shoes were worn below limits. Under direction from the Pacific National Inner Harbour train controller, the driver moved 8960 into the Number 3 Arrival Road in Inner Harbour and waited for the train to be examined (Figure 4).

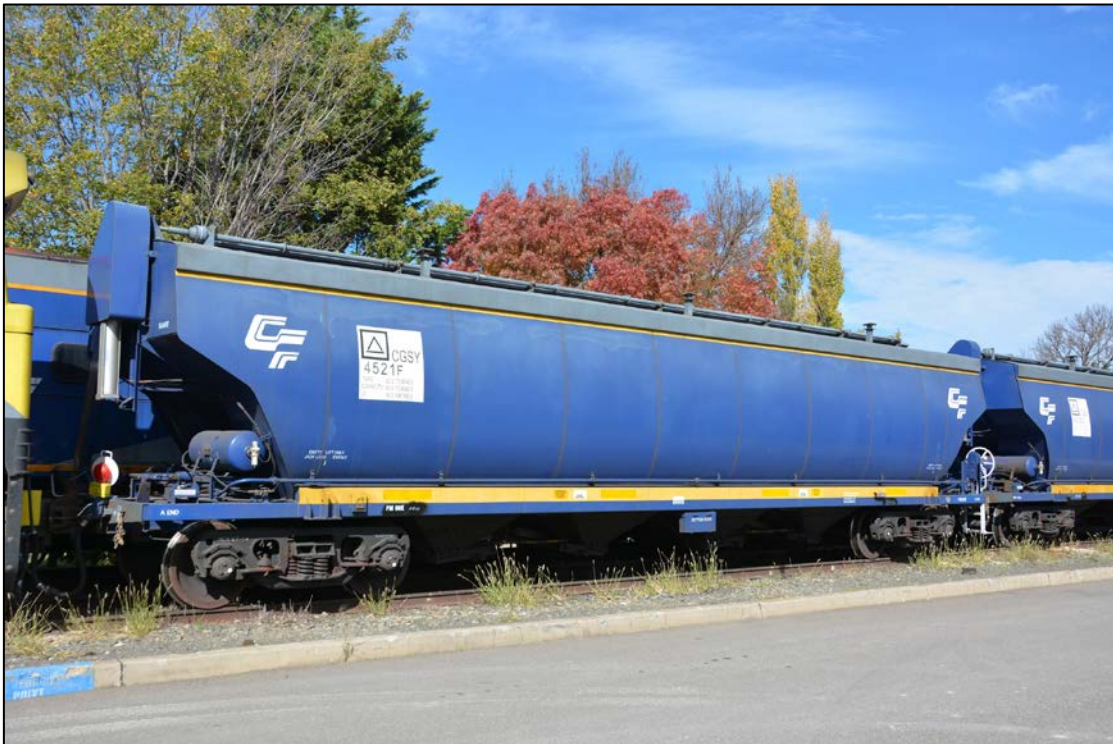
**Figure 7: CGSY wagon**

The wagons were a CGSY grain hopper-type wagon (Figure 7). The wagons were designed and built in China in 2015.

- As well as testing the train's brakes, the brake cylinder piston travel lengths were measured on all 40 CGSY wagons. It found that seven piston lengths exceeded the Asset Standard Authority (ASA) criteria relating to piston travel. Qube stated in their report that as the train had been manually regulated the piston travel was not considered a contributing issue.

- On 1 May 2017, a single car air test (SCAT) was carried out on three randomly chosen wagons: CGSY 4502, CGSY 4507 and CGSY 4510. This test was conducted by an independent contractor. The tests found that the slack adjusters were ineffective. This can cause irregular braking forces if the piston lengths increase outside tolerances and they fail to take up or let out the slack. The issue with the slack adjusters was known to the operator and 'due to their design have never been effective.'<sup>11</sup> The slack adjusters have since been re-engineered but at the time they were manually inspected and regulated prior to every train journey between Goulburn and Unanderra.

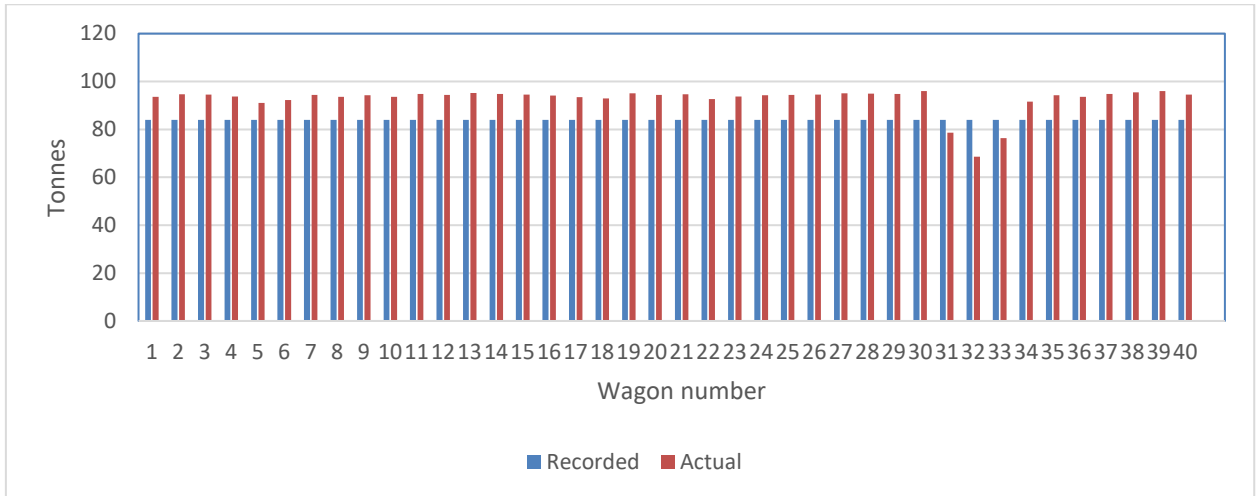
**Figure 9: Wagon mass**

The braking system was operating within specification and were loaded below the maximum allowable payload. However, the train was loaded by approximately 10% more than that recorded on the train's consist record. It is probable that the additional mass placed an extra load on the braking system and affected the handling characteristics of the train.

This figure shows the recorded and actual loading of the 40 wagons in the train consist. Source: Qube Logistics and Quattro grain facility. Calculations by ATSB
