Near collision involving Cessna 210, VH-SYT, and Cessna 206, VH-HPA

46 km south-west of Darwin Airport, Northern Territory, on 6 December 2017

ATSB Transport Safety Report
Aviation Occurrence Investigation
AO-2017-116
Final – 17 January 2019

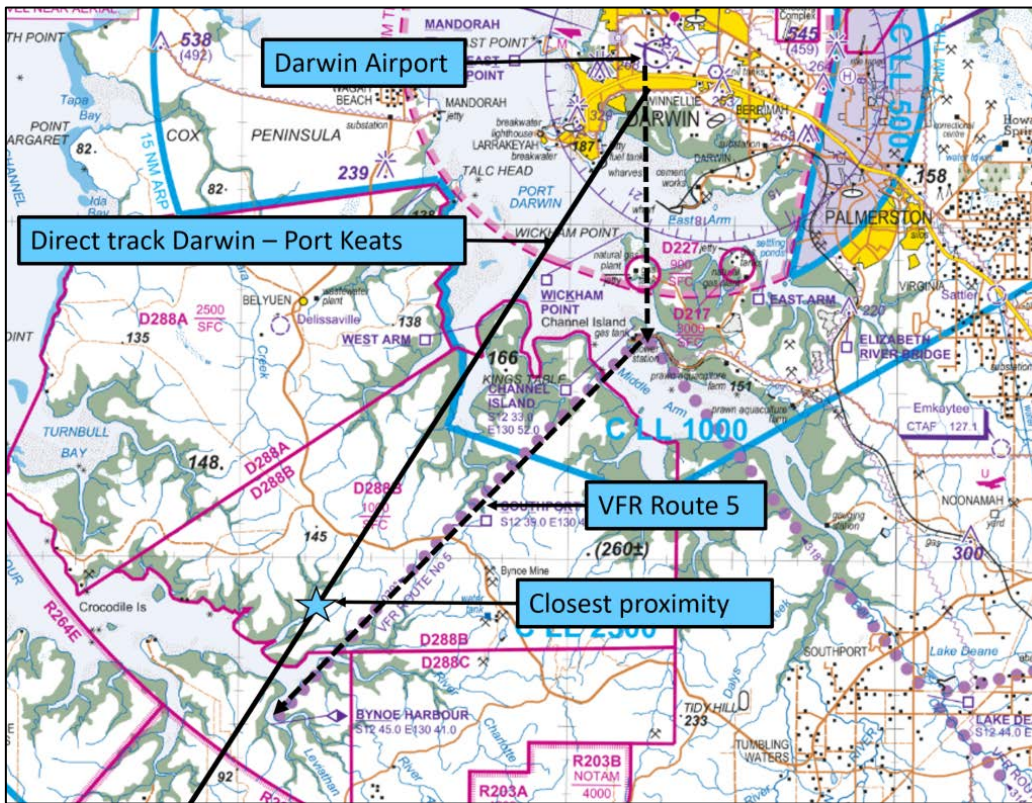
Figure 1: Extract of Darwin Visual Terminal Chart showing VFR Route 5 and direct track to Port Keats

The pilots of the aircraft were both operating charter flights to Port Keats, NT, under the visual flight rules (VFR),² and had planned to track at 8,500 ft. Their initial clearance, in accordance with the traffic management plan for Darwin, was to track via VFR route 5, which tracked south for 5 NM then south-west (Figure 1). Both aircraft were taxiing to depart from runway 18. Prior to take-off, the pilot of each aircraft was advised by air traffic control³ that the other aircraft would also be tracking to Port Keats at 8,500 ft.

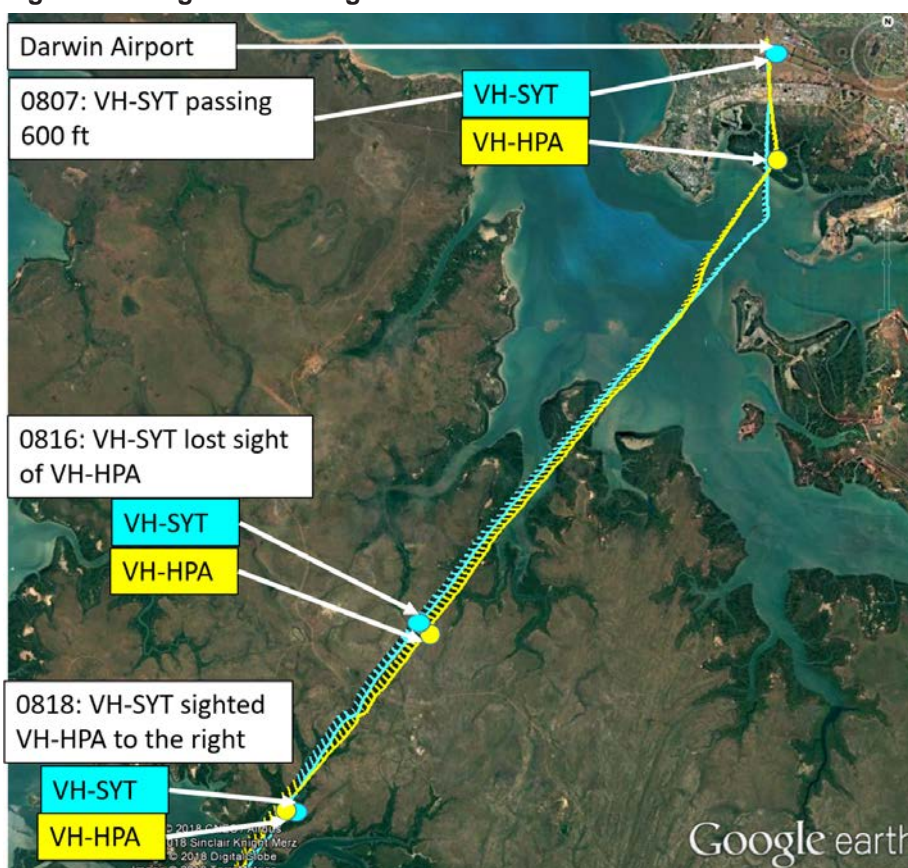
Figure 2: Google Earth image overlaid with aircraft tracks

The approach controller reported that SYT was left on VFR route 5 for about 1 minute to segregate it from HPA, before being re-cleared to track direct to Port Keats at 8,500 ft. The pilot of SYT reported that the direct track to Port Keats put SYT on a similar track to HPA. Therefore, he kept HPA in sight, and manoeuvred to the right of its track, expecting to overtake it.

The radar data at that time indicated lateral separation between the aircraft was 0.27 NM (500 m), with SYT behind and slightly right of HPA and 800 ft below. About 30 seconds later, an ADATS conflict alert (CA)⁵ activated on the controller's situation display (SYT indicated 5,600 ft and HPA 6,400 ft). When HPA reached 6,500 ft, the pilot levelled the aircraft off and completed the top of climb checks.

The pilot of SYT reported that, at that time, he still thought the aircraft were half a nautical mile (900 m) apart and was expecting HPA to be out to his left. However, the radar data indicated that HPA was 800 ft vertically above, and 0.18 NM (333 m) laterally away from SYT.

Both pilots reported that by the time the approach controller cleared SYT to deviate right of track, the two aircraft had already passed each other and the separation between them was increasing. SYT was now to the left of HPA and the pilot of SYT had HPA in sight. The closest proximity according to the radar data was 100 ft vertically and 0.02 NM (37 m) laterally.
