Fall from height and serious injuries to crewmembers on board *Shanghai Spirit*

15 NM north-east of Port Alma, Queensland | 29 January 2017

ATSB Transport Safety Report
Marine Occurrence Investigation
328-MO-2017-001
Final – 21 February 2019

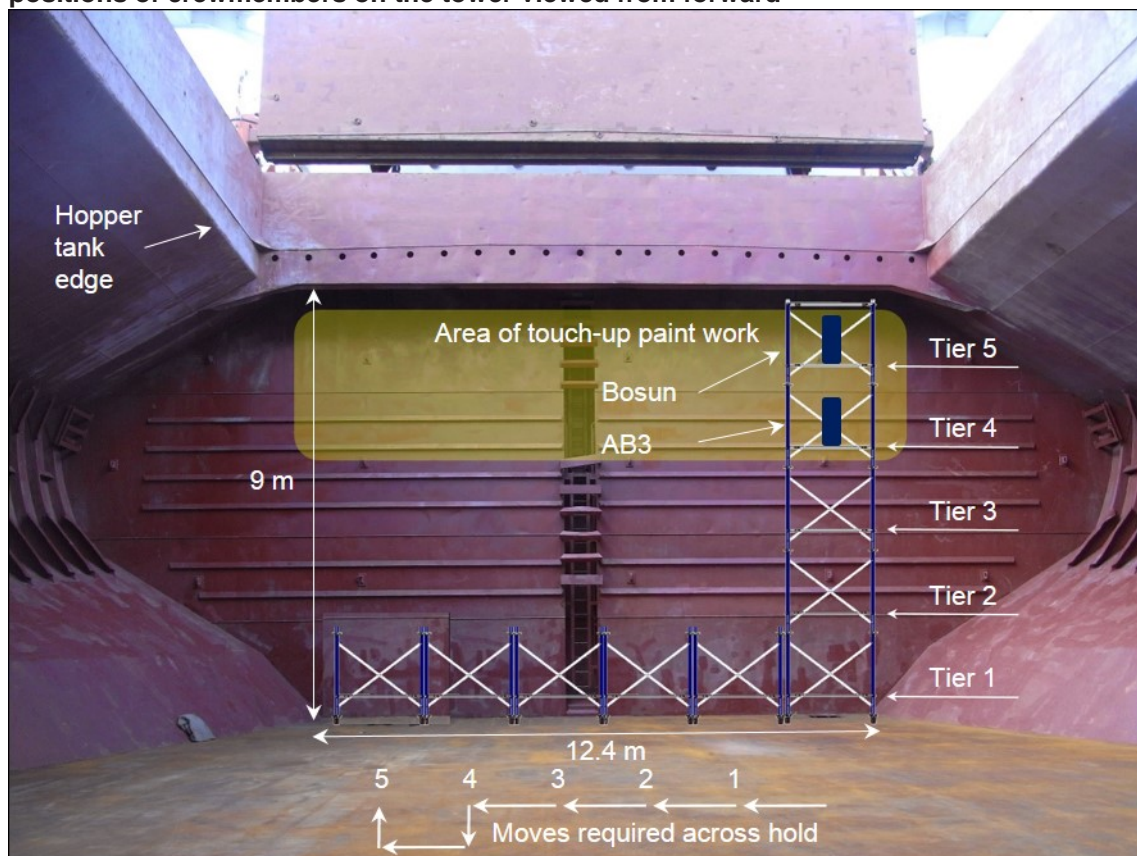
Figure 2: Hold number four showing scaffold tower moves from port to starboard and positions of crewmembers on the tower viewed from forward

A similar work sequence of operation to that in hold number one was followed. However, when the scaffold tower was moved, the bosun decided that he and AB3 would not climb down. Instead, they remained on the scaffold tower as the OS and cadet repositioned it. Additionally, and in

contrast with the morning's activity, neither the bosun or AB3 wore safety harnesses and safety lines were not used.

The work progressed from port to starboard across the aft of the hold. The tower was moved in that direction, in line with the major axis of the scaffold tower footprint, about five times.

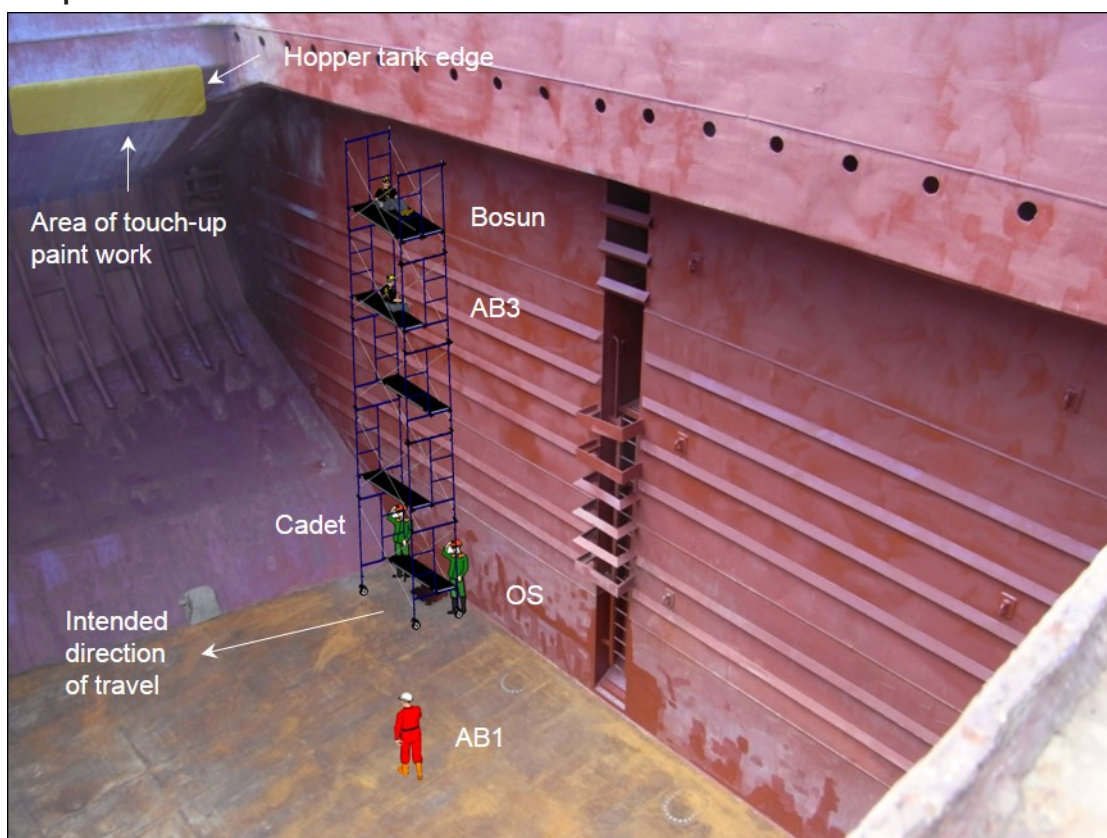
Figure 3: Hold number four showing position of scaffold tower, crewmembers at completion of work and direction of next movement

At the completion of the fifth move, the crewmembers were in position to finish the touch up of the aft bulkhead. The bosun was on tier five of the scaffold tower, about 8 m above the deck and AB3 was one tier below, facing aft, about 6 m above the deck.

After they had completed the work on the aft bulkhead, the bosun then decided to touch up the hopper tank edge (Figure 3). He instructed the OS and cadet to move the scaffold tower forward adjacent to the hopper tank edge, so they could reach the topside tank surface above.

At about 1410, the cadet and OS were in position either side of the base of the scaffold tower. They grasped the scaffold tower legs, released the wheel brakes and started to push the structure forward. The scaffold tower moved about 0.5 m when, without warning, it toppled forward to the deck, taking with it the bosun and AB3.

On hitting the tank top, the scaffold tower came apart and the bosun and AB3 were entangled in the components. AB1, the OS, and the cadet, hurried to assist the injured men.

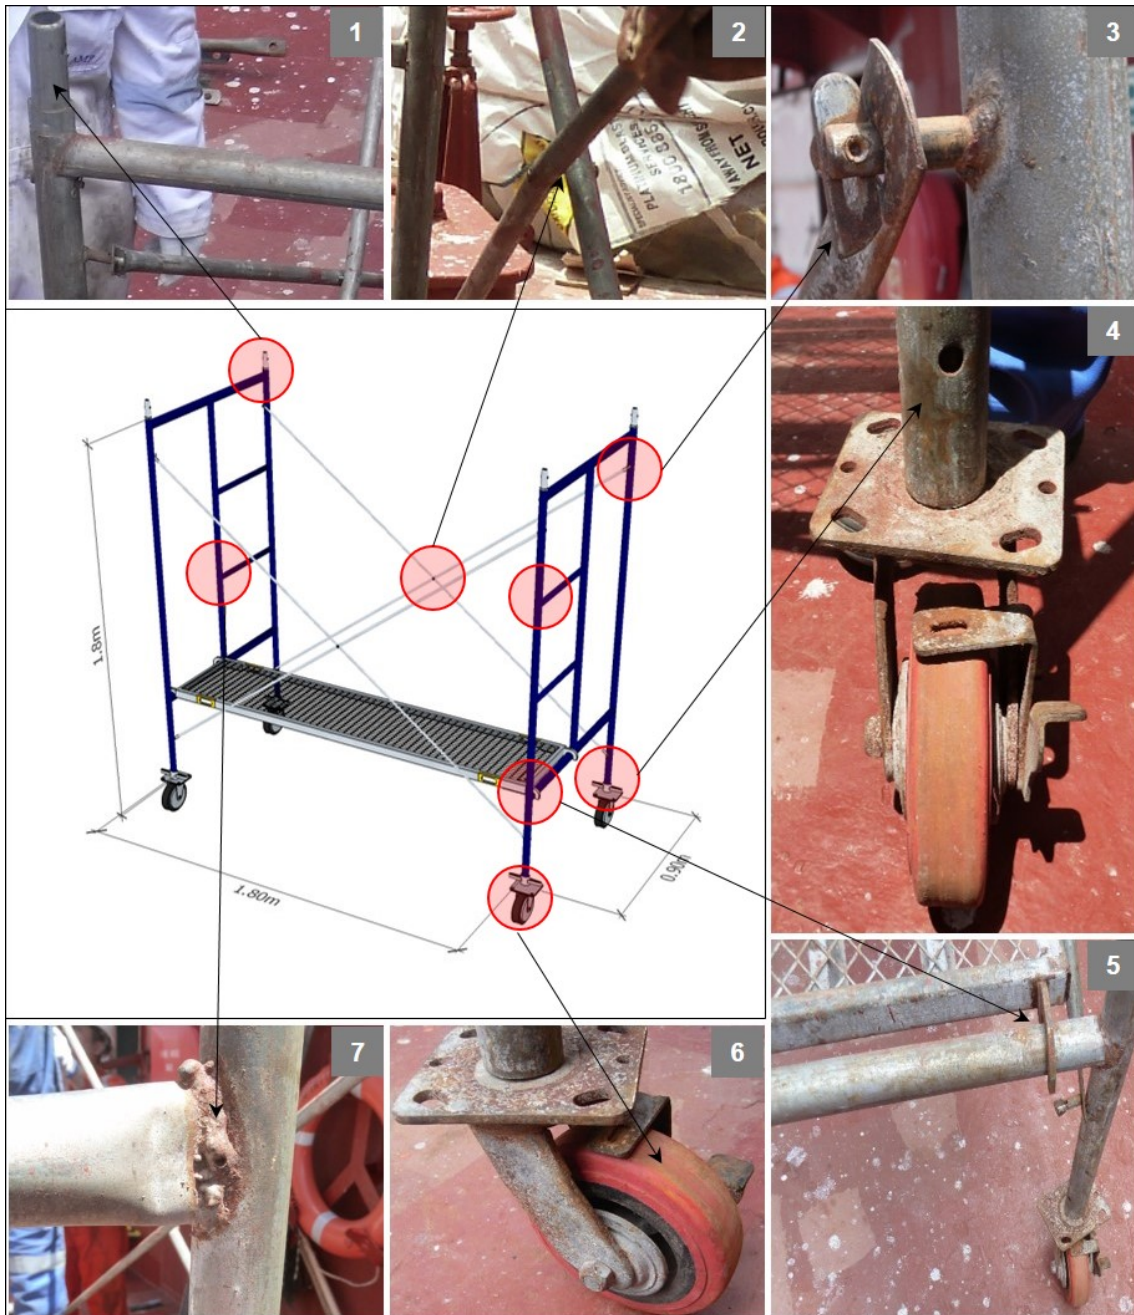
Figure 5: Condition of the scaffold tower

Inspection of *Shanghai Spirit's* scaffolding equipment (Figure 5) identified that it had no manufacturer's identification plate, and all components showed signs of regular use, wear, damage, and some repairs.

The following defects were found during an on board inspection:

1. ladder frame stub piece connections without securing pins
2. loose and bent cross bracing
3. cross brace locking pins loose allowing travel up to with 40 mm
4. swivel wheels stub piece connections without securing pins
5. corroded platform hooks
6. inoperative swivel wheel brakes on three of the four wheels
7. deficient frame ladder welds.

Examination of the scaffold tower following the accident identified a number of defects relating to damaged, loose, corroded and unserviceable components.

While these defects would undoubtedly have reduced the tower's rigidity and stability, it was successfully repositioned during the morning activities, and the majority of the afternoon task with the crewmembers on it, without toppling. That indicated that, despite these flaws, it was sufficiently stable during those moves. Therefore, while the identified defects may have contributed to the accident when it was moved towards the hopper tank edge, the lack of stability associated with movement of the tower in the fore-aft direction along the narrowest base dimension with crewmembers on it, may alone have resulted in it falling.

The scaffolding equipment operating instructions and maintenance manuals/guidelines have been included in the company's safety management system. Further, there is now a requirement for monthly and quarterly inspection of the equipment.
