# Loading irregularity on train 2BM9

Maitland, New South Wales on 16 January 2018

**ATSB Transport Safety Report**  
Rail Occurrence Investigation  
RO-2018-003  
Final – 5 March 2019

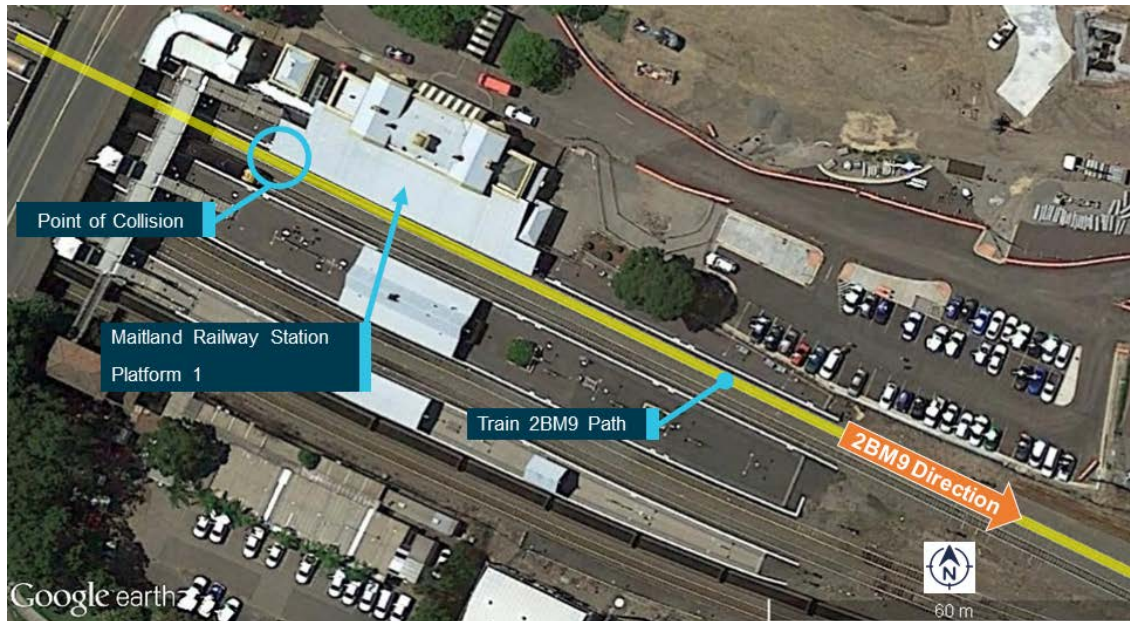
**Figure 2: Maitland Railway Station layout**

Train 2BM9 passed through Maitland Railway Station at approximately 0748 on 16 January 2018. At about this time, the trailing edge of container MGPU7810161 placed on the fifth platform of PQQY50015 collided with the verandah gutter mounting brackets on platform 1 at Maitland Railway Station (Figure 2).

Image shows Maitland Station Platform 1 with 2BM9 path shown by yellow line, point of collision with station infrastructure, and train 2BM9 direction of travel. Source: Google Earth annotated by ATSB.

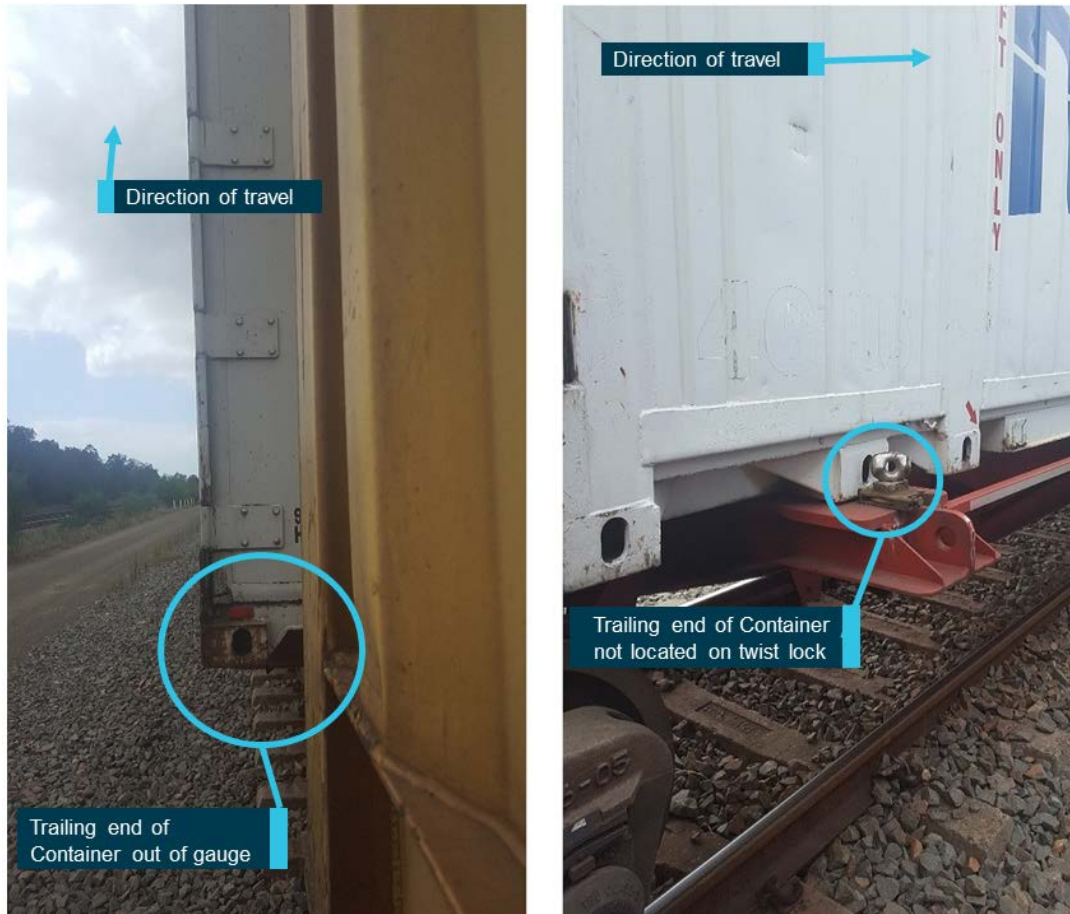
**Figure 3: Out of gauge container MGPU7810161 placed on wagon PQQY50015**

At 0753, the Sydney Trains Station Master at Maitland reported the collision to the ARTC network control officer. The network control officer contacted the 2BM9 train crew at 0755 and organised for them to undertake an inspection of their train at Hexham, NSW. The train crew confirmed at 0829 that a container on wagon PQQY50015 was not secured by the two trailing twist locks (see *Load restraint* below) and was out of gauge (Figure 3).

The left Image shows out of gauge Container MGPU7810161 on wagon PQQY50015. The right image shows the miss-located twist lock. Photos taken at Hexham siding NSW, shortly after collision. Source: SCT, annotated by ATSB.

- It is likely that container MGCU7810161 was not secured to the two trailing twist locks of wagon PQQY50015 correctly at Bromelton.

- SCT published a National Safety Alert advising terminal staff of the SCT protection process to be employed when checking that containers are correctly secured to rail wagons.
- SCT counselled the loader operator involved in loading train 2BM9 and arranged for further training.
- SCT consulted with loading, shunting, and train examination personnel in the development of a documented procedure to describe SCT expectations in relation to inspections and checks that are to be undertaken when loading containers on to rail wagons.

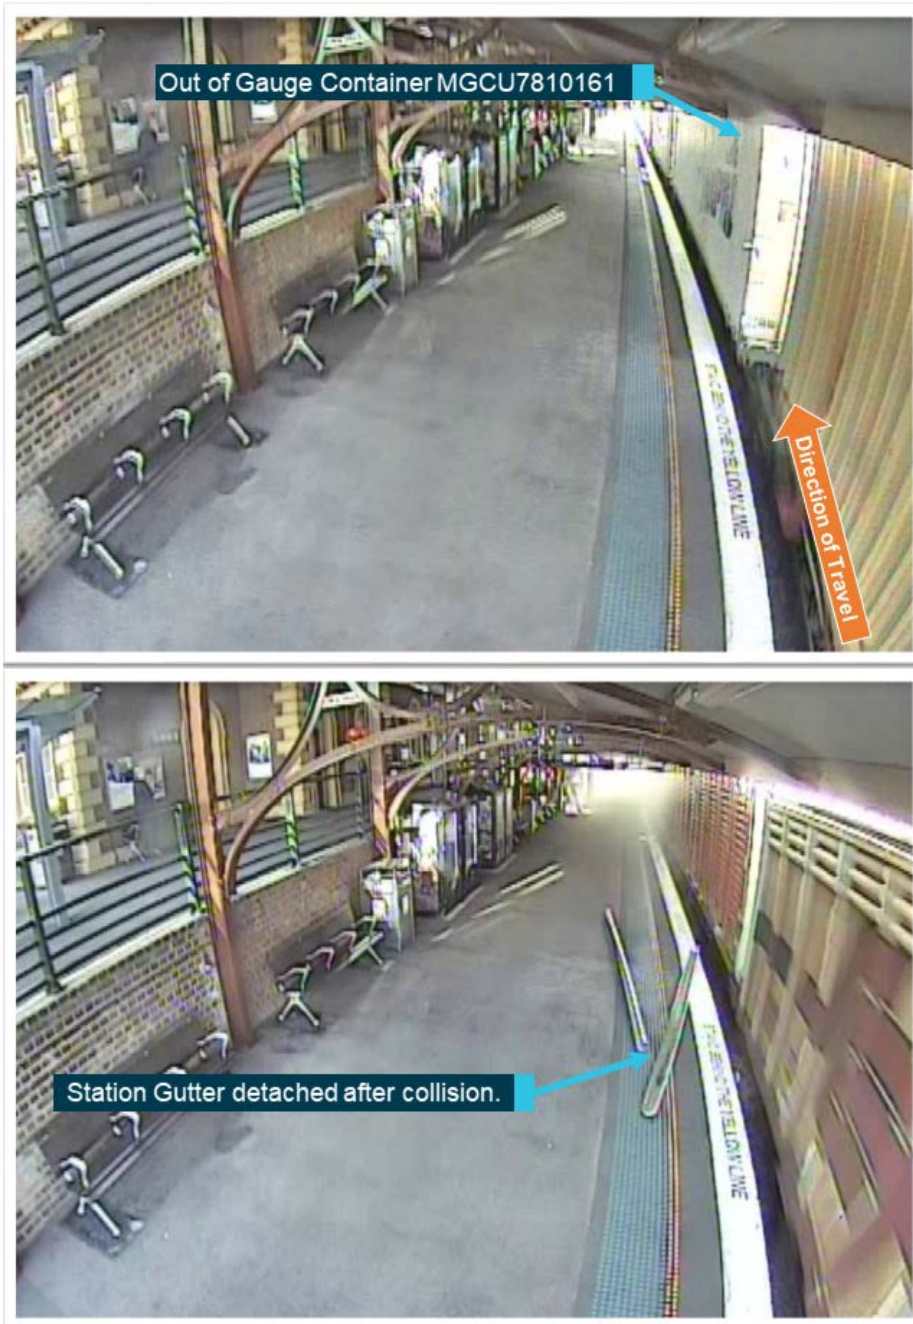
Figure 4: CCTV event recordings from Maitland Railway Station at the time of collision

As a result of the collision, two lengths of the verandah gutter dropped to the surface of platform 1 at Maitland Railway Station (Figure 4). Although there were some people on the platform at this time, the immediate area of the collision was unoccupied, and no injuries were reported.

The first image shows container MGCU7810161 out of gauge prior to the collision and the gutter collapsing. The second image shows the detached guttering shortly after the collision prior to 2BM9 departing the scene. Source: Sydney Trains annotated by ATSB.

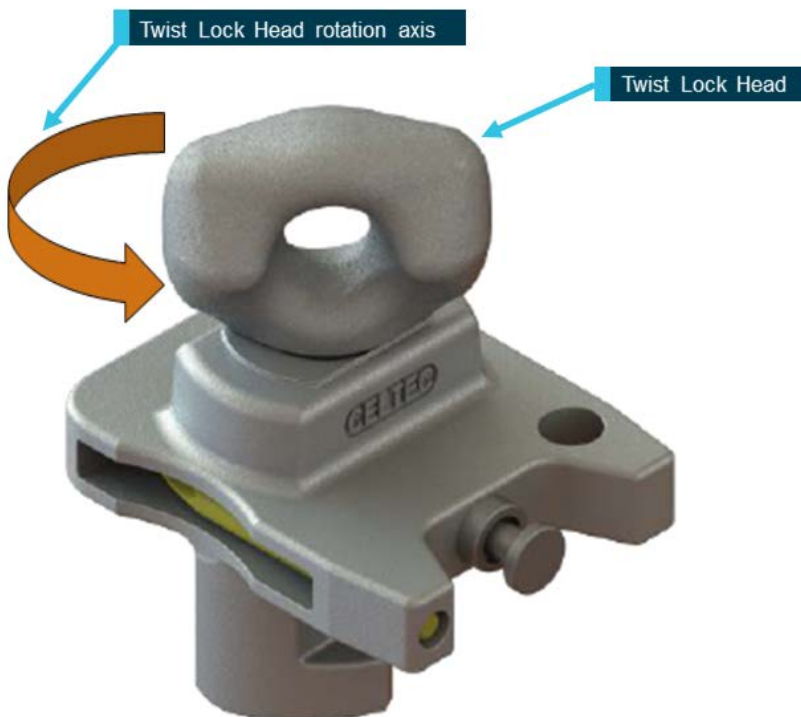
**Figure 5: TFAD automatic type twist lock**

Photo shows an automatic TFAD type twist lock, the same type as in use on platform 5 of wagon PQQY50015 at the time of this incident. Source: Celtec Rail Pty Ltd.

The twist lock's purpose is to restrain freight containers to a rail wagon. The twist lock works by the twist lock head turning within an elongated corner casting on a freight container, thereby restraining the container by its corner casting. The automatic type twist lock applies a spring force to the twist lock head. As the container is lowered onto the rail wagon, the downward force turns the twist lock head, which springs back into its initial position to automatically restrain the container. Conversely, the lifting of the container applies an upward force to release the twist lock from the container corner casting.

Considering the performance of the twist locks after the collision, the ATSB concluded that a mechanical failure of the twist locks was unlikely to have been the reason container MGCU7810161 shifted on its wagon and collided with the Maitland Railway Station verandah.

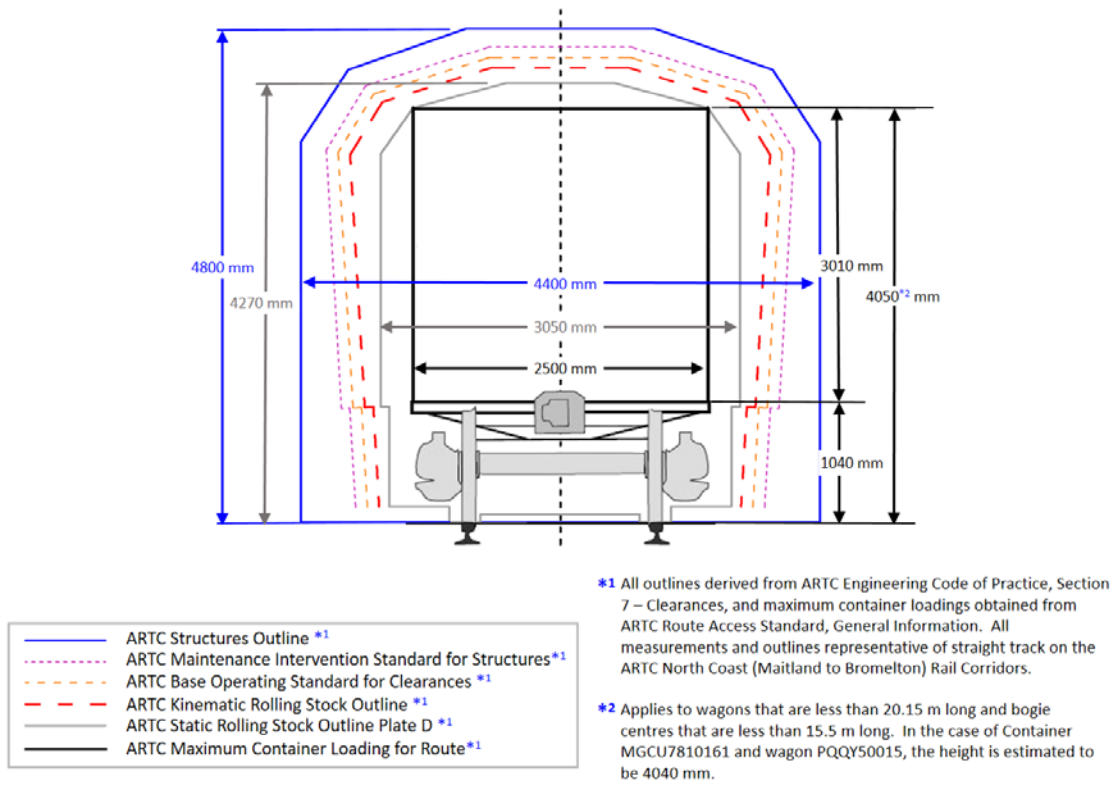
**Figure 6: Clearance outlines for ARTC rolling stock outline type D to track side infrastructure for straight track between Bromelton and Maitland rail corridor**

The maximum container loading permitted for travel between Bromelton and Maitland has a height limit of 4,050 mm and width of 2,500 mm. For train 2BM9, container MGCU7810161 on wagon PQQY50015 had an estimated height of 4,040 mm and a width of 2,500 mm. To examine clearance conditions at Maitland station, the ATSB overlaid these dimensions on to the largest static rolling stock outline that ARTC has permitted for travel on that corridor, rolling stock outline plate D<sup>13</sup> (Figure 6).

The image compares the applicable clearance outlines for trains hauling containerised freight between Bromelton and Maitland on straight track. Source: ARTC Route Access Standard – General Information, and ARTC Engineering (Track and Civil) Code of Practice – Section 7 Clearances, annotated by the ATSB.

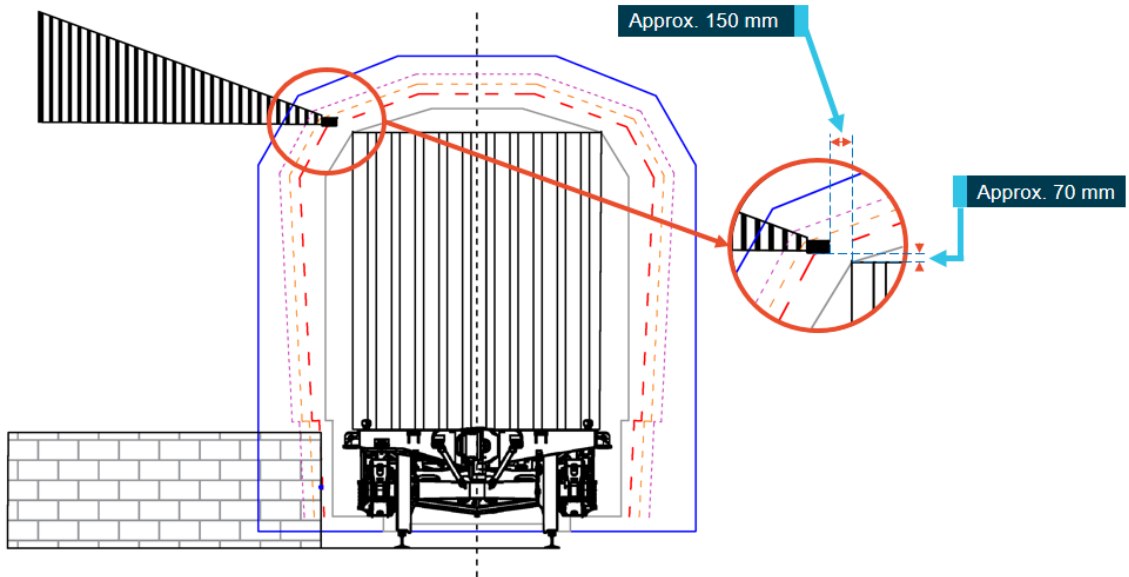
**Figure 7: Maitland Railway Station Platform 1, designed clearance outlines.**

When including the rail infrastructure design for platform 1 at Maitland Railway Station, it can be seen that the verandah gutter coincides with the kinematic rolling stock outline. For a maximum container loading, this provides for a vertical design clearance of approximately 70 mm and a horizontal design clearance of approximately 150 mm (Figure 7).

The image depicts the design clearance outlines for platform 1 at the Maitland Railway Station for a correctly secured container loaded on a PQQY class wagon. Note that verandah height is above container. Source: ATSB.

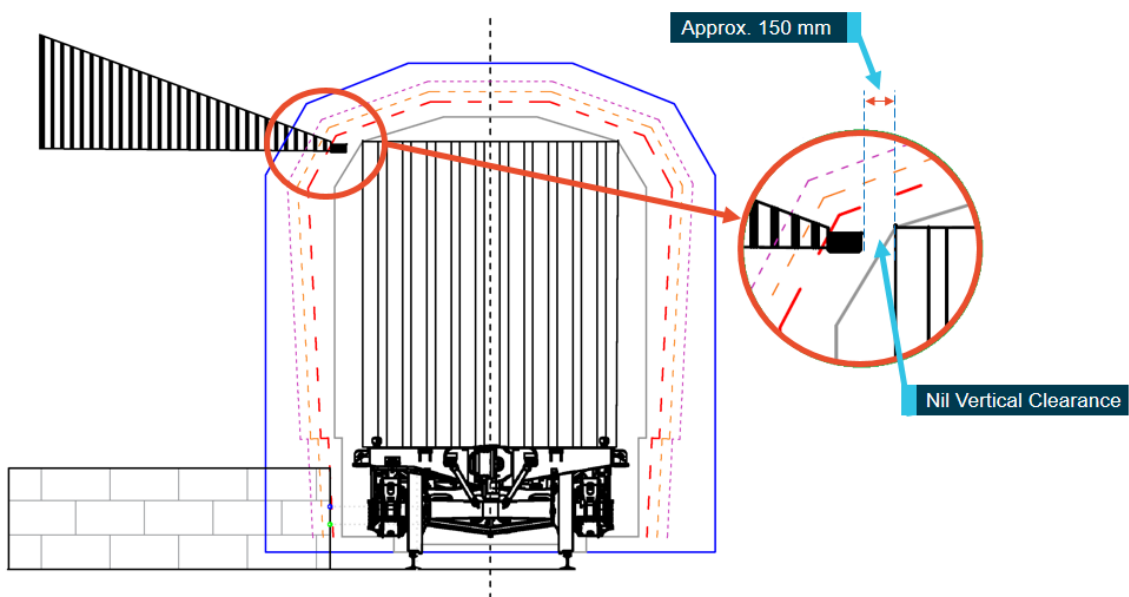
**Figure 8: Maitland Railway Station platform 1, actual clearance outlines**

However, post-collision measurements showed that the measured track height through platform 1 had increased from the design height. Because of the change in track height, the station verandah encroached on the kinematic rolling stock outline, effectively becoming a track obstruction. With respect to a correctly secured container load, the change in track height removed the vertical clearance (previously 70 mm), with the remaining safety margin only provided by the horizontal clearance of approximately 150 mm (Figure 8).

The image depicts the measured clearance outlines for platform 1 at the Maitland Railway Station for a correctly secured container loaded on a PQQY class wagon. Note that verandah height is now at same height as container, and infringing on kinematic rolling stock outline. Source: ATSB.

- ARTC have communicated to all ARTC teams that no further work is to occur at Maitland Railway Station which will impact on track geometry.
- ARTC has installed new physical plaques at Maitland Railway Station and amended track design documentation to indicate that track height must not be raised at this location.
- ARTC has undertaken a detailed survey of the clearance at platform 1, Maitland Railway Station.
- ARTC has committed to lowering the track height through Maitland Railway Station back to the design levels. An interim 20 km/hour speed restriction will apply for coal and freight traffic until this work is completed.

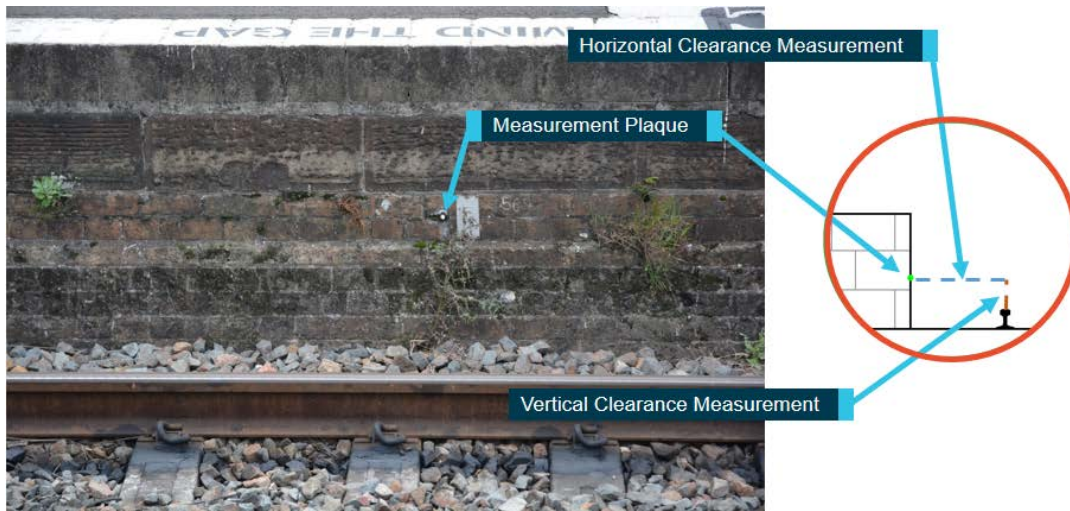
**Figure 9: Maitland Railway Station, platform 1 track clearance measurement plaque**

The ARTC had scheduled and undertaken inspections of clearances for the railway station on a yearly cycle prior to this incident. These inspections required the measurement of the vertical and horizontal clearance between the closest rail and physical measurement plaques fitted to the platform wall (Figure 9).

The image shows a measurement plaque on the Maitland Railway Station platform 1 wall, with inset graphic showing where scheduled clearance measurements were undertaken prior to the collision. Source: ATSB.

The horizontal and vertical clearance inspection records for platform 1 at Maitland showed that over time the vertical clearance measurement had reduced due to an increase in the track height through platform 1. The change in vertical clearance exceeded the limits defined by the ARTC management of clearance specification, and the platform 1 design measurements.

The increased track height and consequential decrease in vertical clearance measurement at Maitland railway station was not identified (or corrected) by ARTC.

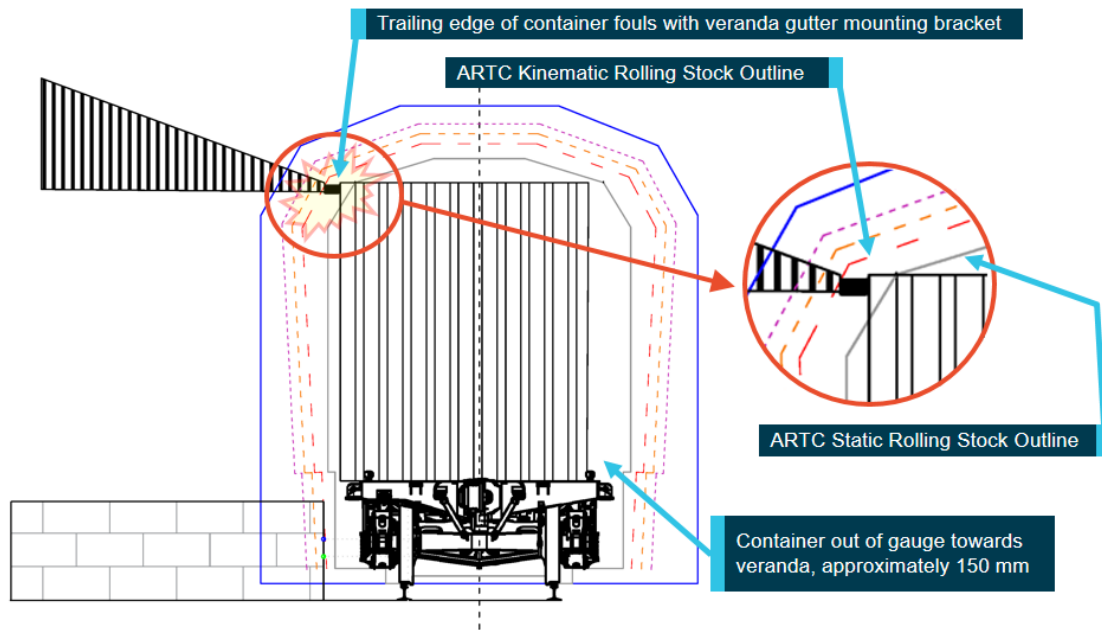
**Figure 10: ARTC rolling stock clearance outline in respect to Platform 1 at Maitland Railway Station, with container load shifted towards station verandah**

On 16 January 2018, container MGCU7810161 had shifted laterally on wagon PQQY50015 by approximately 150 mm, exceeding the permissible ARTC static rolling stock outline for that rail corridor. The ATSB found that the reduction in structure clearances due to the raised track height (relative to the documented design for platform 1), combined with the out-of-gauge container on wagon PQQY50015, contributed to the collision with the Maitland Railway Station verandah. (Figure 10).

The image depicts the dimensions of the rolling stock, with an estimated amount of load shift based on witness observations. Note that the magnified portion of graphic shows the container infringing on the ARTC Rolling Stock Outline, and station verandah infringing on the ARTC Kinematic Rolling Stock Outline. Source: ATSB.
