Undetected engine thrust reverser deactivation involving Airbus A320, VH-VGZ

Sydney Airport, New South Wales, on 20 September 2018

ATSB Transport Safety Report
Aviation Occurrence Investigation
AO-2018-064
Final – 22 March 2019

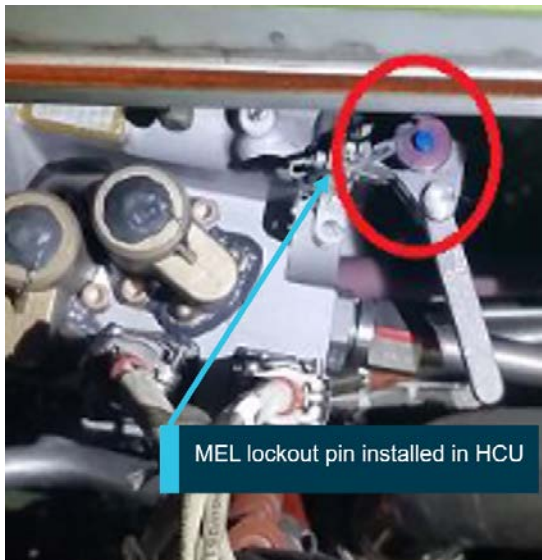
Figure 1: MEL lockout pin installed in thrust reverser hydraulic control unit (HCU)

Following the incident, an engineering inspection revealed that the thrust reversers were in the de-activated position; with the minimum equipment list (MEL) lockout pin installed (Figure 1). The lockout pins were removed from each of the engines, thrust reversers were tested and found to be serviceable, and the aircraft was returned to service.

Following non-operation of the thrust reversers during the landing roll, an engineering check revealed that the MEL lockout pins were installed in the hydraulic control units (HCU) resulting in deactivation of the thrust reverser system. The pins were installed as part of required maintenance action and unintentionally not removed prior to flight.

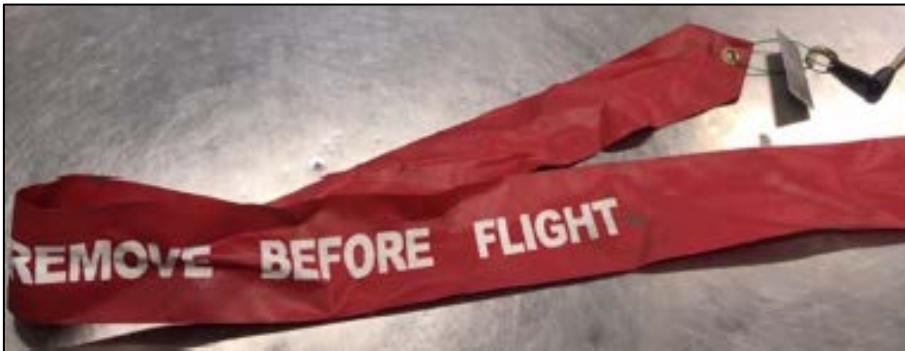
Figure 2: Lockout pin with warning flag

The installed MEL lockout pins were not identified following completion of the engine leak check procedure. Consequently, both engine cowlings were closed with the lockout pins in place and the thrust reversers inoperative.

Although the required operational check of the thrust reverser would have prevented this incident, other maintenance actions hampered detection of the HCU lockout. Thrust reverser de-activation required the use of a lockout pin with a red flag attached to provide a visual indication that the HCU was de-activated. The MEL lockout pin that was actually fitted was designed for in service use and was much less visually obvious than the pin used during maintenance.

- A Quality Alert was issued, with a requirement for all Brisbane-based maintenance staff to read and sign. The Quality Alert reminded engineers to ‘always use the lockout pins issued from the tool crib unless a MEL is required to be applied to the aircraft.’
- The occurrence was discussed with all Jetstar’s aircraft-certifying staff, including the effect of perceived time pressures and the importance of documentation and compliance.
- A review of the process of previous lockout pin management in Brisbane was conducted to rule out a systemic problem with lockout pin management.
- All A320 thrust reverser lockout pins were inspected to confirm they were correctly identified and flagged.
- An A320 de-activation board, containing the correct A320 lockout tooling, has been constructed. The trolley will sit next to the aircraft during maintenance visits for ease of access.
