Air traffic control procedural errors at Perth Airport

Perth, Western Australia, on 9 May 2018

ATSB Transport Safety Report
Aviation Occurrence Investigation
AO-2018-037
Final – 12 March 2019

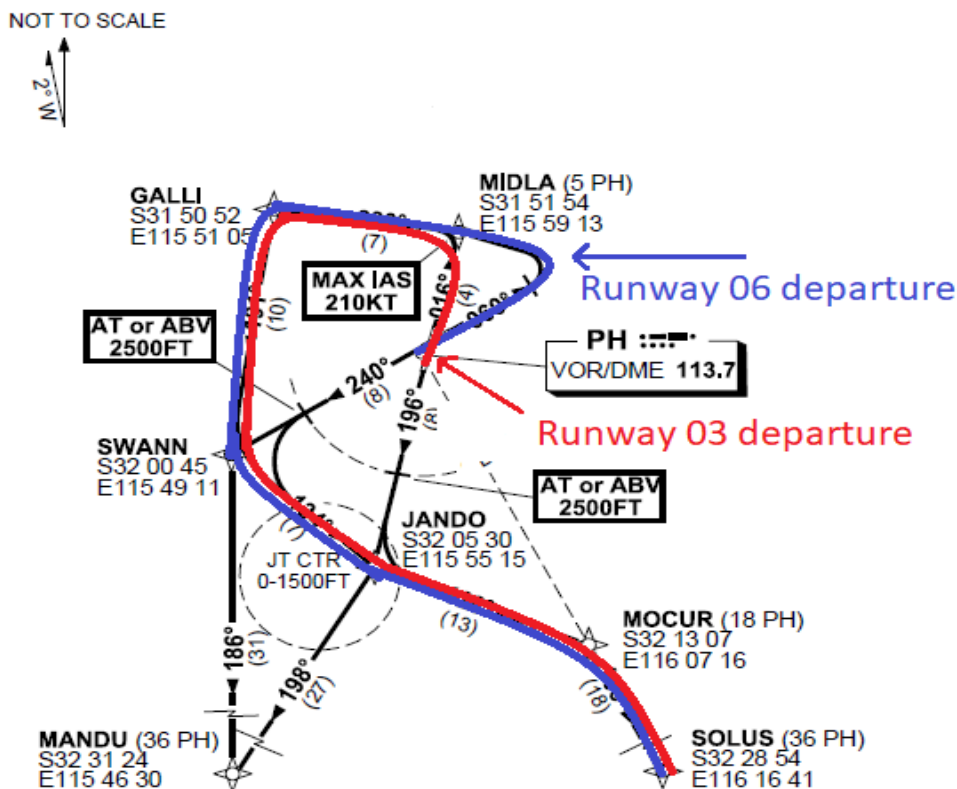
Figure 1: Perth Airport SOLUS THREE SIDs from runway 03 (red highlight) and runway 06 (blue highlight)

Based on the airways clearance and ATIS, the RXA2113 crew programmed the aircraft flight management system (FMS) for a departure from runway 03 direct to MIDLA followed by a left turn to track as specified by the SID to SOLUS, followed by the flight-planned route (Figure 1: red highlight).

From the perspective of the crew and controllers in the tower, the take-off and departure was uneventful. However, the departures controller was expecting the aircraft to be on a northward track to MIDLA rather than tracking initially to the north-east before turning left to MIDLA (runway 03 departure, Figure 1). The aircraft was soon on the flight planned track and there was no reported loss of separation with any other aircraft.

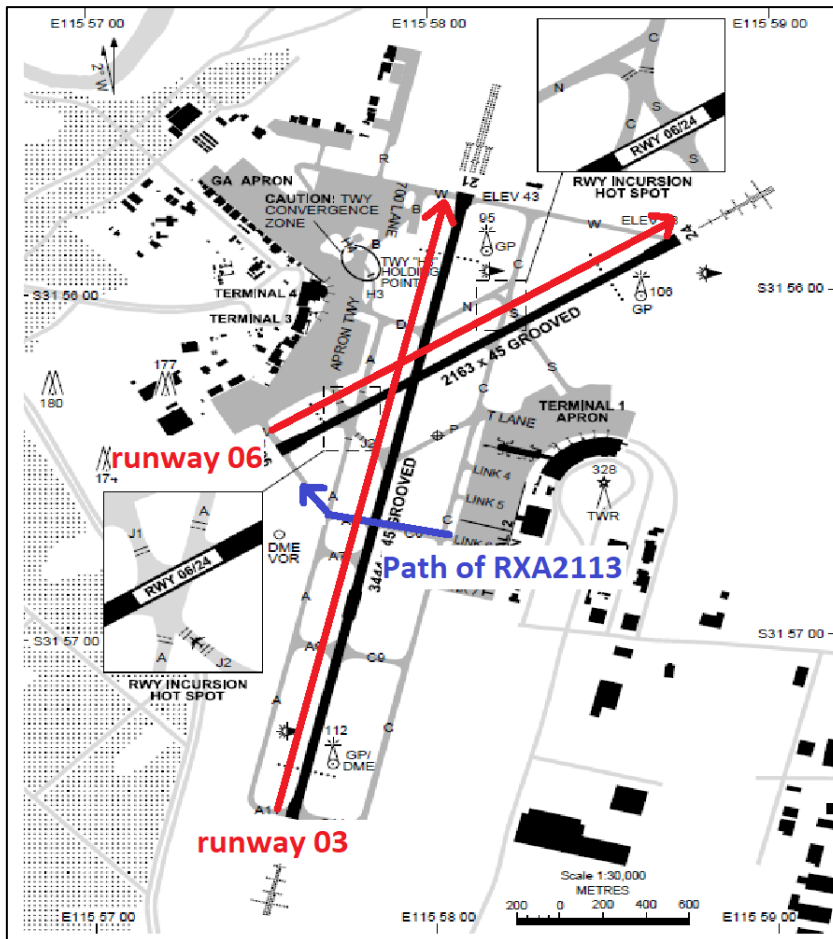
At 0905, the RXA2113 crew contacted the SMC to request taxi clearance. The SMC recalled that he referred to the flight data record on his display and perceived that the aircraft was departing off runway 06. Accordingly, the SMC issued instructions for RXA2113 to taxi via taxiway 'Charlie Six' (C6) and hold short of runway 03 (Figure 2). At the same time, the SMC selected the intermediate hold point as the clearance limit on the ATS graphical display.

Figure 2: Perth Airport taxiway map with RXA2113 route highlighted in blue

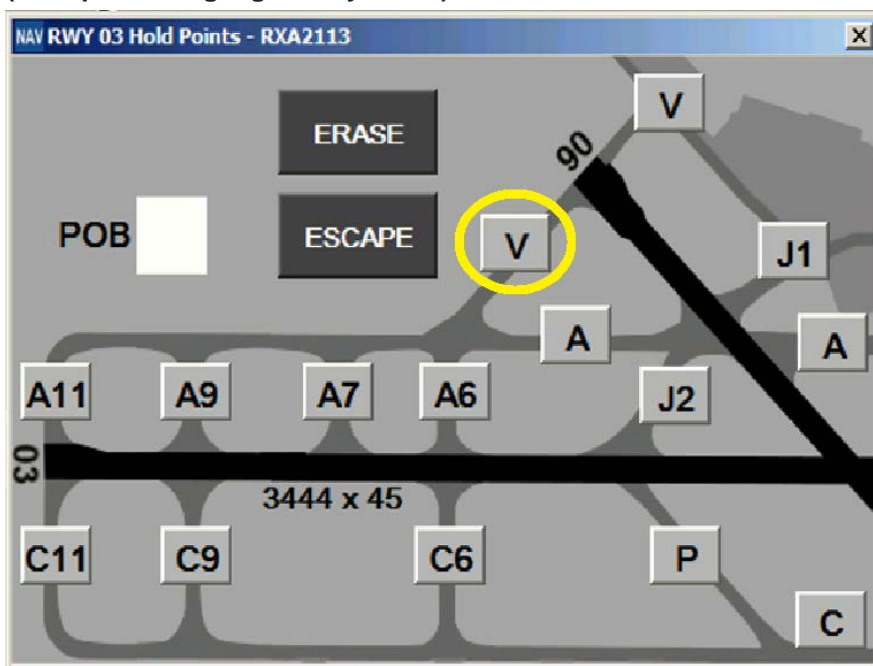
Immediately after the SMC instructed the RXA2113 crew to taxi to hold point V, he recorded that hold point in the ATC system. The SMC called up the ‘RWY03 Hold Points’ selection panel within the ATC system. The SMC used this panel to record the taxi clearance for RXA2113 to hold point V (Figure 4).

This panel presented all valid hold points for runway 03 departures. Although the hold point options on the graphical display were delimited to those associated with the system-assigned runway, hold point V was available to facilitate traffic flow from terminals 3 and 4.

Figure 4: Hold point selection panel in ATC system for runway 03 departures (Hold point V highlighted by ATSB)

The ATSB noted that the ATS system did not provide any specific inhibitions to prevent or alert the controllers to the taxi of aircraft to non-conforming hold-points.
