Fuel exhaustion and forced landing involving Cessna 172M, VH-TUX

72 km south of Kalgoorlie Boulder Aerodrome, Western Australia, on 5 January 2018

ATSB Transport Safety Report
Aviation Occurrence Investigation
AO-2018-005
Final – 17 March 2019

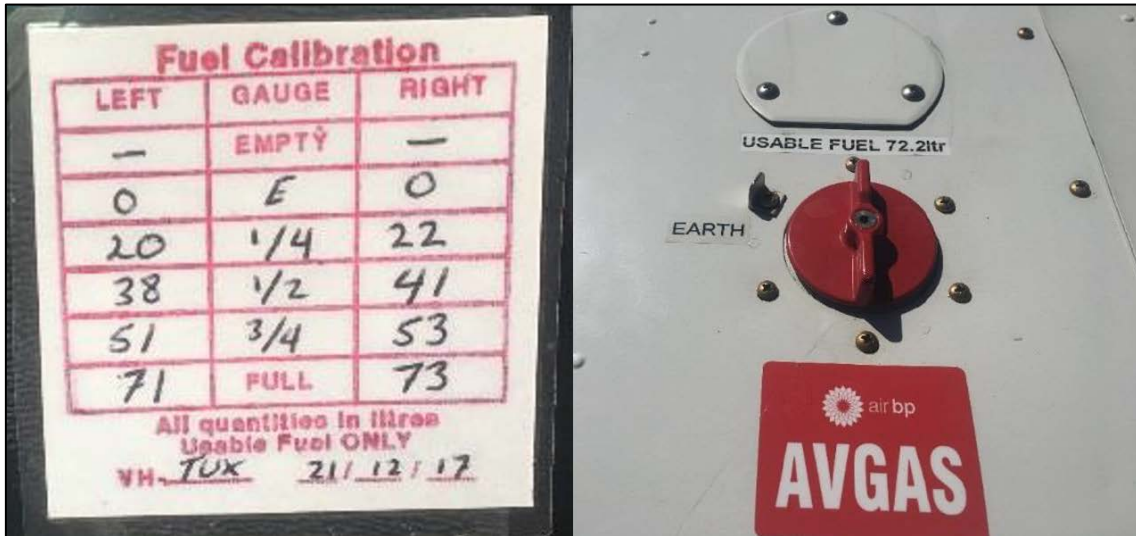
Figure 2: Fuel placard and label installed on VH-TUX

The Cessna 172M utilises a gravity feed fuel system from a fuel tank mounted in each wing. Both wings on TUX had been replaced during the recent repairs, with wings from another Cessna 172M. However, the replacement wings were fitted with smaller capacity tanks, which reduced the useable fuel capacity from the original 182 litres to 144 litres. A fuel gauge calibration check was performed on 21 December 2017 and a fuel calibration placard was affixed to the centre of the instrument panel. Fuel quantity labels were also placed adjacent to the fuel filler caps indicating the respective tank's fuel capacity (Figure 2).

A hand written entry dated 22 December 2017 adjacent section 1.3 Fuel in the Pilots Operating Handbook recorded ‘Wings replaced, fuel capacity 144 litres, Refer PenYan Supplement⁴ for fuel consumption data.’

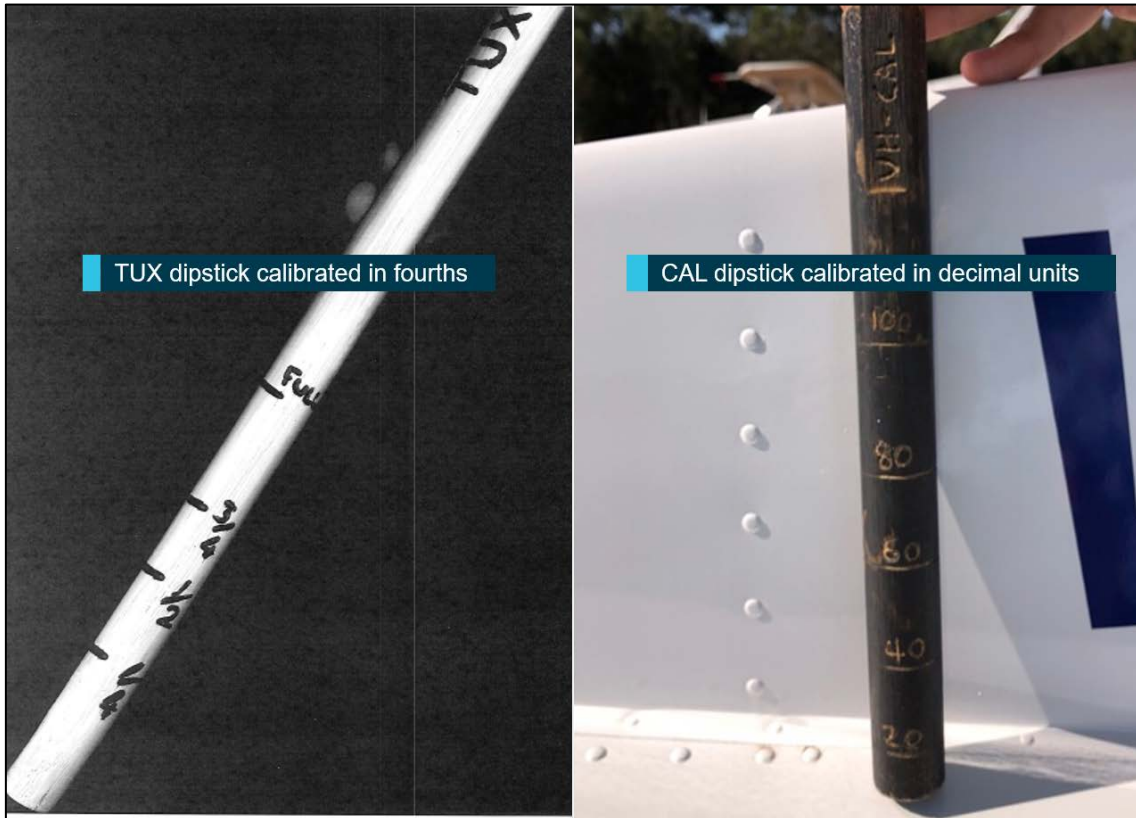
Figure 3: Fuel dip sticks from Cessna aircraft TUX and CAL

The pilot did note that the dipstick was graduated in quarters, rather than in decimal increments (litres). He considered that these markings when used to determine the fuel quantity remaining was not optimal as it potentially made it more difficult for a pilot to check actual fuel (in litres) remaining in the aircraft, if departing with less than full tanks (Figure 3).

Image of fuel dipsticks from the incident aircraft VH-TUX (left) and the aircraft VH-CAL (right) flown by the pilot earlier on the morning of 5 January 2018. Source: Goldfields Air Services, annotated by ATSB
