Engine failure and forced landing involving Gippsland Aeronautics GA-8 Airvan, VH-BFL

8.5 km NNW of Bellburn Airstrip Western Australia, on 14 May 2018

ATSB Transport Safety Report
Aviation Occurrence Investigation
AO-2018-036
Final – 18 April 2019

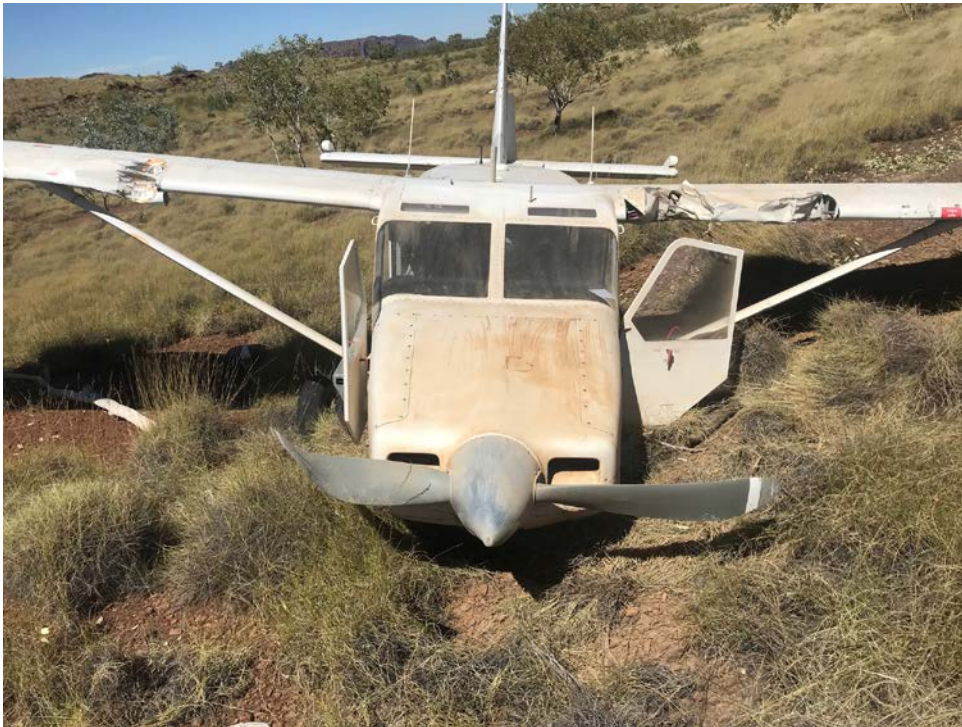
Figure 1: VH-BFL forced landing site

electrical system. During the landing roll, the wings hit some small trees. Towards the end of the landing roll, the aircraft went into a ditch and tore off the nose landing gear.

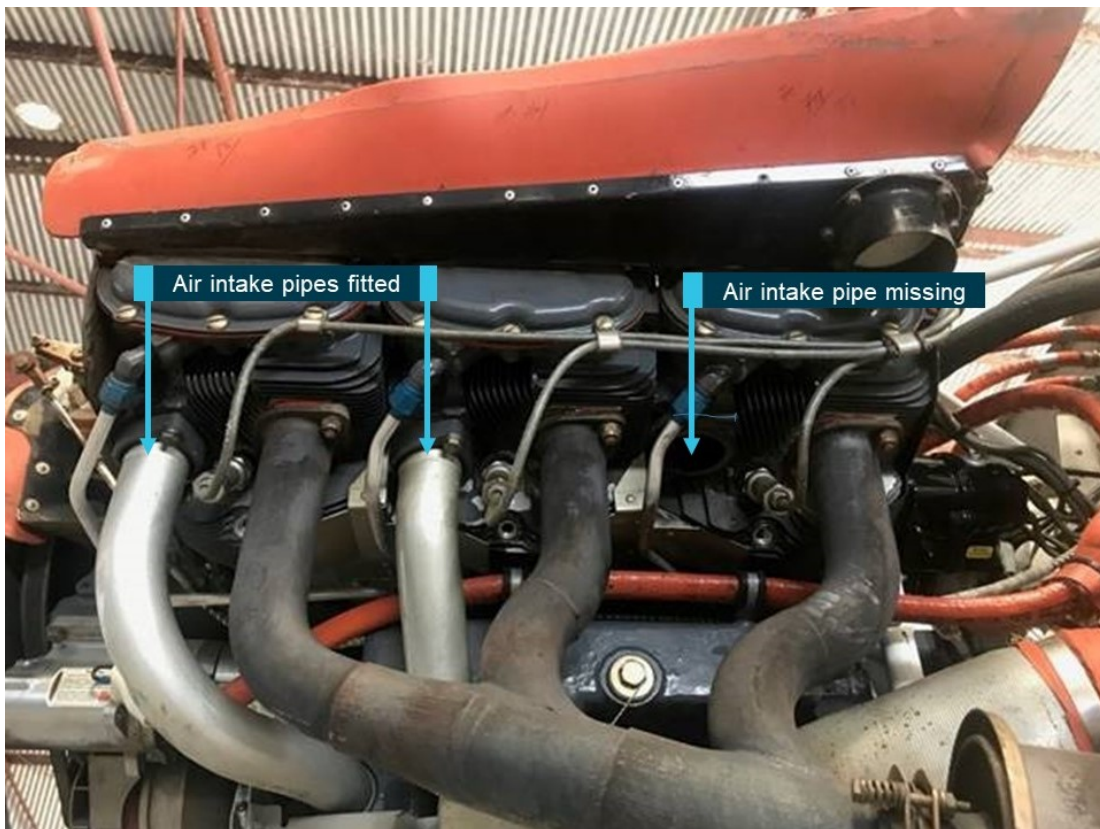
The operator carried out a visual inspection of the aircraft at the accident site and noted that the number six cylinder air intake pipe was missing from the engine. Due to difficulties accessing the remote site, there was a delay in recovery and further examination of the wreckage by the operator.

Figure 2: Image of engine with number six cylinder air intake pipe missing

The reported performance of the aircraft was consistent with the likely symptoms resulting from the air intake pipe to number six engine cylinder becoming loose and then detaching in flight. Consequently, the ATSB concluded that the missing intake pipe was the cause of the loss of power however, consistent with the previous occurrence in 2015, the reason for the air intake pipe coming loose could not be determined.

- The air intake pipe to engine cylinder number six probably detached in flight, leading to the loss of engine performance. There was insufficient evidence to determine why the intake pipe detached from the engine.
- Recent forced landing practice performed by the pilot as part of the operator’s joining procedures likely reduced the risk of mishandling the emergency and may have prevented more serious injuries being received by the pilot and passengers during the forced landing.

- A 'spanner check' was carried out immediately after the accident on all Lycoming engines in the operator's fleet. The same check was also carried out on engines from other manufacturers that had been recently overhauled and fitted. No deficiencies were found.
- Engineering staff were reminded to remain vigilant when refitting engine components.

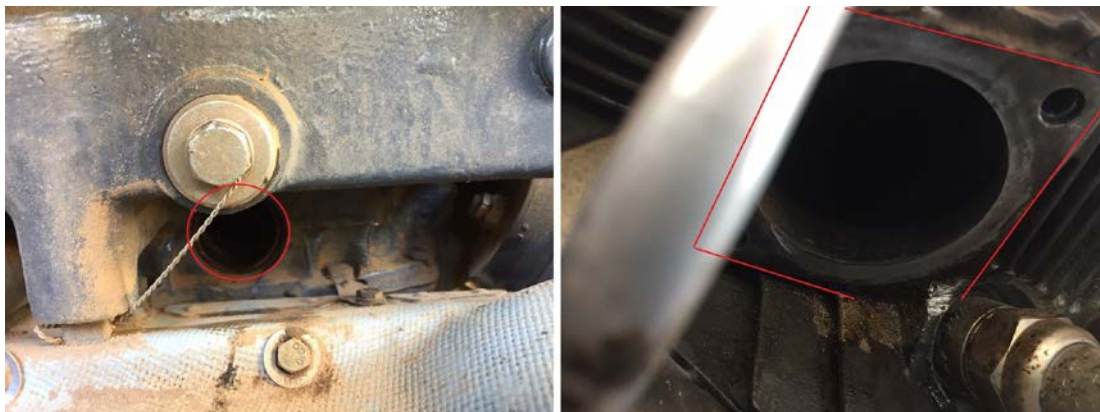
- When visiting the forced landing site, several days after the event, a search of the forced landing site was performed however, the missing intake pipe was not found (Figures 2 and 3).
- The pilot had recently completed the company induction training package, which included several practice forced landings.

Figure 3: Lower (left image) and upper (right image) air intake pipe attachments points highlighted in red. Air intake pipe, bolts and flange are missing.
