# In-flight break-up involving Cessna 210B, VH-DBU

30 km NW Albany, WA on 24 October 2017

**ATSB Transport Safety Report**  
Aviation Occurrence Investigation  
AO-2017-103  
Final – 16 May 2019

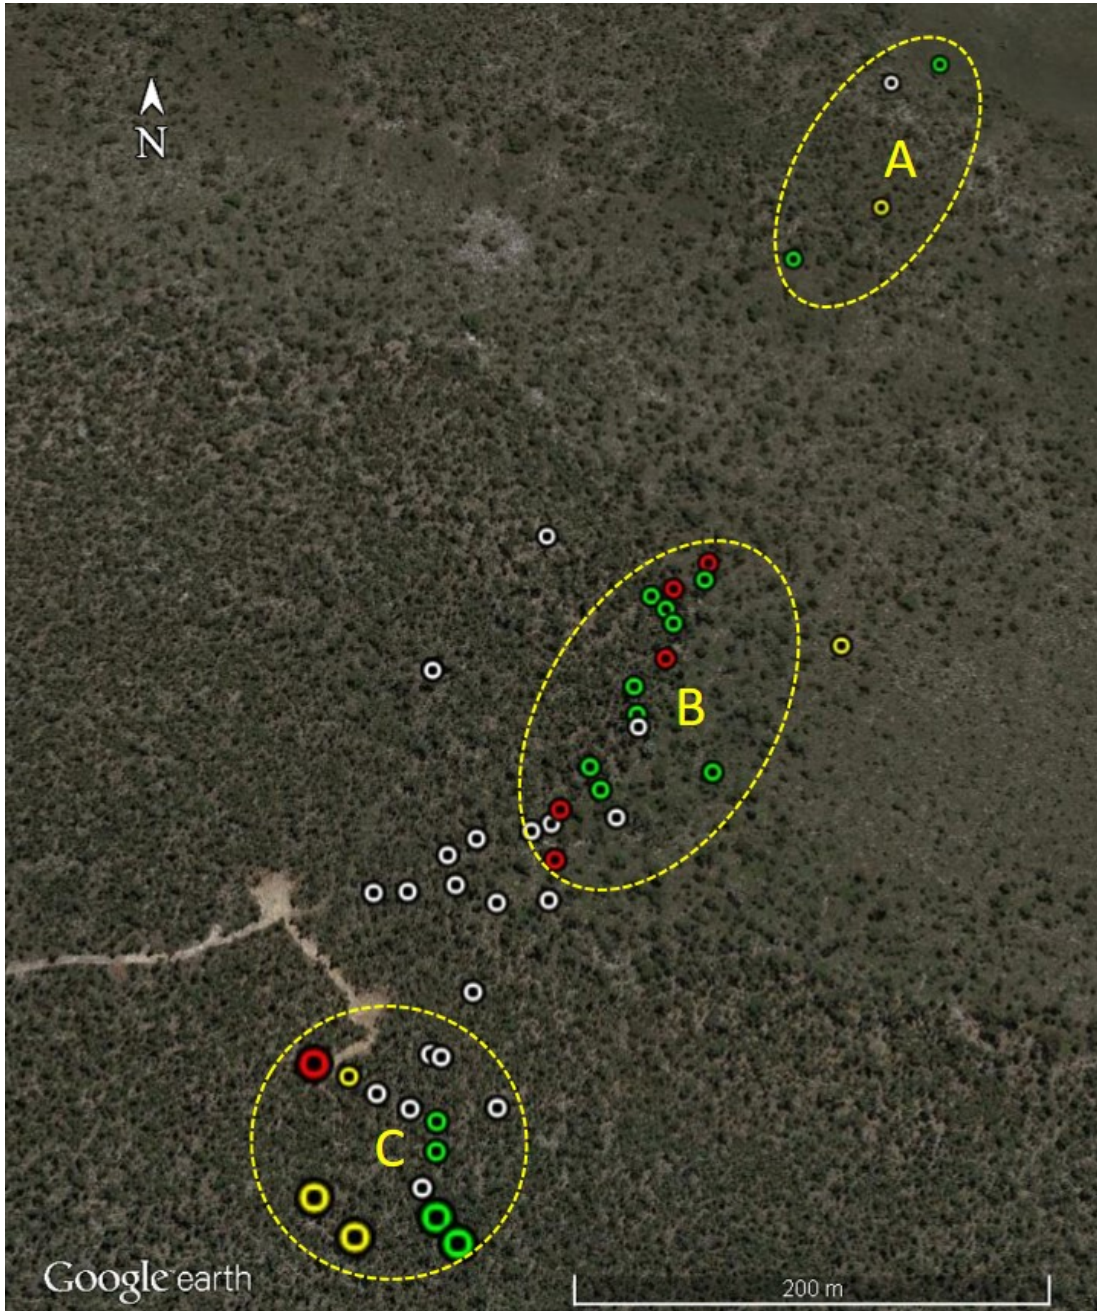
**Figure 3: Wreckage plot**

For ease of reference and interpretation, three zones were delineated and named according to likely chronology of events from A to C.

- most but not all of the aircraft parts have been identified and these were found within an area of about 700 m long and 250 m wide that was oriented in a south-westerly direction
- not accounted for are the right cabin door and small sections of the right wing (areas identified in Figure 7)
- the main wreckage, that included the fuselage, engine and propeller, was severely affected by fire (Figure 4)
- the left wing (Figure 5), inboard right wing (Figure 6), tailplane, and fuselage (main wreckage) were grouped in zone C but not structurally contiguous, which is consistent with an in-flight break-up

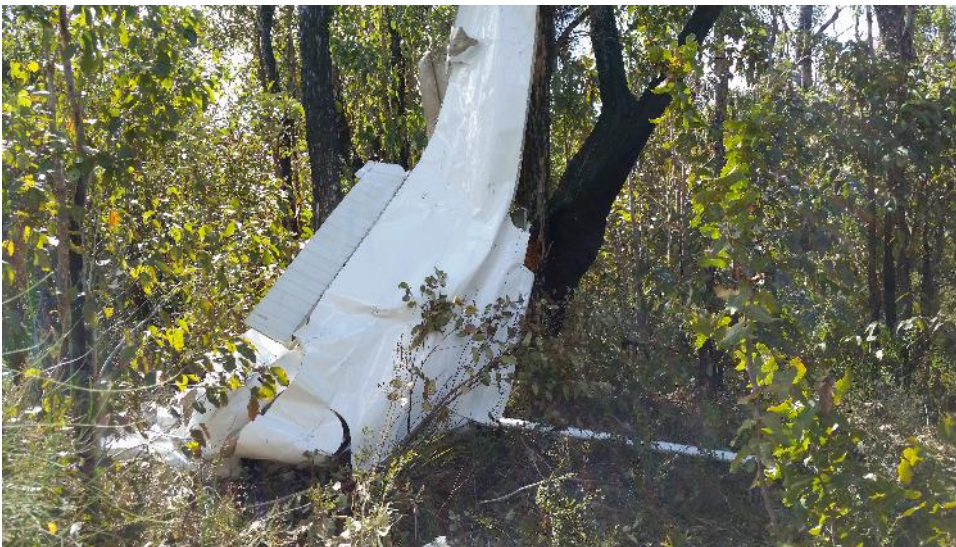
**Figure 5: Left wing in as found position**

- separation of the outboard leading edge skin, outboard aileron section and wing tip fairing
- a downward bend near the wing strut attachment and general nose-up twisting of the outboard section. Some distortion was related to post-break-up impact with vegetation and the ground.
- overload failure of the wing-fuselage attachments.

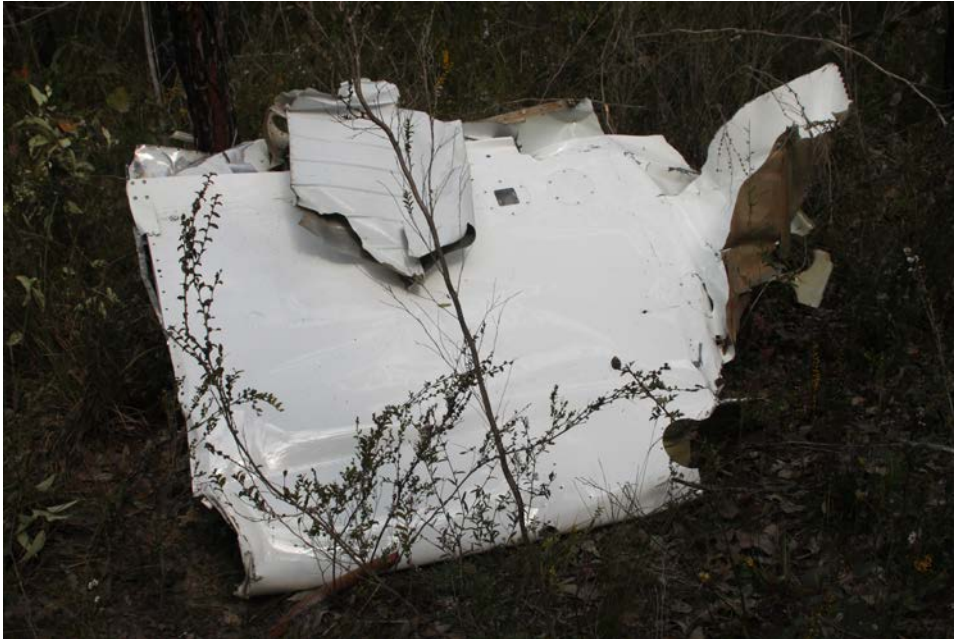
**Figure 6: Right wing inboard section in as found position (zone C)**

- the items furthest from the main wreckage were pieces of right wing skin and rear fuselage skin (zone A)
- many of the major parts of the aircraft had been damaged in-flight and during the ground impact
- the right wing outboard of the fuel tank had fragmented in-flight (Figure 6).

- significant fragmentation and distortion with two primary fracture lines in front to rear orientation
- bending in multiple directions with some torsional effects
- overload failure of the wing-fuselage attachments.

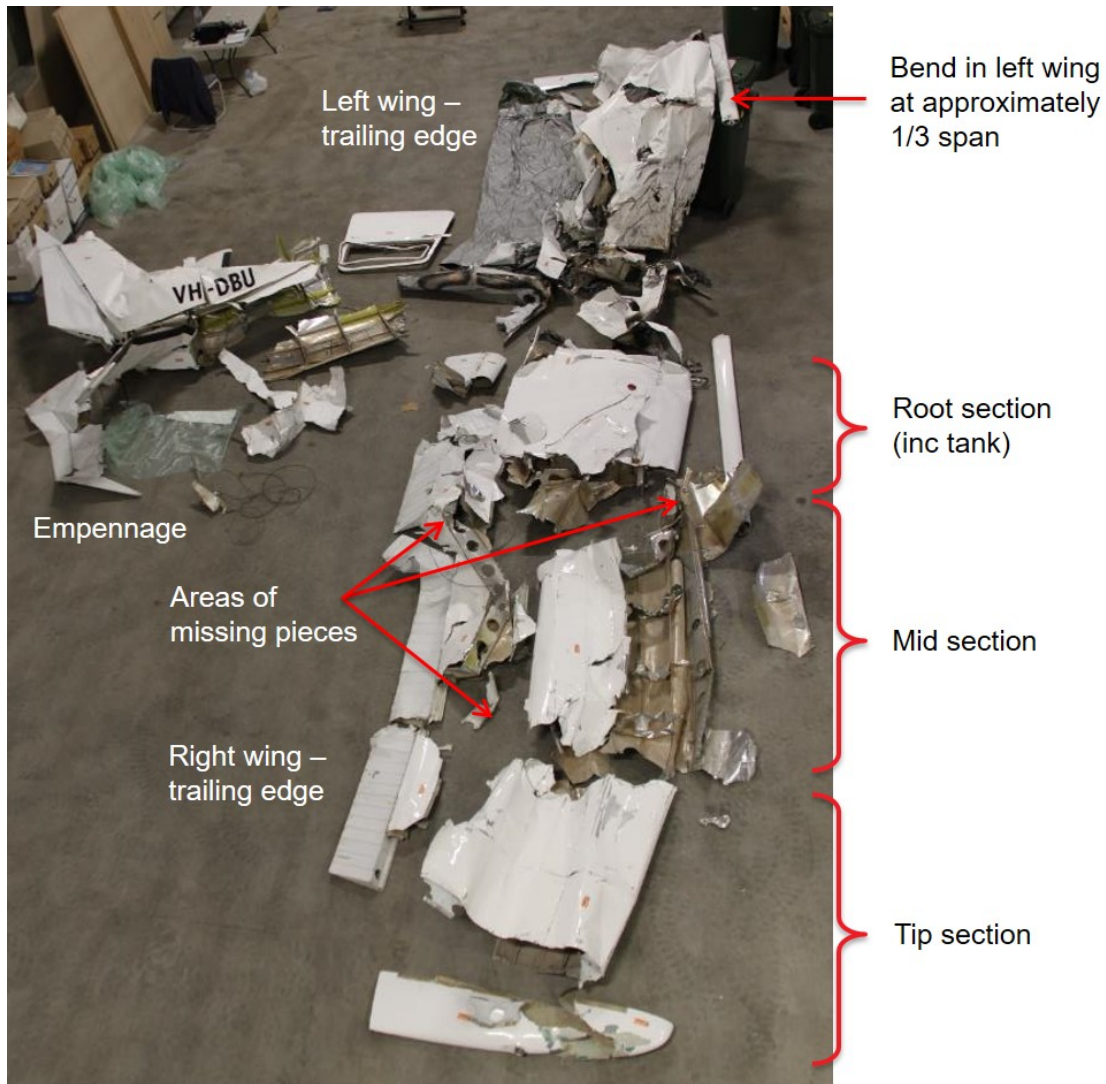
**Figure 7: Wreckage loosely reassembled at storage facility**

The ATSB recovered the wing, tailplane, and selected fuselage pieces and moved them to a secure storage location for further examination. With the parts loosely reassembled (Figure 7), the ATSB mapped the damage and inspected the fracture surfaces in context. The ATSB summarises the results of that process in the dot points following.

- no signs of pre-existing material deficiencies such as corrosion or metal fatigue
- all fractures were consistent with over-stress of the material
- all flight controls were connected or disrupted during the break-up.

The break-up of the right wing was notable in terms of the degree of fragmentation and the high level of torsional and reverse bending. This is not characteristic of a simple overstress situation where the excessive aerodynamic forces on the wings are generally symmetric in direction and magnitude. In that case, if the aircraft breaks up in flight, the sequence typically begins with separation of a substantial piece of each outboard wing. The failure characteristics of both wings is likely to be consistent and further in-flight disruption would be variable but not necessarily extensive.
