Runaway and collision between 'J' class and 'Nagasaki' class trams

Sydney Tramway Museum, Loftus, New South Wales | 15 May 2016

ATSB Transport Safety Report
Rail Occurrence Investigation
RO-2016-006
Final – 17 May 2019

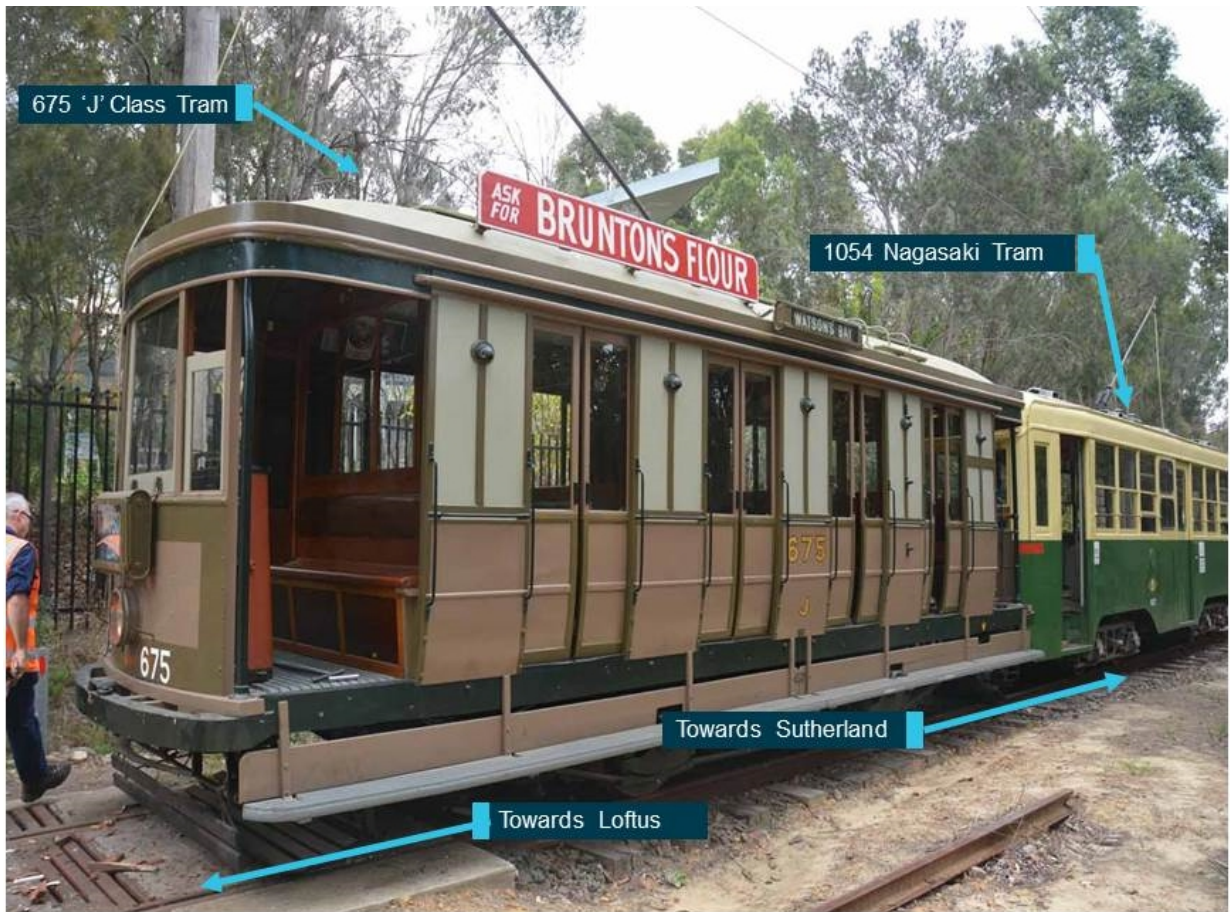
Figure 1: 675 'J' class and 1054 'Nagasaki' class tram collision

The 'J' class had travelled in an unmanned state for approximately 283 m. Marks on the rail indicated that the collision force moved the 'Nagasaki' 13.5 m back towards Sutherland.

As a result of the collision, there was minimal damage to the steel-bodied exterior of the Nagasaki. The 'J' class's floor hoist (support) was compressed and the wooden floor panels were damaged. The front exterior face of the 'J' class was damaged and broken wood was observed within and around the trams (Figure 6).

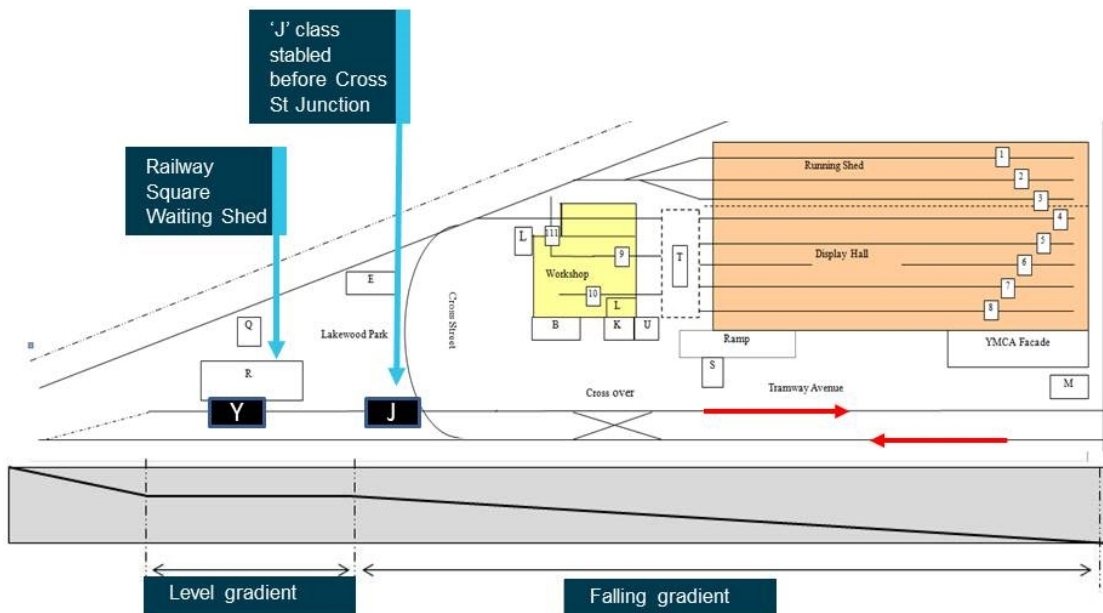
Figure 5: Sequence of trams parked while the Nagasaki tram was heading to Sutherland

At approximately 1050, the 'J' class was moved forward towards Sutherland and parked just before Cross St junction to line up with a kerb (Figure 5). The air brakes were used to stop the tram however, the handbrake was not applied. In lieu of the handbrake, a STM staff member placed the hardwood wheel chock used previously under the front left-hand wheel of the 'J' class. The 'J' class was parked on a falling gradient facing towards Sutherland with the control key removed and was left unattended.

Prior to the runaway, the 'J' class was moved and parked on the falling gradient adjacent to Cross St junction (Figure 5). The service air brake was applied and a single hardwood wheel chock was

The ATSB also found that although the falling gradient near Cross St junction had been identified within its SMS documents, it was likely difficult for drivers to observe visually.

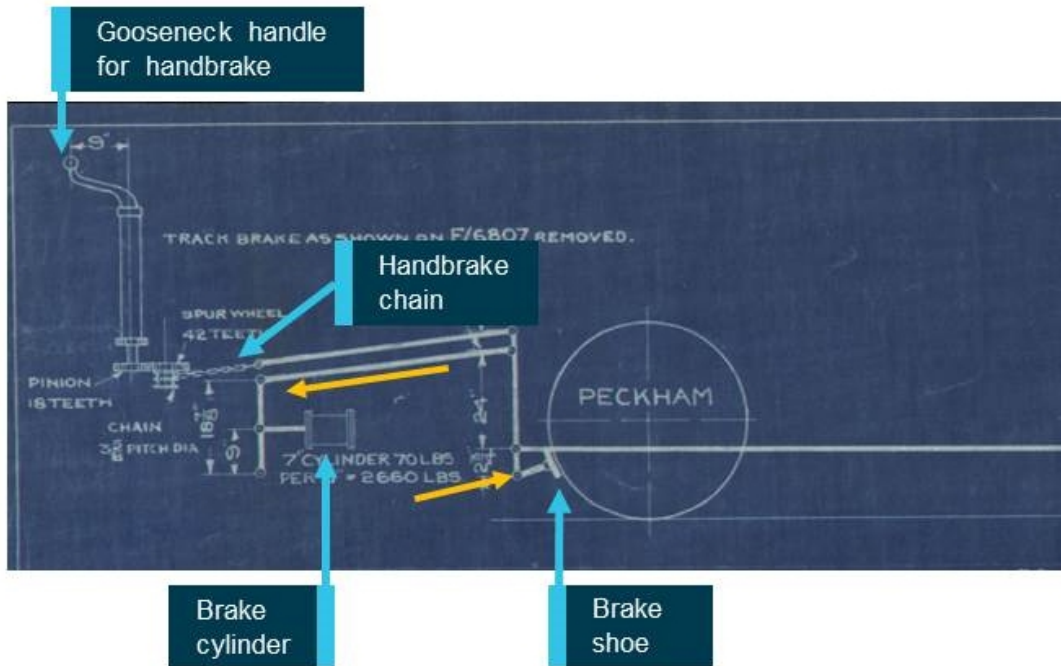
Figure 7: Air brake and handbrake system on the 675 ‘J’ class tram. The yellow arrows denote force direction for applying braking effort

The manual lapping air brake system on the 'J' class does not retain air in its brake cylinder indefinitely. In the lap position, air gradually releases from the system and braking effort reduces over time after application. Therefore, a service brake application is not suitable as a park brake. This is different to a self-lapping air brake system where the air valve automatically feeds air into the system as brake cylinder pressure.

At approximately 1050, the 'J' class was parked adjacent to Cross St junction on a falling gradient with the air brakes applied and the driver controlled air valve in the lap position. The 'J' class was then left unattended. Air within the brake system likely released, which gradually reduced the 'J' class' available braking effort. The braking effort holding the 'J' class from moving likely reduced to a point where the brake could not hold the mass of the tram on the downhill gradient and relied on the chock to restrain its movement. At approximately 1055, the 'J' class started to roll down the gradient.

The time between brake application and the tram rolling down the grade suggested the retention time of air within the brake cylinder was less than five minutes. STM later advised the retention time was approximately four minutes and thirty seconds.

The ATSB found that the handbrake was not applied to the tram prior to it running away on the falling gradient.

- STM has made the application of handbrakes mandatory.
- STM's Safety Management System (SMS) now requires trams to be stabled on level track.
- STM has included yellow markings to delineate level track from a descending gradient.
- STM has stopped using hardwood wheel chocks to stable its trams.

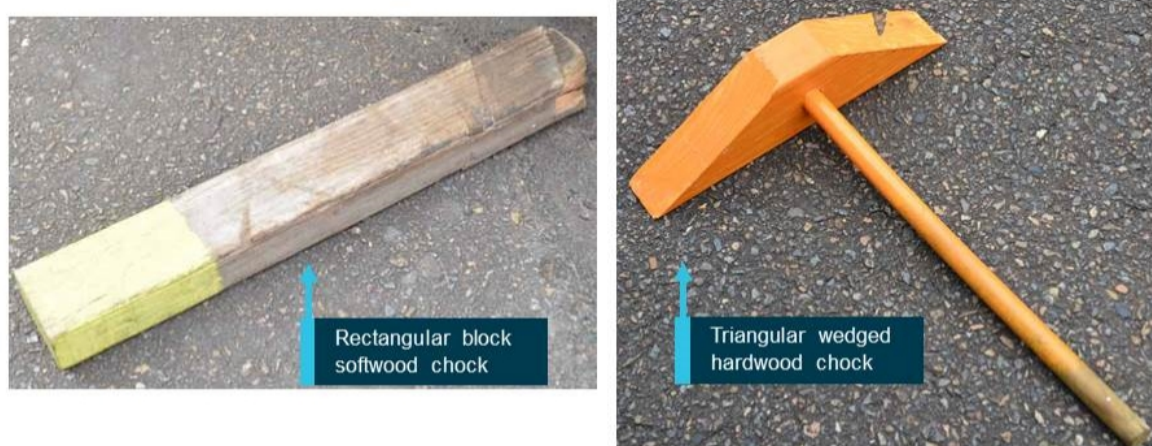
Figure 8: Comparison of the old and new type chock

The ATSB identified that the chock type used to stable the 'J' class on the day of the incident was newly adopted by STM. It was a triangular wedged hardwood chock (Figure 8). Applying this type of chock required the crew member to visually line up the wedge with the curve tread face of the wheel.

ATSB investigators noted that the 'J' class had a lowered footboard which hindered the access to install the chock. This meant that lining up the triangular wedged hardwood chock with the wheel would have required the crew to get down lower than usual to visually line it up and place it against the wheel.

The ATSB replicated the process to install the hardwood chock under the 'J' class. The ATSB found that the chock could not be installed against the wheel adequately due to the chock fouling the brake gear. The ATSB determined it was likely the chock was incorrectly installed and did not function as intended.

After the incident, the chock was found in the four foot with witness marks on it consistent with that of a tram having driven over it at an angle (Figure 8). This was likely due to the 'J' class wheel rolling over the chock.

- **STM did not follow its change management process for adopting the new hardwood chock type. Subsequently, the hardwood chock could not be applied reliably under the 'J' class wheel and could not restrict its movement [Safety Issue].**
