Derailment of acid train 9T90

near Kimburra, Queensland | 28 September 2017

ATSB Transport Safety Report
Rail Occurrence Investigation
RO-2017-013
Final – 13 June 2019

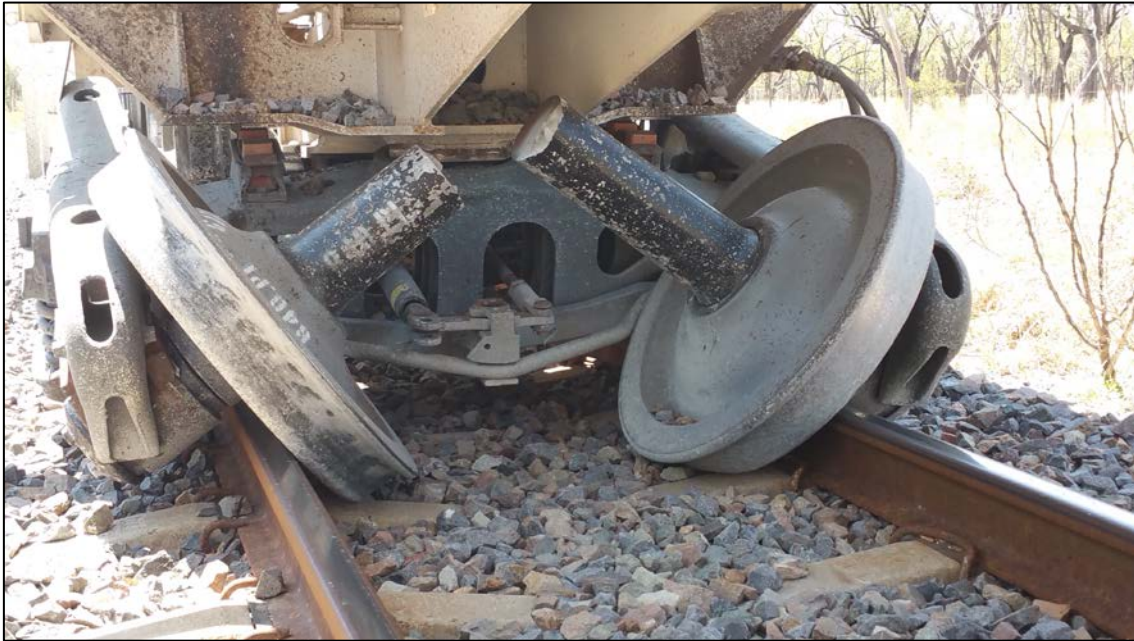
Figure 2: Failed axle in-situ from train 9T90

At 2310, the driver contacted the network control centre (NCC) in Townsville to report the train had stopped. He also advised that the other driver had exited the locomotive to inspect the train and determine the source of the sparks. A short time later, the driver confirmed to the NCC that an axle on the train had fractured, allowing one wheel set on the fourteenth wagon to derail (Figure 2).

There were no injuries or sulphuric acid spill. The track and rolling stock sustained minor damage. The train was repaired and the Mount Isa line was reopened at about 1630 the following day.

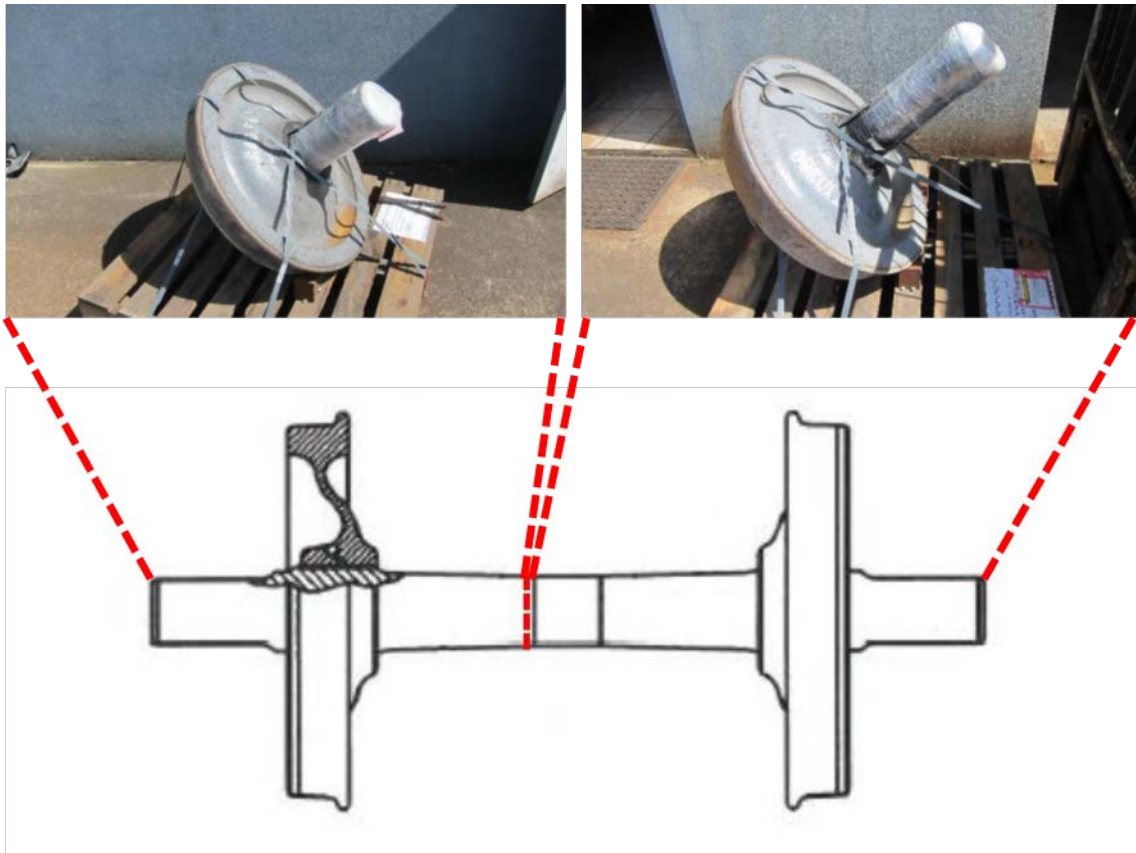
Figure 6: Fracture location on axle barrel

That examination identified that the axle fractured about 341 mm and 526 mm from the in-board side of each wheel disc, (Figure 6).

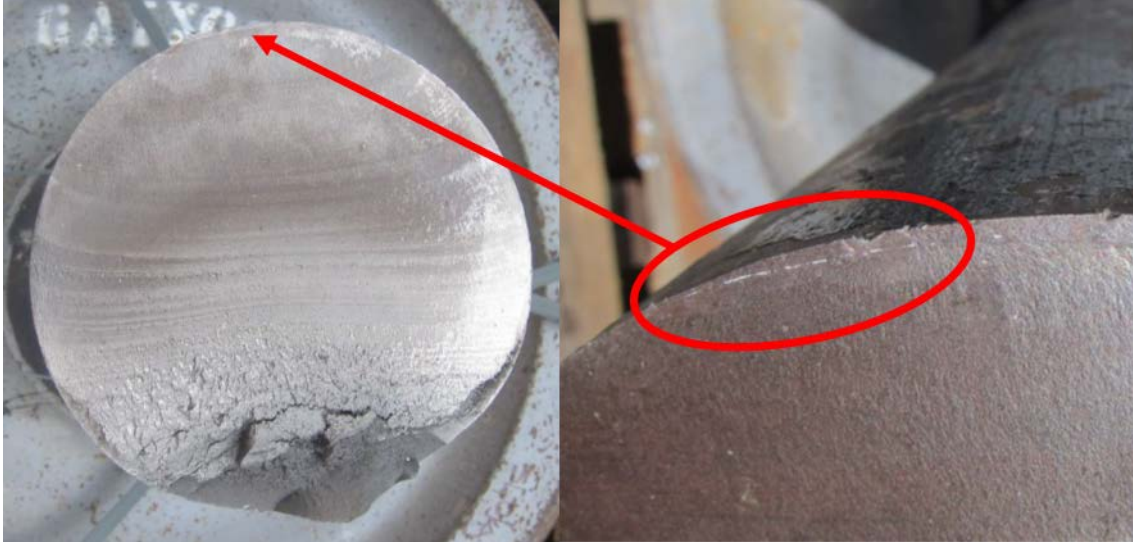
Figure 7: White paint on fracture surface near origin

QUT noted that the fracture surfaces were intact with minimal secondary damage. There was a 70-mm long fine circumferential white line present at the fracture initiation region at a depth of up to about 3 mm (Figure 7).

A scanning electron microscope (SEM) with an energy dispersive spectrometer (EDS) was used to determine the elemental composition of the white line. The SEM EDS analysis indicated the white line residue was rich in titanium, a pigment used in white paint. During the magnetic particle inspection process, white paint is applied to the axle barrel.

A magnetic particle inspection (MPI) was carried out on the axle three months prior to the failure/derailment. As part of that inspection, white paint containing titanium oxide was applied to the surface of the axle. Examination of the axle fracture surface found titanium oxide residue at a depth within the fatigue crack. That physical evidence indicated that the paint seeped into the fatigue crack during the last MPI and that therefore the fatigue crack was present at the time of the testing. Additionally, the length of the paint residue indicated that the size of the fatigue crack present at the time of the inspection should have been detectable under the MPI process.

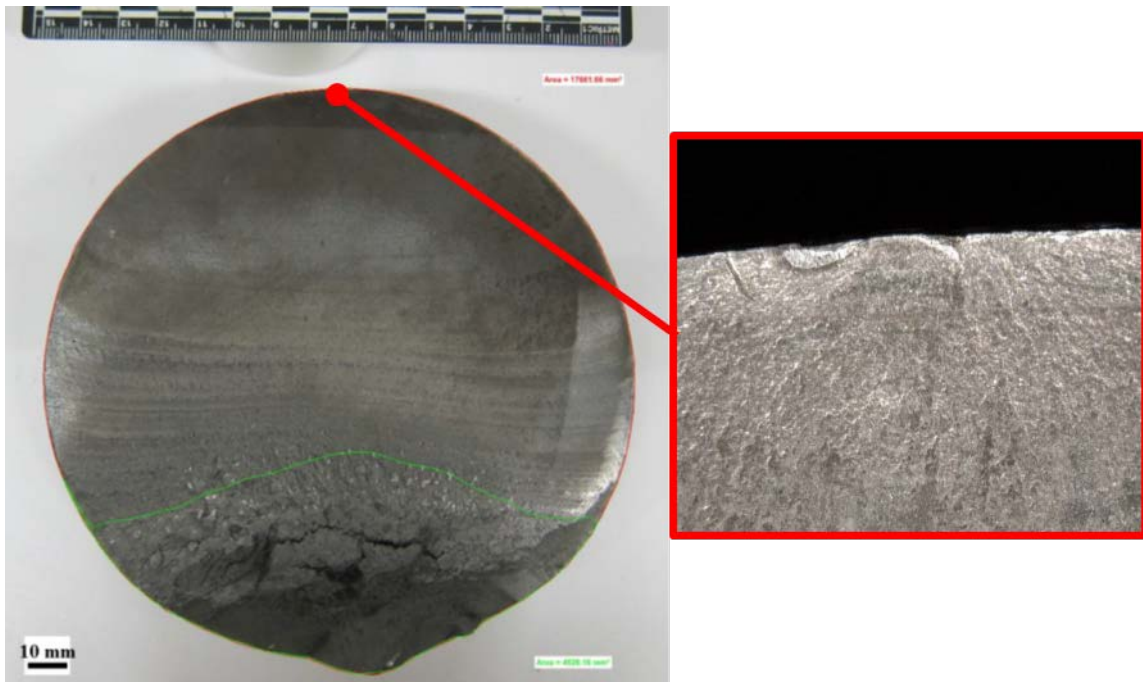
Figure 8: Fatigue origin

Examination of the axle fracture surfaces also identified a single, distinct mechanical notch on the surface of the axle from which faint beach⁷ marks originated (Figure 8).

These beach marks indicated propagation of a fatigue crack. The fracture surface was flat and almost perpendicular to the axle barrel's longitudinal axis. The fatigue fracture face displayed smooth texture indicating fatigue propagation. The fatigue area was relatively large, about 74 per cent of the fracture surface area, penetrating to a critical depth of about 94-110 mm. Once the crack propagated that far, the remaining section could not support the load and failed rapidly due to overstress.

Detailed metallurgical examination of the failed axle identified that in-service impact damage to the axle surface created a notch that led to the initiation of a fatigue crack. That crack propagated undetected until it reached a critical size, resulting in an overstress fracture of the axle. Fracture of the axle led to the separation of the axle halves and subsequent derailment of train 9T90.

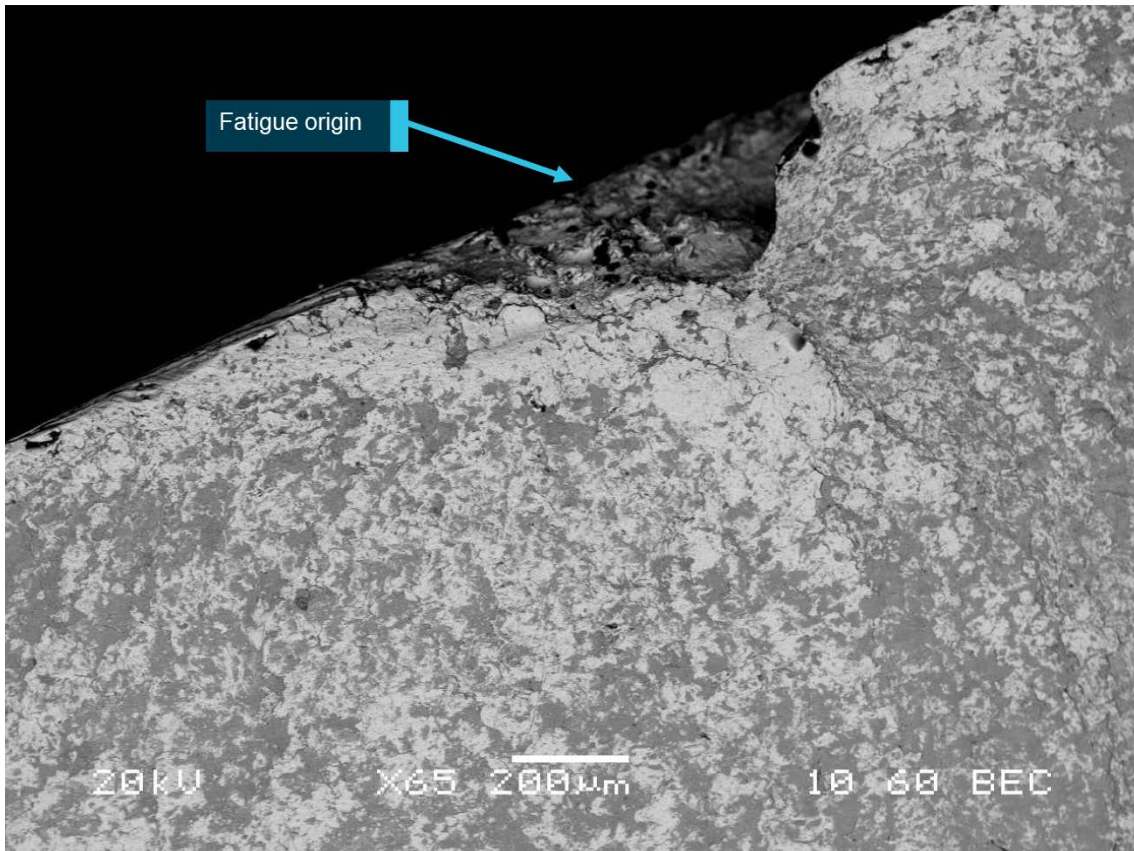
Figure 9: SEM image showing the initiating notch at the fatigue crack origin

The mechanical notch measured about 1 mm in length and about 0.2 mm in depth (Figure 9). For this type of axle, the condemning limit is damage extending 3 mm deep or greater. IPL and Aurizon permitted repairs on notches up to 1.5 mm deep in the axle central area, and up to 2 mm deep elsewhere. There was no evidence that the coincident mechanical notch was detected or repaired during the last inspection on 7 June 2017. Although, given the shallow notch depth (0.2 mm), it may have been assessed as not requiring repair.

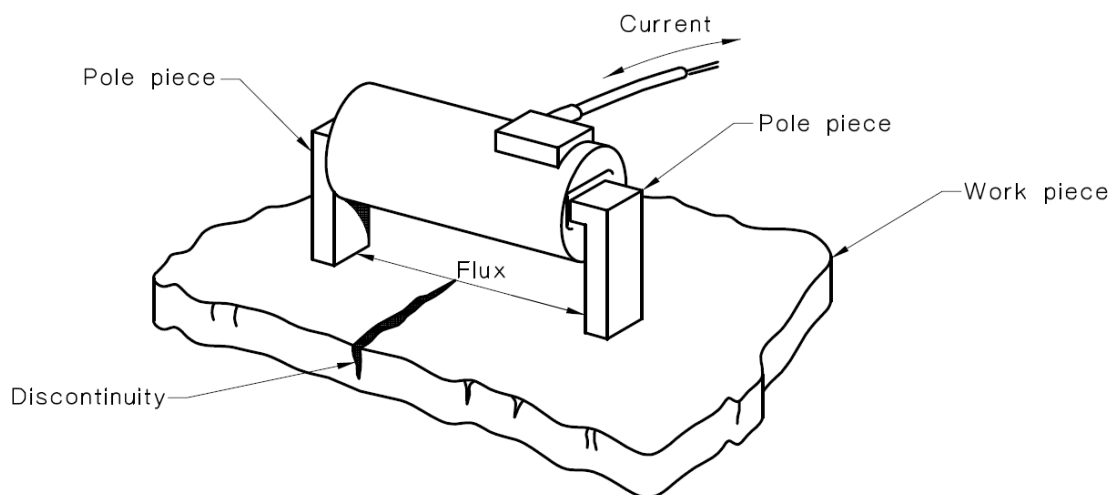
Figure 10: AC yoke

During a site visit to the Aurizon Rockhampton wheel shop, the ATSB observed that only the dead weight test was conducted. A standard test piece with known discontinuities was not used. Additionally, the local work instructions did not reflect the Aurizon and AS1711 requirements to performance check the AC yoke using the standard test piece.

Although the lift test was performed, the omission of the standard test piece during the equipment testing did not adequately verify the overall system performance. As a result, a defect that may have affected the ability to observe the crack would have been more difficult to identify.

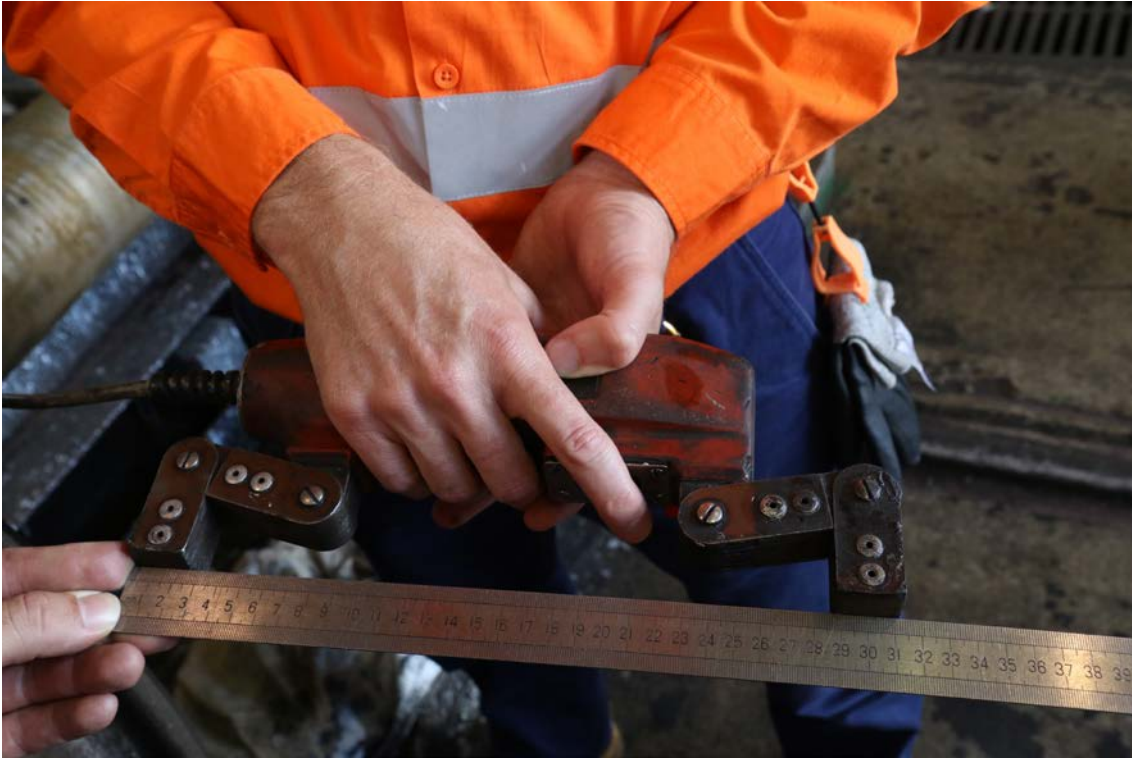
Figure 11: AC yoke measurement

During a site visit to the Rockhampton wheel shop, the ATSB noted that during the inspection/testing process, the magnetic ink media (Ardrox 800/3) was not reapplied in between AC yoke placements, nor was there the positional overlap between each test. Both of these processes were required and detailed in Australian Standard AS1171.

The measured width of the AC yoke on the day of the site visit. Source: ATSB

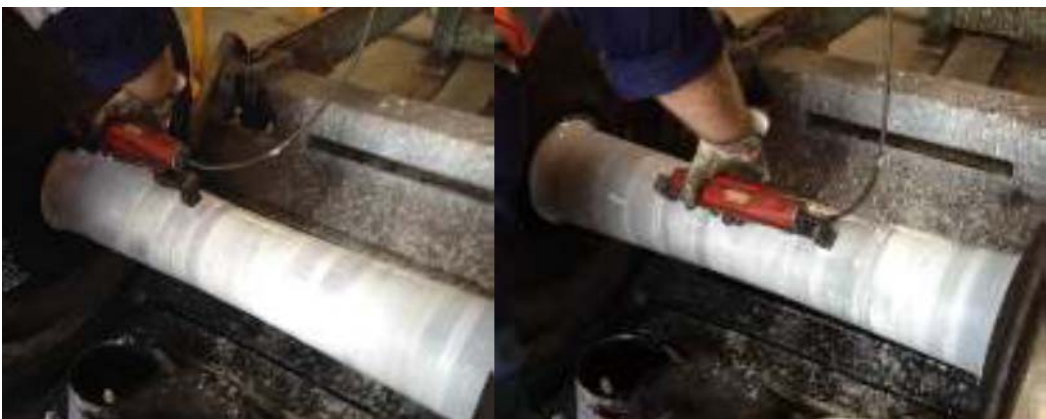
Figure 12: AC yoke placement

The AC yoke poles are adjustable and the yoke used at the wheel shop had been set to a distance of about one third the length of the axle shaft. The AC yoke was placed on one end of the axle (perpendicular to the centre line), energy applied to create magnetic flux, checked for potential indications, and then moved to the next third and the process repeated. There was no overlap between consecutive tests observed during the ATSB site visit. Once one side of the axle was inspected, the work instruction specified that axle be rotated through 90° and the process repeated until the entire axle was tested (Figure 12). During the site visit, the ATSB noted that the axle was rotated 120° rather than 90°. This equated to nine tests for the axle instead of the required 12.

There were no work instructions detailing where to place the yoke during the inspection and the adjustable alternating current (AC) yoke was set for one-third the width of the axle. The observed practice was that there was no overlap between the pole arms from one yoke placement to another. This meant that potential indications near or beneath the AC yoke poles may not be sufficiently energised to create enough magnetic flux to accurately and reliably indicate a potential crack. Furthermore, the AC yoke pole placement may also have physically obscured or masked potential crack indications. In the case of the failed axle, the location of the fracture closely correlated with the overlap point of the AC yoke poles.
