# Derailment of coal train 9869

8 km west of Oakey, Queensland | 21 July 2017

**ATSB Transport Safety Report**  
Rail Occurrence Investigation  
RO-2017-007  
Final – 26 June 2019

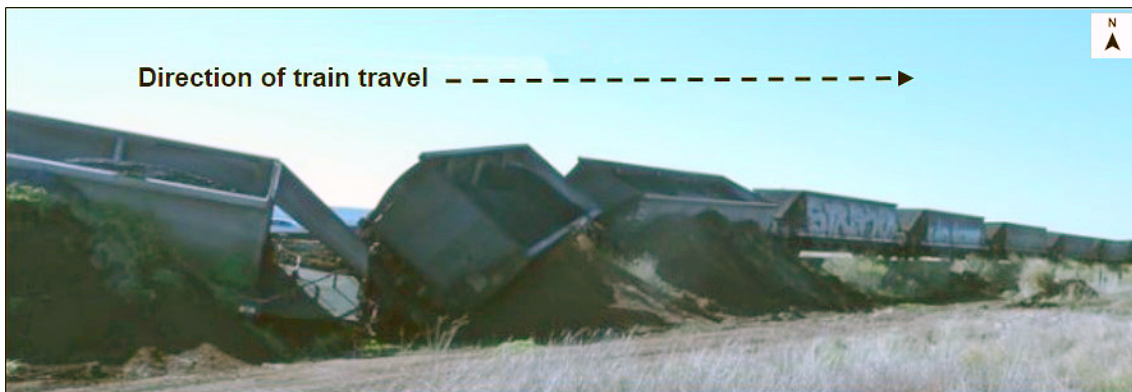
**Figure 3: Derailed coal wagons of train 9869**

There were no injuries to the train crew or members of the public. A visual inspection of the train identified both locomotives and 18 coal wagons had derailed. There was also damage to about 300 m of rail infrastructure (Figure 3).

*The image shows derailed coal wagons of train 9869 – all wagons in the scene were in a derailed state.*

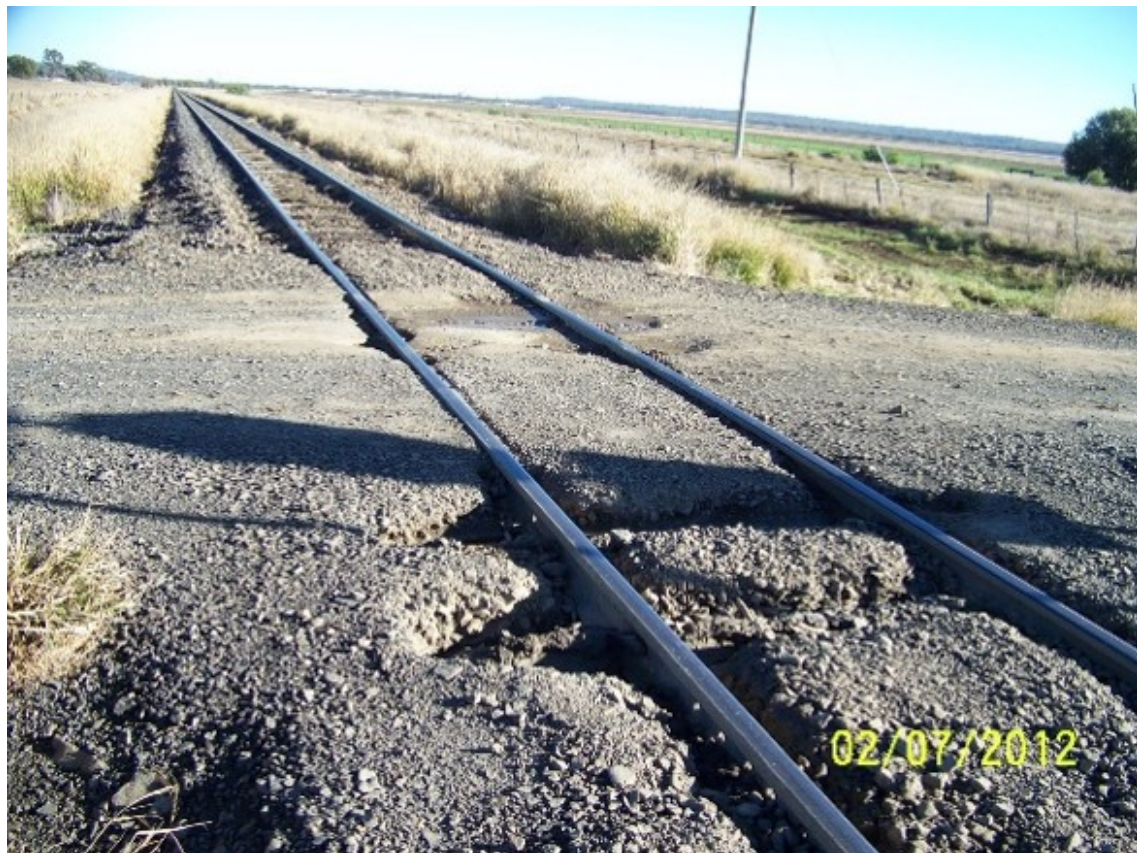
**Figure 5: An image taken by the assessor during the July 2012 assessment of level crossing ID 2309**

Crossing gravel surface is breaking up. Track is “pumping”<sup>5</sup> and contributing to surface deterioration...  
[Figure 5]

*The assessors report recorded that the crossing gravel surface is breaking up and the track is ‘pumping’ and contributing to surface deterioration.  
Source: QR*

Repair gravel surface in accordance with QR Standard Drawing No.2586. Carry out track maintenance works to address track ‘pumping’ issue.

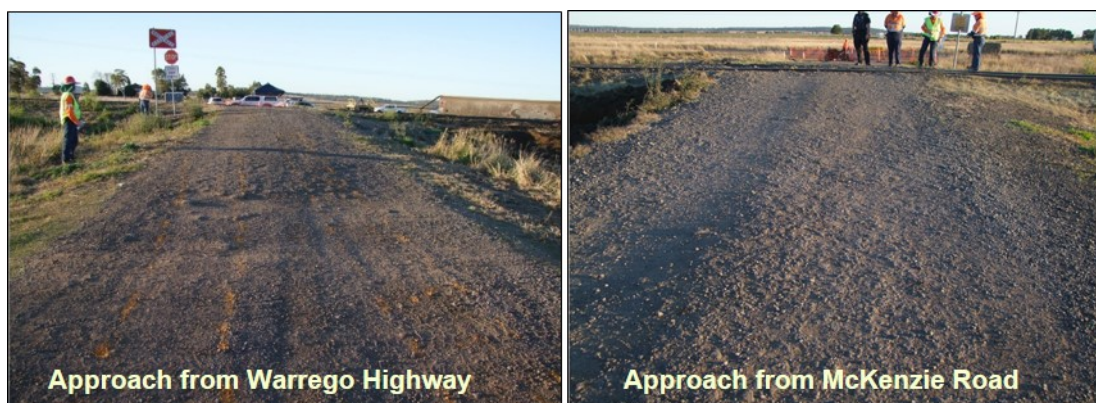
**Figure 6: The condition of the gravel-based road surface at the crossing on 22 July 2017**

The approach roads to the level crossing were unsealed and constructed from compressed gravel road base. The on-site examination identified noticeable wheel furrows cut into the road surface on the approach to the level crossing from both sides (Figure 6).

*The images show the deteriorated state of the road surface and evidence of wheel furrow marks cut into the road surface.*  
Source ATSB

An examination of the level crossing on 22 July 2017, the day after the derailment, identified that the approach roads to the level crossing were in a deteriorated state. There were significant wheel furrows in the gravel-based approach roads, which lowered the underframe of vehicles relative to the road surface, if they followed the furrows. In addition, there was not a level plane over the crossing surface, with the 5 per cent incline in the approach roads extending up close to the rails. The available evidence also indicated that the head and probably some of the web of each rail was exposed above the crossing surface, although the extent the webs were exposed could not be determined. Collectively, these factors, in the period leading up to the derailment, presented a significant risk associated with low-clearance road vehicles and agricultural machinery passing over the level crossing and damaging the rail infrastructure.

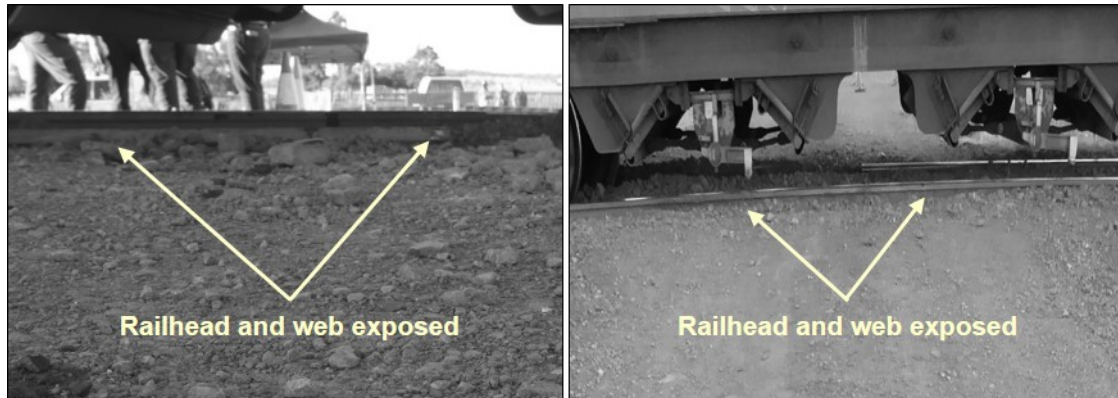
**Figure 7: The exposed railhead and rail web at level crossing ID 2309**

When inspected by the ATSB following the derailment, the head of each running rail at the level crossing was standing noticeably proud above the crossing surface. In some areas, the web<sup>7</sup> of the rail was exposed (although see *Examination of rail track*). This was particularly noticeable where the wheel furrows in the road surface intersected with the rail lines (Figure 7).

The images show the deteriorated condition of the crossing surface with the railhead and some of the rail web exposed. The image on the left is the approach from the Warrego Highway and the image on the right is the approach from McKenzie Road.

As noted in *Examination of approach roads*, the site examination identified that the web of each rail was partially exposed at the level crossing and was clearly visible above the crossing surface. This was at least partly due to the low clearance vehicle colliding with the rails together with the derailment lifting the rails and displacing the gravel-based material previously surrounding the rails. Therefore, the extent to which the rail webs had been exposed, prior to the impact, was not able to be determined. However, it was noted that, where the wheel furrows intersected with the rails, the top of the rail webs had a distinctly different appearance to the lower sections of the webs, indicating that they had been exposed for some time.

- The condition of level crossing ID 2309 was degraded, with significant wheel furrows in the approach roads, the absence of a level plane over the crossing surface, and the head of both rails was exposed. Some of the web of the rails was also probably exposed.

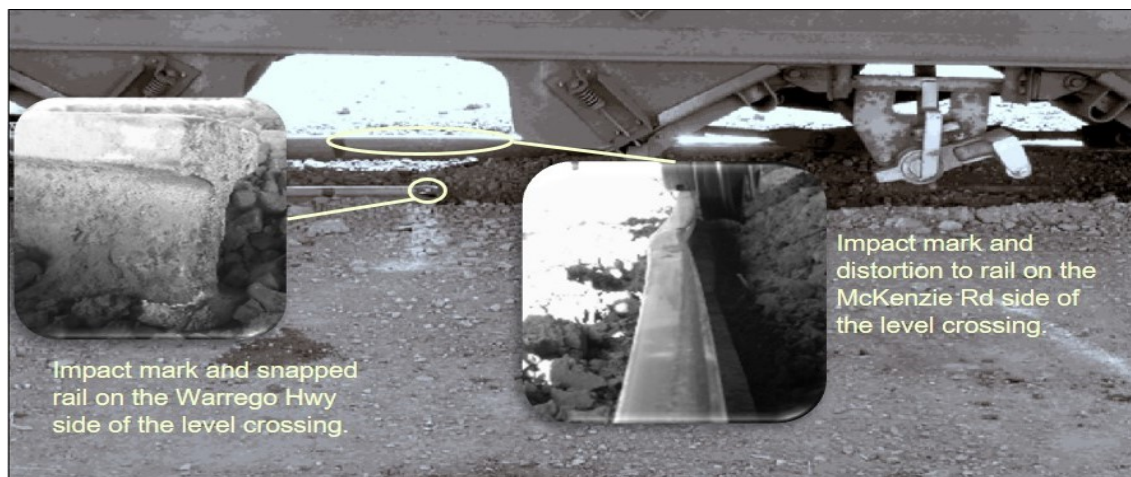
**Figure 8: Damage to the rails at level crossing ID 2309**

The rail on the Warrego Highway side of the level crossing, which took the initial impact, was broken at the impact mark. The matching impact mark to the head of the parallel rail showed distortion to the gauge face, resulting in a gauge disparity of 55 mm (Figure 8).

The image shows corresponding impact marks in the head of each rail, which distorted the gauge and compromised the track integrity.  
Source: ATSB

The impact marks to each rail were located in the middle of the level crossing, between the wheel furrows made by road vehicles as they passed over the level crossing.

Laboratory testing of a section of the damaged rail and the analysis of fracture propagation marks indicated that a factor external to the rail environment was involved in the lateral displacement of the rails. More specifically, the impact marks on each railhead indicated that the underframe of a low-clearance heavy road vehicle struck the track at some stage prior to the derailment. The impact marks confirmed that the road vehicle involved entered the level crossing from the Warrego Highway side.

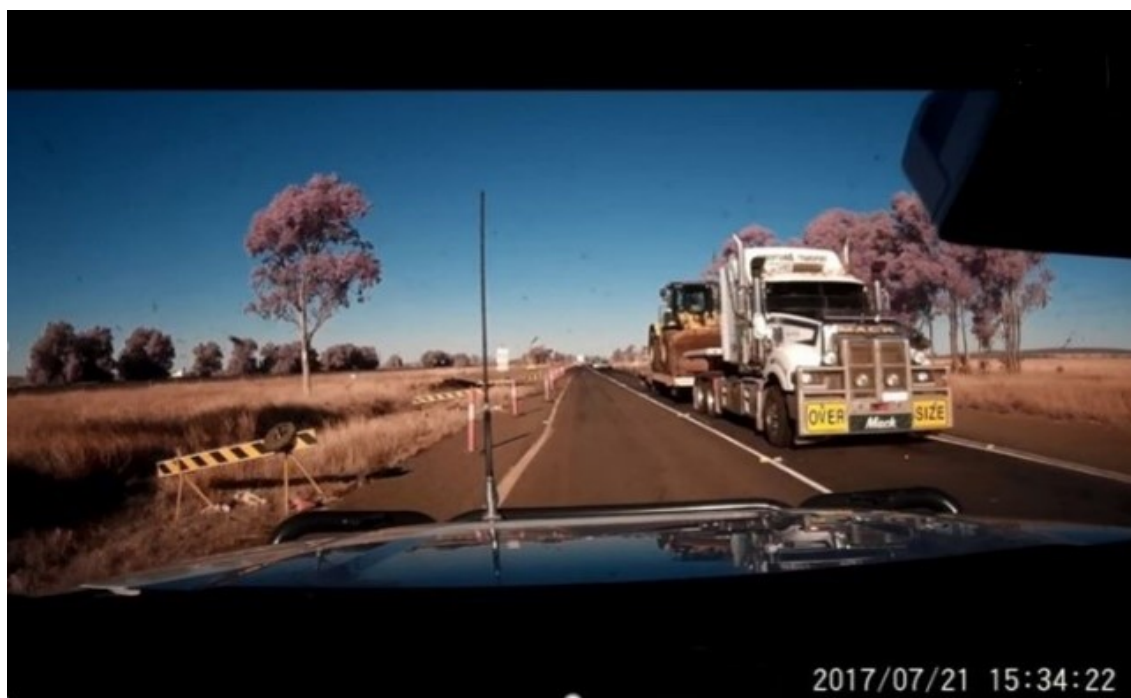
**Figure 10: Dash camera footage from a private vehicle**

At about 1534 on 21 July 2017, video footage recorded by a camera fitted to a private vehicle travelling east on the Warrego Highway showed a prime mover and low-loader combination travelling west on approach to level crossing ID 2309. The heavy road vehicle was transporting a yellow front-end loader (Figure 10).

*The image shows a prime mover and low-loader carrying a front-end loader as it approached level crossing ID 2309. The time stamped on the image is 1534:22 on Friday 21 July 2017. Source: private vehicle operator*

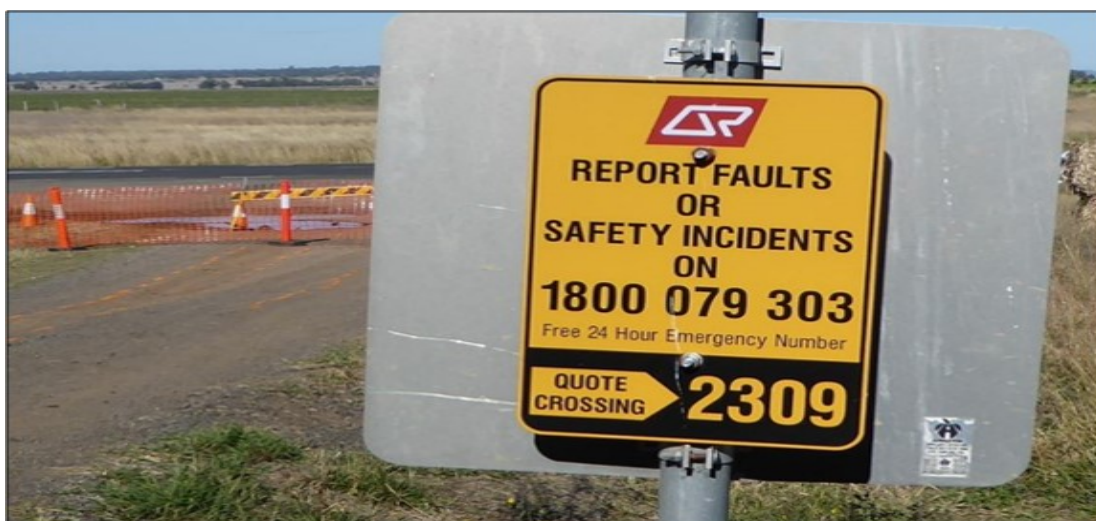
**Figure 11: Incident reporting sign at level crossing ID 2309**

There were 'incident reporting signs' in place at the level crossing on the day the railway infrastructure was damaged. The signs provided an emergency contact number for reporting faults or safety incidents at the level crossing (Figure 11).

On the day of the derailment, no advice of rail infrastructure damage at the level crossing was received by QR or the local police.

The image shows the incident reporting sign and the emergency contact number, in place at level crossing ID 2309 on the day of the derailment.
