Pilot incapacitation involving Piper PA-31, VH-TWU

near King Island, Tasmania, on 8 November 2018

ATSB Transport Safety Report
Aviation Occurrence Investigation
AO-2018-075
Final – 25 June 2019

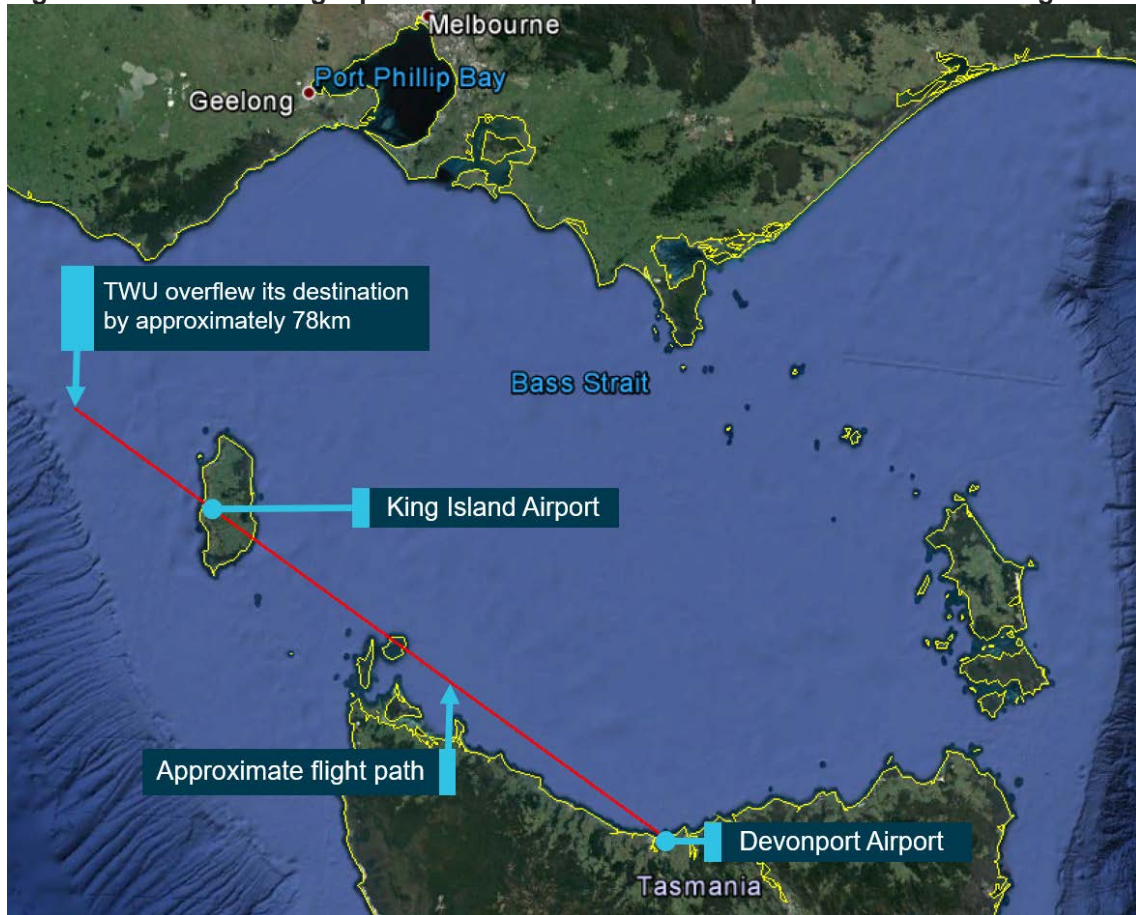
At 0725:12 air traffic control (ATC) attempted to make contact with the pilot regarding his approach into King Island. No response was received. For approximately 8 minutes (between 0725 and 0733), ATC, with assistance from nearby aircraft, attempted contact with the pilot of TWU. At 0733:16 ATC received a transmission from the pilot of TWU who advised that operations were normal. The furthest point reached from the intended destination was approximately 78 km north-west of King Island (Figure 1).

Figure 1: Overview of flight path for VH-TWU and distance past destination of King Island
