Derailment of coal train EF01

Duaringa, Queensland | 24 January 2018

ATSB Transport Safety Report
Rail Occurrence Investigation
RO-2018-005
Final – 28 June 2019

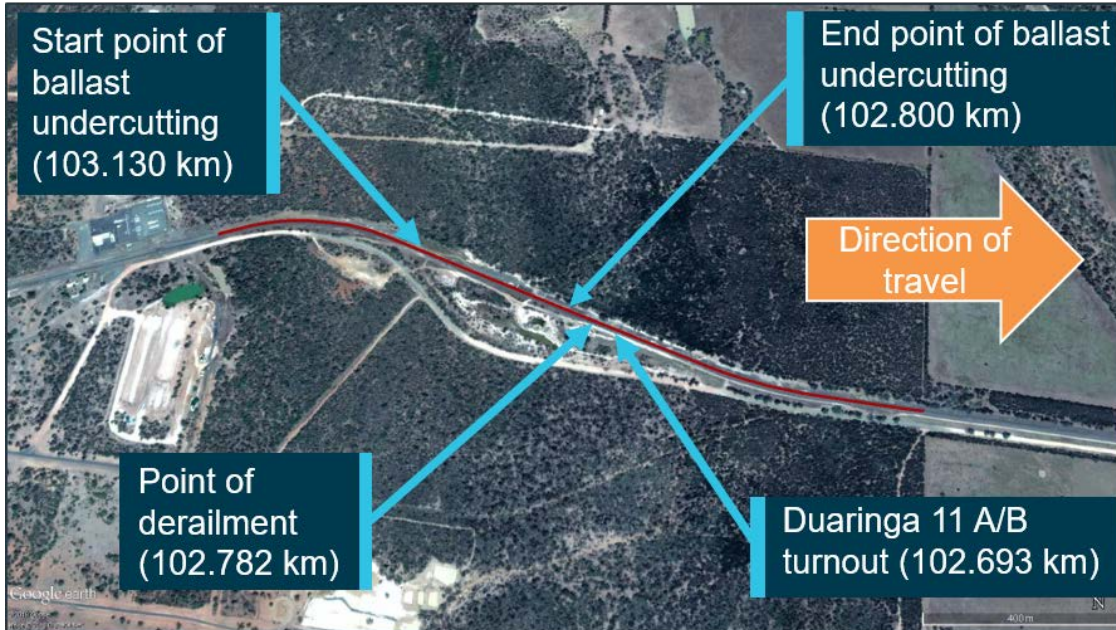
Line voltage was lost, indicating that the 25kV AC overhead line equipment had been damaged, and at 1348, the train came to a halt; 65 seconds after the lead locomotive had passed over the track buckle (Figure 1).

Figure 1: Position of train EF01 after the derailment, and area of ballast undercutting on the Duaringa to Aroona down line

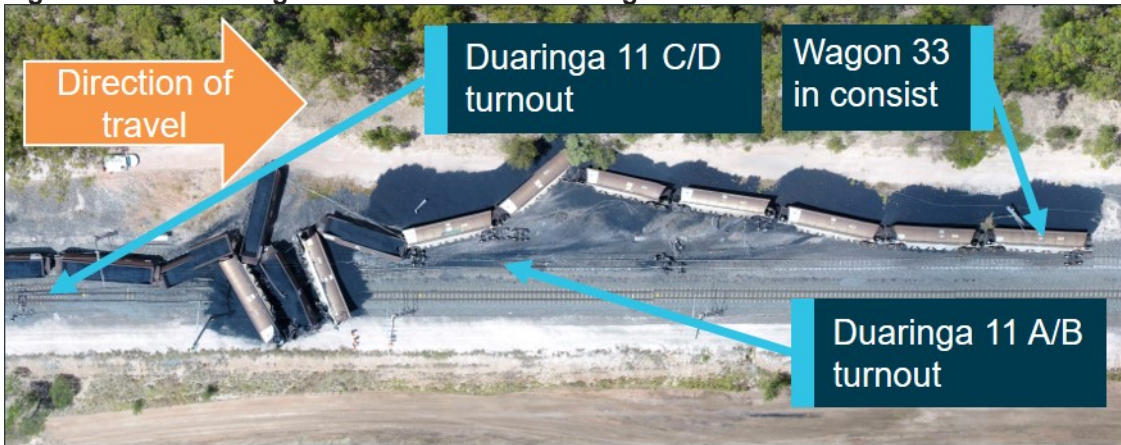
The 13 wagons in positions 33 to 45 were completely derailed. Eleven were on their sides, spread across the up and down lines at the eastern end of Duaringa, over the 11 A/B and 11 C/D turnouts and along the northern side of the track (Figures 2 and 3).

Figure 2: Derailed wagons 33 to 46 on the Duaringa to Aroona down line

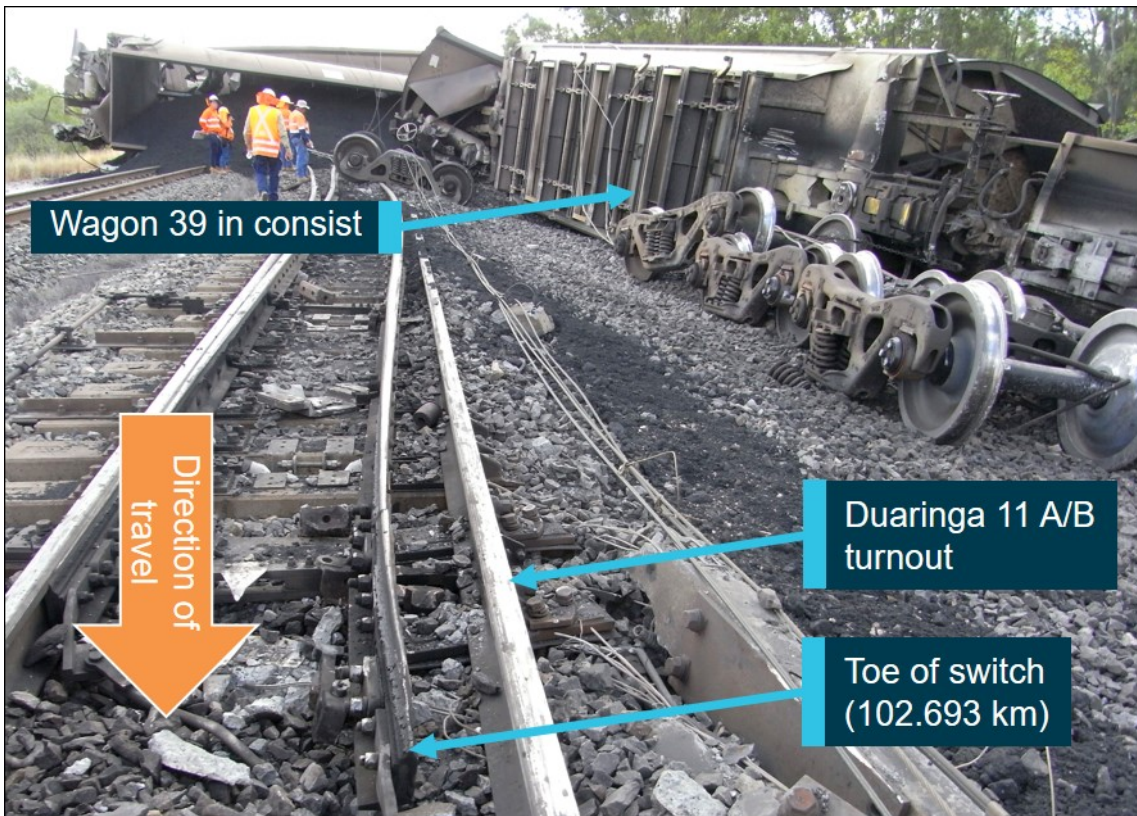
Figure 3: Looking back towards the point of derailment over the damaged 11 A/B turnout.

There were no injuries. Of the 17 wagons that derailed, 13 were extensively damaged and not expected to be repaired. In addition, 502 m of track on the down line and 54 m of track on the adjacent up line was damaged, with rails, sleepers and overhead line equipment requiring replacement.

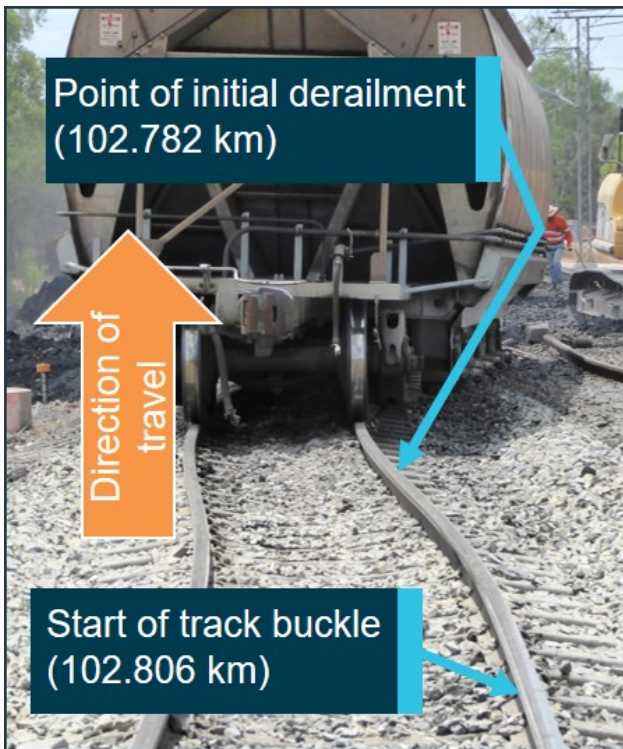
At Duaringa, these factors acted together upon the short section of track between the end point of the ballast undercutting work (102.800 km) and the fixed point associated with the 11 A/B turnout (102.693 km). A track buckle was seen by the driver to begin to form as loaded coal train EF01 approached (Figure 4).

Figure 4: Track buckle, point of derailment and last derailed wagon (46 in consist)

As the train passed over it, the amplitude of the buckle increased. The lead locomotive and first 11 wagons ran over the track buckle without derailing before the wheels of wagon 12 were unable to steer through it. The right-hand wheel of the leading wheelset of the leading bogie climbed over the head of the rail and derailed at 102.782 km.

The buckle developed laterally and assumed a full 'S' shape. Wagons 33 to 45 were subject to extreme lateral forces as they passed over it and derailed completely.

If compressive rail stress had been identified as a hazard at the site, it is likely that arrangements would have been made to impose a temporary speed restriction on the track section on completion of the ballast cleaning work. A temporary speed restriction would have reduced the risk of a train derailment.
