From: s. 47F(1)
Sent: Monday, 27 July 2015 12:04 PM
To: ATSB - Comms
Cc: s. 47F(1)
Subject: FW: AO-2015-086 Collision with terrain involving a PA32 aircraft, VH-BDG at Lakeside Airpark, Queensland on 26 July, 2015 [DLM=For-Official-Use-Only] Aviation Investigation Web Notification.pdf

The ATSB is investigation a collision with terrain at Lakeside Airpark, Queensland on 26 July, 2015 involving a PA32 aircraft, registered VH-BKD. [sic]

During landing, the aircraft struck the runway, then veered off, striking an embankment before coming to a stop in a nearby dam.

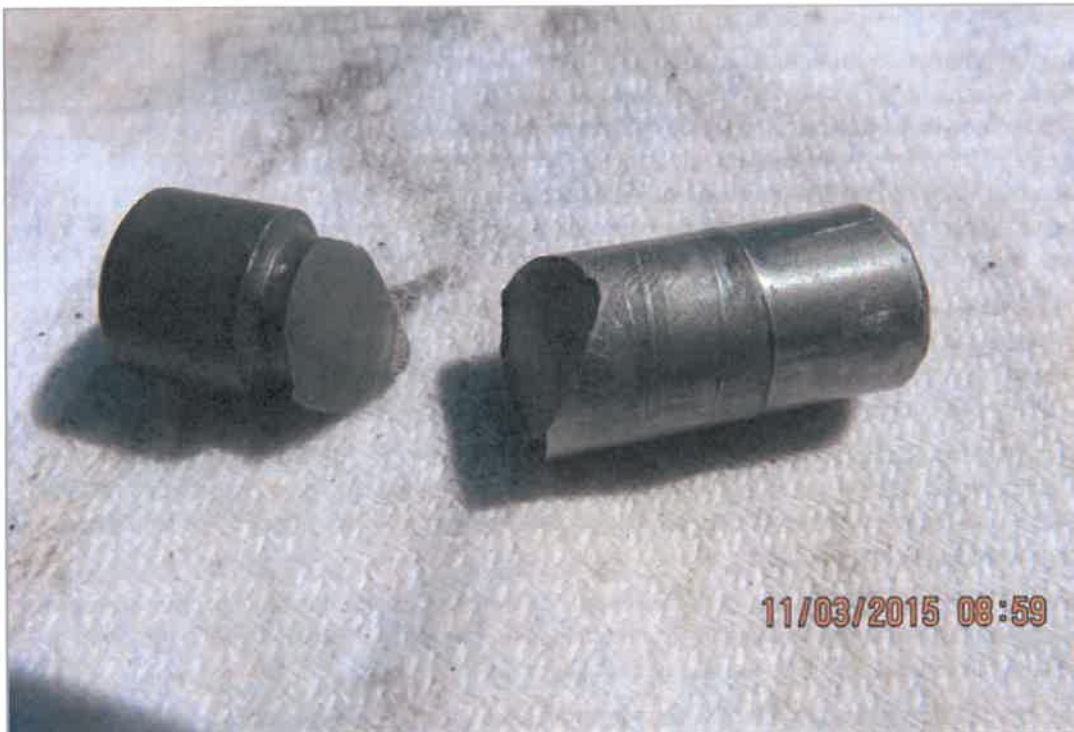
Figure 1: Failed nose landing gear downlock pin

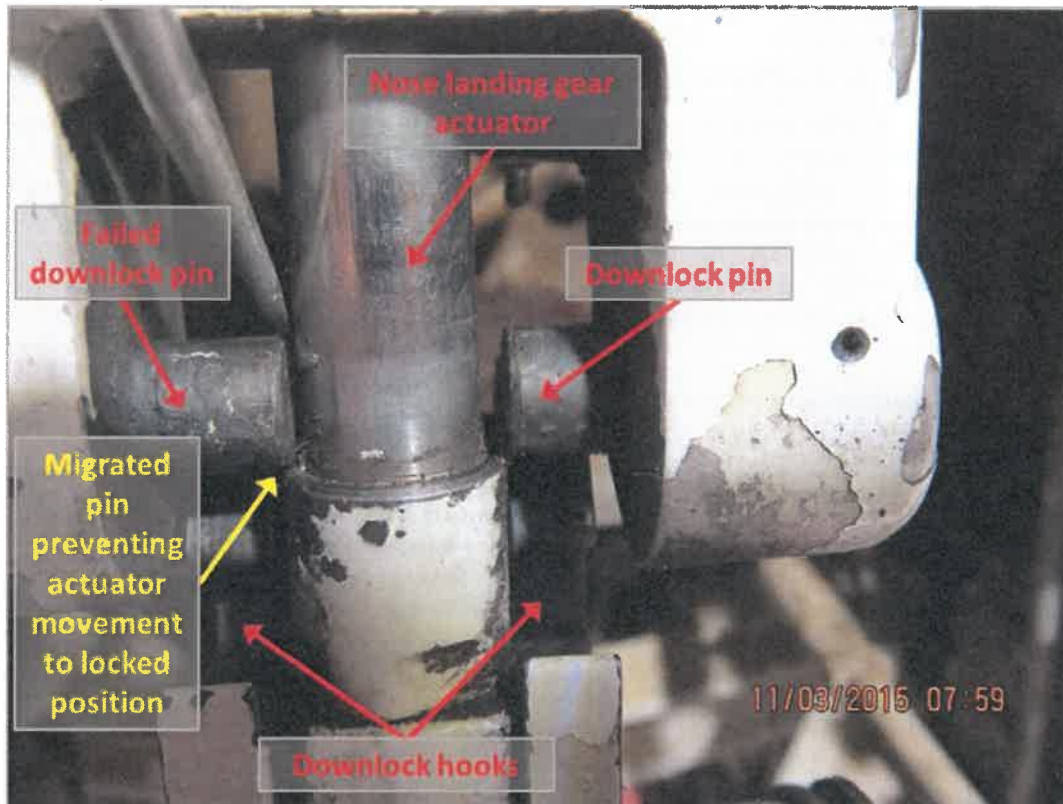
Figure 2: SMP nose landing gear downlock assembly, showing the failed downlock pin preventing actuator movement to the locked position

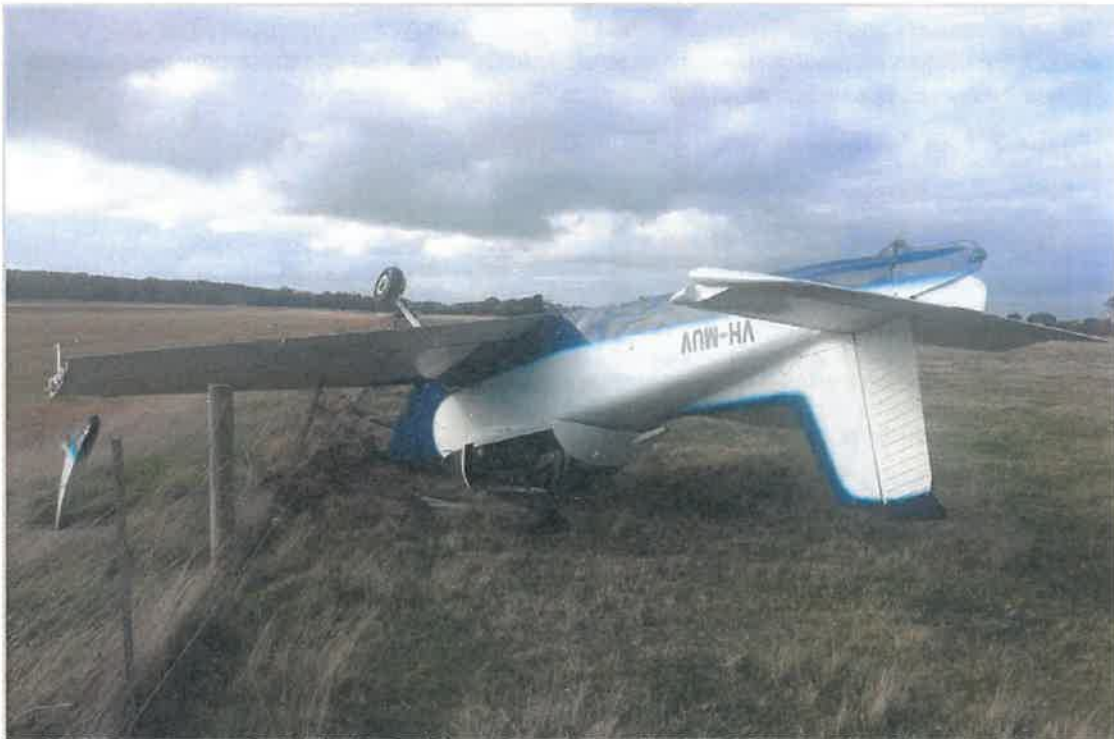
Figure 1: VH-MUV inverted after flipping over the airport perimeter fence

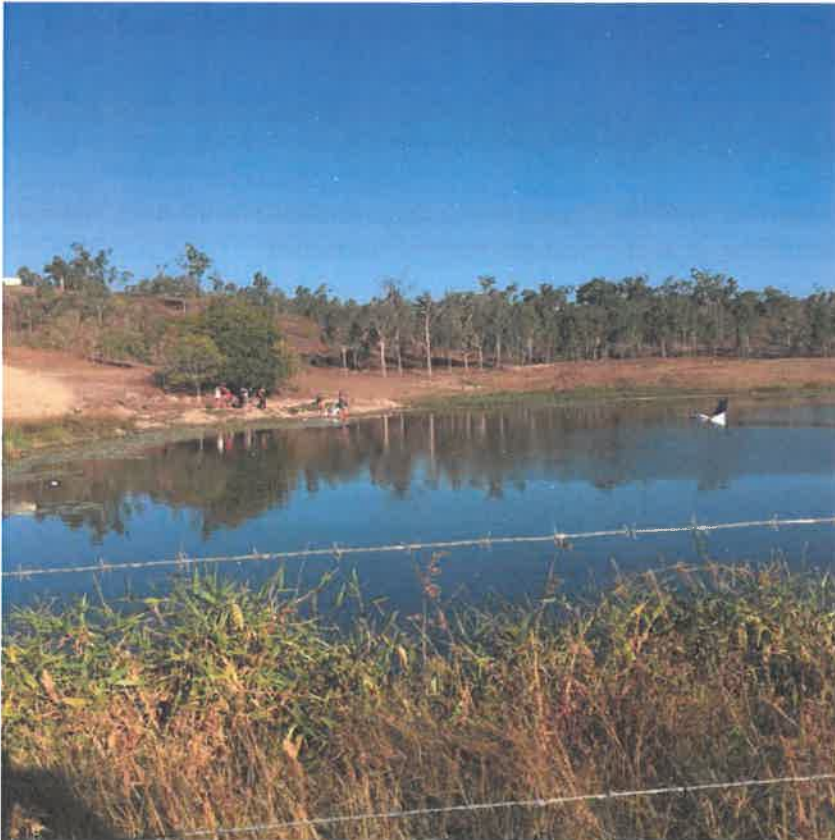
Figure 5: Post accident showing VH-BDG partially submerged in the dam

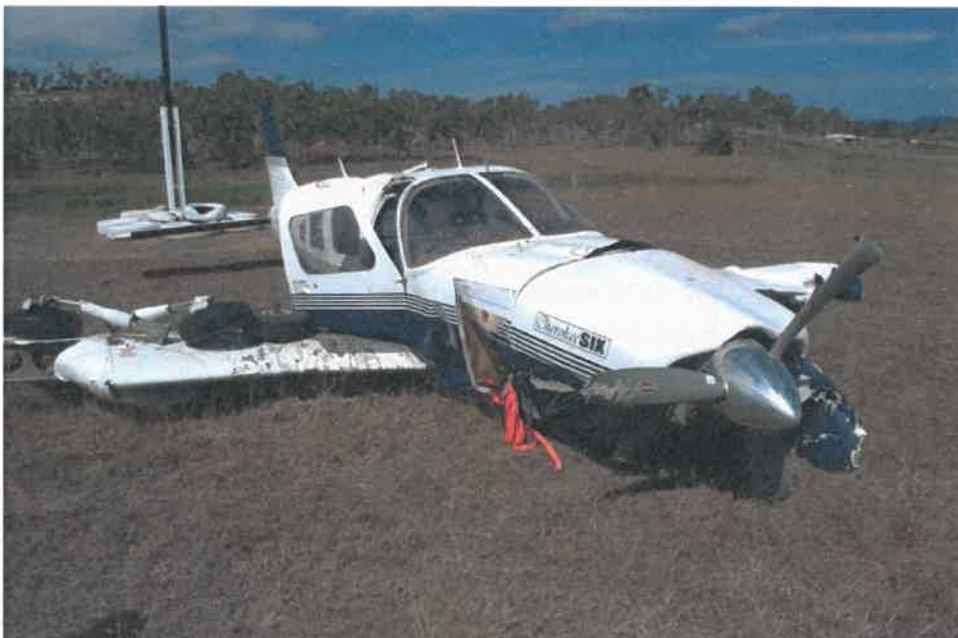
Figure 6: VH-BDG after retrieval from the lake. Passenger 2 (below) reported that the left wing crumpled during the 'cartwheeling' toward the lake. Note: Significant damage occurred during the retrieval process

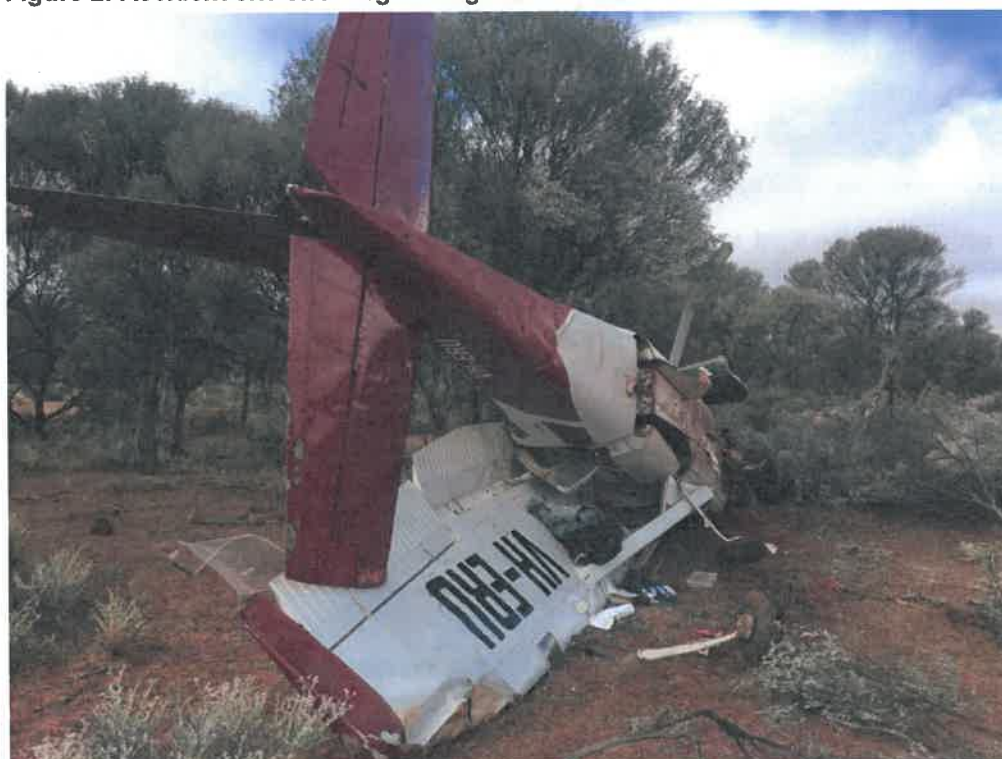
Figure 2: Accident site showing damage to VH-ERU

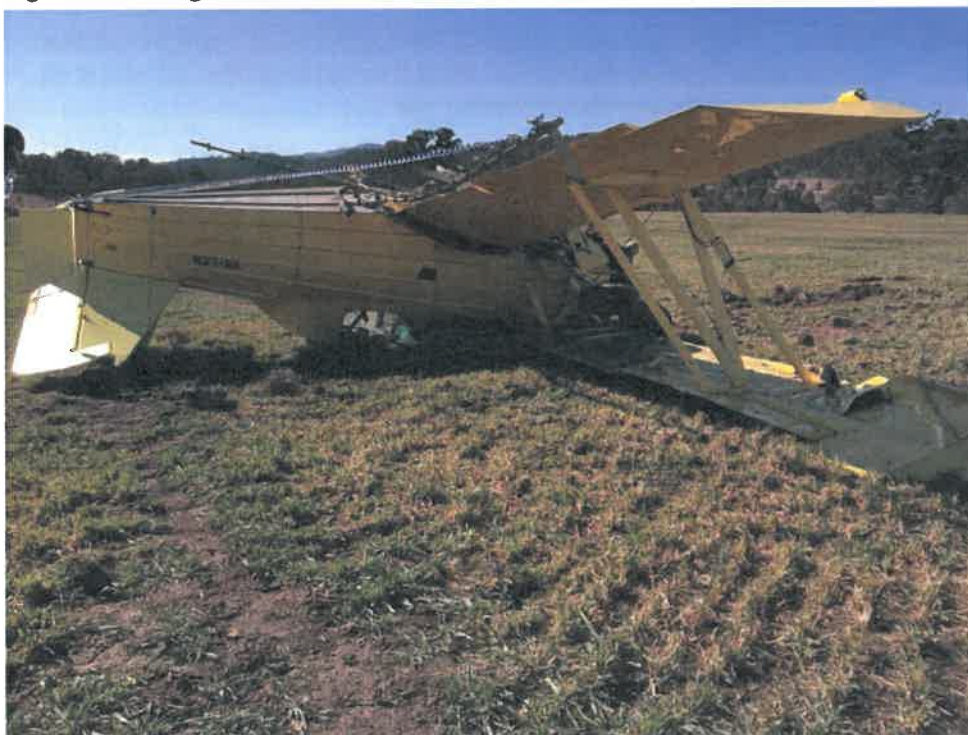
Figure 2: Damage to VH-LKN

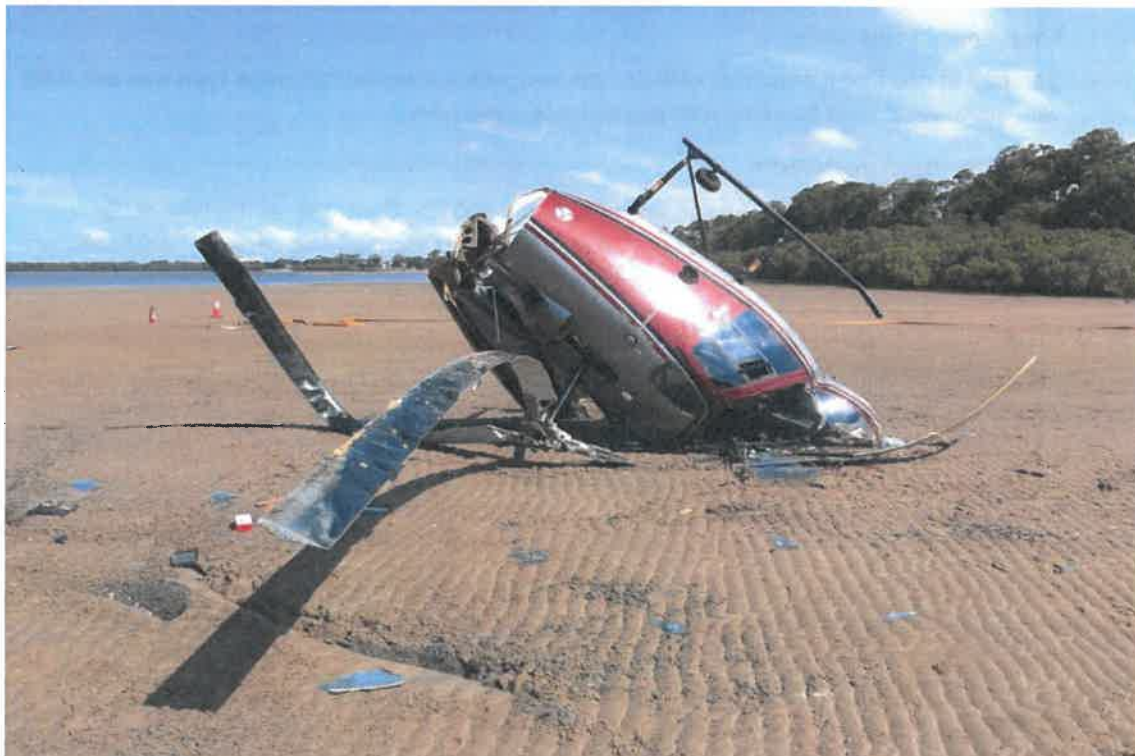
Figure 1: Accident site showing the damage to VH-YHD

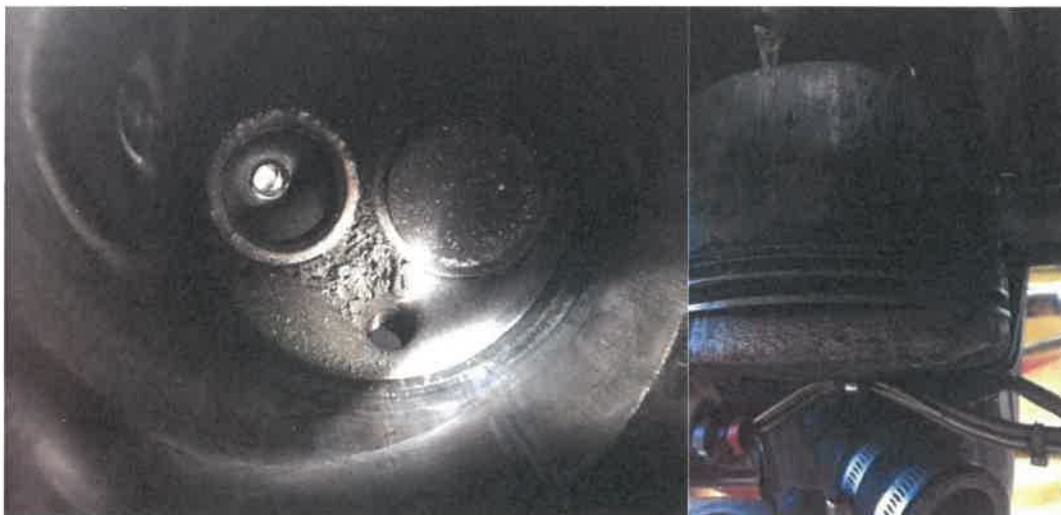
Figure 2: Damage to number three cylinder and piston

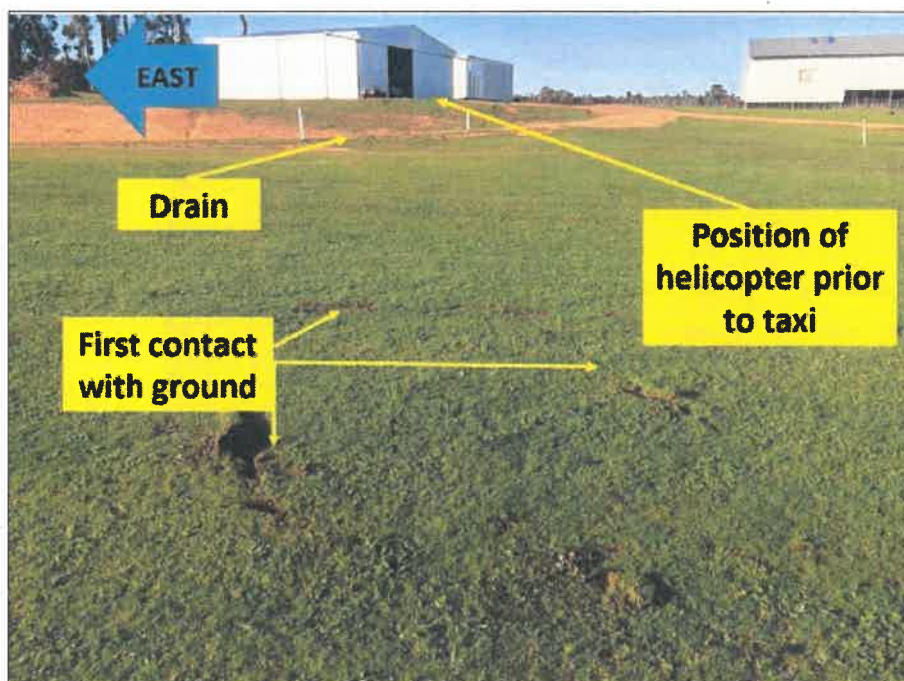
Figure 1: Marks where the helicopter tail and skid struck the ground. The drain the pilot planned to clear prior to transitioning to forward flight and hangar are in the background

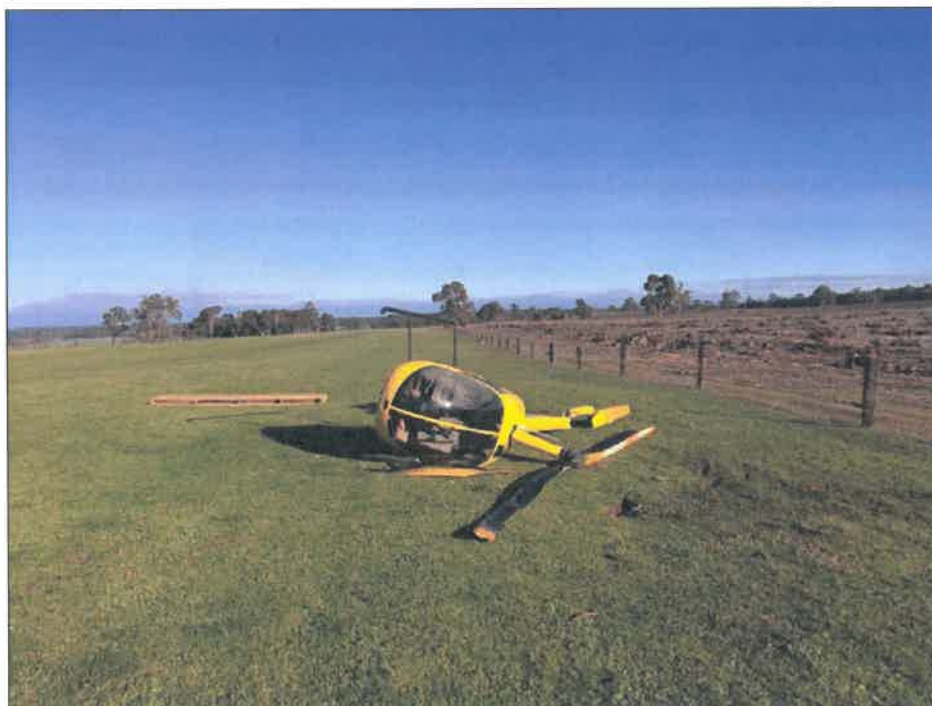
Figure 2: VH-RBT at rest on the left side. Note the broken tail boom and rotor blades

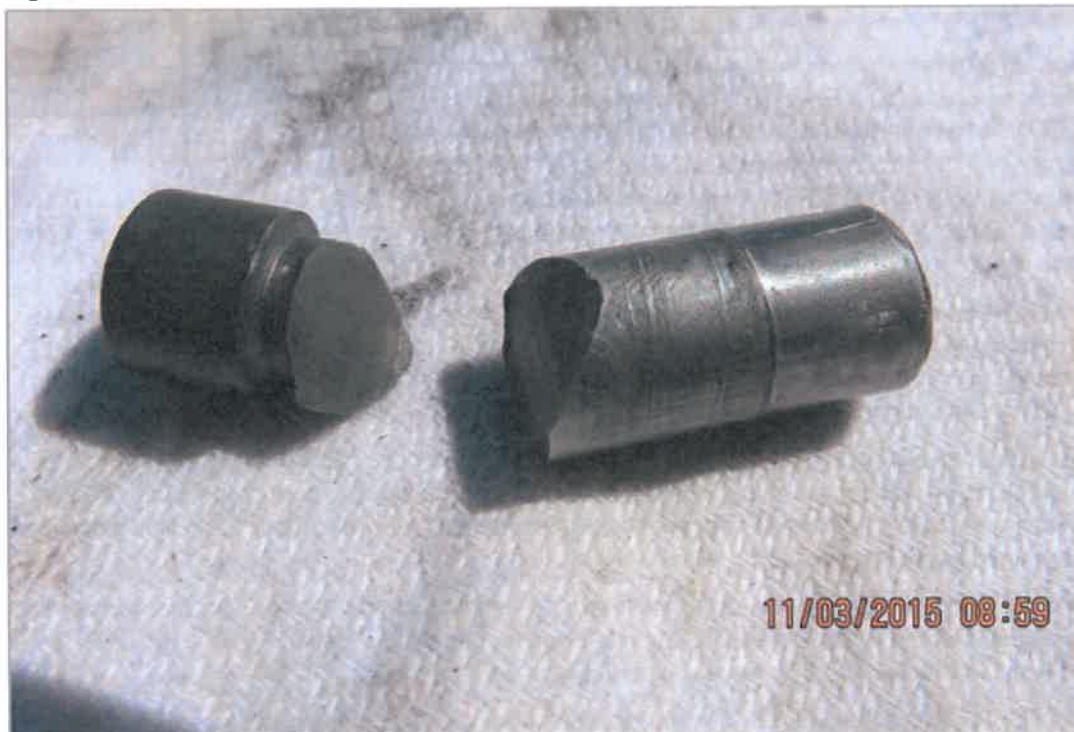
Figure 1: Failed nose landing gear downlock pin

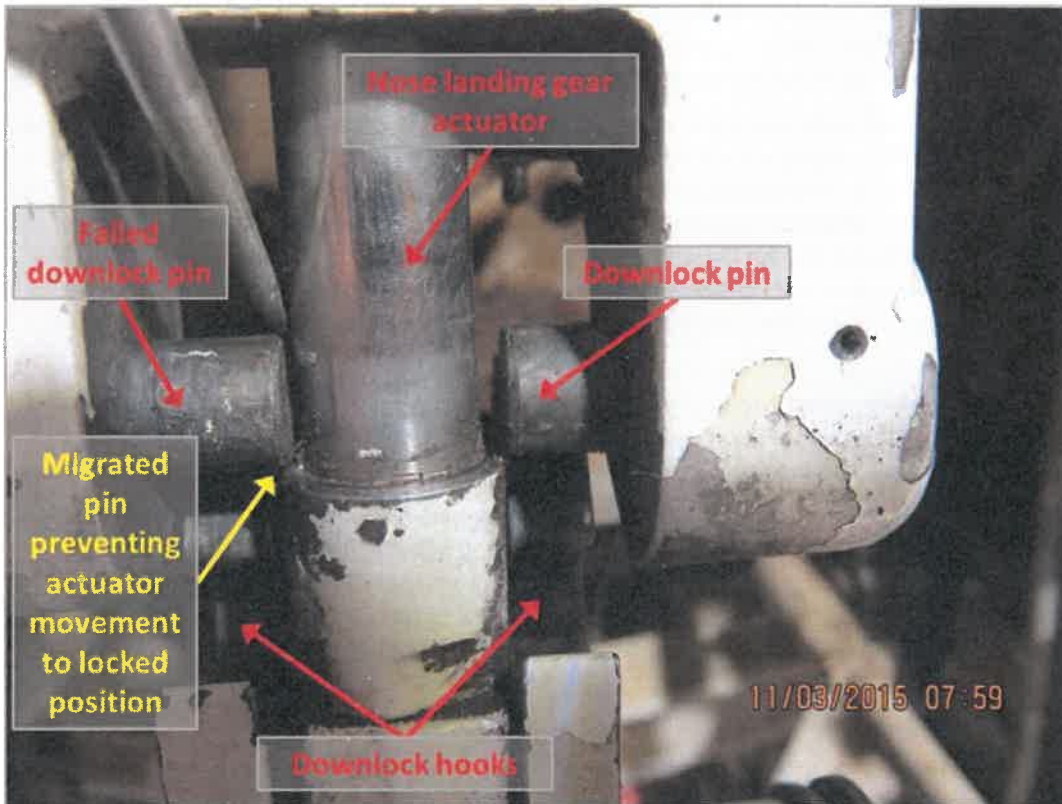
Figure 2: SMP nose landing gear downlock assembly, showing the failed downlock pin preventing actuator movement to the locked position

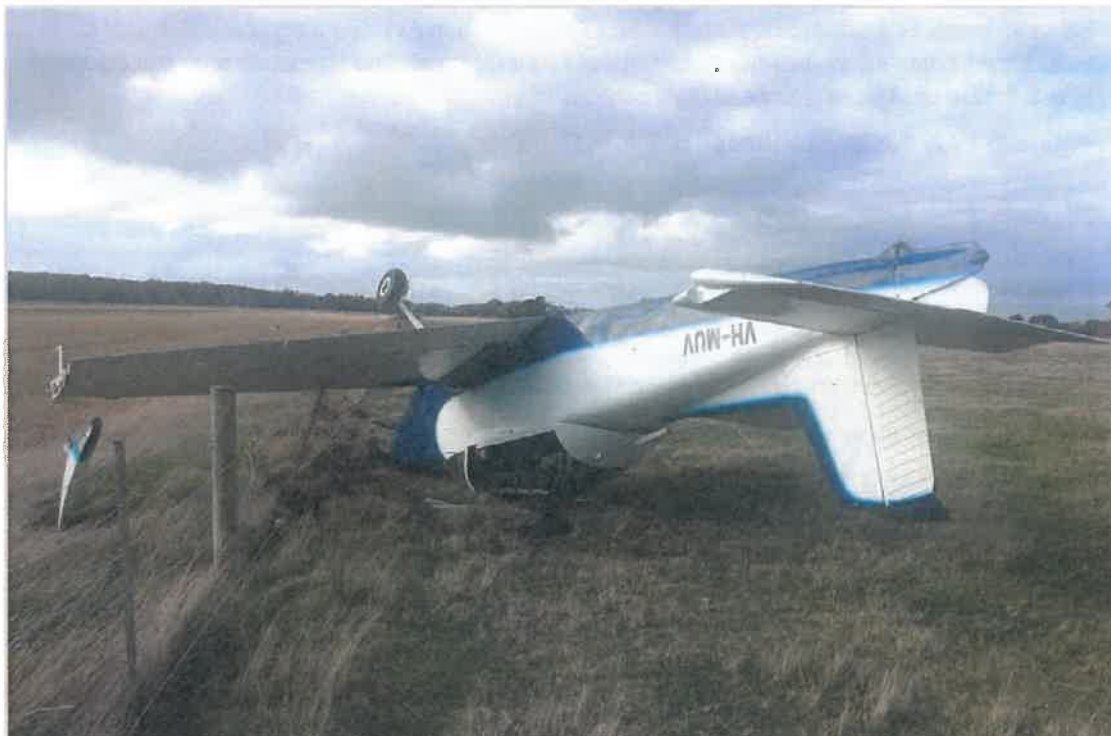
Figure 1: VH-MUV inverted after flipping over the airport perimeter fence

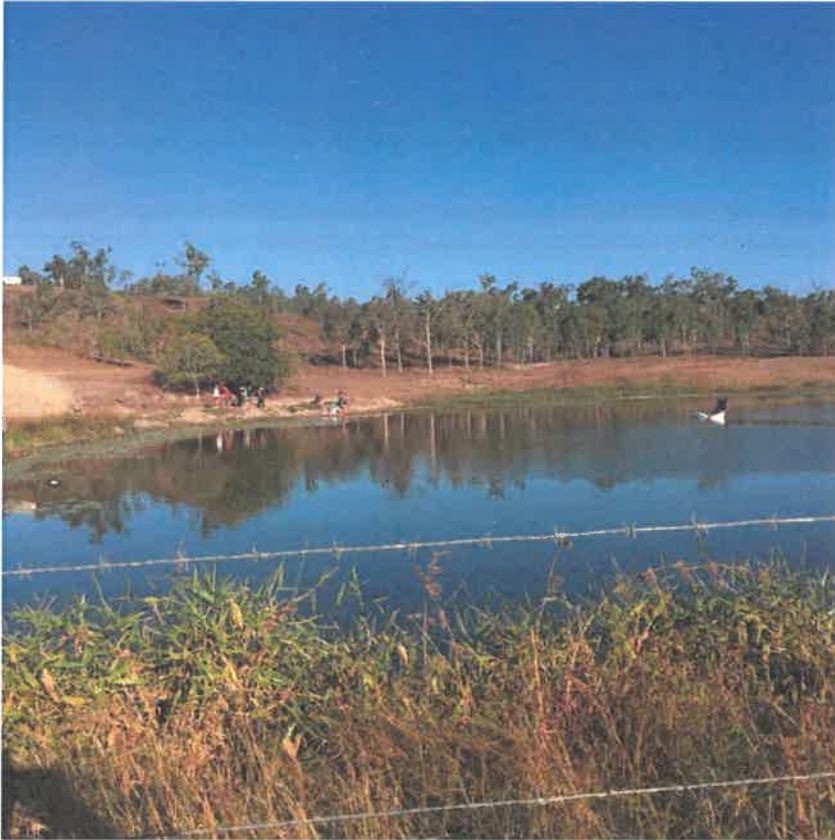
Figure 5: Post accident showing VH-BDG partially submerged in the dam

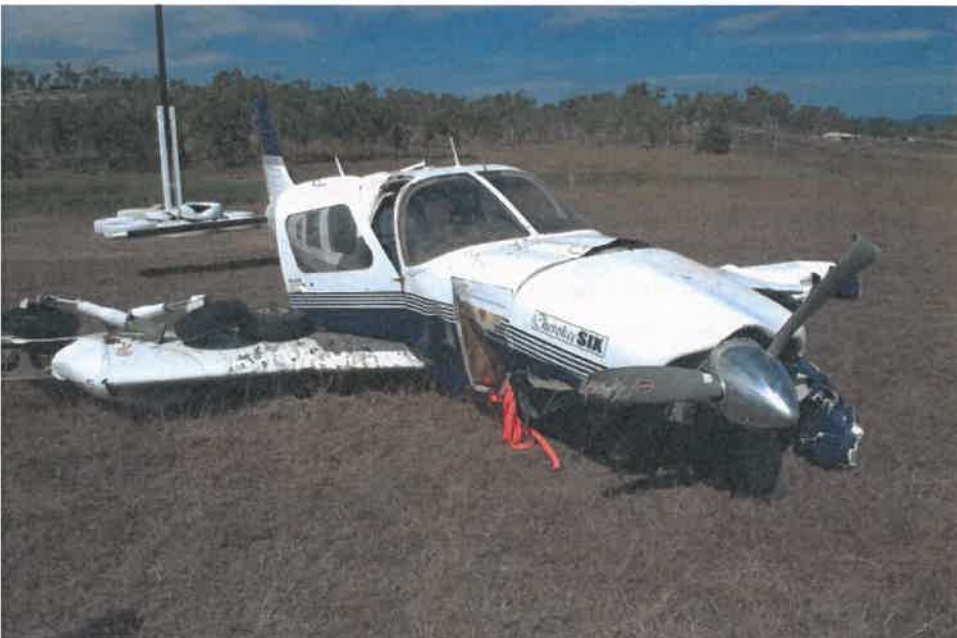
Figure 6: VH-BDG after retrieval from the lake. Passenger 2 (below) reported that the left wing crumpled during the 'cartwheeling' toward the lake. Note: Significant damage occurred during the retrieval process

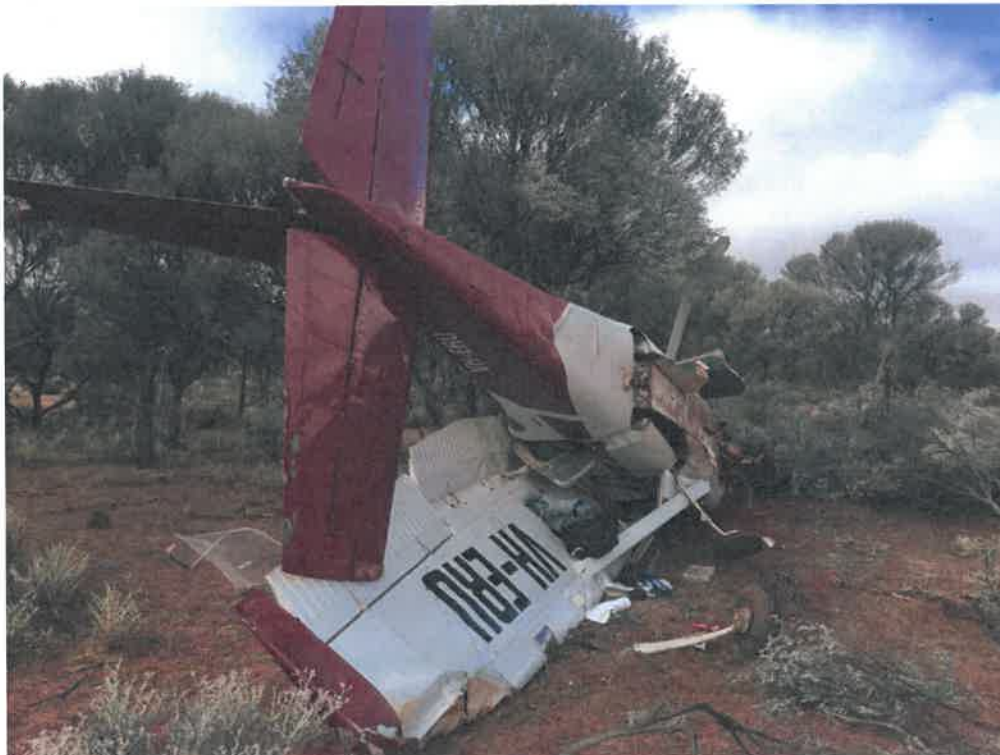
Figure 2: Accident site showing damage to VH-ERU

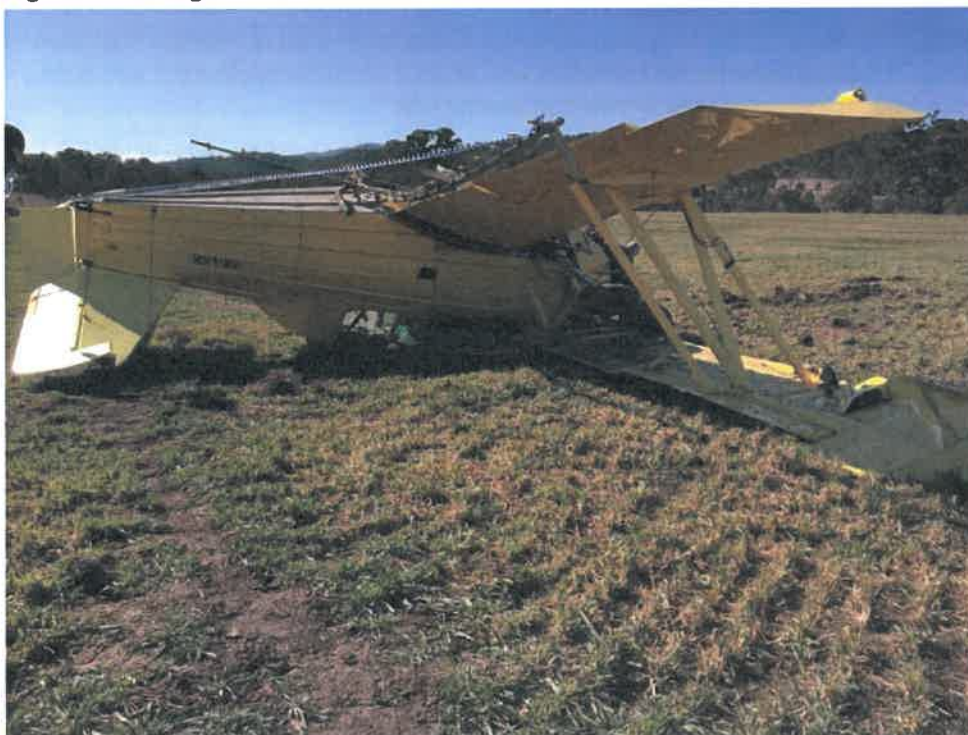
Figure 2: Damage to VH-LKN

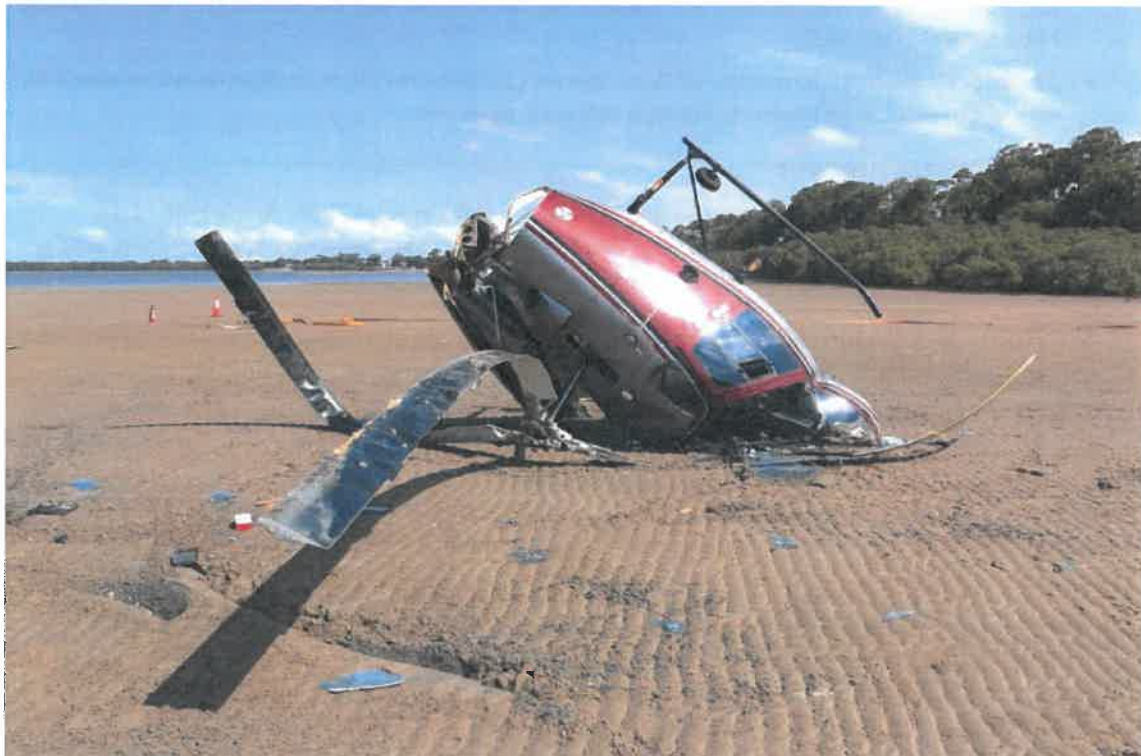
Figure 1: Accident site showing the damage to VH-YHD

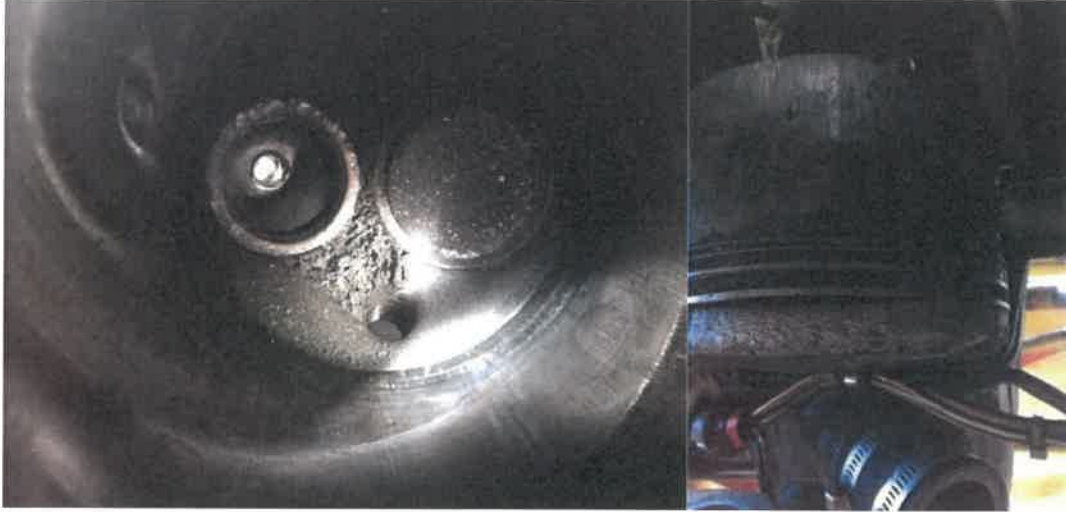
Figure 2: Damage to number three cylinder and piston

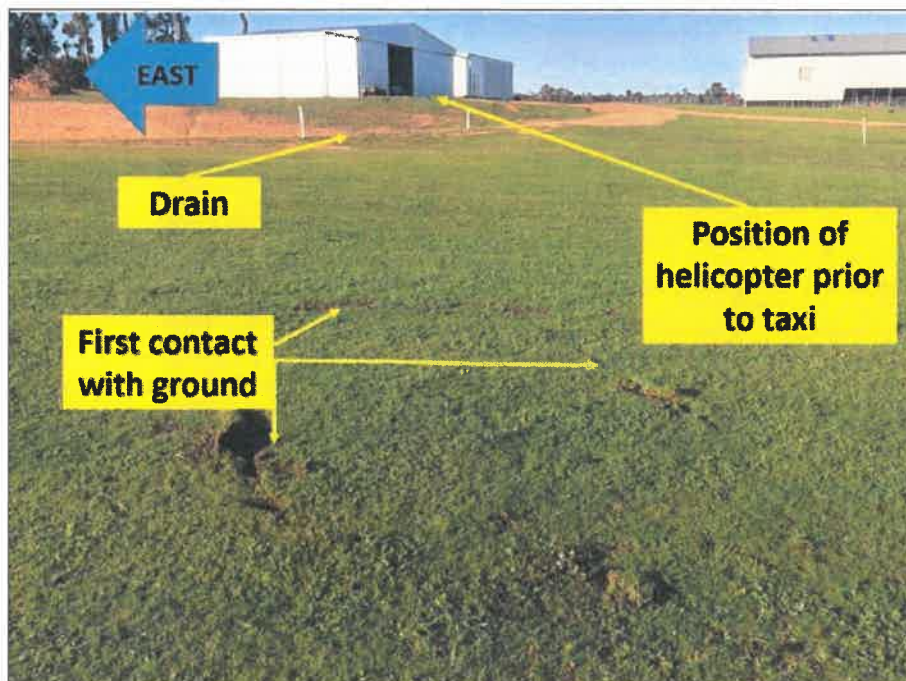
Figure 1: Marks where the helicopter tail and skid struck the ground. The drain the pilot planned to clear prior to transitioning to forward flight and hangar are in the background

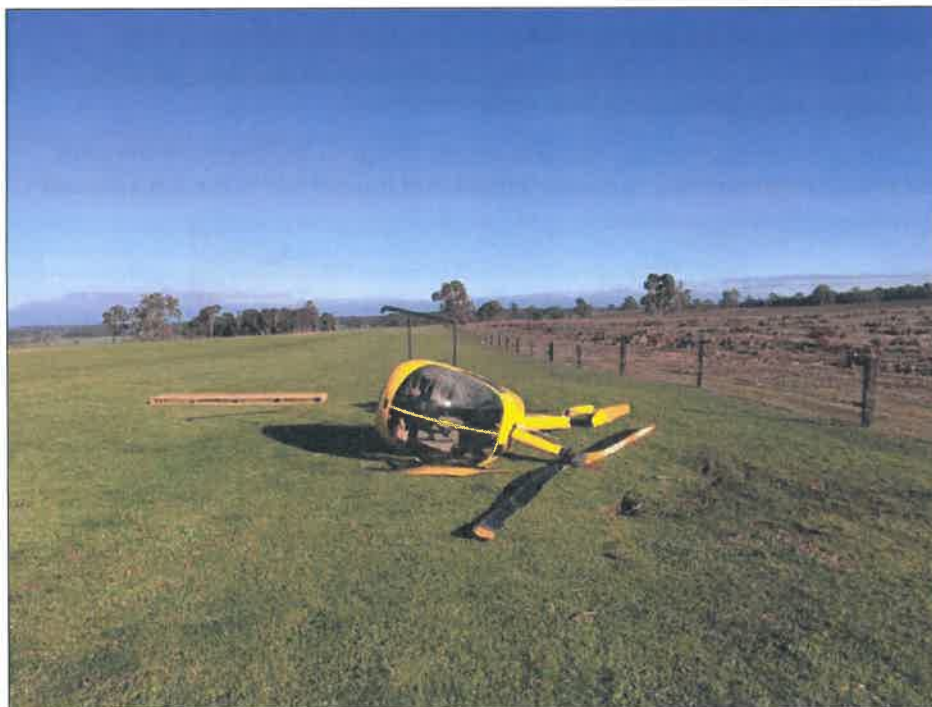
Figure 2: VH-RBT at rest on the left side. Note the broken tail boom and rotor blades
